## Site Management Plan

Pelham Bay Landfill  
Bronx, New York  
NYSDEC Index # 2-03-001

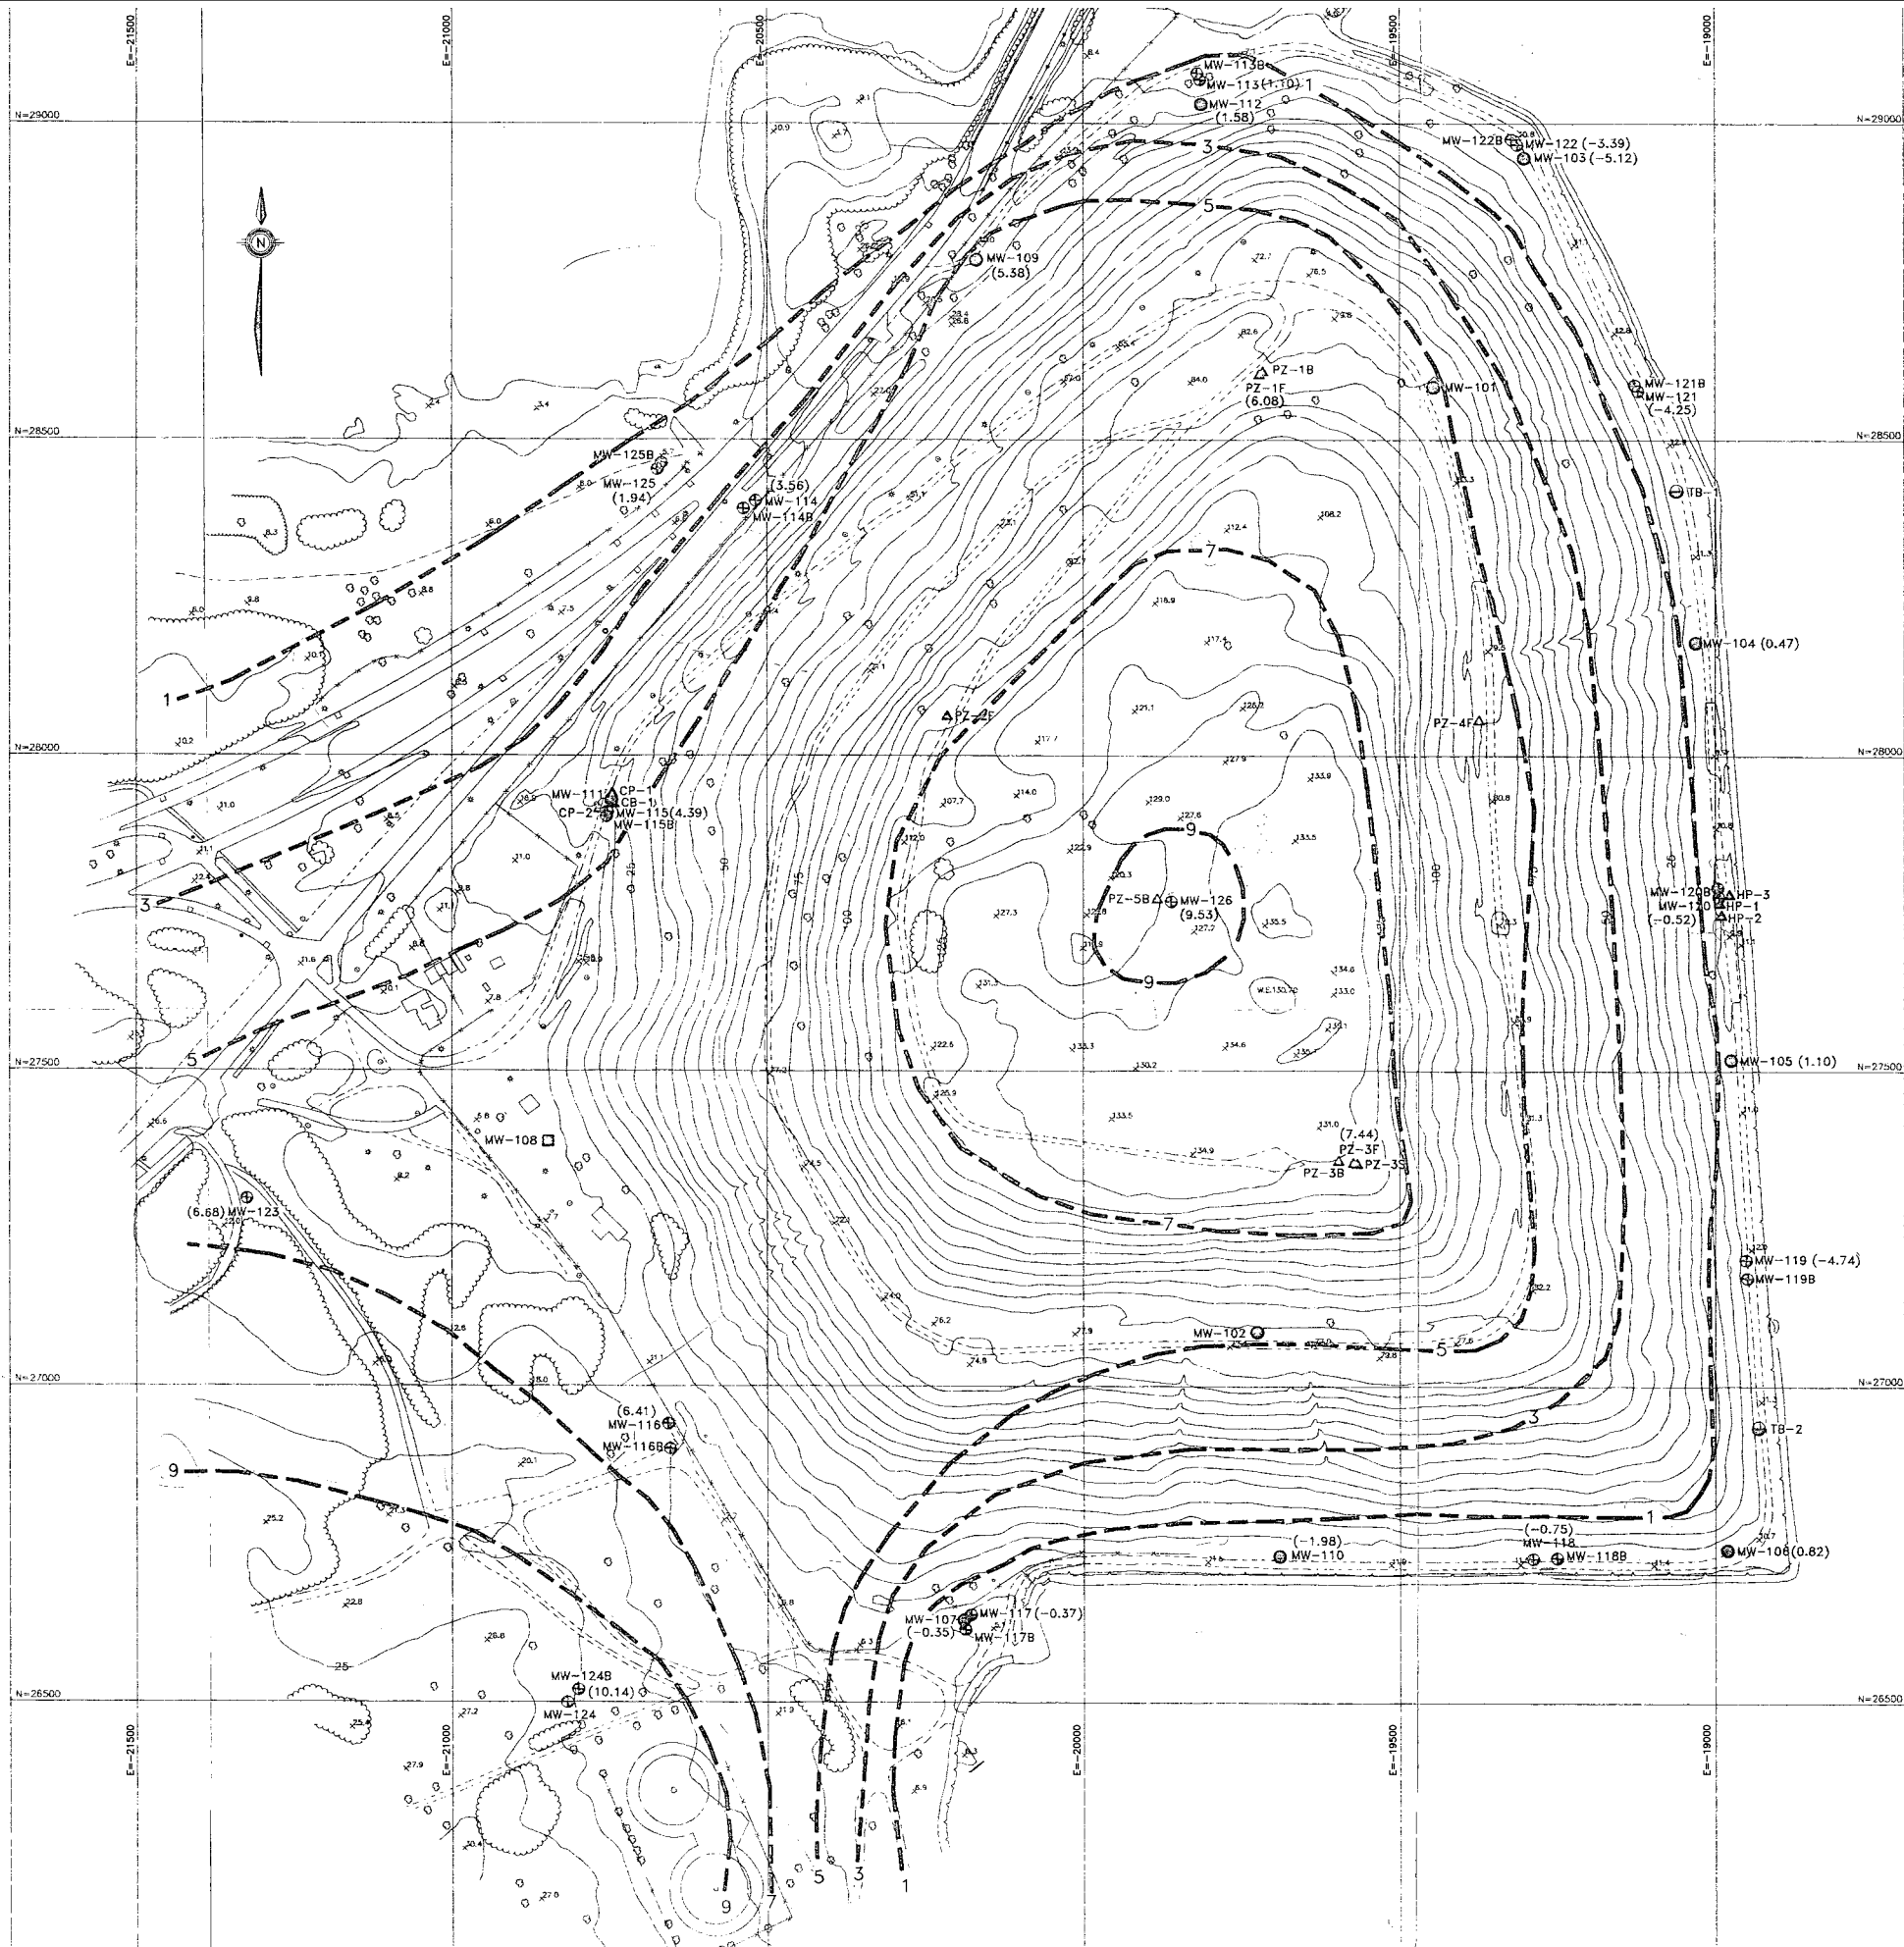
- LEGEND:**
- MW-103 MONITORING WELLS INSTALLED 1989
  - MW-108 MONITORING WELL DESTROYED DURING IRM
  - PZ-3B PIEZOMETER INSTALLED 1992
  - MW-113 MONITORING WELLS INSTALLED 1992
  - MW-116B BEDROCK WELLS INSTALLED 1992
  - TB-1 TEST BORING ADVANCED 1992
  - (-1.9B) GROUNDWATER ELEVATIONS, NOVEMBER 5, 1992
  - - - 5 - - - GROUNDWATER ELEVATION CONTOURS - LOW TIDE

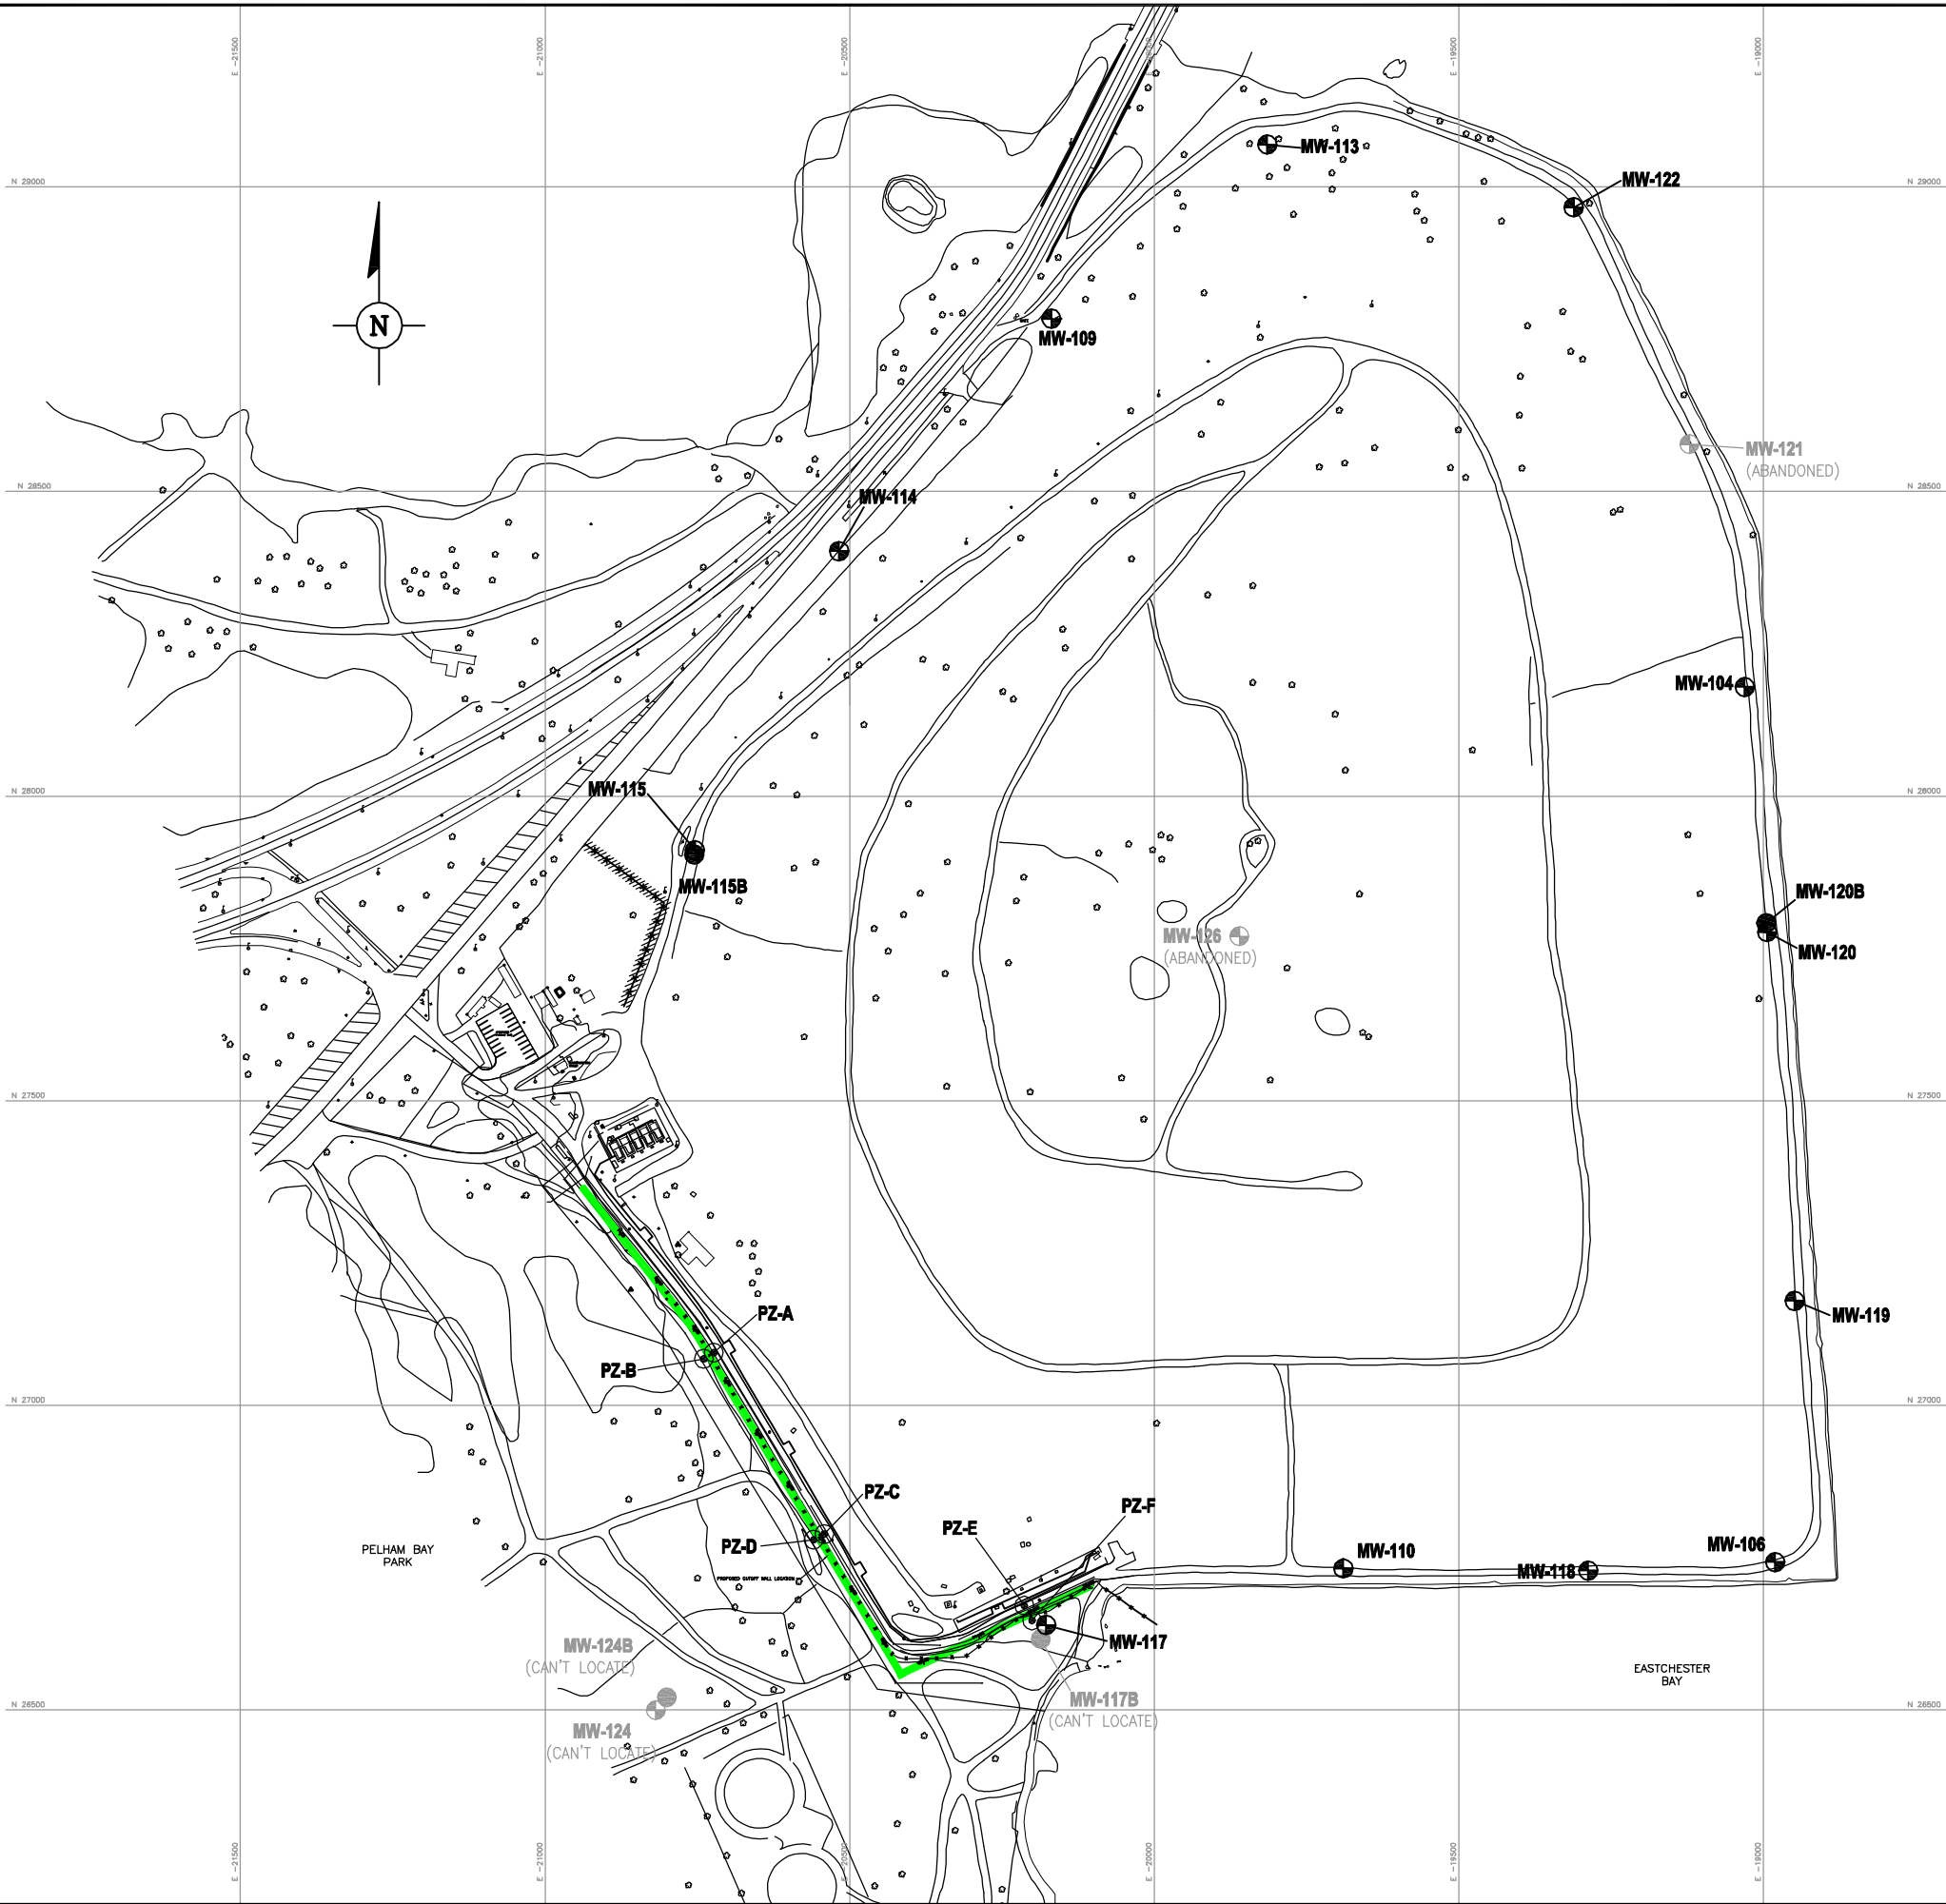
- MW-103 MONITORING WELL
- MW-120B BEDROCK MONITORING WELL
- PZ-A PIEZOMETERS
- FORMER MONITORING WELLS
- SLURRY WALL
