**Fountain Avenue Landfill  
Brooklyn, New York  
NYSDEC Site No. 224003**

**Annual Post Closure Operation, Maintenance  
and Monitoring Program  
January 2022 through December 2022**

**March 2023**

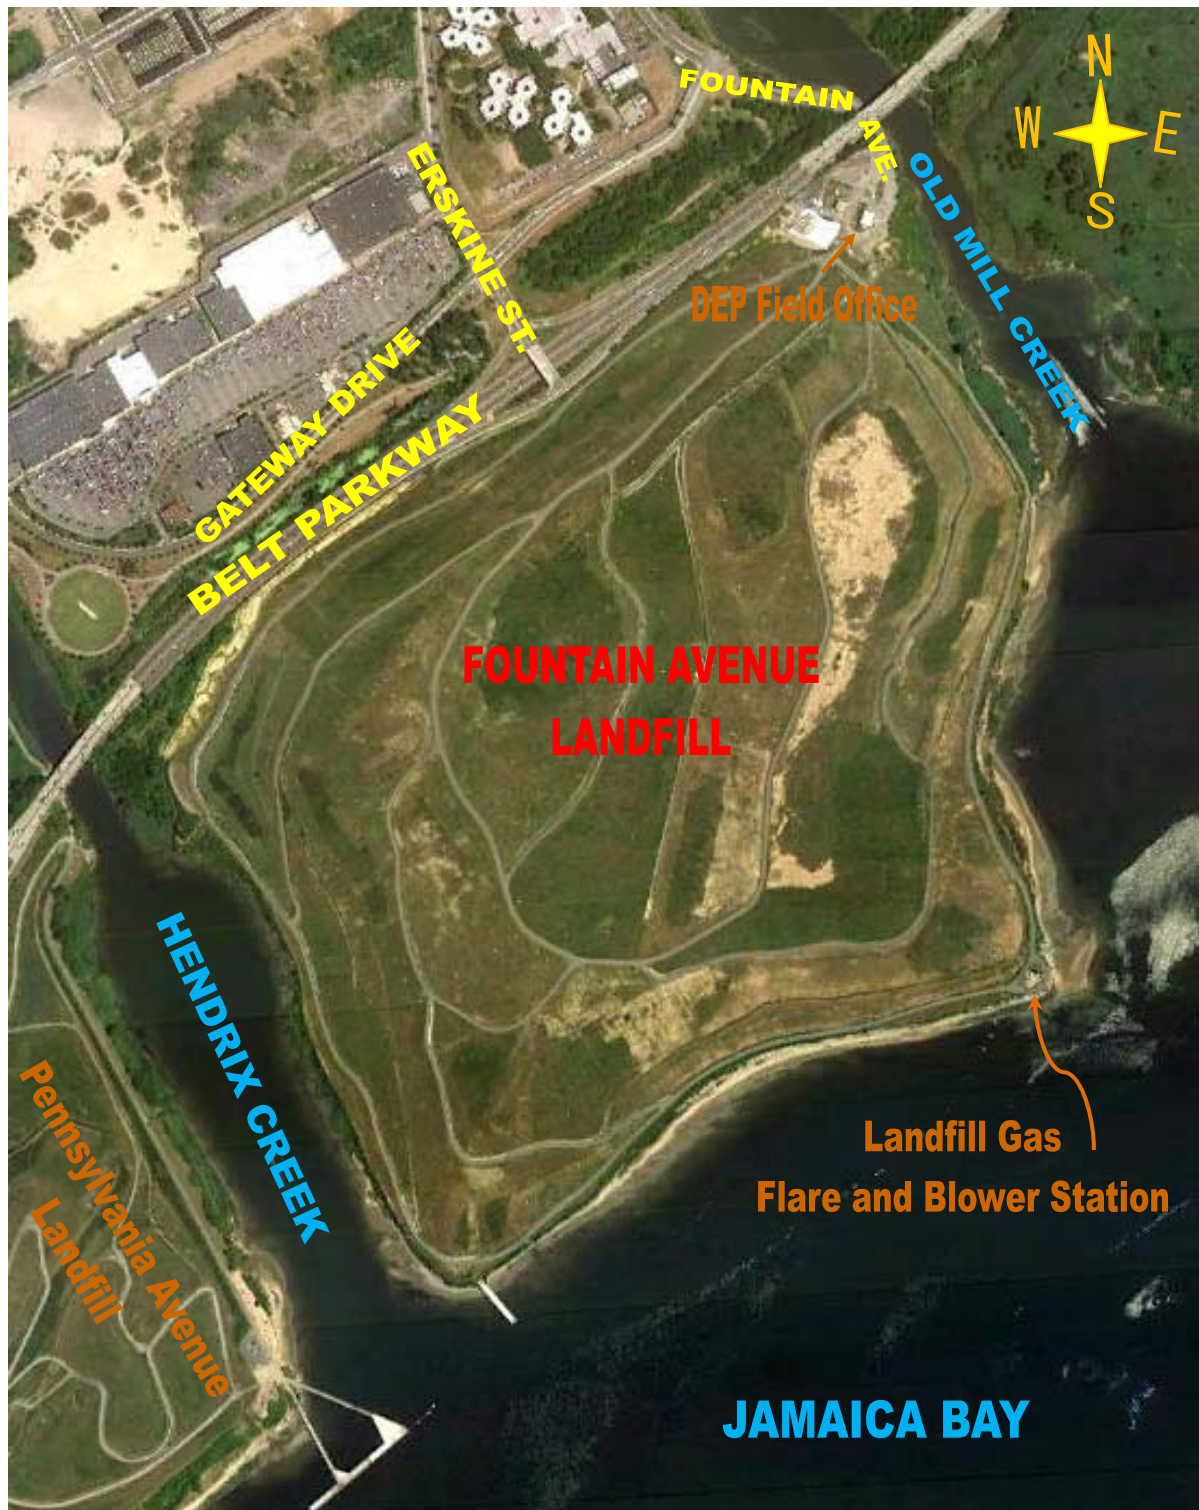
Figure 1: Fountain Avenue Landfill  
Site Map

The FAL is an inactive hazardous waste disposal site located on 297 acres at the southern end of Fountain Avenue in Brooklyn, New York. It is bounded on the northwest by the Belt Parkway, on the southeast by Jamaica Bay, on the southwest by Hendrix Creek and on the east by Old Mill Creek. A site location map is provided in Figure 1.
