# Supplemental Investigation Report – 222 Maspeth Avenue

Former Equity Works MGP Site 222-254 Maspeth Avenue Brooklyn, Kings County, New York NYSDEC Site No.: 224050 Order of Consent Index #: A2-0552-0606

March 1, 2019

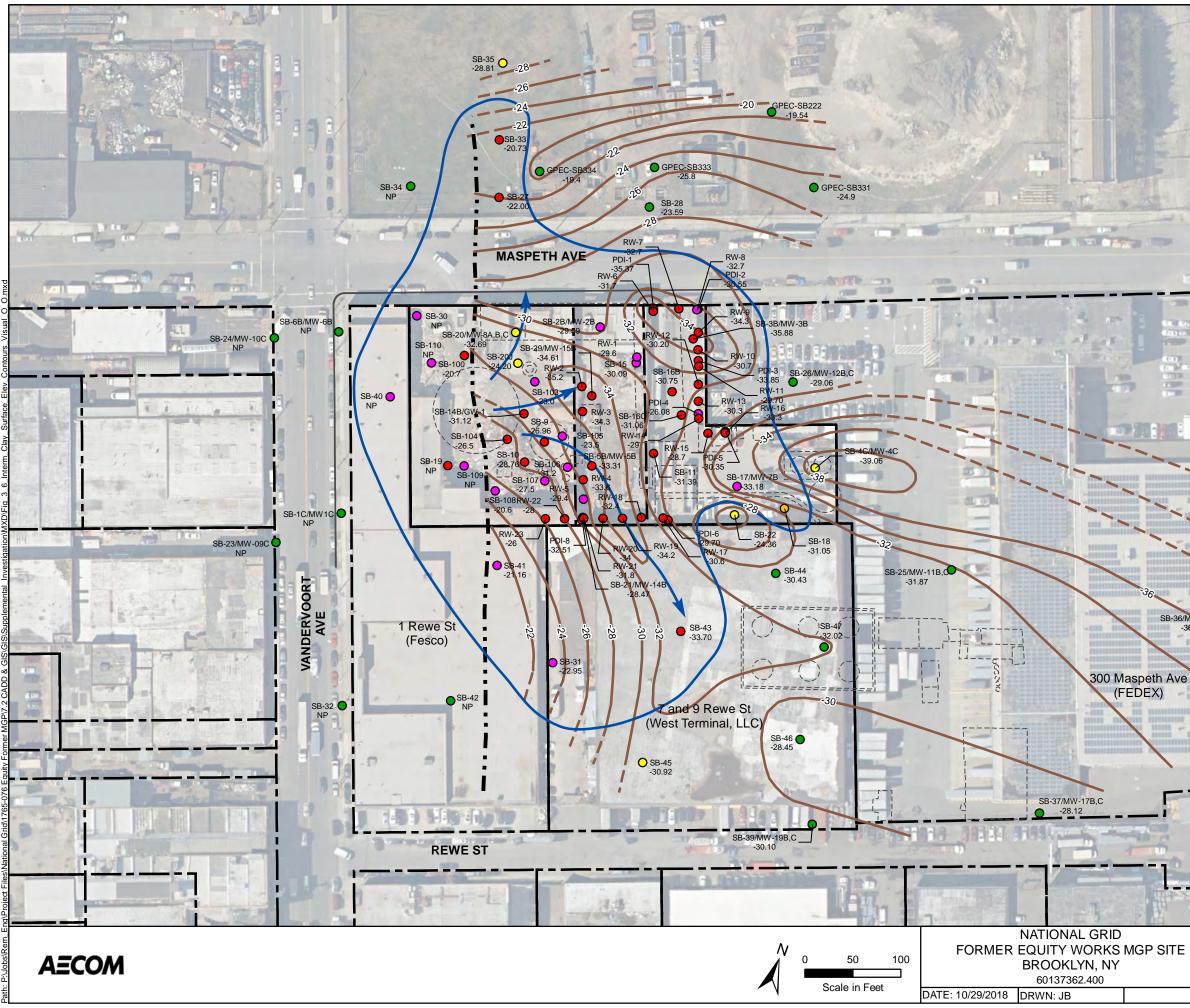
FIGURE 3-6 INTERMEDIATE CLAY SURFACE ELEVATION CONTOURS AND VISUAL/OLFACTORY OBSERVATIONS

- 1. Symbol color represents worst-case observations of impacts in the 10 ft above the top of the clay surface.
- 2. The following points were not used to generate the clay contours based on professional judgement: SB-28, SB-9, RW-10, SB-20J, SB-21, PDI-2, RW-6, RW-5, RW-11, SB-37, PDI-8, PDI-4, PDI-6, SB-100, SB-103, SB-105, SB-108.

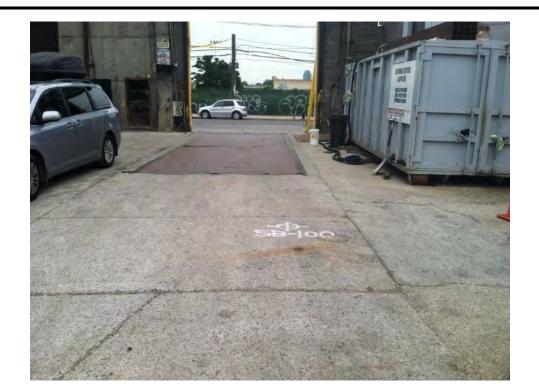
Photo No.Date:1Jul/Aug2018Description:View of the entrance to222 Maspeth Avenue

as well general conditions on the northwestern portion of the lot in vicinity of SB-100 location.

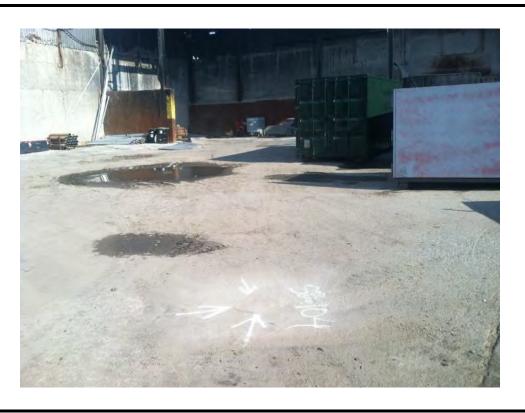
Photo No. 4	Date: Jul/Aug 2018
Description:

General conditions on the central and southeastern portions of 222 Maspeth in vicinity of SB-104 and SB-107 locations.
