WORKPLAN. 224050. 2012-07-05.

Re: Equity Former MGP Site
Interim Remedial Measure
254 Maspeth Ave. Property, Work Plan
Site# 224050

Subject: Pre-Design Investigation Report and Interim Remedial Measure Work Plan – 254 Maspeth Avenue Property
Equity Former Works Manufactured Gas Plant (MGP) Site
Brooklyn, New York
NYSDEC Site No.: 224050, Order on Consent Index #: A2-0552-0606

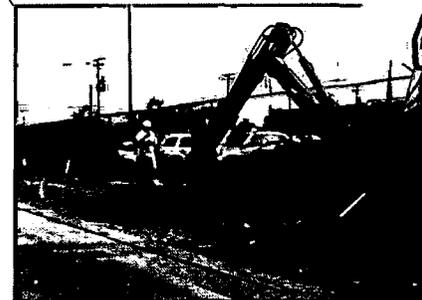
DEPTH (FEET)	VISUAL IMPACTS (FEET)	PID HEADSPACE (PPM)	SOIL STRATIG-RAPHY USCS	SOIL CLASS' USCS	SOIL DESCRIPTION LOG	STRUCTURES ENCOUNTERED OR COMMENTS
0				FILL	0-4' SAND (fill); sand and pieces of concrete, boulder sized rocks, brick pieces (pebble to cobble sized), <20%slag/ash, black/brown color, dry, no odors or staining.	
1		ND				
2		ND				
3		ND			3': fewer of the larger. boulder-sized pieces, moist.	
4		ND				
5		ND			4-6.83' SAND (fill): sand, moist, gravels, pieces of bricks, slag, ash, few boulders, reddish-black-brown color.	
6		ND				
7		ND			6.83': wet, groundwater observed seeping into test pit.

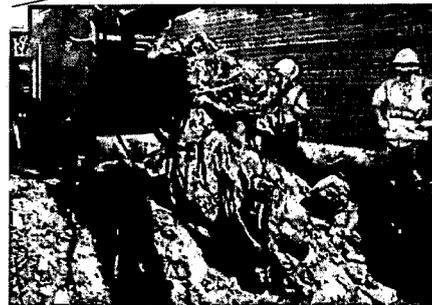
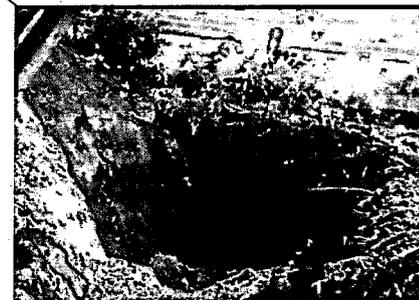
DEPTH (FEET)	VISUAL IMPACTS (FEET)	PID HEADSPACE (PPM)	SOIL STRATIGRAPHY USCS	SOIL CLASS USCS	SOIL DESCRIPTION LOG	STRUCTURES ENCOUNTERED OR COMMENTS
0		0.0		FILL	0-7' SAND (fill): sand, mixed urban debris including rugs, tires, plastic bags, wood pieces, bricks, cobbles, concrete (pebble to boulder sized), dry to moist, very slight naphthalene-like odor (possibly from wood debris).	
1		0.0				
2		0.0			2: large boulder, pieces of brick with mortar on southern side of test pit.	
3		0.0				
4		0.0			4: observe less amounts of urban debris, no visible impacts observed or odors detected.	
5		0.0				
6		0.0				
6.83		ND			6.83': Groundwater observed.	
7

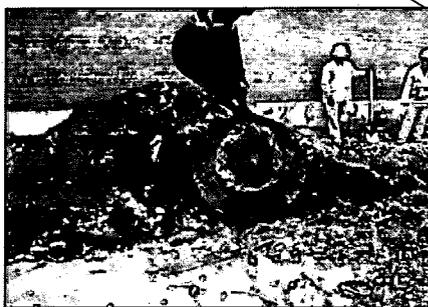
0-6.0' SAND (fill): sand and rocks (pebble to boulder-size), mixed urban debris including; rugs, tires, plastic bags, wood pieces, bricks, cobbles, concrete (pebble to boulder sized), dry to moist, sulfur-like odor throughout. Increased amount of urban fill along northern and eastern walls of the test pit. No visible impacts observed or odors detected. The mixed urban debris appears to have been previously burned.		
1		ND					
2		ND				2.0': Blackish-colored layer observed (urban debris appears to have been burned or discolored from natural staining (possibly from sulfate reducing bacteria). Very slight Naphthalene-like odor (possibly from groundwater).	
3		ND					
4		ND					
5		ND					
6		ND			6.0': Groundwater observed.		
7

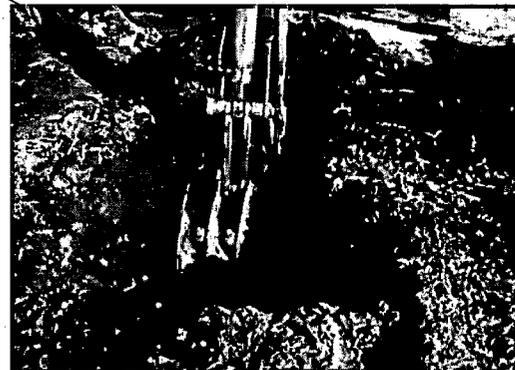
DEPTH (FEET)	VISUAL IMPACTS (FEET)	PID HEADSPACE (PPM)	SOIL STRATIGRAPHY USCS	SOIL CLASS USCS	SOIL DESCRIPTION LOG	STRUCTURES ENCOUNTERED OR COMMENTS
0		0.0		FILL	0-0.1' (Fill).	Note: oil spills (fuel/oil) at surface in area. PID readings appear to be background due to fuel oil at surface and operational gases/odors and hydrogen sulfide odor.
1		0.2			0.1-6.83' (Fill): burned debris (wood pieces, ships, plastic, rugs, concrete, metal pieces, glass, bricks).	
2		0.1			2: Slight sewage and hydrocarbon-like odor (hydraulic oil, not a tar-like odor); perched water at 2.0 ft bgs on western wall.	
3		0.2				
4		0.3			4: Perched water on eastern wall.	
5		0.2			5.75'-6.0': sand with silt layer; yellowish brown.	
6					6: groundwater on bottom, slight sheen noted on water, but appears to be biological. Could be due to fuel oil seeping in with perched groundwater.	
7

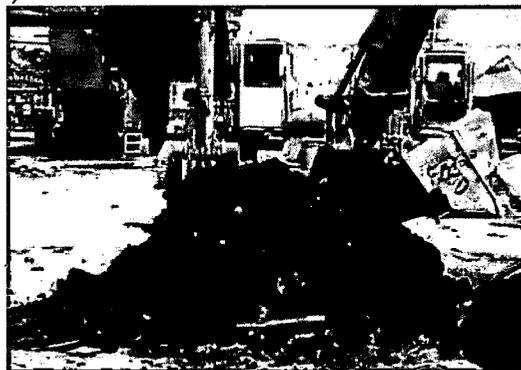
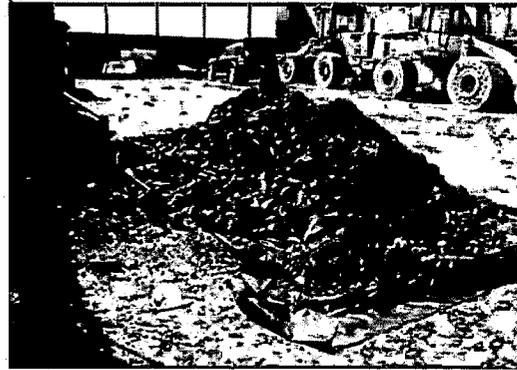
FILL	0'-6.5' SAND (fill): sand with pebbles and cobbles of rocks, bricks, concrete, mixed in with burned debris (wood pieces/chips, metal pipes, flashing, rubber, rugs, plastic, black color due to burned debris and organics).	Rotten egg smell began as soon as ground broke
2	0.2	2'-3': Perched water all the way down to ~6' (perched zones have a lot of water)				
3	1.0					
4	0.1					
5	0.1	4': Debris larger at depth, lots of metal pipes, strapping, flashings, large chunks of concrete.				
6	0.0	5': Wood log (large piece).				
	ND	~6': ground water encountered (perched zones above it make it hard to tell exactly where groundwater is).				
7
