**INTERIM REMEDIAL MEASURE (IRM)
COMPLETION REPORT**

**GREENPOINT ENERGY CENTER
SITE No: V006312, NORTHEAST CORNER
Greenpoint, Brooklyn, New York**

**KEYSPAN CORPORATION
One MetroTech Center, Brooklyn, New York**

**Paulus, Sokolowski and Sartor Engineering, PC
67A Mountain Boulevard Extension
P.O. Box 4039
Warren (Somerset County), New Jersey 07059**

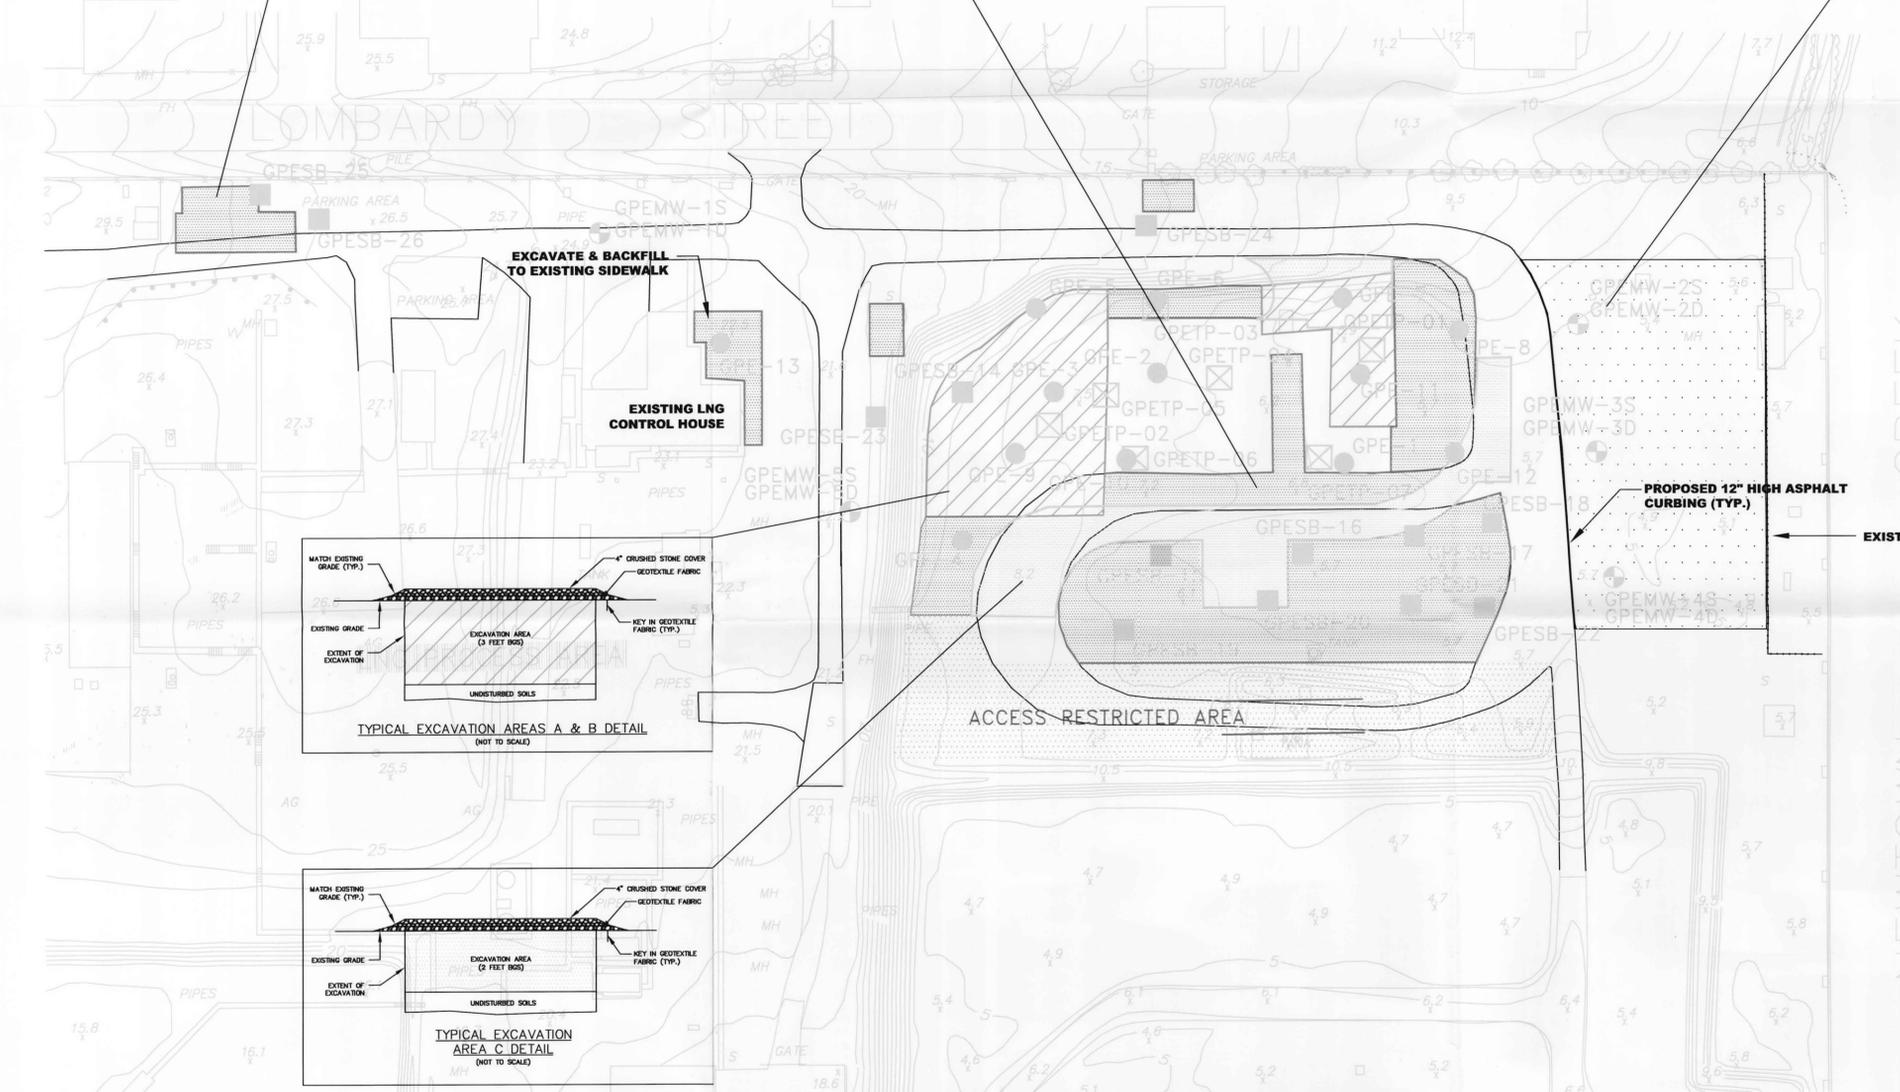
PROPOSED REMEDIAL ACTION SITE PLAN

As part of Excavation Area E, the March 2005 IRAWP included excavating a 20 by 30 foot area in the northern portion of the remedial area as depicted in Figure 3. This area was not excavated during the field effort due to the fact that this area will not be subject to future site related construction activities. In addition, no visually impacted material was observed during the installation of soil boring GPESB-24.

The proposed extent of excavation activities for Excavation Area E, as detailed in the March 2005 IRAWP, was expanded during the field activities based on the observed locations of visually impacted materials as depicted in Figure 3. The following provides a detailed description of the remedial activities for each sub-area of Excavation Area E.

The proposed remedial activities for this area as detailed in the March 2005 IRAWP included excavating an area as depicted on Figure 3 to a depth of one (1) feet bgs that would have resulted in an approximate in-place excavation volume of 567 cubic yards. However, during the actual implementation of the proposed excavation activities, visually impacted soil was observed at a depth of approximately one (1) to one and one half (1.5) feet bgs. As such, the depth of the excavation was extended to remove the visually impacted soil. This resulted in an additional in-place excavation volume of approximately 142 cubic yards, based on an average additional depth of approximately 0.25 feet. The total in-place

The proposed remedial activities for this area as detailed in the March 2005 IRAWP included excavating an area as depicted on Figure 3 to a depth of one (1) feet bgs. This resulted in an estimated in-place excavation volume of 70 cubic yards. However, during the actual implementation of the proposed excavation activities, visually impacted soil was observed at a depth of approximately three (3) feet bgs. As such, the depth of the excavation was extended to remove the visually impacted soil. This resulted in an additional in-place excavation volume of approximately 138 cubic yards, based on an average additional depth of approximately 2 feet. The total in-place volume of material excavated from Excavation Area E2-A was approximately 208 cubic yards. Excavated materials were direct-loaded onto transport vehicles for off-site disposal. The excavation areas were backfilled to the existing grade with certified clean backfill material.

The proposed remedial activities for this area as detailed in the March 2005 IRAWP included excavating an area as depicted on Figure 3 to a depth of one (1) feet bgs. This resulted in an approximate in-place volume of 58 cubic yards. However, during the actual implementation of the proposed excavation activities, visually impacted soil was observed at a depth of approximately three (3) feet bgs. As such, the depth of the excavation was extended to remove the visually impacted soil. This resulted in an additional in-place excavation volume of approximately 116 cubic yards, based on an average additional depth of approximately 2 feet. The total in-place volume of material excavated from Excavation Area E3 was approximately 174 cubic yards. Excavated materials were direct-loaded onto transport vehicles for off-site disposal. The excavation areas were backfilled to the existing grade with certified clean backfill material.

As proposed in the March 2005 IRAWP, this area was excavated to a depth of approximately one (1) foot bgs and backfilled with clean material as depicted in Figure 3. No visually impacted material was observed to exist deeper than this depth during the field effort. As such, this resulted in an in-place excavation volume of approximately 174 cubic yards, based on an average excavation depth of one (1) bgs. Excavated materials were direct-loaded onto transport vehicles for off-site disposal. The excavation areas were backfilled to the existing grade with certified clean backfill material.

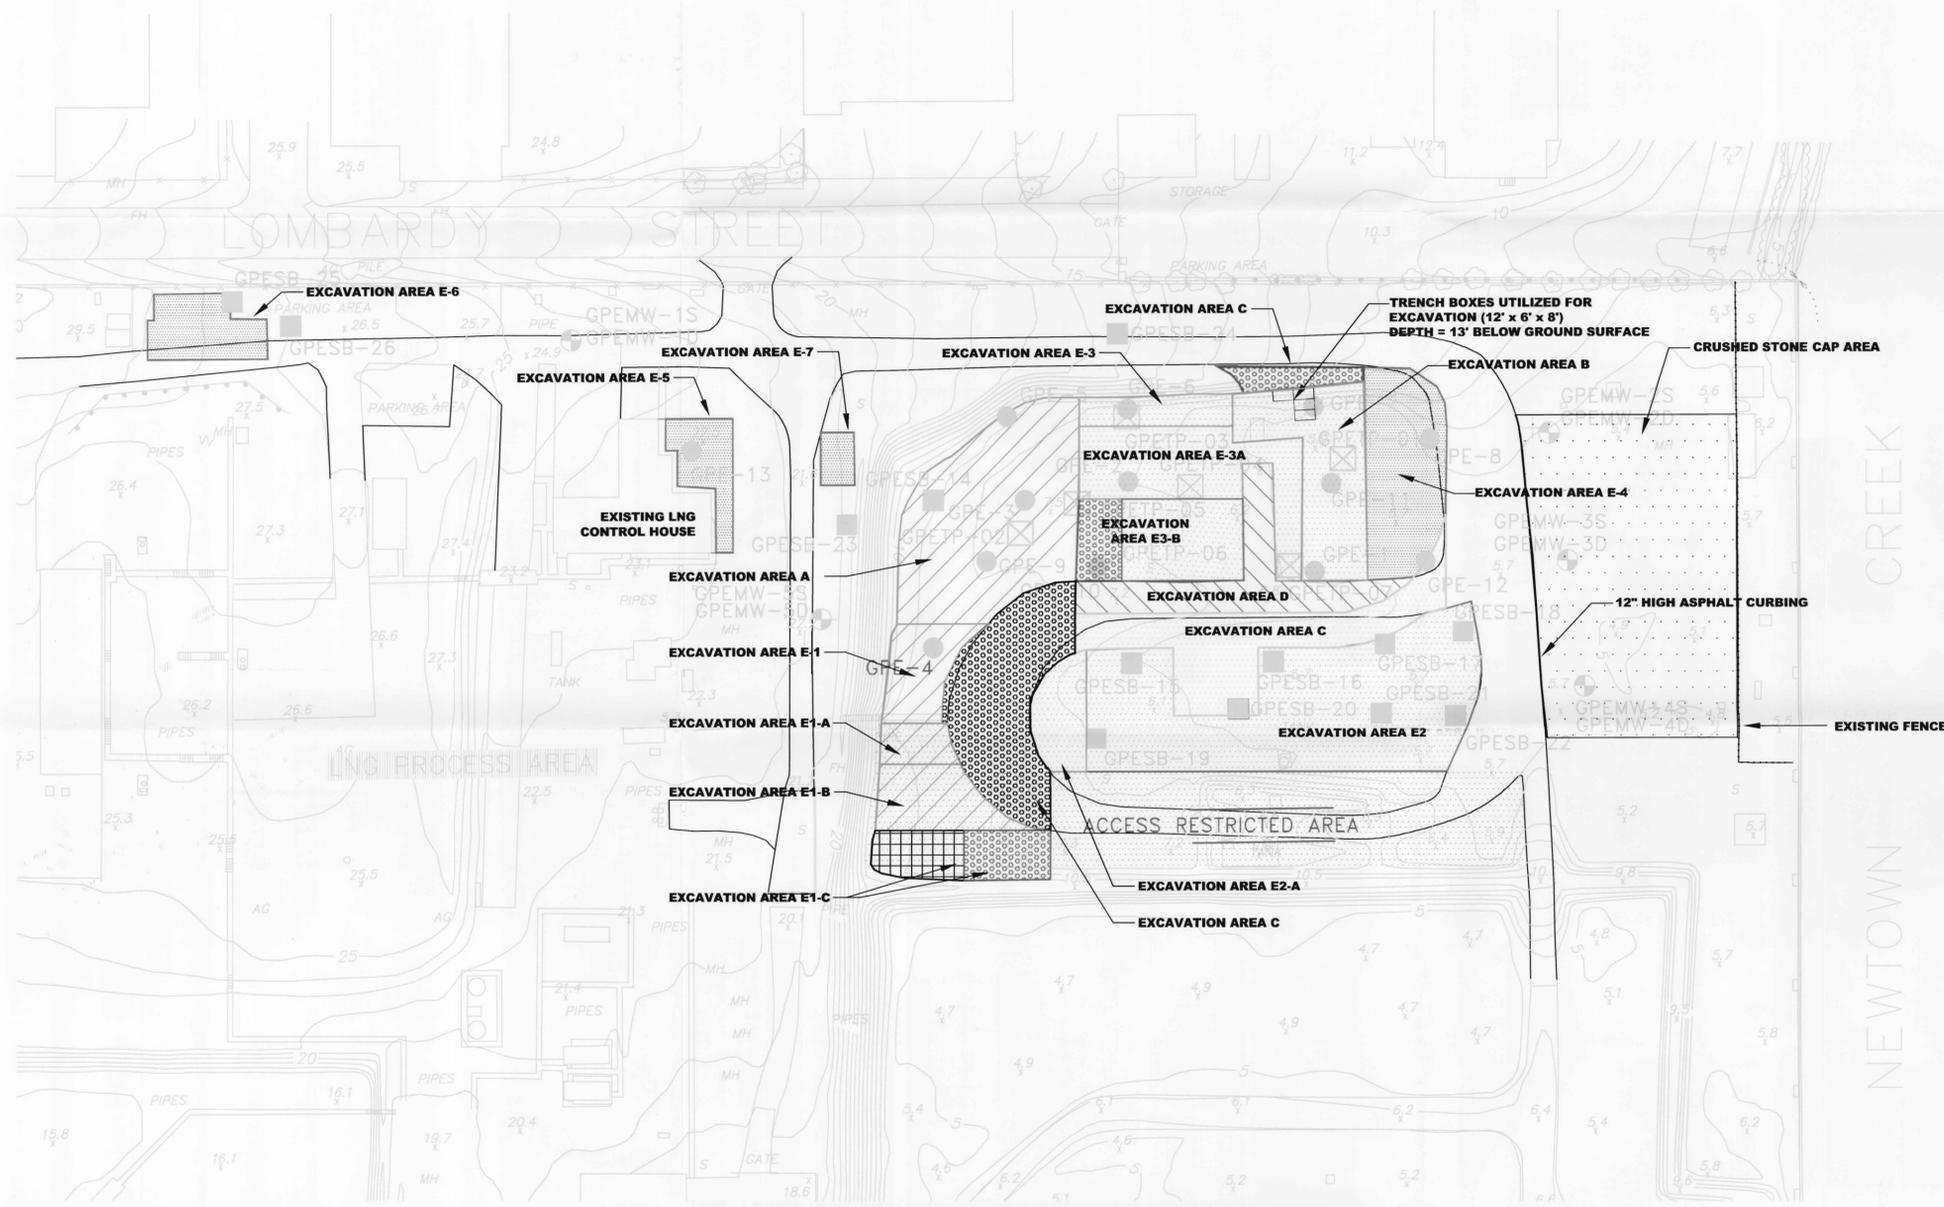
MODIFIED REMEDIAL ACTION SITE PLAN

In addition, the extent of Excavation Area B was extended to the west as depicted on Figure 4 due to the presence of visually impacted material observed at a depth of approximately three (3) feet bgs.

However, during the actual implementation of the proposed excavation activities, visually impacted soil was observed deeper in some areas and not at all in others. As such, the extent of the excavation was modified as depicted in Figure 4.

During excavation activities in this area, visually impacted material was observed to be located at a depth of approximately three and one half (3.5) to four (4) feet bgs as depicted in Figure 4. As such, the depth of excavation was extended in this area to remove the visually impacted material. This resulted in an additional in-place excavation volume of approximately 229 cubic yards, based on an additional average excavation depth of 2.75 feet. The total in-place volume of material excavated from Excavation Area E1 was approximately 312 cubic yards. Excavated materials were direct-loaded onto transport vehicles for off-site disposal. The excavation areas were backfilled to the existing grade with certified clean backfill material.

Due to the continual observed presence of visually impacted material located at approximately three (3) feet bgs, the excavation activities in Excavation Area E3 were extended to the south into Excavation Area E3-A as depicted in Figure 4. As per the March 2005 IRAWP, no remedial activities were proposed in this area. However, due to the presence of visually impacted material, remedial activities were extended into this area. As such, this area was excavated to a depth of three (3) feet bgs. This resulted in an additional in-place excavation volume of approximately 460 cubic yards, based on an average depth of 3 feet. Excavated materials were direct-loaded onto transport vehicles for off-site disposal. The excavation areas were backfilled to the existing grade with certified clean backfill material.

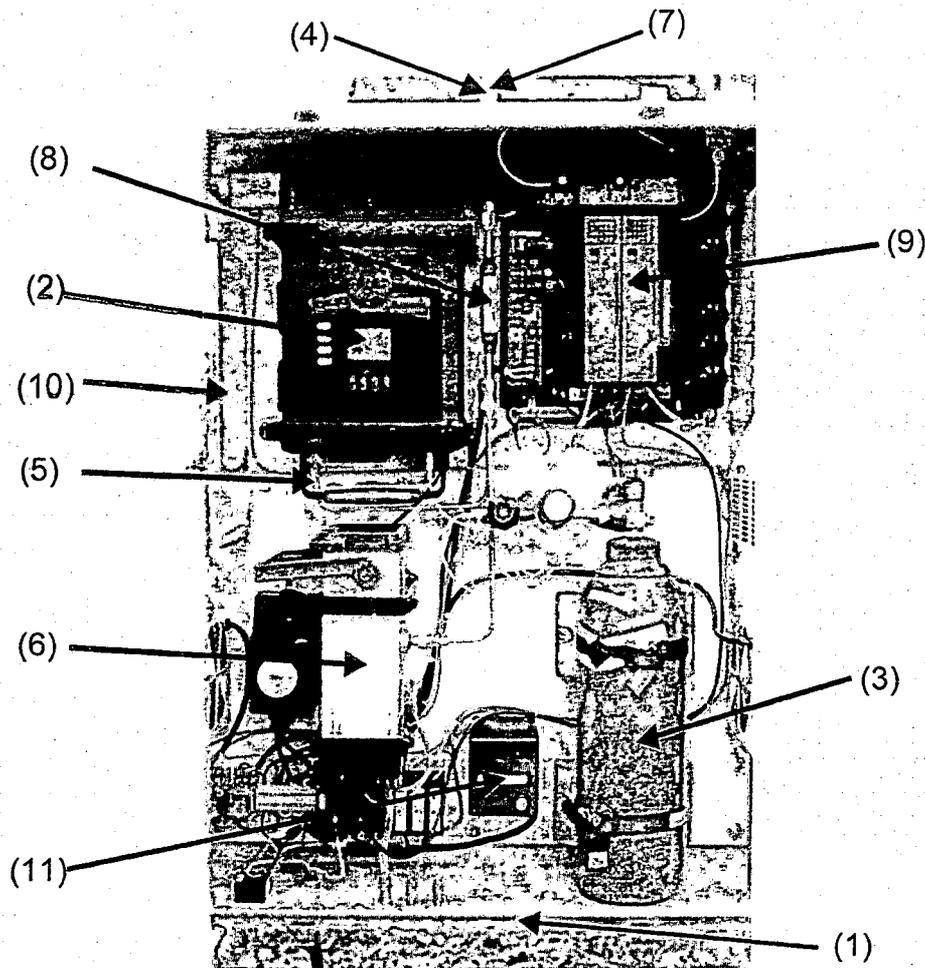
Figure 3

1. Station enclosure
2. PhotoVac Voyager gas chromatograph (GC)
3. GC carrier gas
4. GC sample inlet
5. GC sample inlet tubing
6. MIE DataRAM 2000 portable real-time aerosol monitor
7. DataRAM sample inlet with PM-10 impactor
8. DataRAM sample tubing with in-line heater
9. Data communications device
10. Heat exchanger
11. Heater element

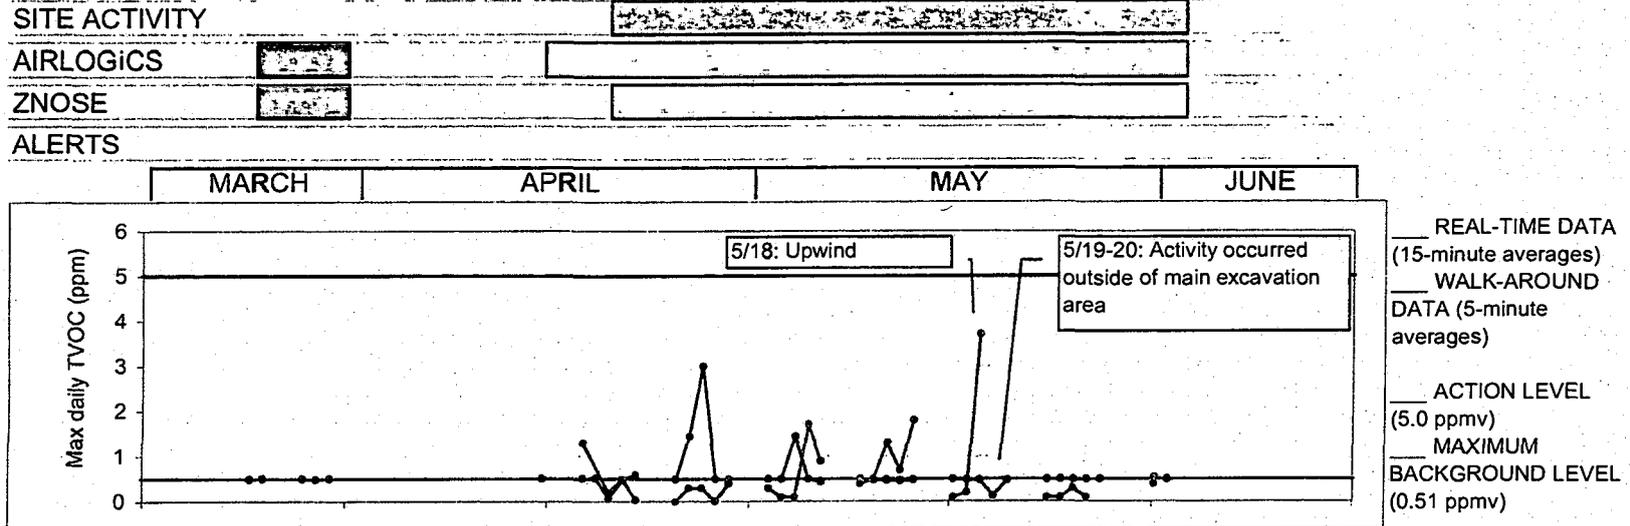
Figure 5a. Station 1 TVOC maximum averages.

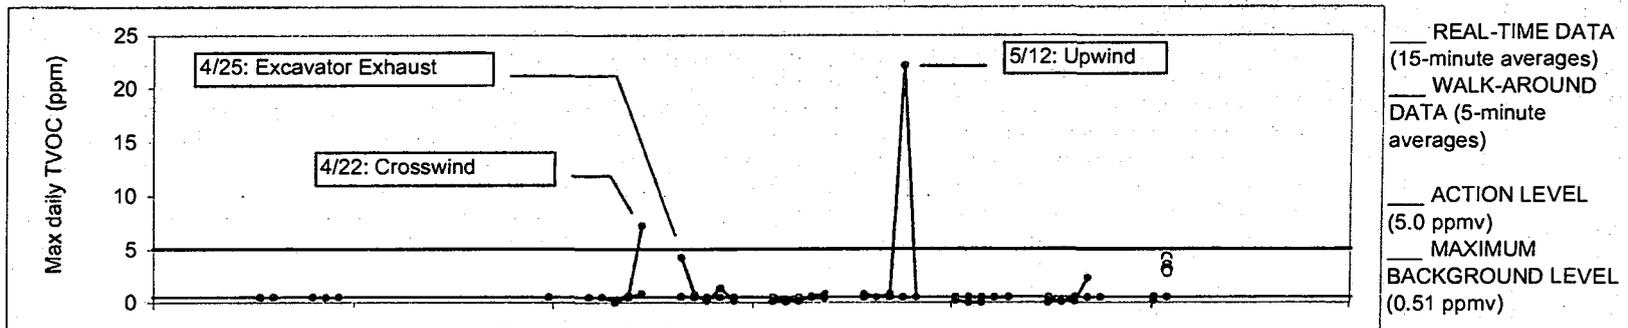
Figure 5b. Station 2 TVOC maximum averages.

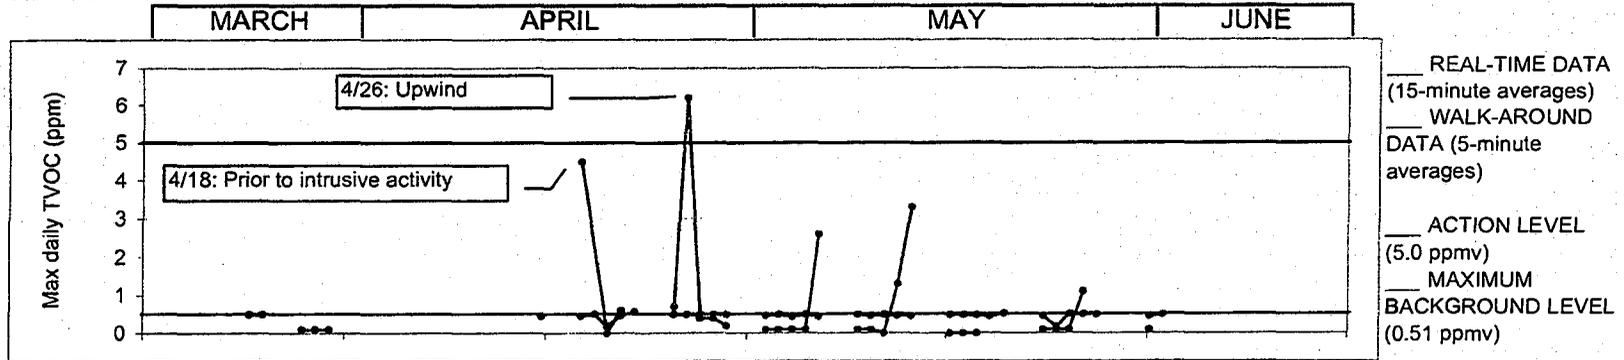
Figure 5c. Station 3 TVOC maximum averages.

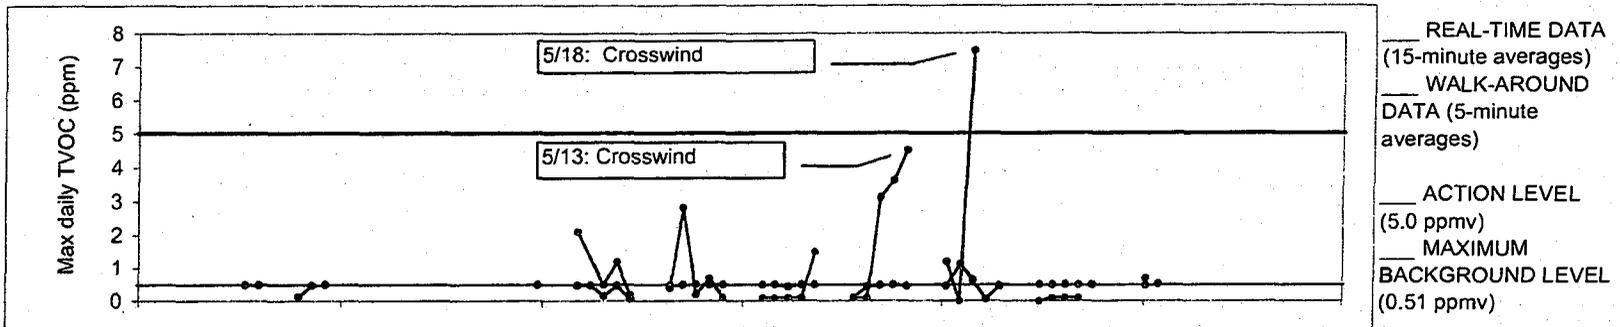
Figure 5d. Station 4 TVOC maximum averages.

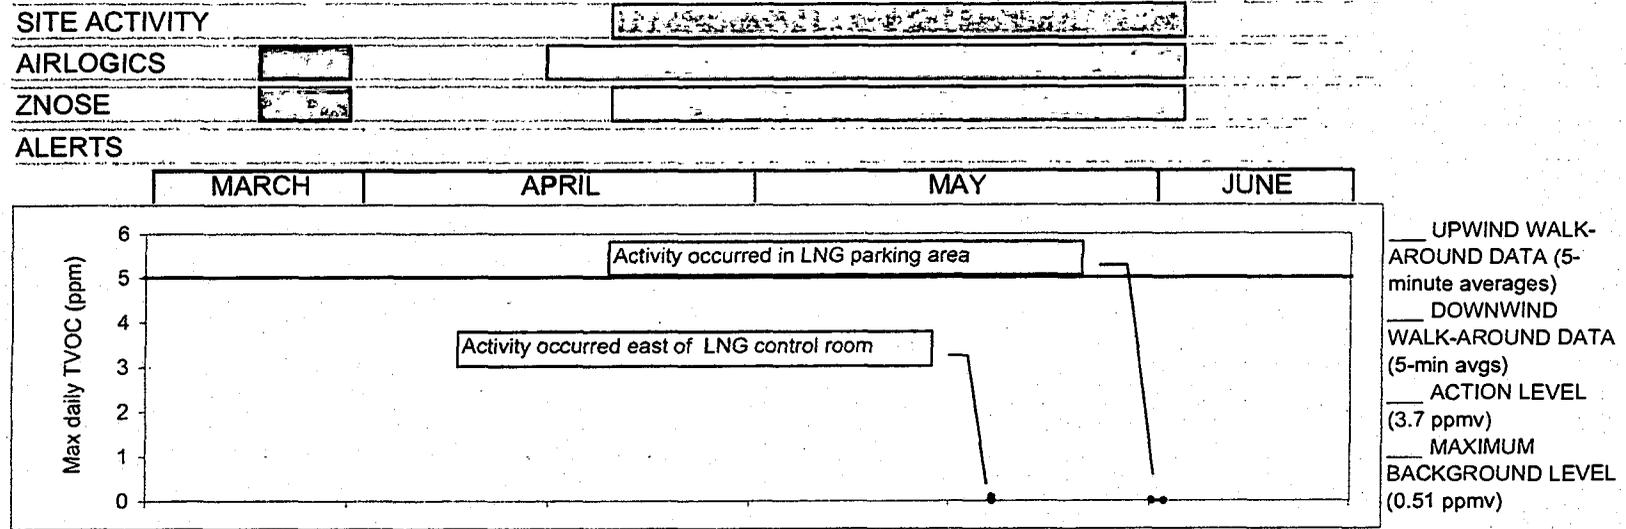
Figure 5e. TVOC maximum averages (walk-around).

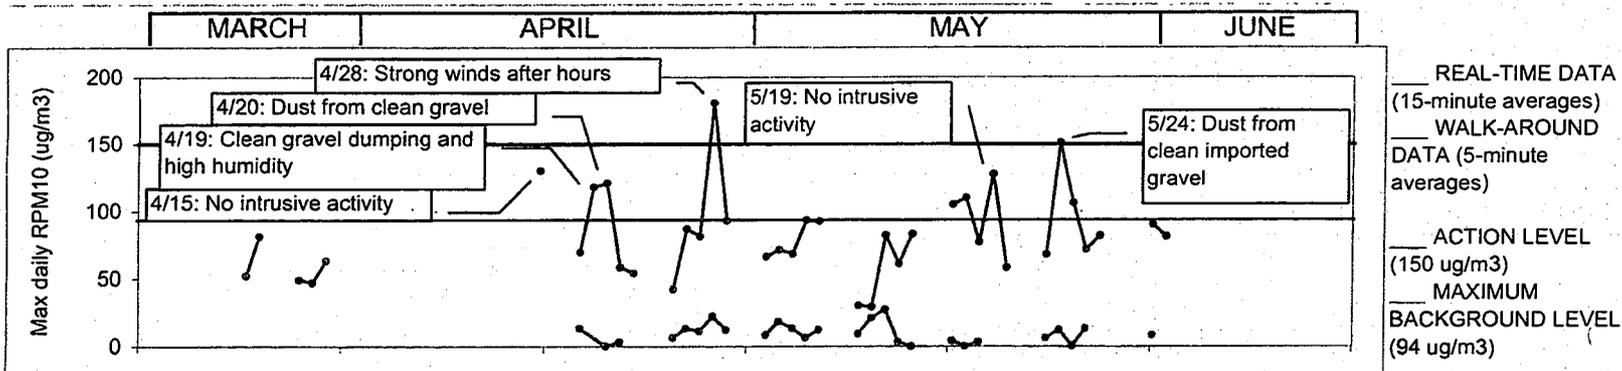
Figure 6c. Station 3 RPM₁₀ maximum averages.

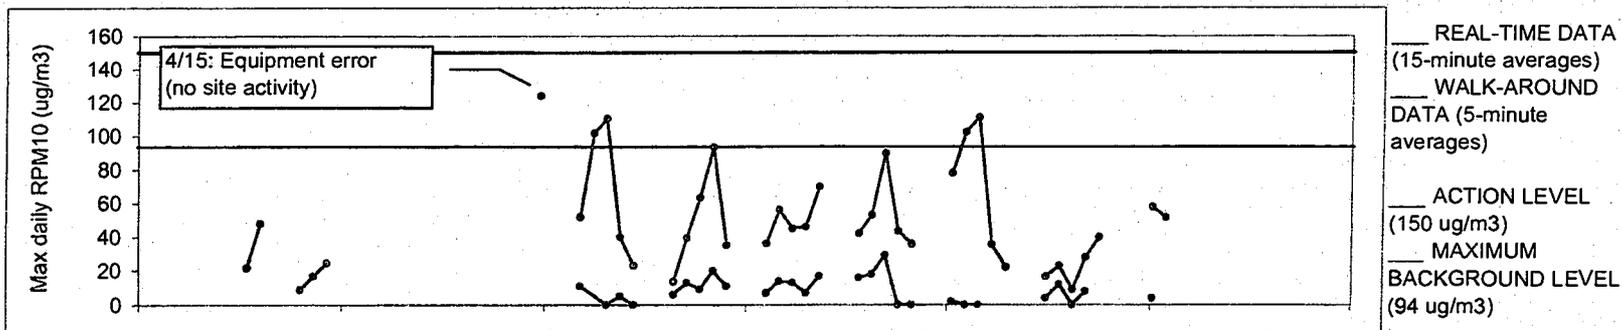
Figure 6d. Station 4 RPM₁₀ maximum averages.

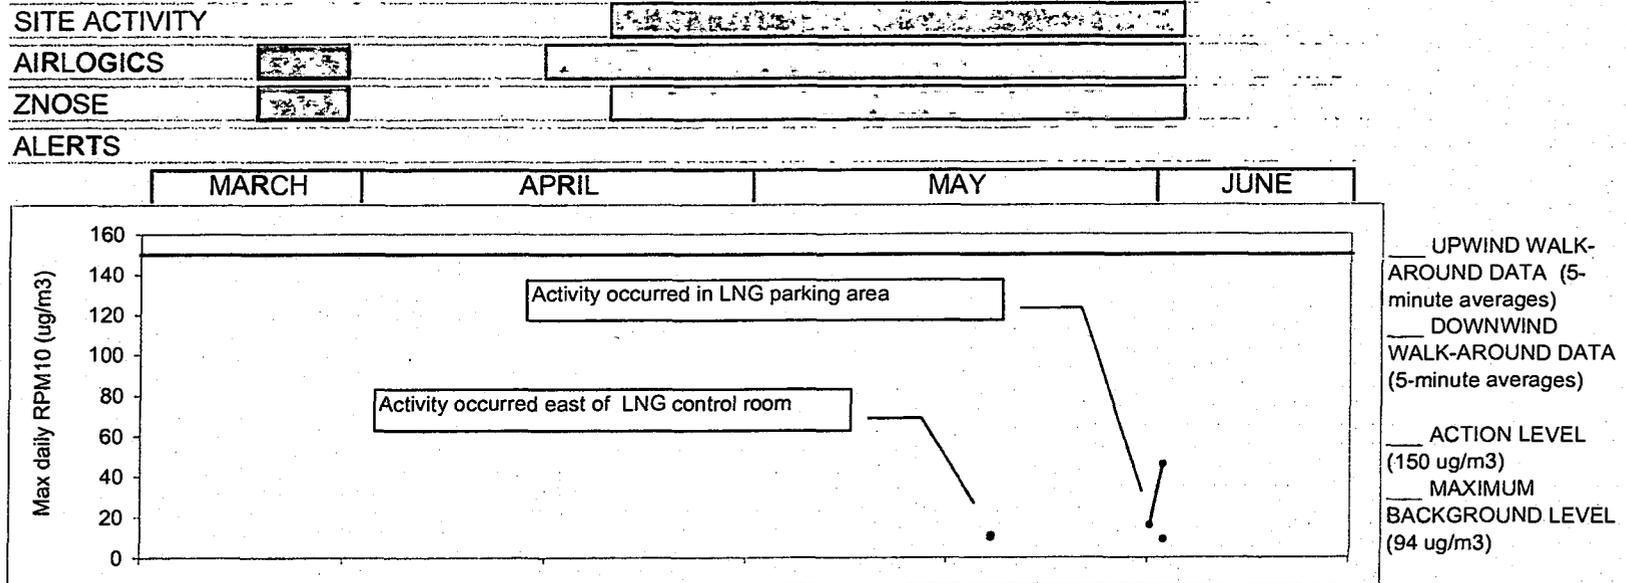
Figure 6e. RPM₁₀ maximum averages (walk-around).

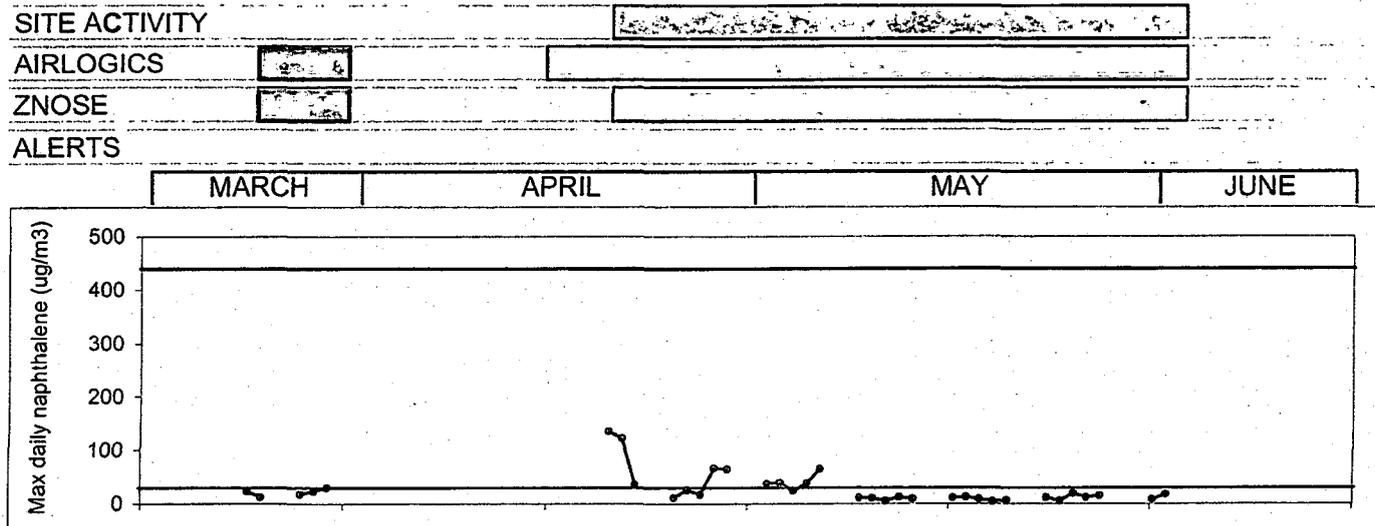
Figure 7. Downwind naphthalene maximum daily 15-minute average.

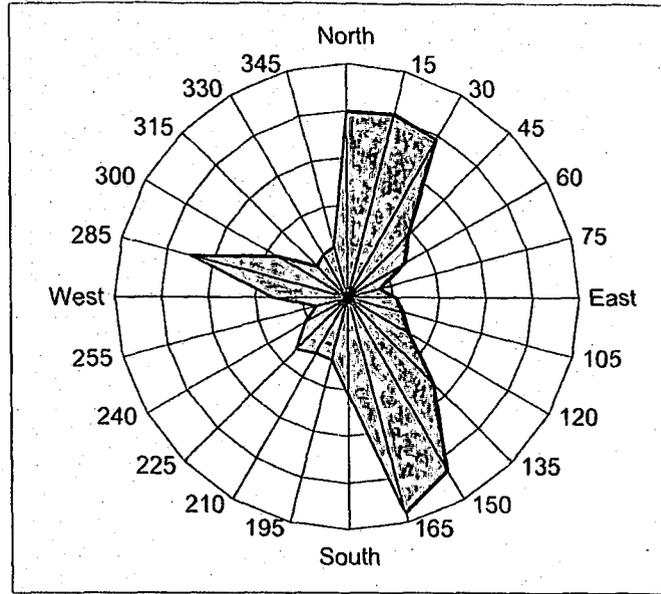
Figure 8
Distribution of Wind Direction (4/15/2005 - 6/2/2005)
Community Air Monitoring Plan Report
Greenpoint Energy Center

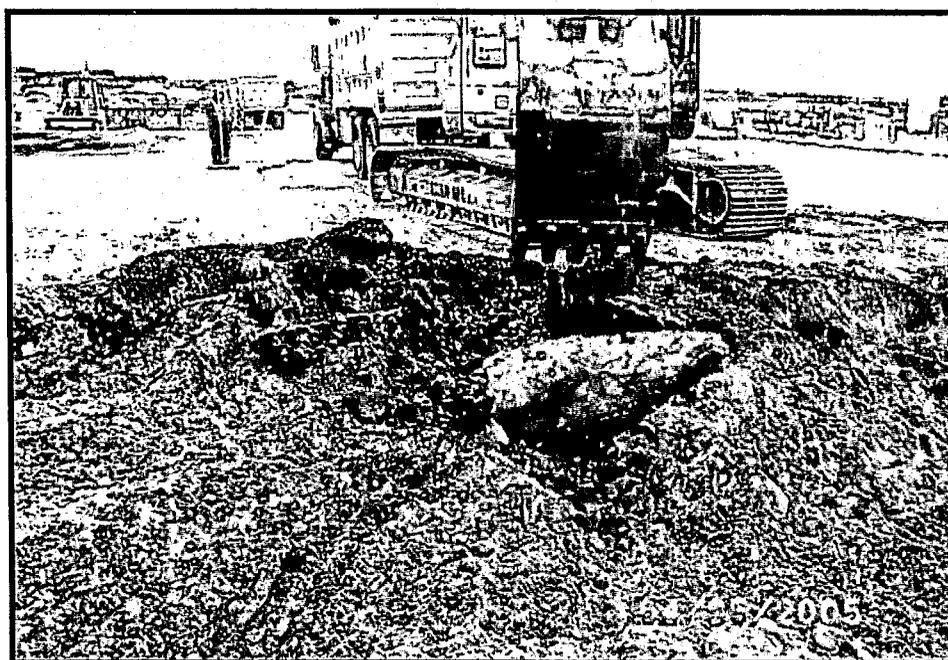
Excavation Area A - Tar layer 2.0 ft. bgs near asphalt road

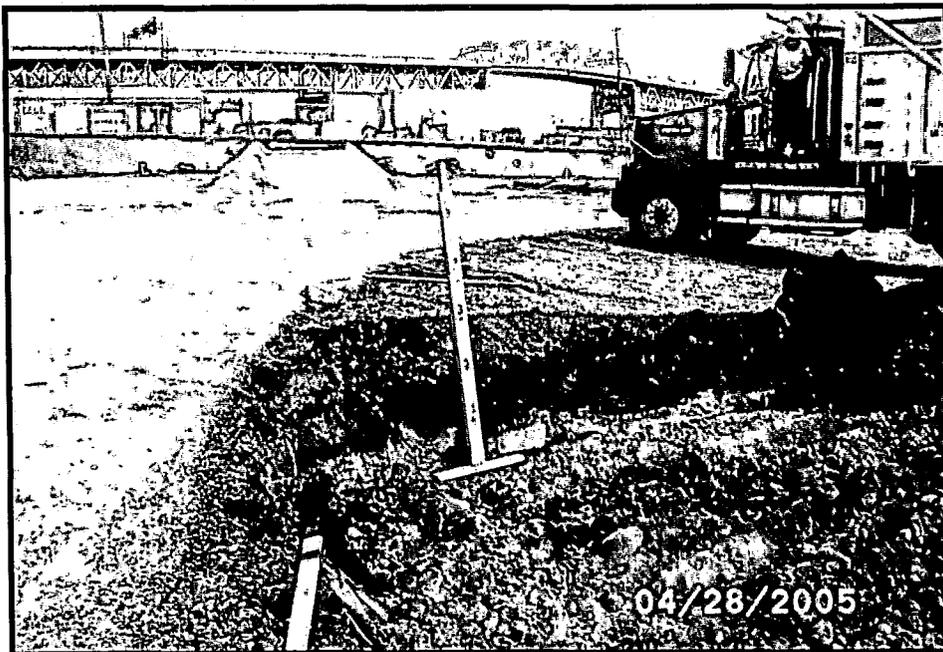
Excavation Area E - Impacted soils on north wall east of asphalt road

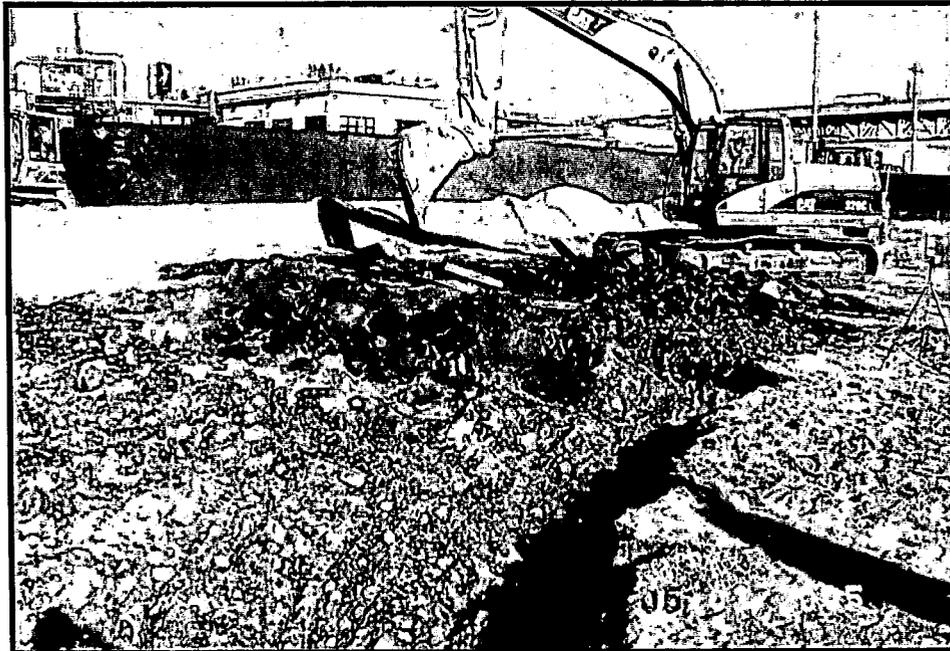
Excavation Area C – Impacted soils beneath asphalt roadway

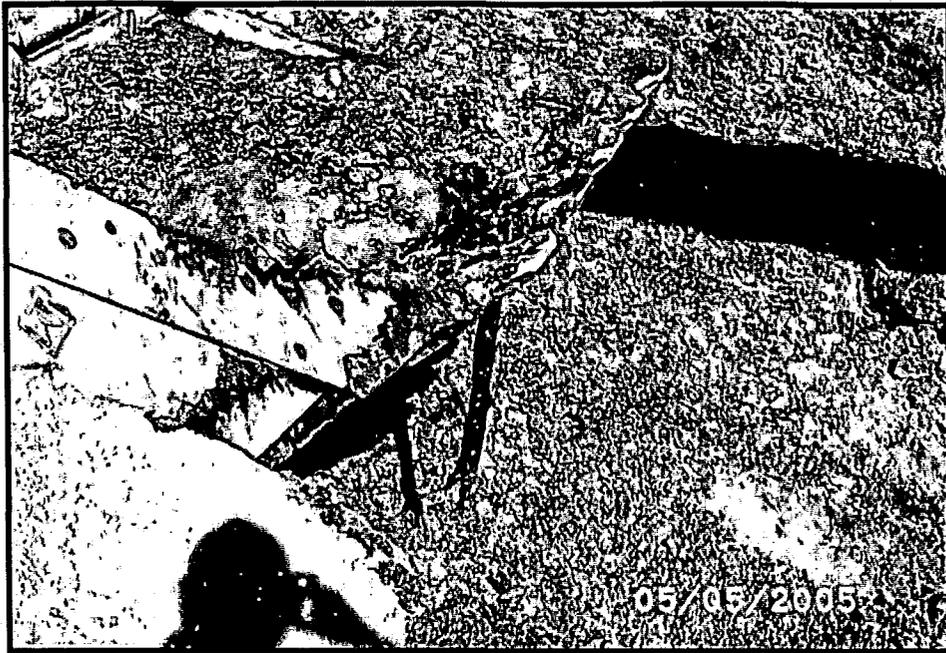
Excavation Area C - Purple stained soils from 4.0 to 4.5 ft. bgs

During the excavation activities in Excavation Area B, a metal bearing waste was encountered. The waste, which had a purple coloration, was segregated and staged within roll-off containers for waste characterization sampling. The waste material was sampled and determined to be non-hazardous. As such, the waste material was disposed of off-site along with the other excavated soil. The analytical results for the metal bearing waste is included in Appendix B.

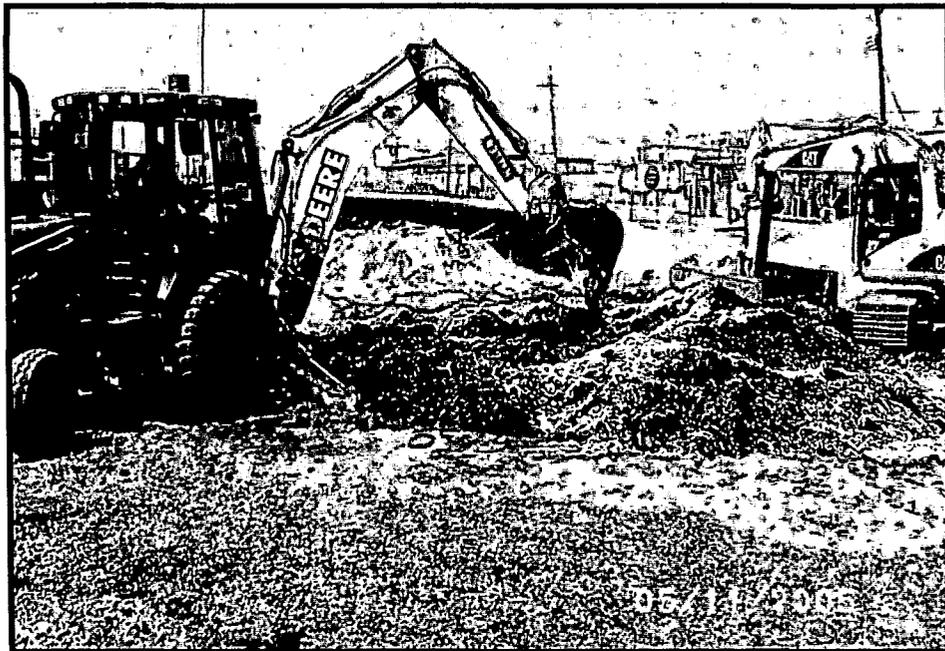
Excavation Area B - Excavation of impacted soils; use of odor suppressant foam

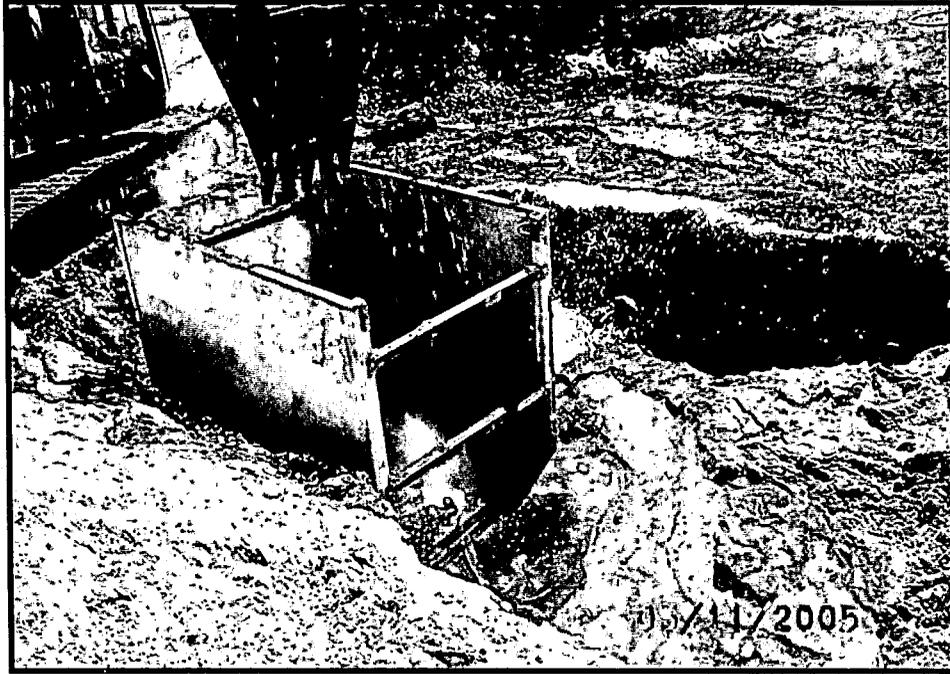
Excavation Area B – Excavation to 13 ft. bgs using trench boxes

However, as per the March 31, 2005 correspondence from the NYSDEC, it was requested that the excavation activities around soil boring GPE-7 extend down to approximately 13 feet bgs in order to remove visually impacted material that was noted during the installation of the soil boring. As such, a series of trench boxes were utilized and visually impacted soil was removed in this area as depicted in Figure 4 to approximately 13 feet bgs. The dimensions of the trench boxes were approximately twelve feet long by 6 feet wide by 8 feet deep. No dewatering was performed during the excavation within the trench boxes. The trench boxes supported the sides of the excavation above the water table and the groundwater itself supported the sides of the excavation within the existing water table.

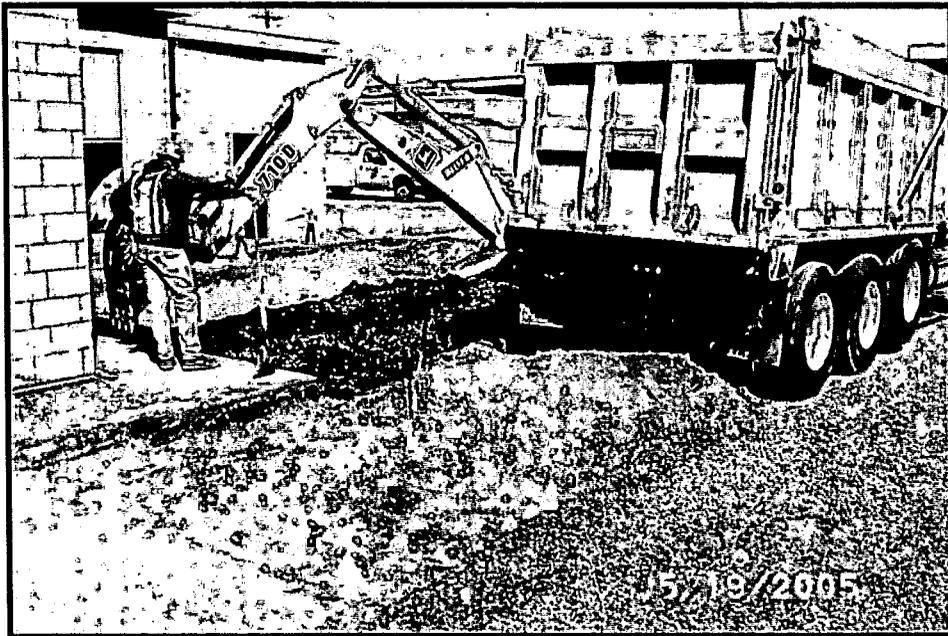
Excavation Area E – Soil removal near LNG Plant at 1.0 to 1.5 ft. bgs

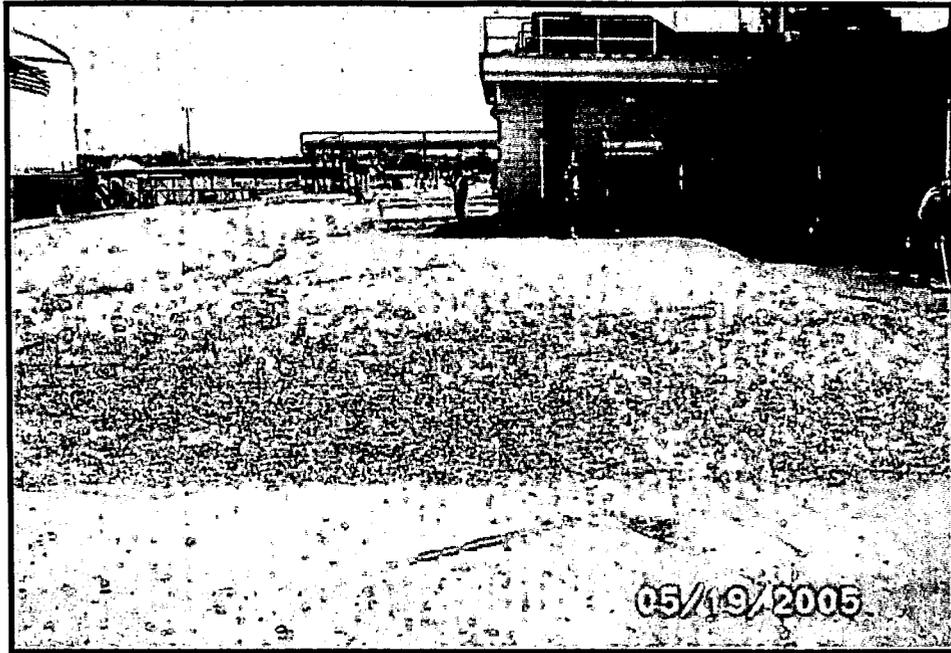
Excavation Area E – Site restoration near LNG Plant

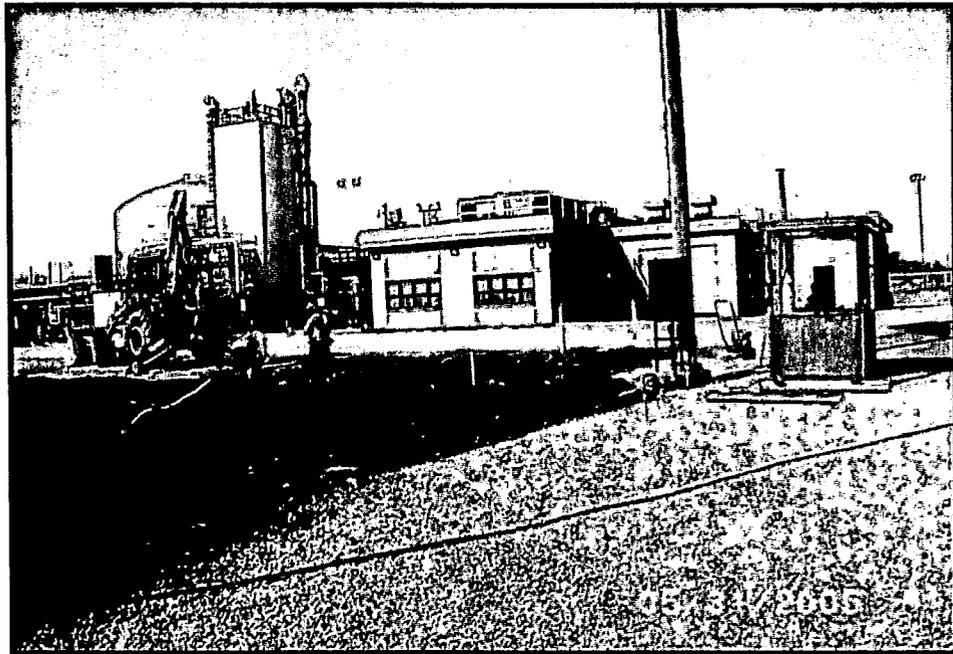
Excavation Area E – Soil removal near switchgear station at 1.0 ft. bgs

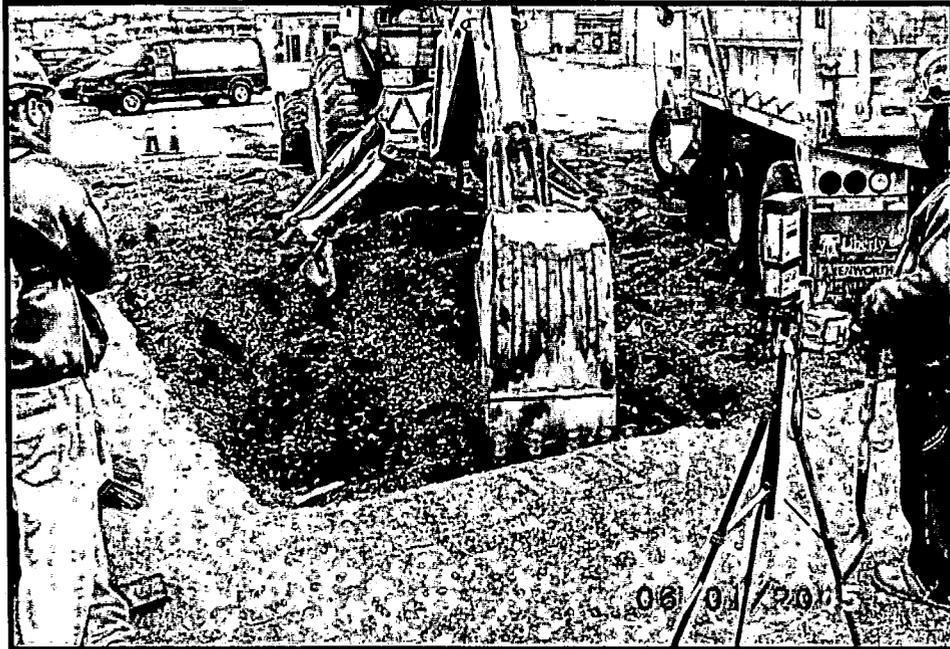
Excavation Area E – Soil removal near substation location at 1.0 ft. bgs

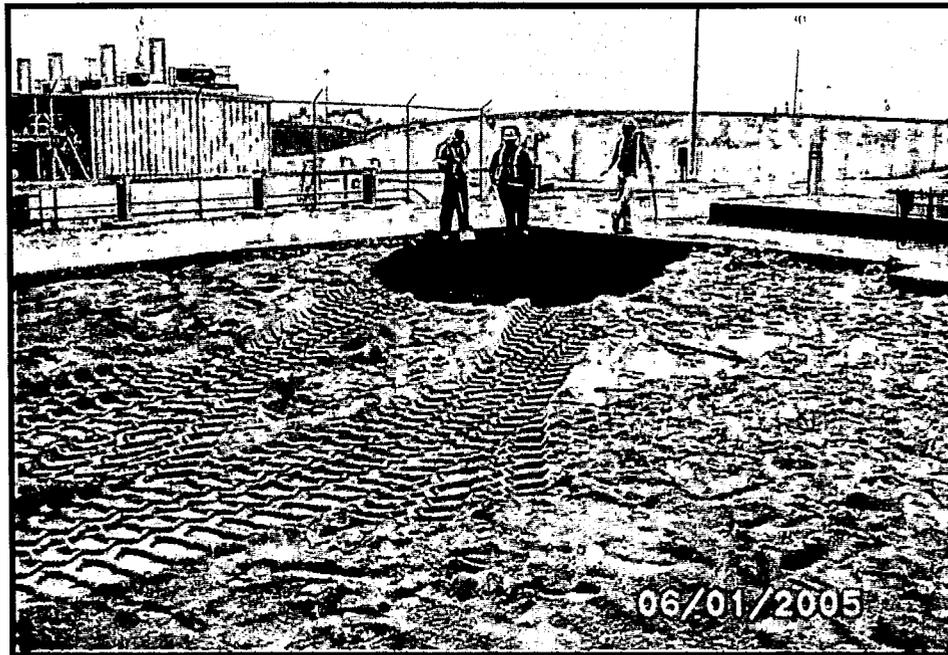
Excavation Area E – Site restoration near substation location

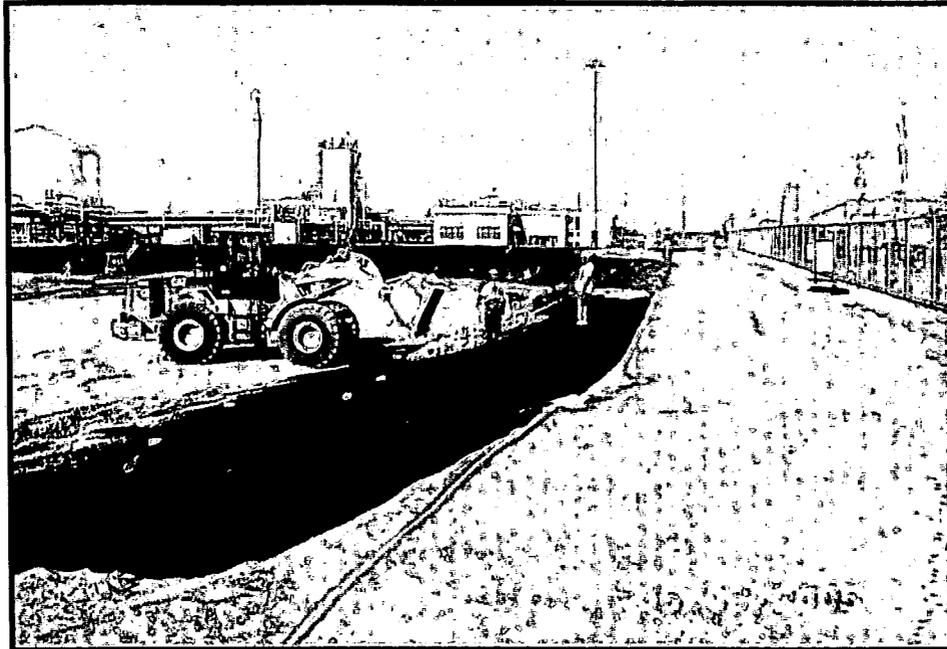
Excavation Area C – Site restoration with rip wrap on northeastern berm

Seven (7) inch diameter riprap stone was placed as a cover material over the excavated portions of the existing soil berm along the northeastern portion of the remedial area. The source of this material was the West Nyack, New York quarry owned by Tilcon New York Inc. This riprap stone cover replaced the previous asphalt emulsion cover as a soil erosion control measure.

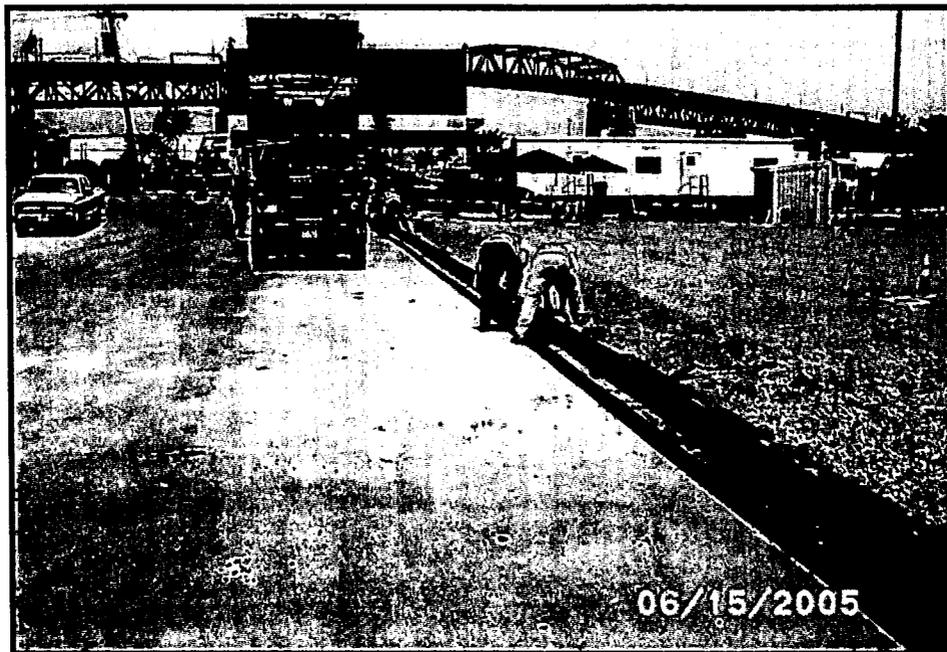
Crushed Stone Cap Area - Asphalt curbing on west side of cap

- Preparing the area (i.e. minor grading), as necessary;
- Installing a geotextile fabric on the existing grade in accordance with manufacturer's recommendations;
- Constructing a 12-inch high asphalt curb between the Crushed Stone Cap Area and the existing road; and
- Backfilling the area with one foot of $\frac{3}{4}$ inch diameter crushed stone as approved by KeySpan.
