# Site Characterization Work Plan

**Bay Ridge Former Holder Stations A and B Site  
Brooklyn, New York  
NYSDEC Site No.: 224058  
Order on Consent Index #: A2-0552-0606**

**Prepared for:  
National Grid, USA  
287 Maspeth Avenue, Brooklyn, NY 11211**

**Prepared by:  
AECOM  
One World Financial Center  
200 Liberty Street, 25<sup>th</sup> floor  
New York, NY 10281  
Project No. 60137360-100**

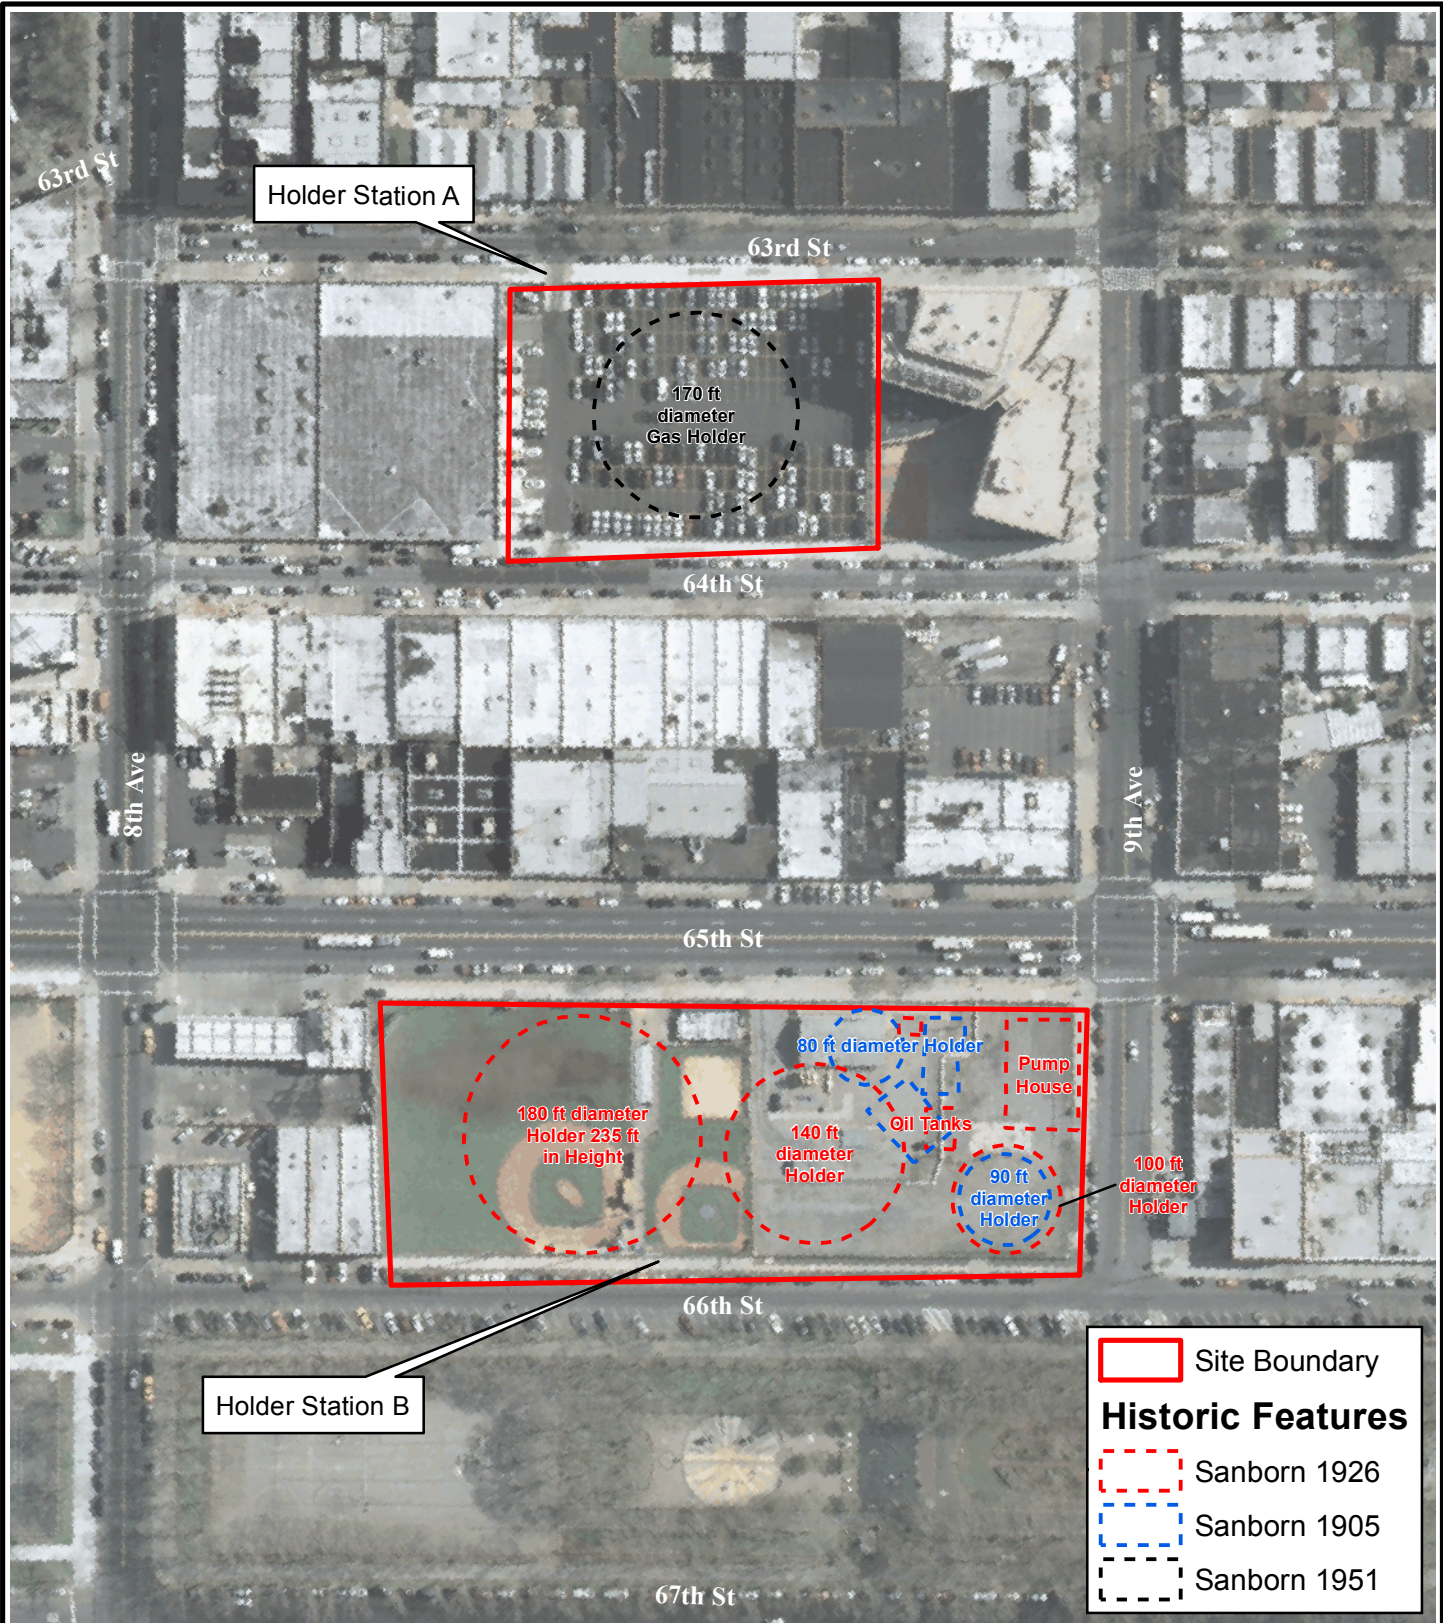
2-1

**Site Boundary**

**Historic Features**

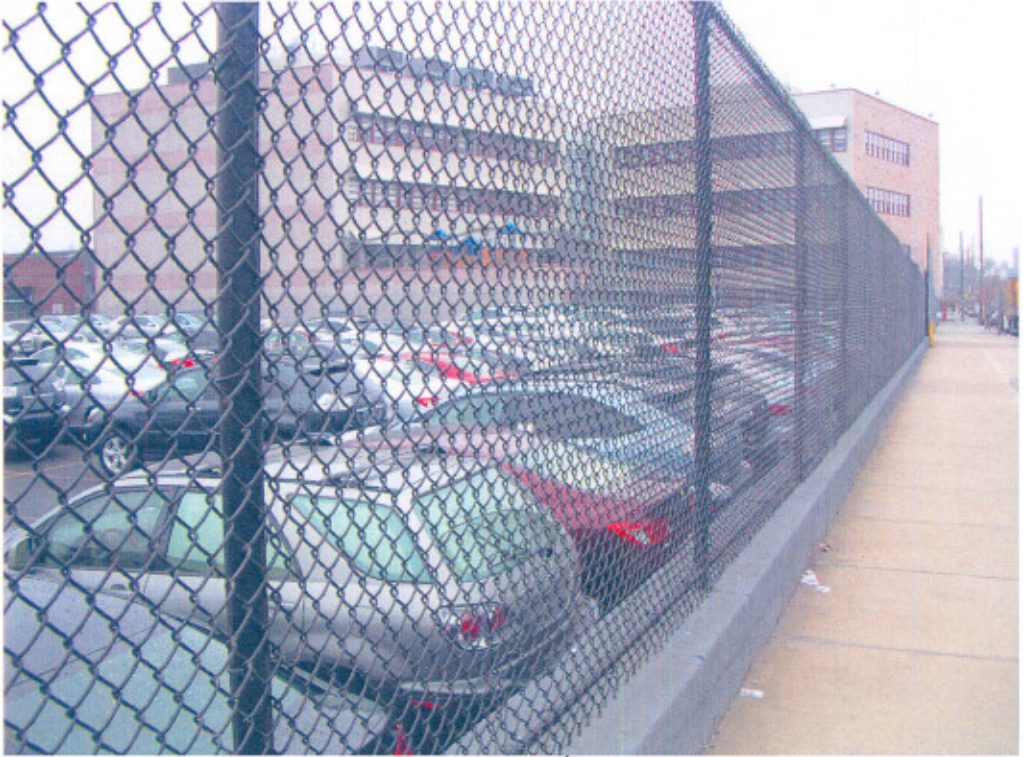
Photograph taken on April 2, 2007 from 64<sup>th</sup> Street of the parking lot (Holder Station A) looking southeast towards the Vincent D. Grippo School and 9<sup>th</sup> Avenue.

Holder Station A is currently used as a parking lot for a new car dealer. This parcel is entirely paved and fenced with two locked gates, one on 64<sup>th</sup> Street and one on 65<sup>th</sup> Street. It is unknown if the holder foundation is still present on this parcel.

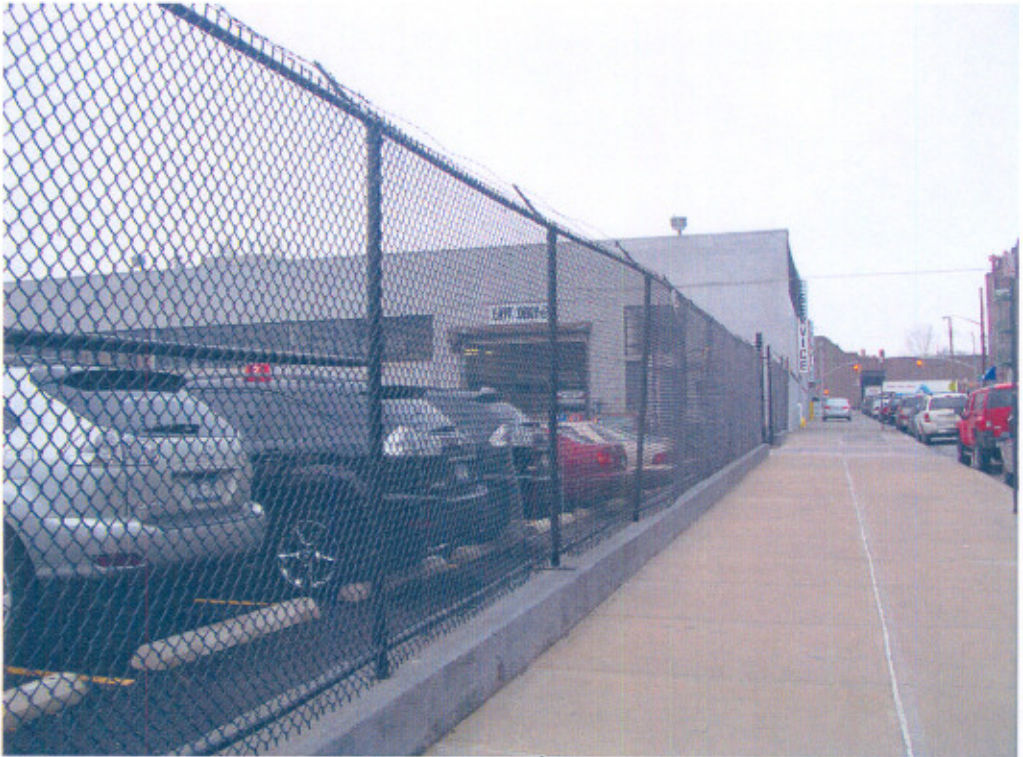
Photograph taken on April 2, 2007 on 63<sup>rd</sup> Street of the parking lot (Holder Station B) looking northwest towards the Lexus service entrance and 8<sup>th</sup> Avenue.

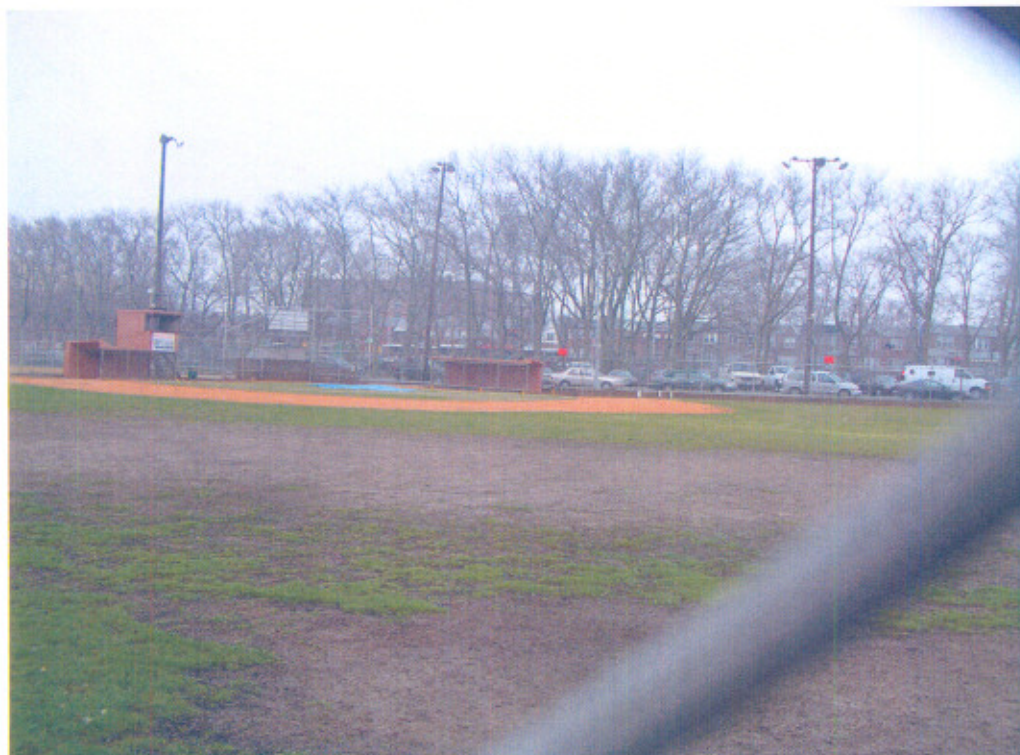
Photograph taken on April 2, 2007 of the northwestern portion of Holder Station B from 65<sup>th</sup> Street.

The ground surface on the eastern half of the Holder Station B property is a mix of concrete, asphalt and dirt parking with occasional grassed areas. The western half of this property is comprised of two baseball fields. For site characterization purposes, collection of 10 surface soil samples is proposed in the area of the ball fields as shown Figure 3-2. The proposed surface soil samples will be collected from the 0 to 2-inch bgs interval with vegetation removed. The samples will be collected from proposed boring locations using a stainless steel or disposable polyethylene trowel. All surface soil samples will be collected during utility clearance activities performed prior to borehole advancement.

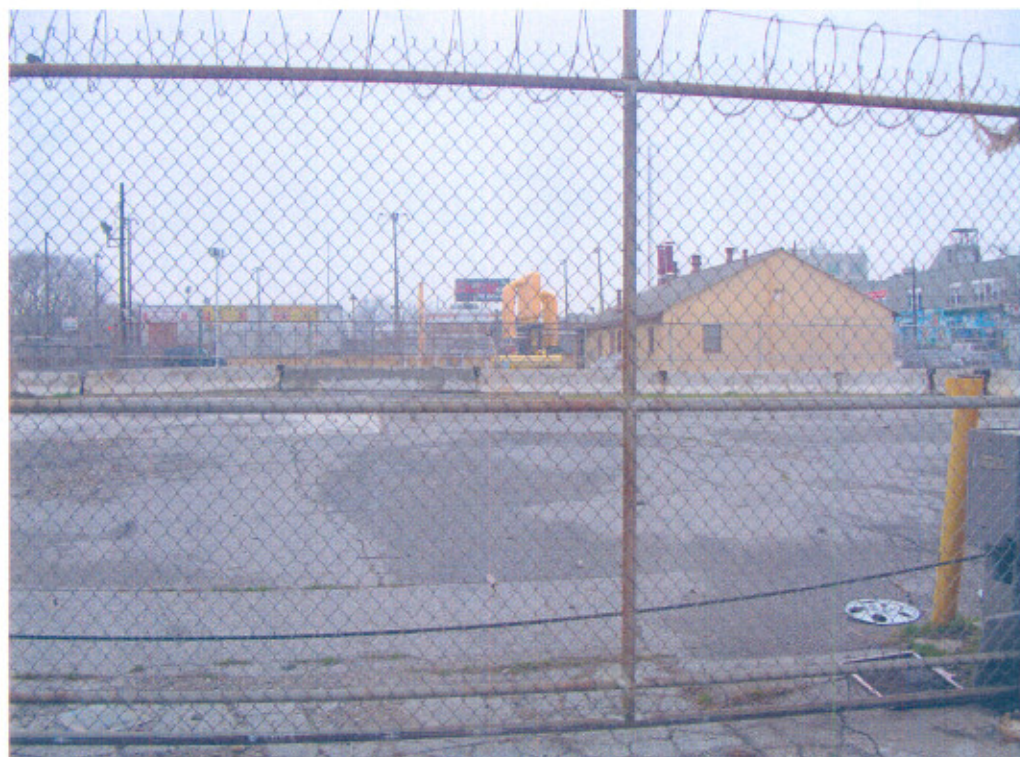
Photograph taken on April 2, 2007 of the southeastern portion of Holder Station B from 9<sup>th</sup> Avenue.

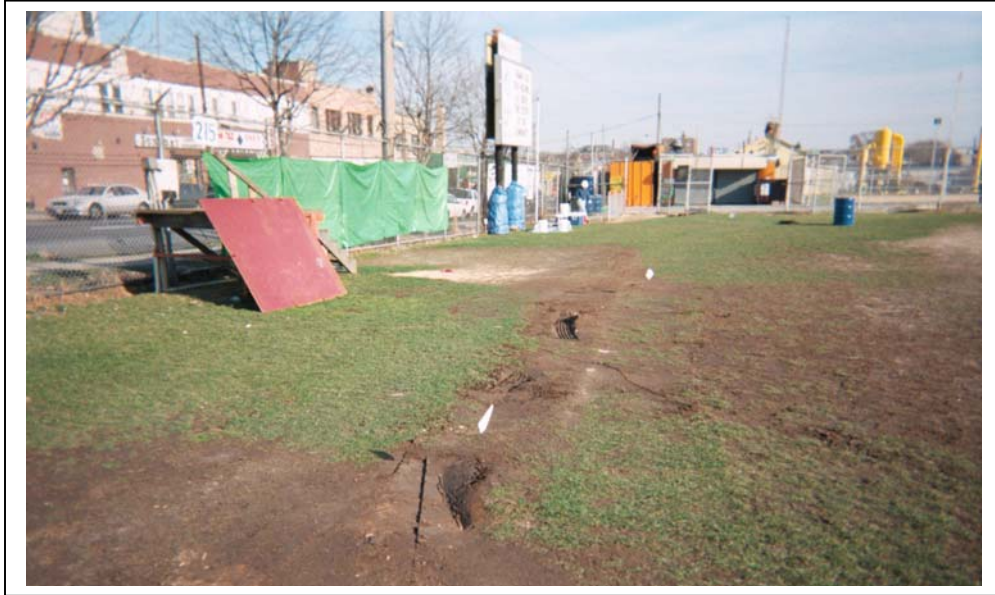
**Photo/Frame No.:** 3 **Direction of View:** East-southeast  
**Date/Time:** 3-13-00/15:43 **Subject:** SB-2 location (white pin flag in foreground)  
**Photographer:** R. Watt after completion.

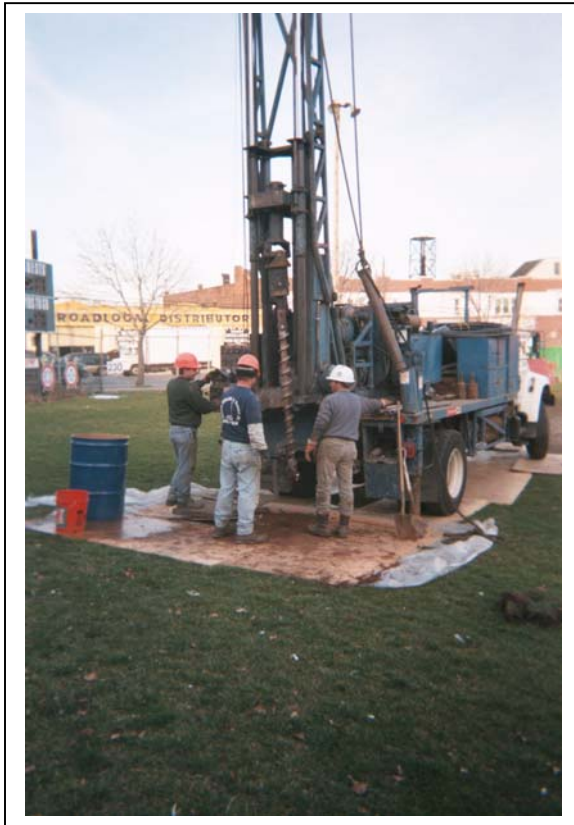
**Photo/Frame No.:** 4  
**Date/Time:** 3-13-00/16:52  
**Photographer:** R. Watt  
**Direction of View:** Northeast  
**Subject:** Drill rig (Aquifer Drilling & Testing) near completion of boring SB-3.

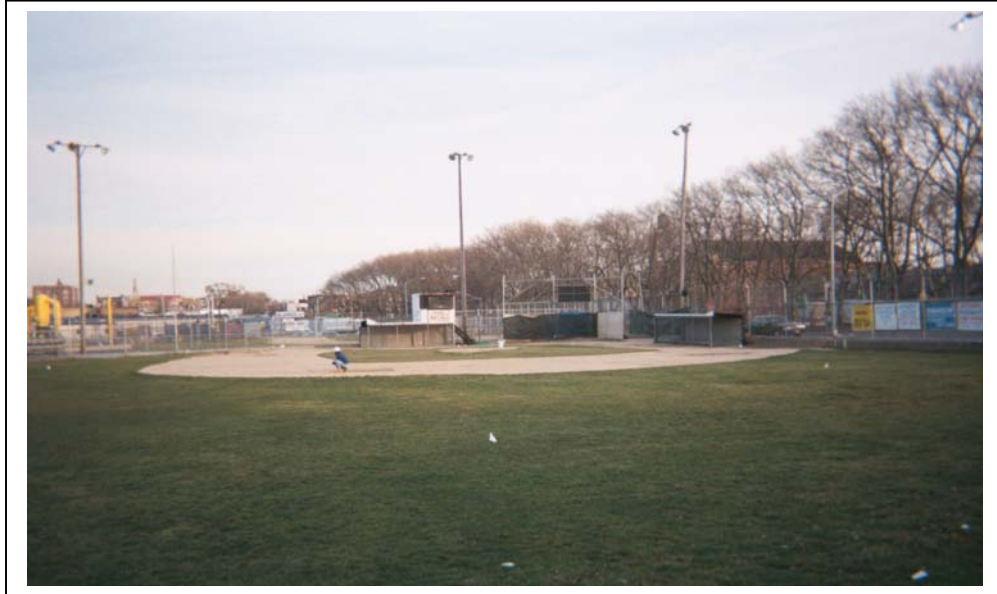
**Photo/Frame No.:** 5 **Direction of View:** Southeast  
**Date/Time:** 3-13-00/16:52 **Subject:** Large ball field from near gas station on northwest side of site; sample locations at white pin flags.  
**Photographer:** R. Watt

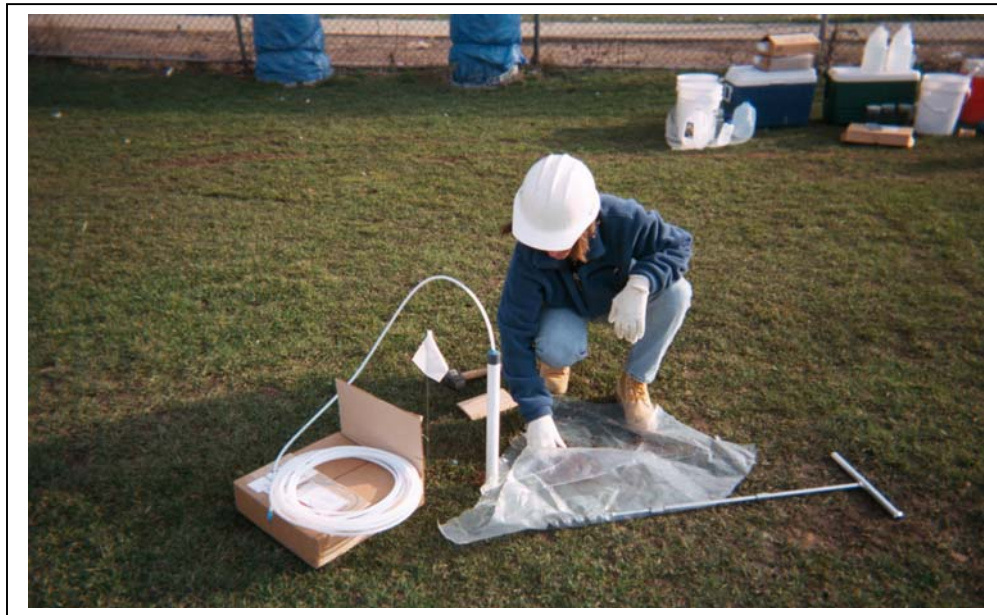
**Photo/Frame No.:** 6 **Direction of View:** Northeast  
**Date/Time:** 3-14-00/07:55 **Subject:** Preparation of soil gas probe at SG-1.  
**Photographer:** R. Watt

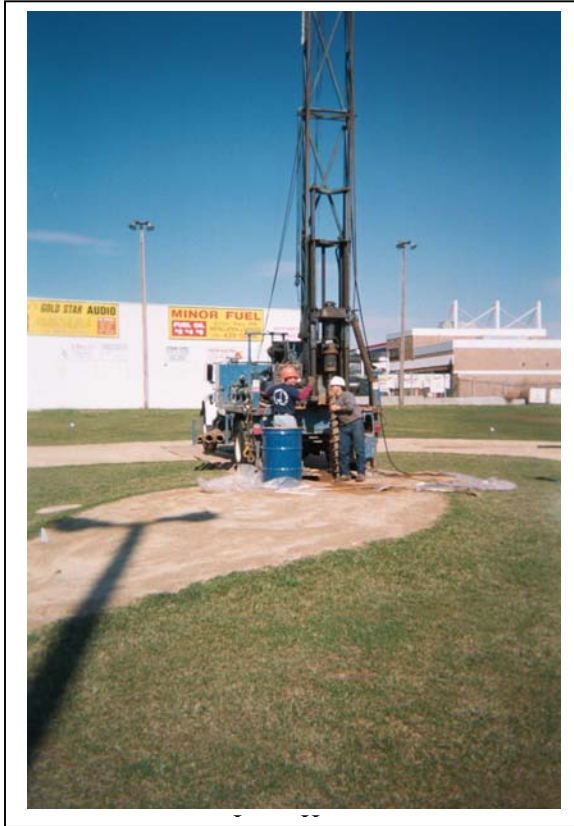
**Photo/Frame No.:** 7

**Direction of View:** Northwest

**Subject:** Auger drilling at SB-5  
(pitching mound of large  
ball field).
