**RE: Former Front Street Holder Station Site
Brooklyn, Kings County
Index No. A2-0552-0606, Site No. 224063
Well Decommissioning**

On behalf of National Grid, URS Corporation (URS) has decommissioned the five monitoring wells installed during the Site Characterization of the former Front Street Holder Station site in Brooklyn, NY (the Site). The text following this introductory paragraph has been prepared by URS to document the well decommissioning and associated restoration of sidewalks. Copies of the well decommissioning logs and photographs of the sidewalk repairs are attached.

SIDEWALK FLAG REPAIR PHOTOGRAPHS

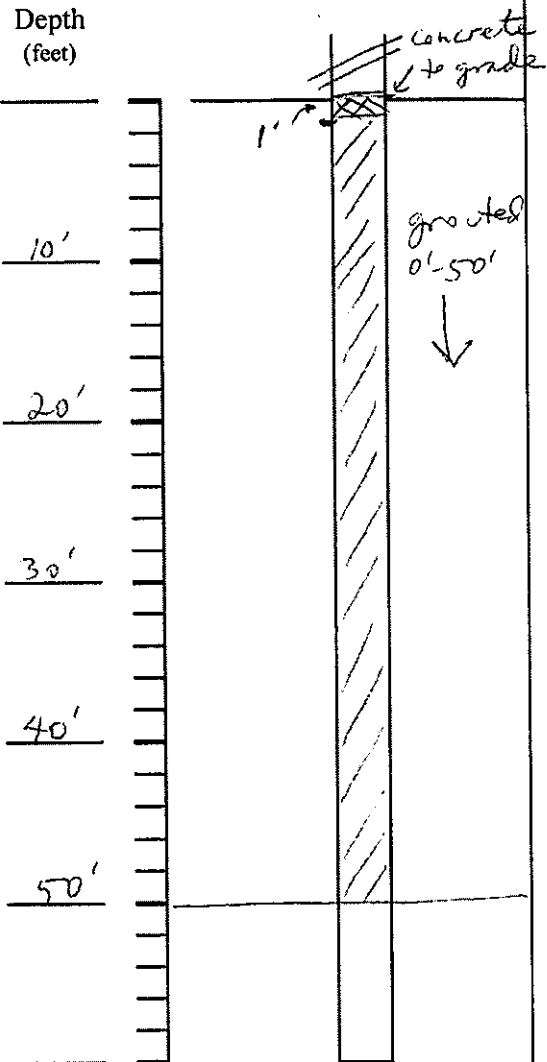
FIGURE 3

Well I.D.: MW-01
 Driller: Quincy Brandt
 Inspector: Megan Dascoli
 Date: 10/24/13

0-50'
1
30
200
Portland
25
0
30
30

Note: Before decommissioning, water level was measured, below top of casing. DTW = 43.02 DTB = 50.26

All wells were grouted in place. The decommissioning process involved placing a cement/bentonite grout mixture into the well, using a tremie pipe, from the base of the well up to approximately 5 feet below grade. The upper portion of the well riser was then broken off or unscrewed and then grout added to approximately 1 foot below grade. The remaining 1 foot was then backfilled with concrete.

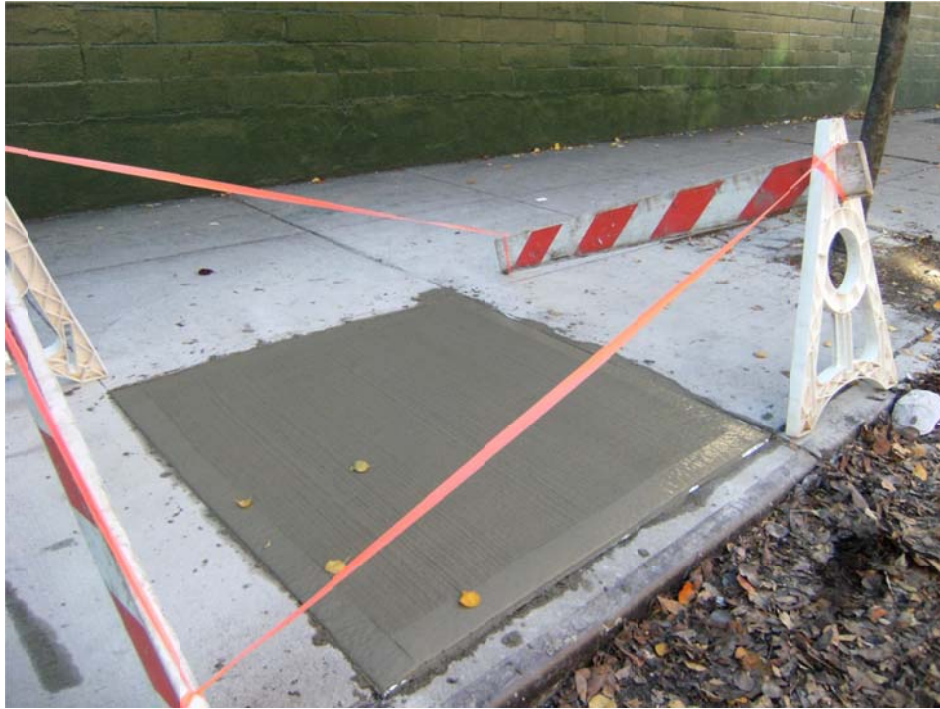
1

Looking south at former
MW-01 location at 218
Front Street.

- 218 Front Street – one 5 ft by 5 ft flag at the former location of well MW-1;
- 218A Front Street – one 5 ft by 5 ft flag at the location of a gas valve box (this flag was mistakenly removed by NY Paving prior to URS arriving at the site);
- 206 Front Street – one 5 ft by 5 ft flag at the former location of well MW-3 and the adjacent 5 ft by 5 ft flag which was the location of a boring that was abandoned due to shallow drilling refusal; and
- 171 York Street – two 5.5 ft by 6.5 ft flags, one at former location of well MW-2 and one at the former location of well MW-4.

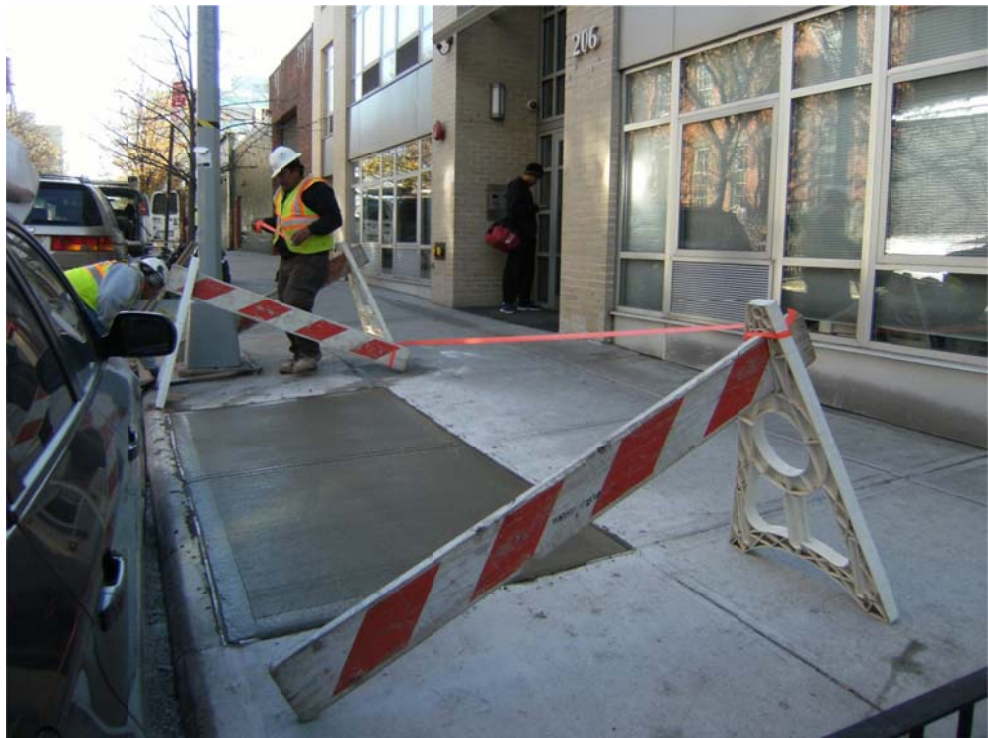
2

Looking east at former
MW-03 location near 206
Front Street. Two flags
were replaced- one that
held the monitoring well
and one that had a patch
from a refusal.

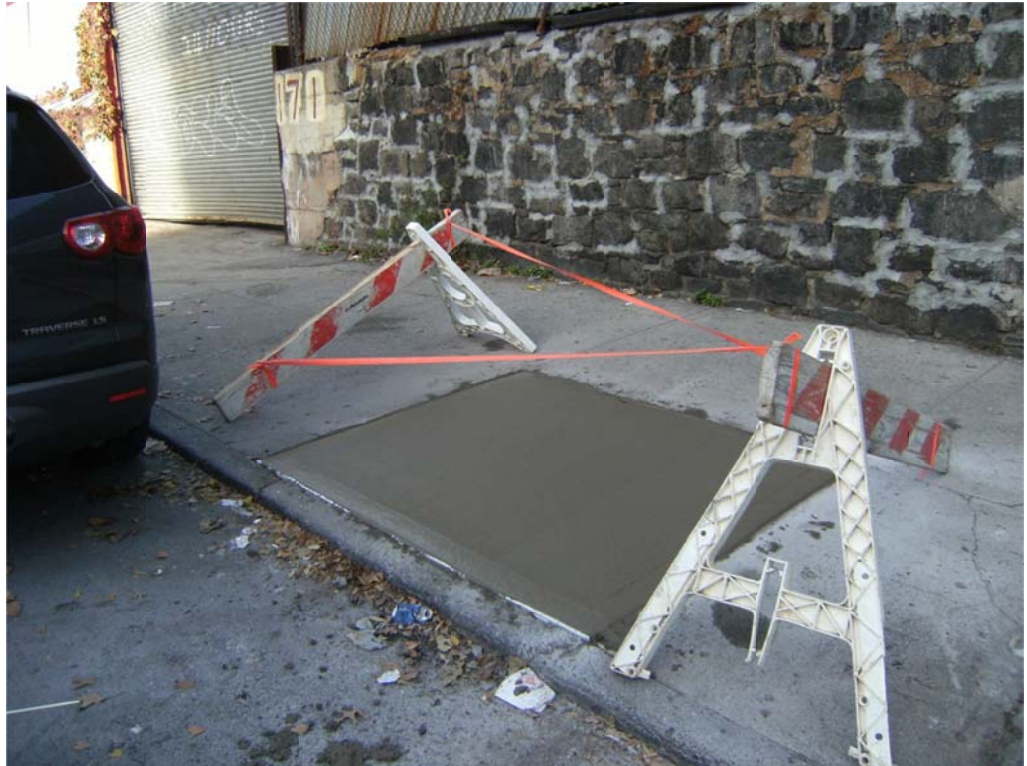
3

Looking northwest at former MW-02 location just east of the lumber yard at 171 York Street.

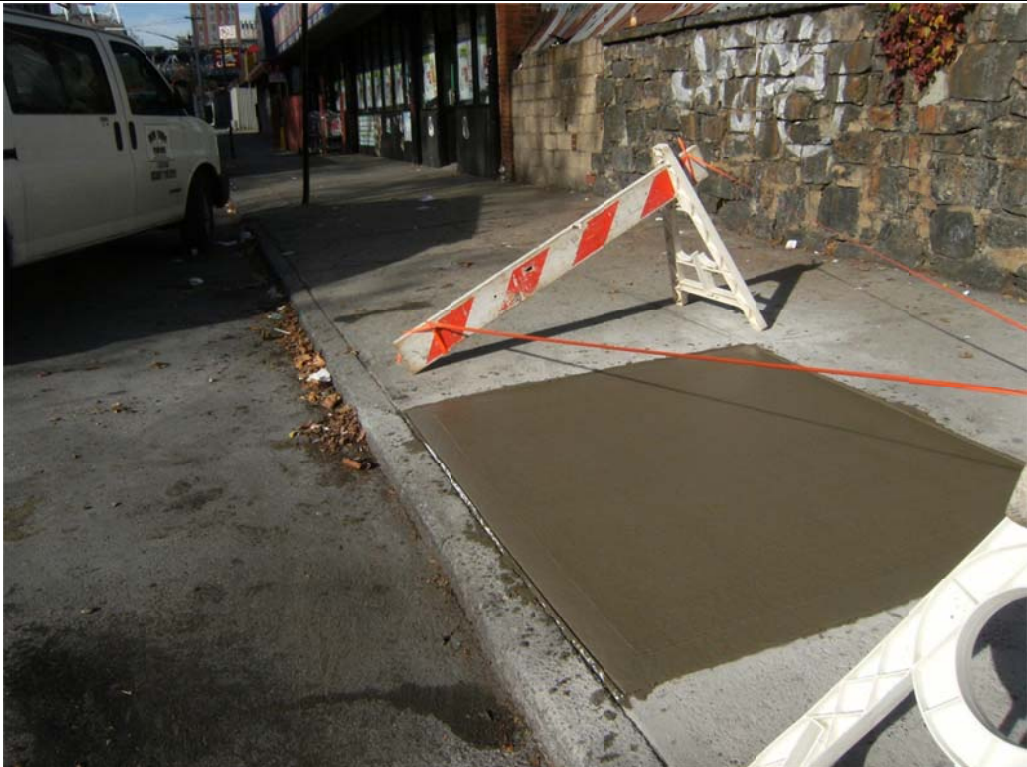
4

Looking northwest at former MW-4 location west of 171 York Street.

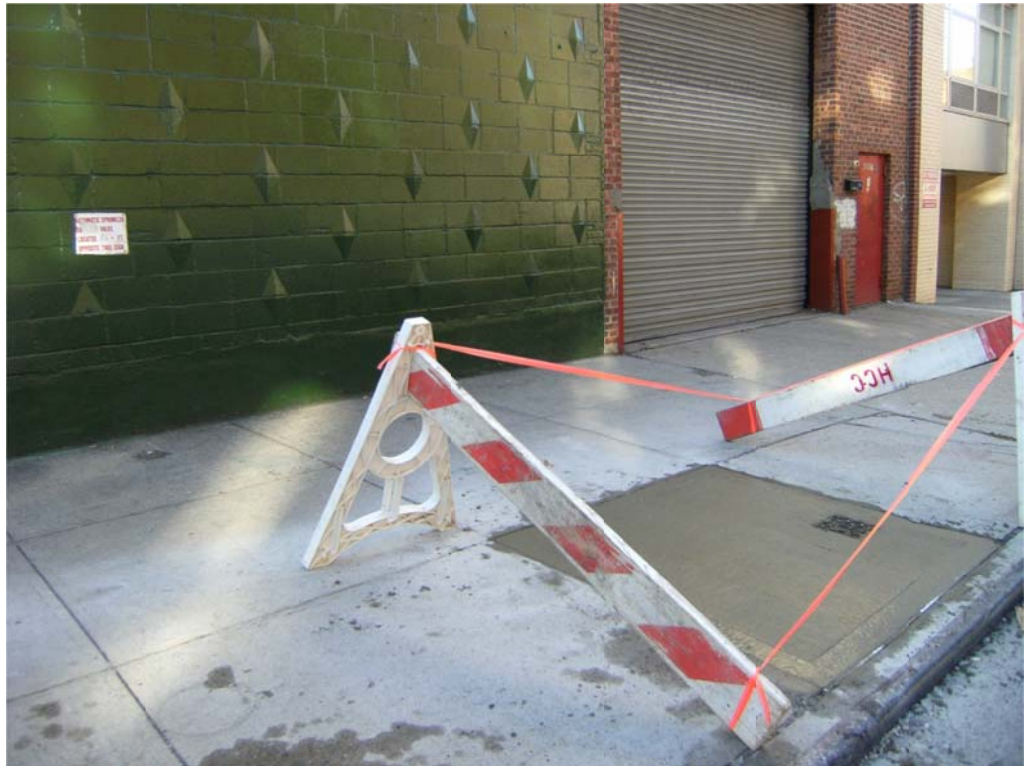
5

Looking southwest at accidentally replaced flag with gas meter box near 218A Front Street. NY Paving had mistakenly marked this flag for replacement instead of MW-03 location, which was then correctly marked out and replaced.
