DNAPL RECOVERY LETTER REPORT

WORK ASSIGNMENT D007622-30

FORMER SPIC AND SPAN CLEANERS & DYERS, INC. SITE GREENPOINT/EAST WILLIAMSBURG INDUSTRIAL AREA

SITE NO. 224129 KINGS (C), NY

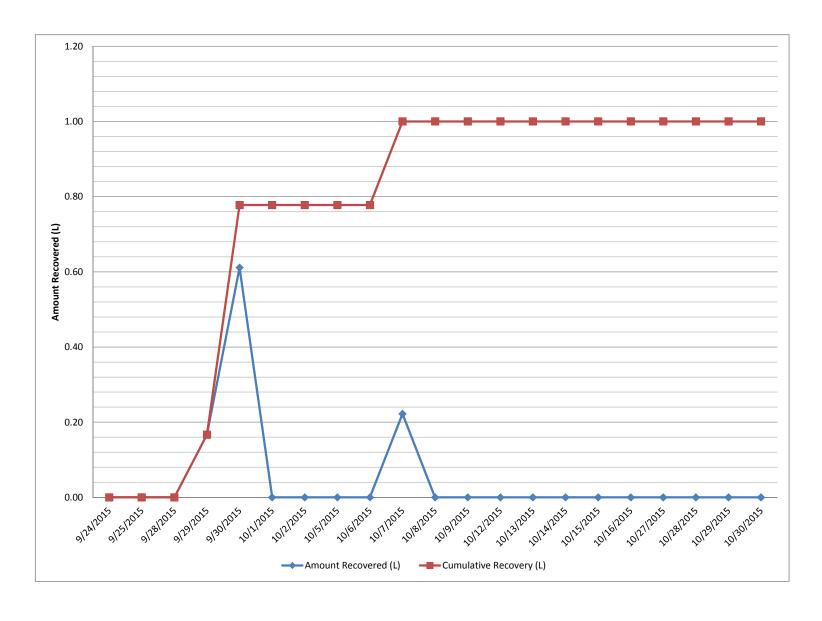
SUMMARY OF DNAPL PRODUCT RECOVERY IN DEC-024 FORMER SPIC AND SPAN CLEANERS AND DRYERS SITE

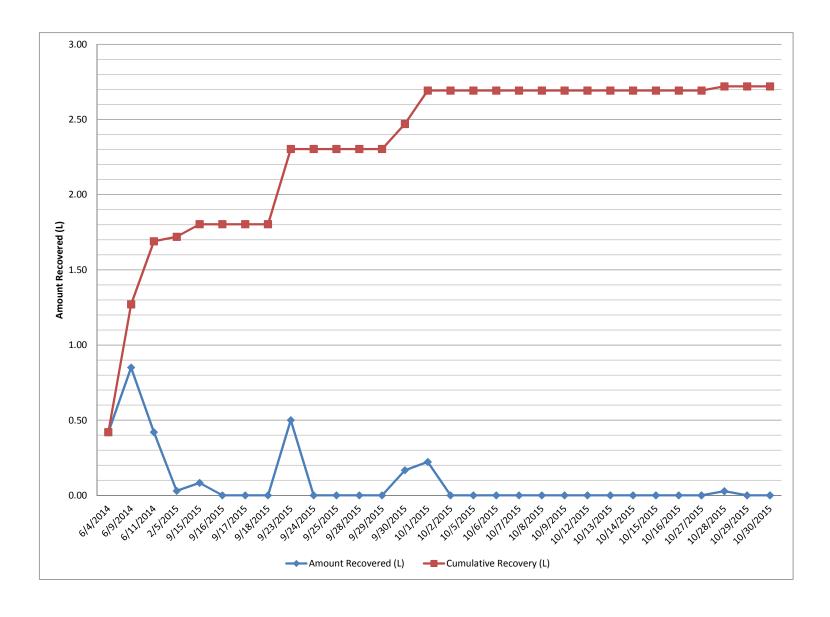
SUMMARY OF DNAPL PRODUCT RECOVERY IN DEC-024D FORMER SPIC AND SPAN CLEANERS AND DRYERS SITE

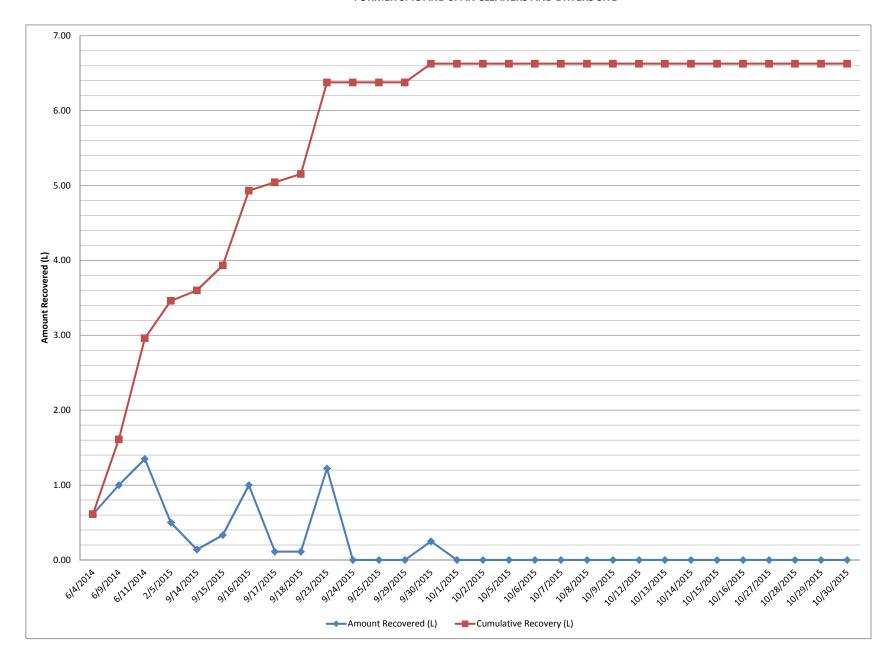
SUMMARY OF DNAPL PRODUCT RECOVERY IN DEC-024DR FORMER SPIC AND SPAN CLEANERS AND DRYERS SITE

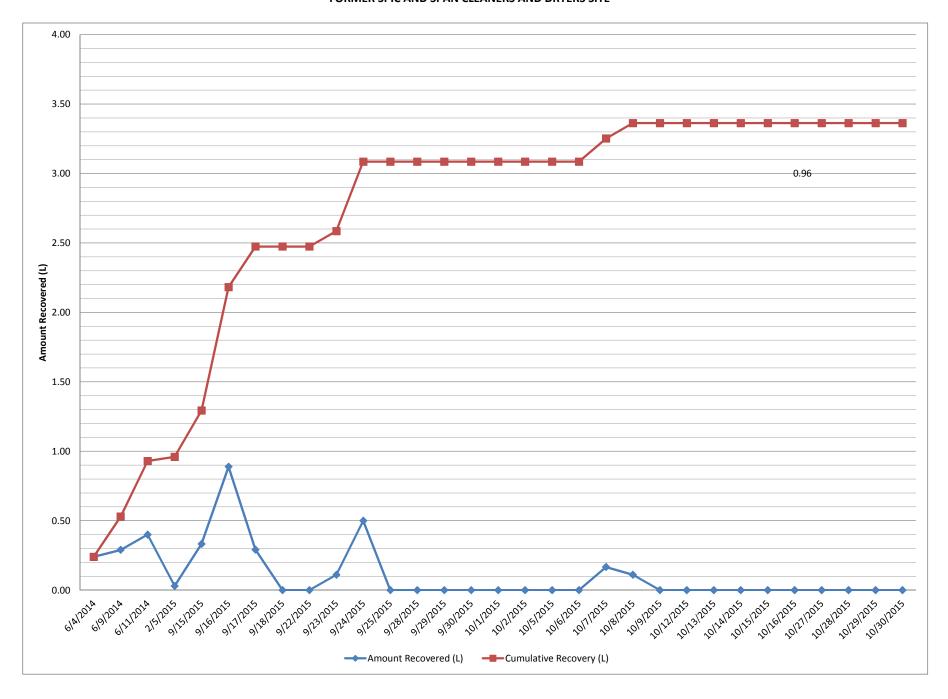
SUMMARY OF DNAPL PRODUCT RECOVERY IN DEC-092D FORMER SPIC AND SPAN CLEANERS AND DRYERS SITE

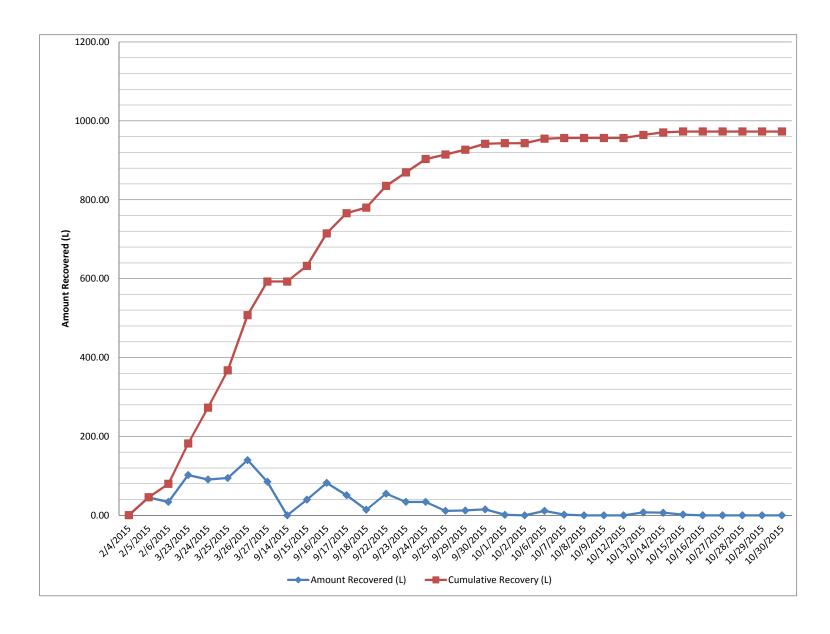
SUMMARY OF DNAPL PRODUCT RECOVERY IN DEC-136 FORMER SPIC AND SPAN CLEANERS AND DRYERS SITE

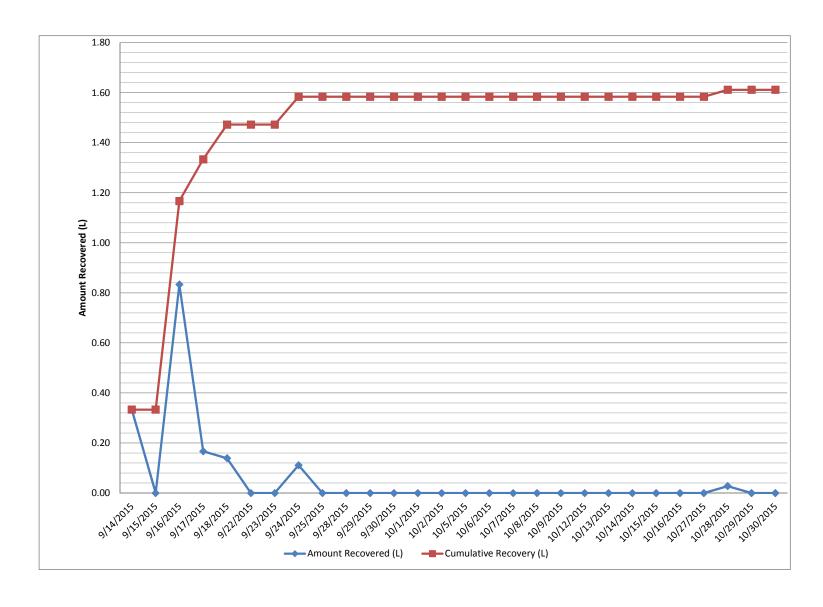
SUMMARY OF DNAPL PRODUCT RECOVERY IN DEC-136D FORMER SPIC AND SPAN CLEANERS AND DRYERS SITE

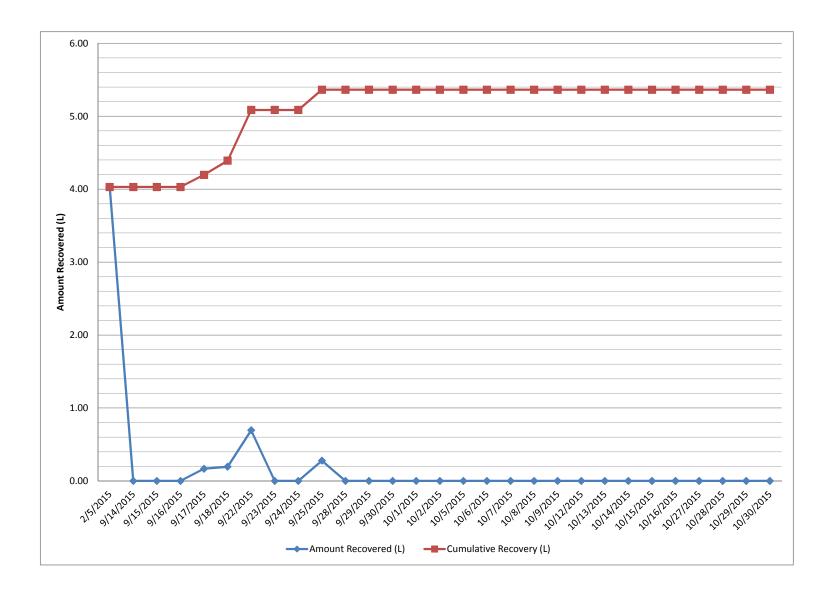
SUMMARY OF DNAPL PRODUCT RECOVERY IN EW-01 FORMER SPIC AND SPAN CLEANERS AND DRYERS SITE

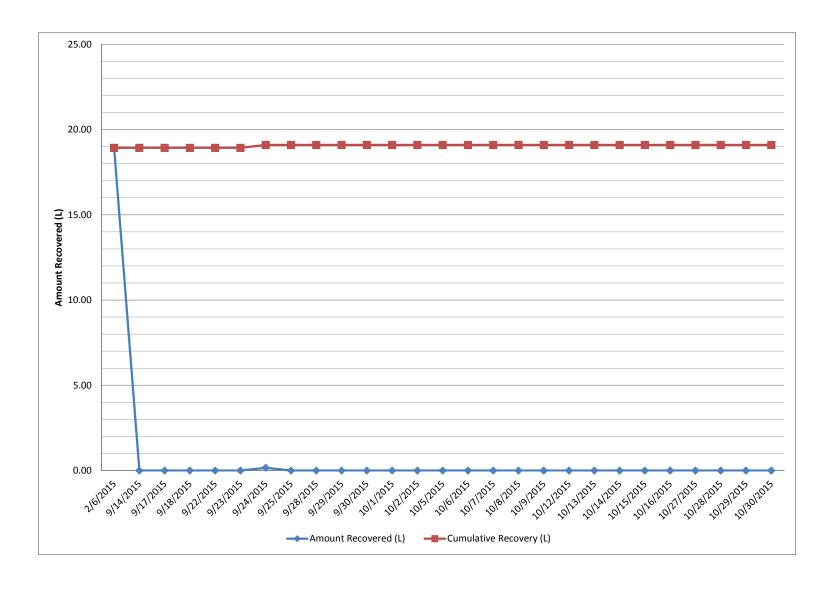
SUMMARY OF DNAPL PRODUCT RECOVERY IN EW-02 FORMER SPIC AND SPAN CLEANERS AND DRYERS SITE

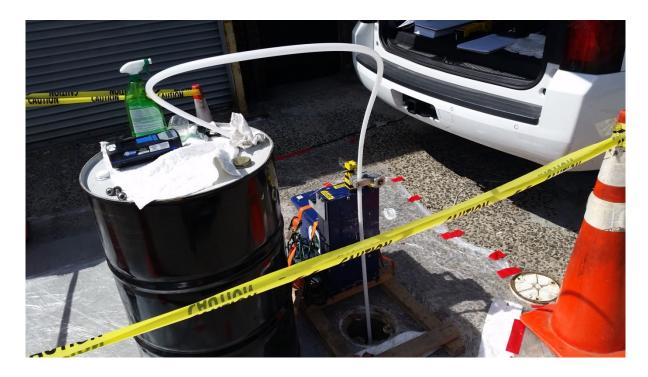
Photo 6: 9/14/15: Waterra pump and drum set up for DNAPL removal at DEC-136

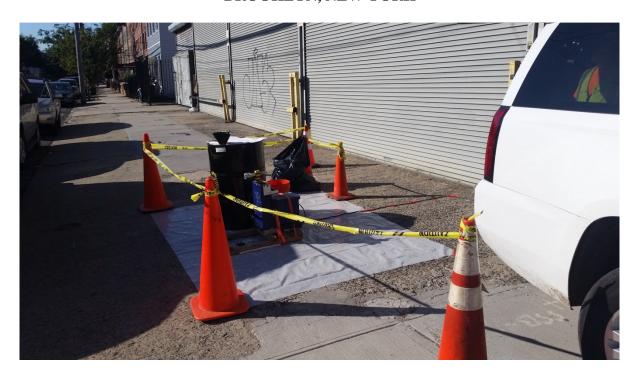
Photo 7: 9/15/15: Waterra pump set up for DNAPL removal at DEC-136.

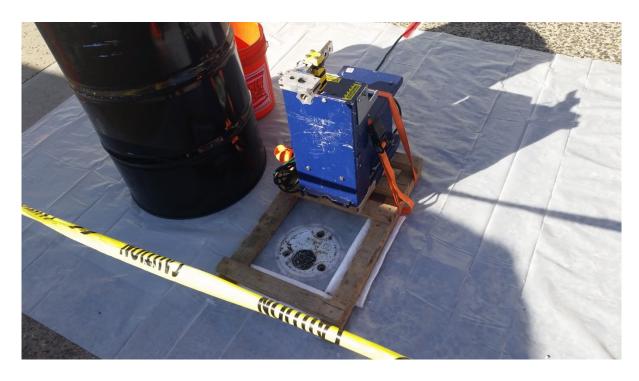
Photo 8: 9/15/15: Waterra pump set up for DNAPL removal at DEC-136

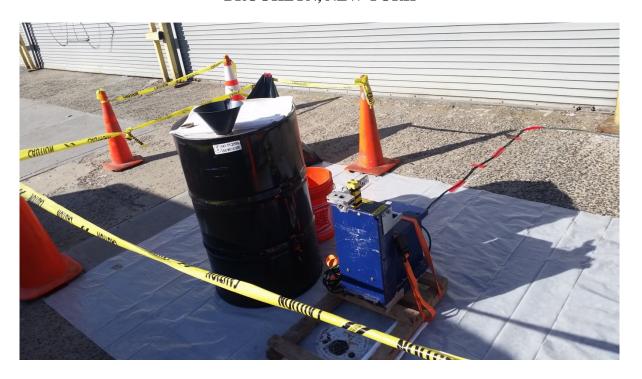
Photo 9: 9/15/15: Waterra pump and drum set up for DNAPL removal at DEC-136

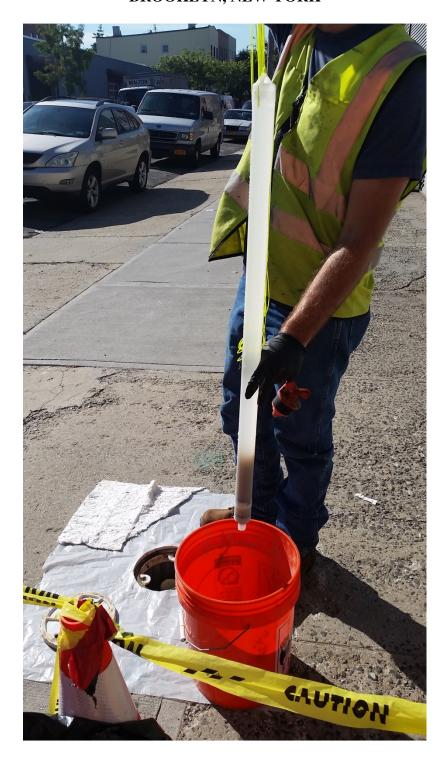
Photo 11: 9/16/15: Bailer showing DNAPL at DEC-136D
