# REMEDIAL INVESTIGATION REPORT

**Former ACME Steel/Metal Works  
95 Lombardy Street/46 Anthony Street  
Brooklyn, New York**

**NYSDEC Site No. 224131**

**July 2013**

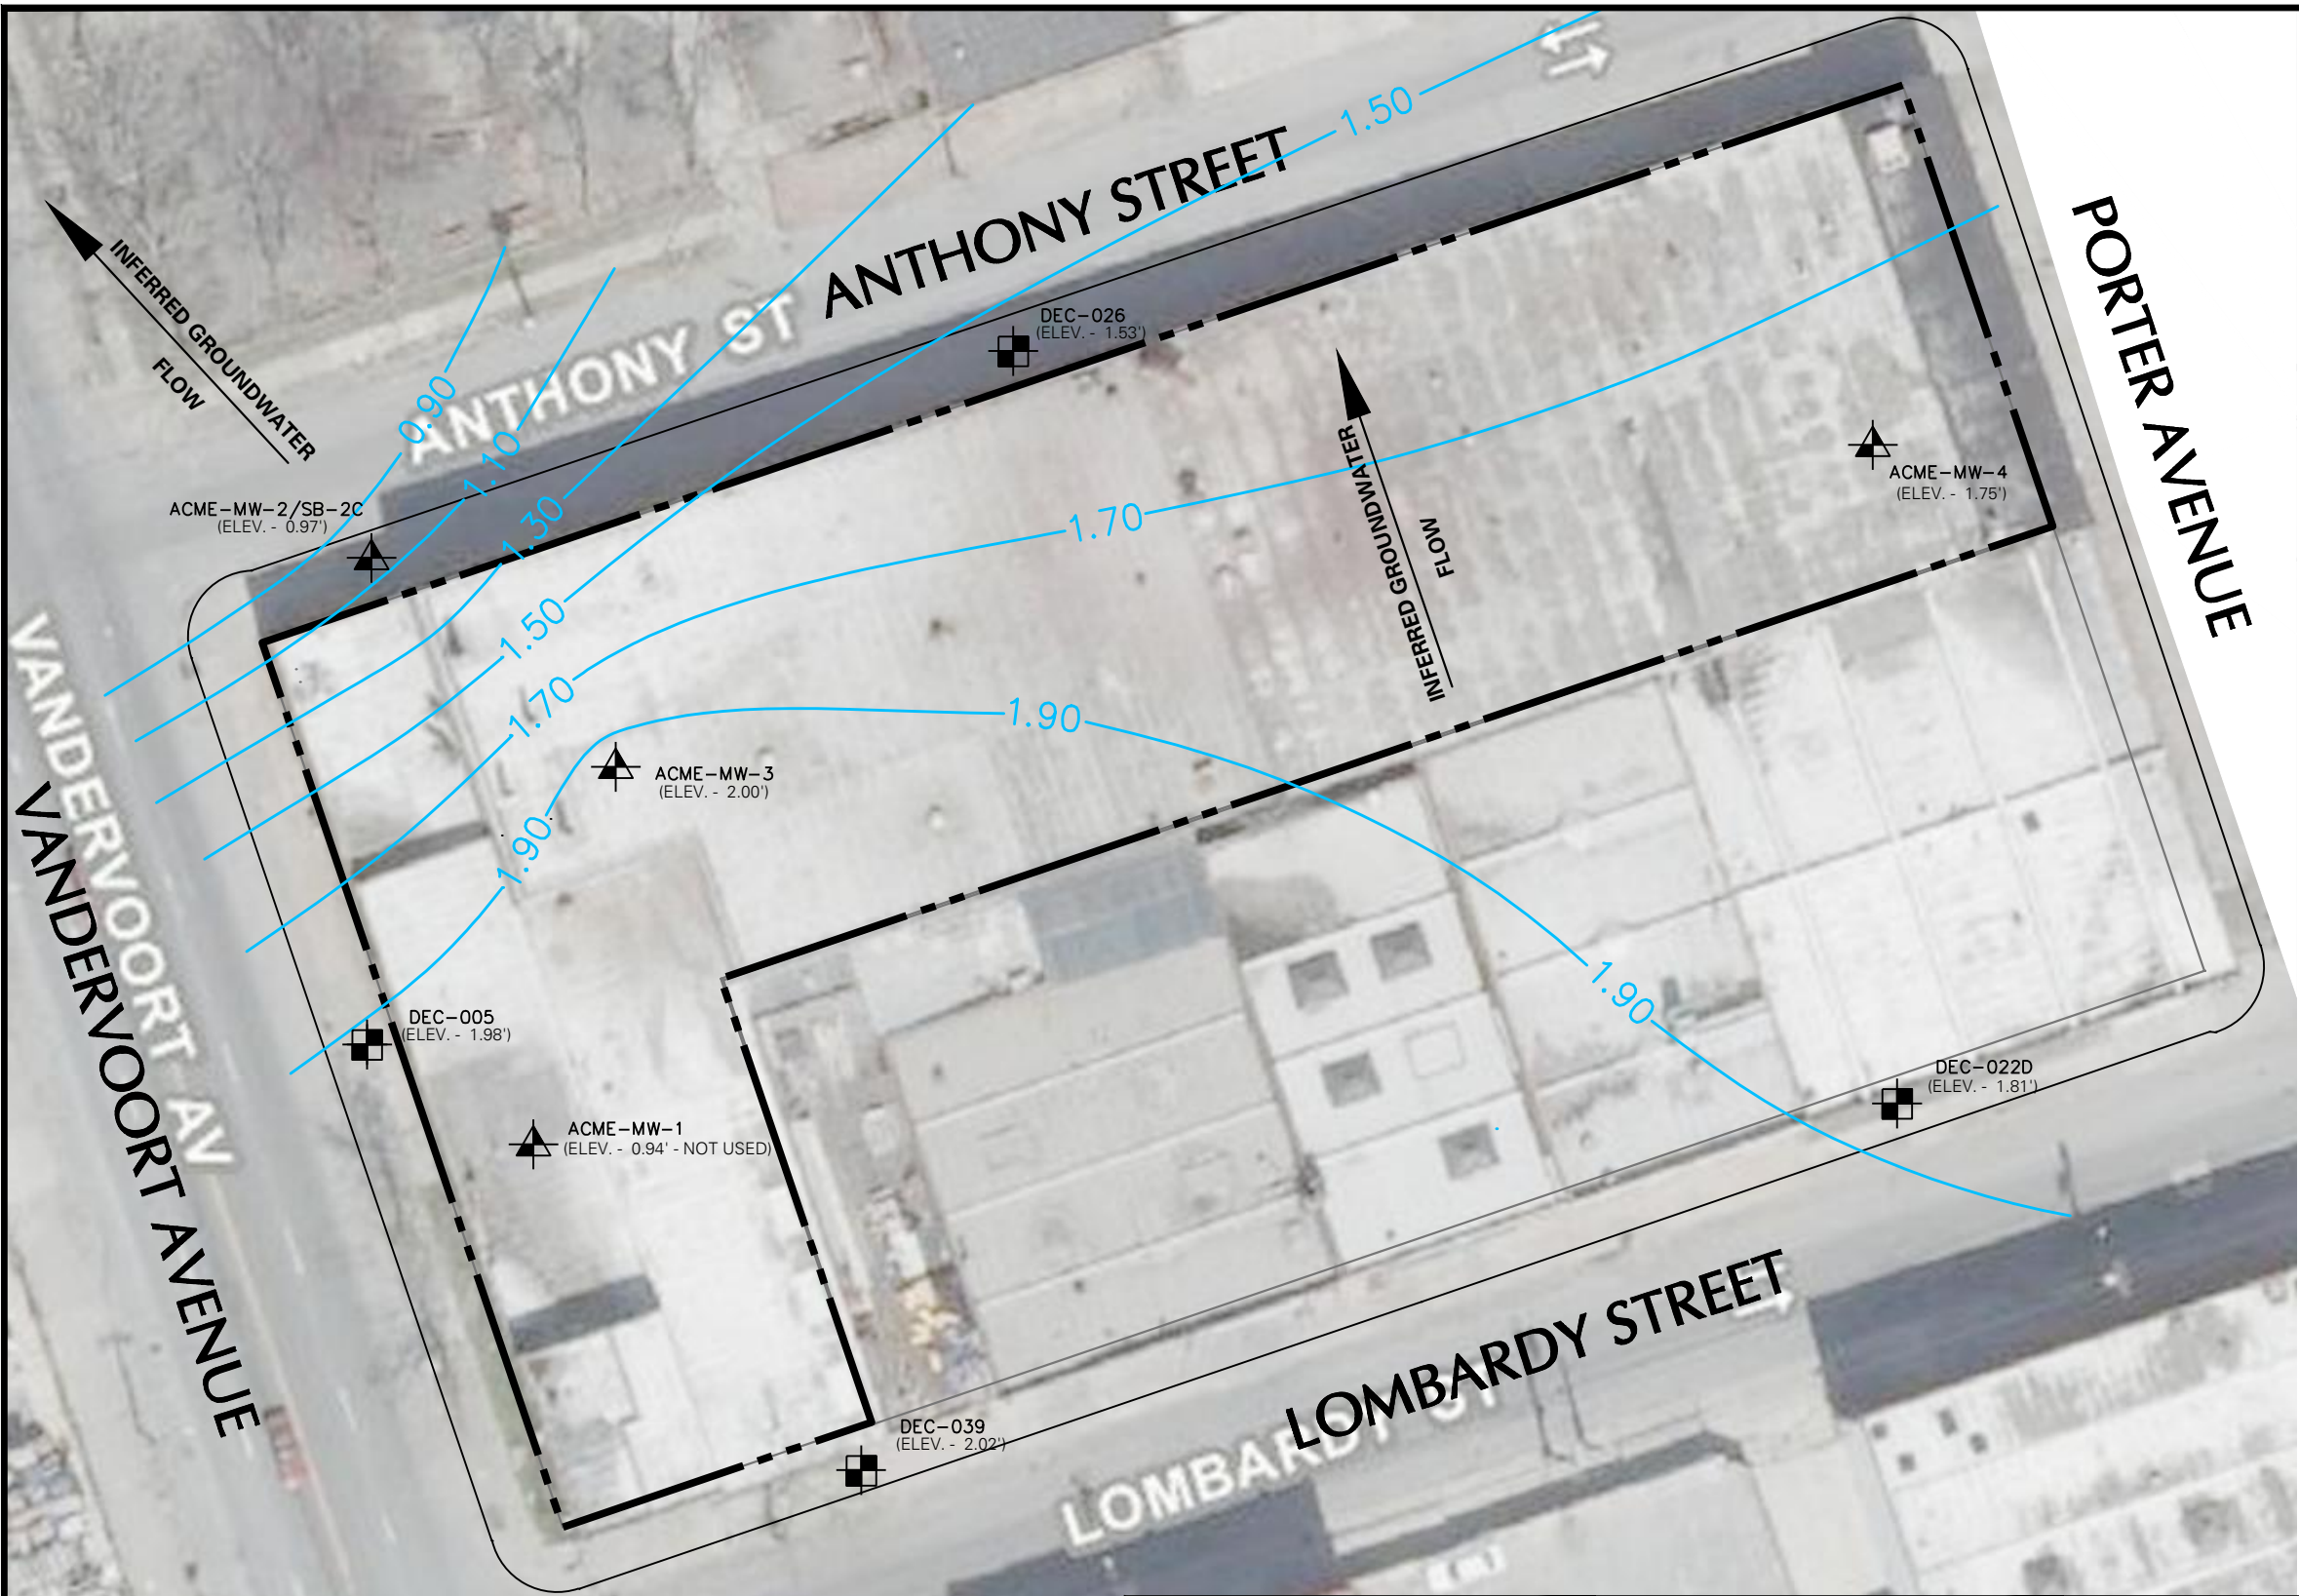
**4**

- SITE BOUNDARY
- BUILDING OUTLINE
- RI SHALLOW GROUNDWATER MONITORING WELL LOCATION
- EXISTING SHALLOW GROUNDWATER MONITORING WELL LOCATION
- 1.90 INFERRED GROUNDWATER ELEVATION CONTOUR (FEET)

Provided below is a description of the regional and site specific geology and hydrogeology that was observed during the RI. Shallow and deep groundwater contour maps are provided as Figures 4 and 5, respectively. Subsurface profiles presenting the inferred Site geology are presented on Figures 6 through 8. Top of clay contour maps are presented on Figures 9 and 10.

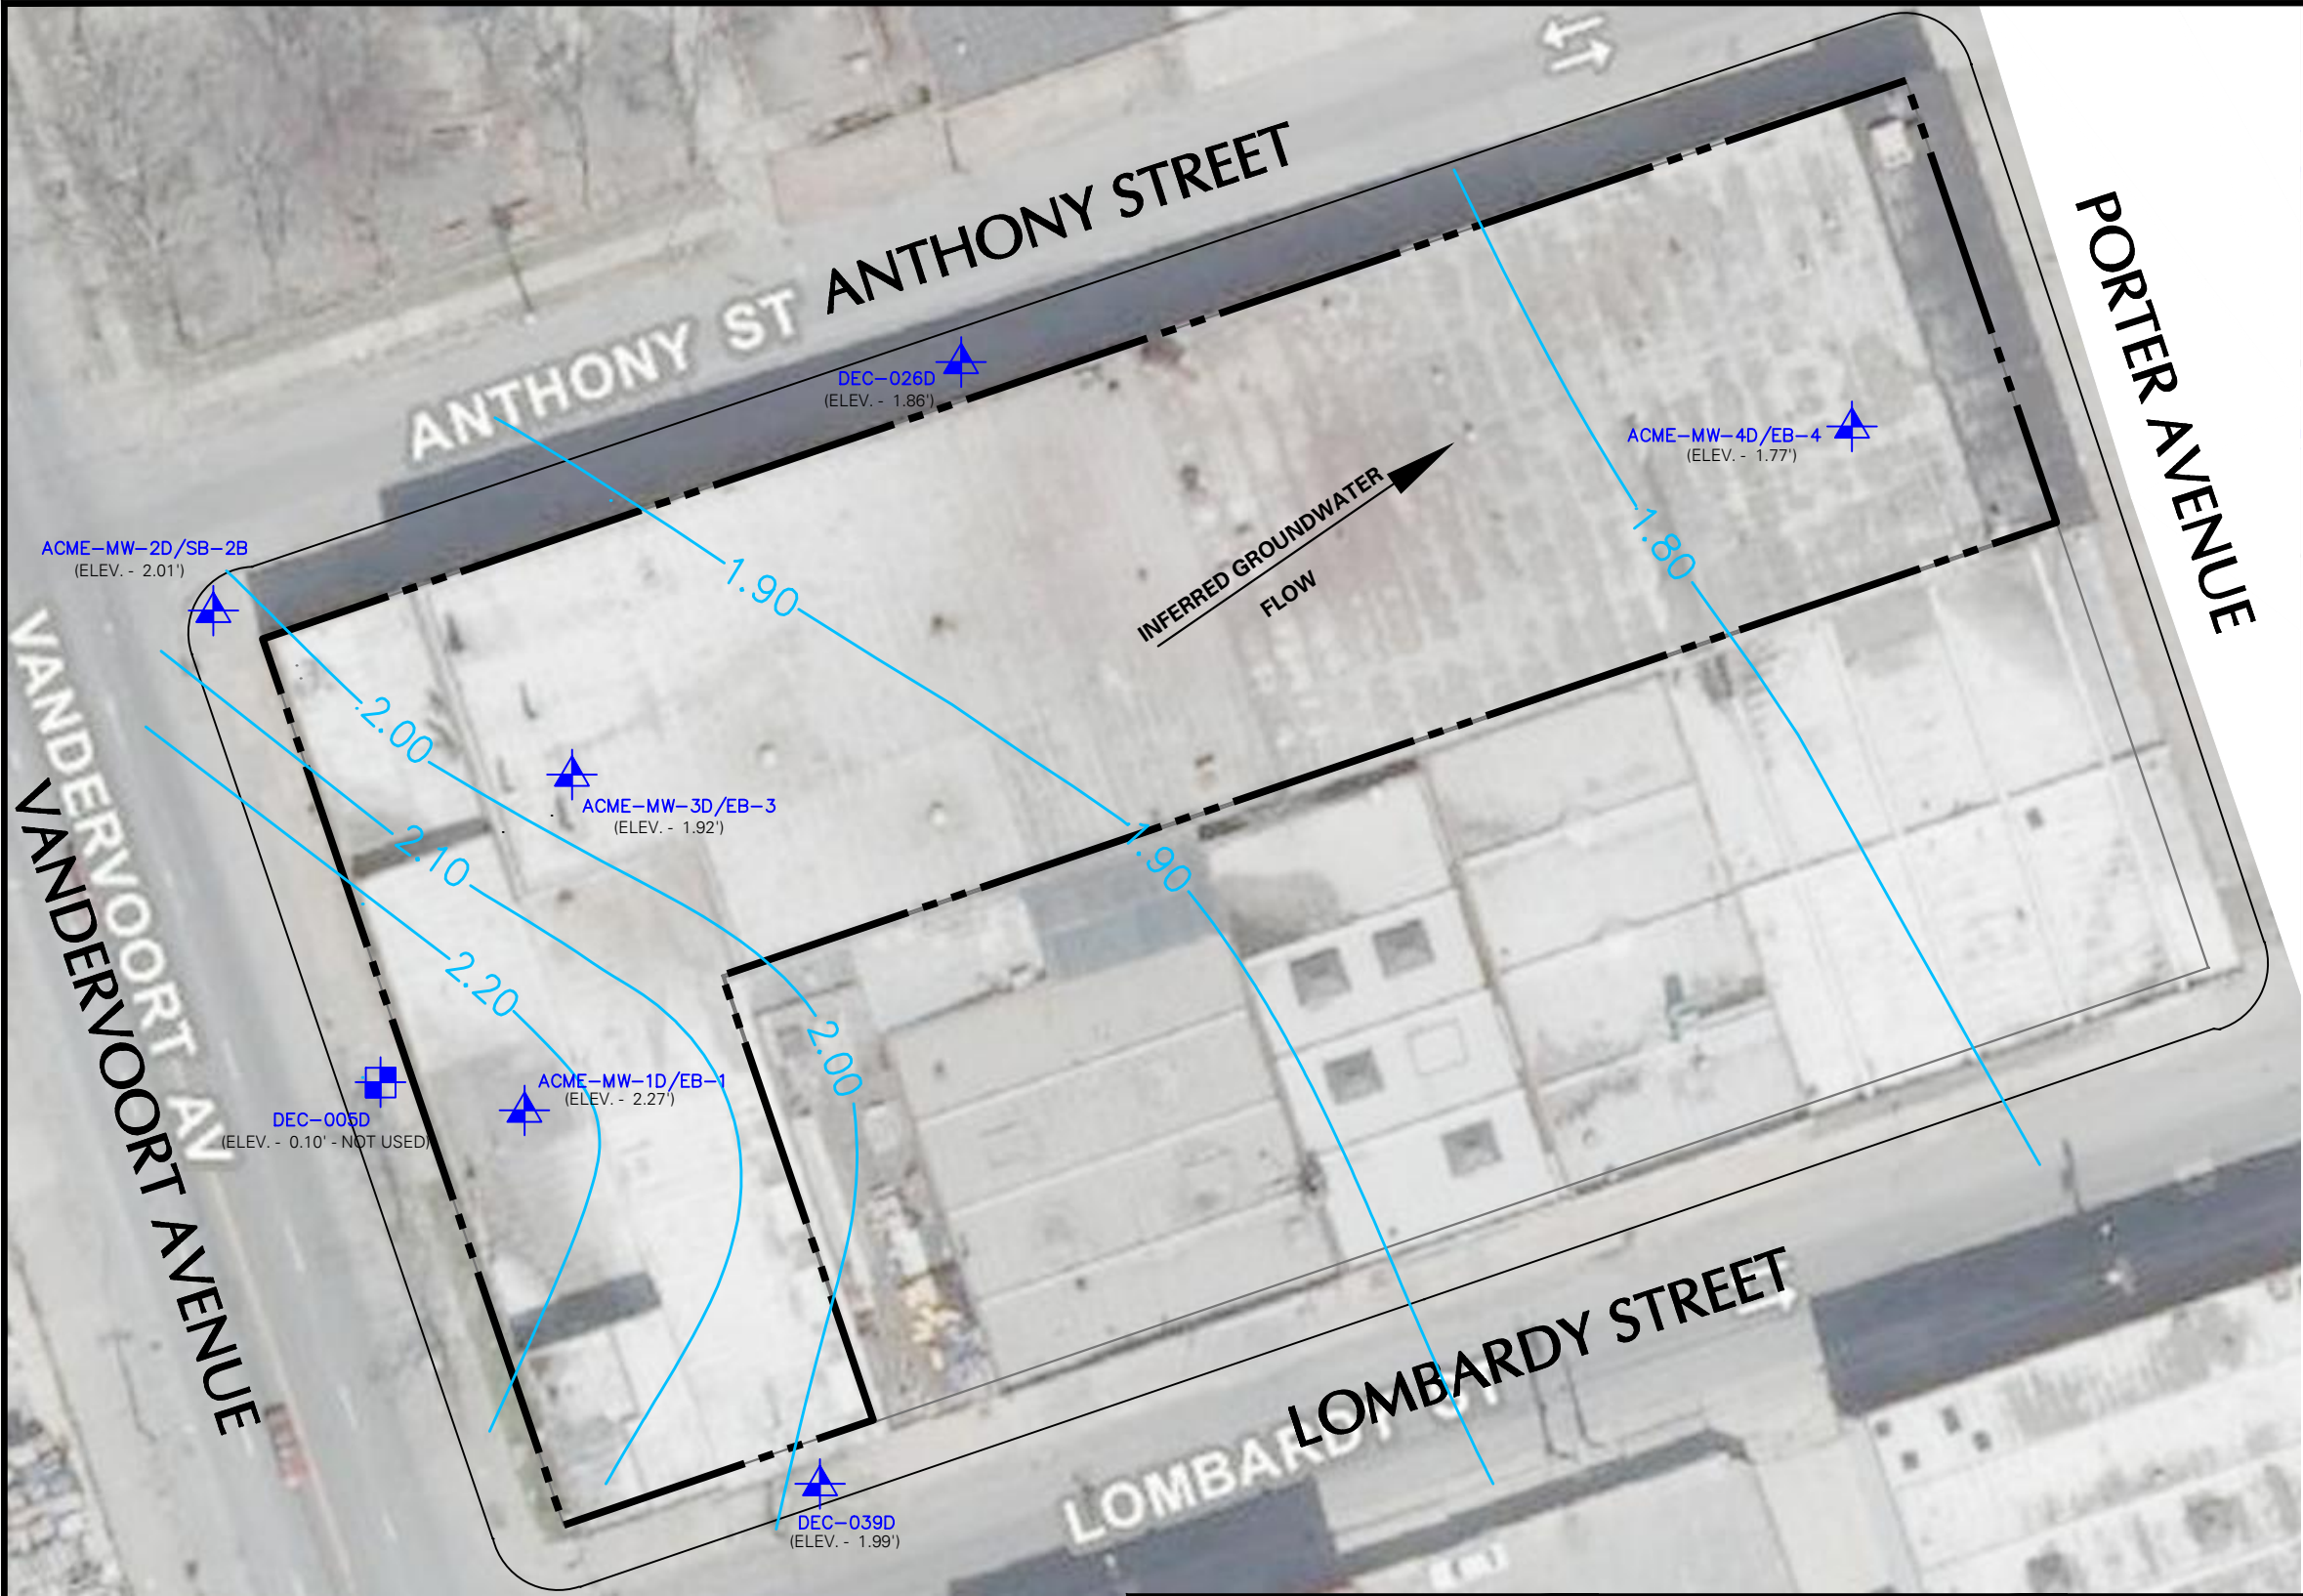
Project No. 170157201	Figure No.  <b>5</b>
Date 01/09/2013	
Scale 1" = 40'	
Drawn By EB	
Submission Date	Sheet 5 of 19

**DEEP OVERBURDEN GROUNDWATER COUNTOUR MAP**

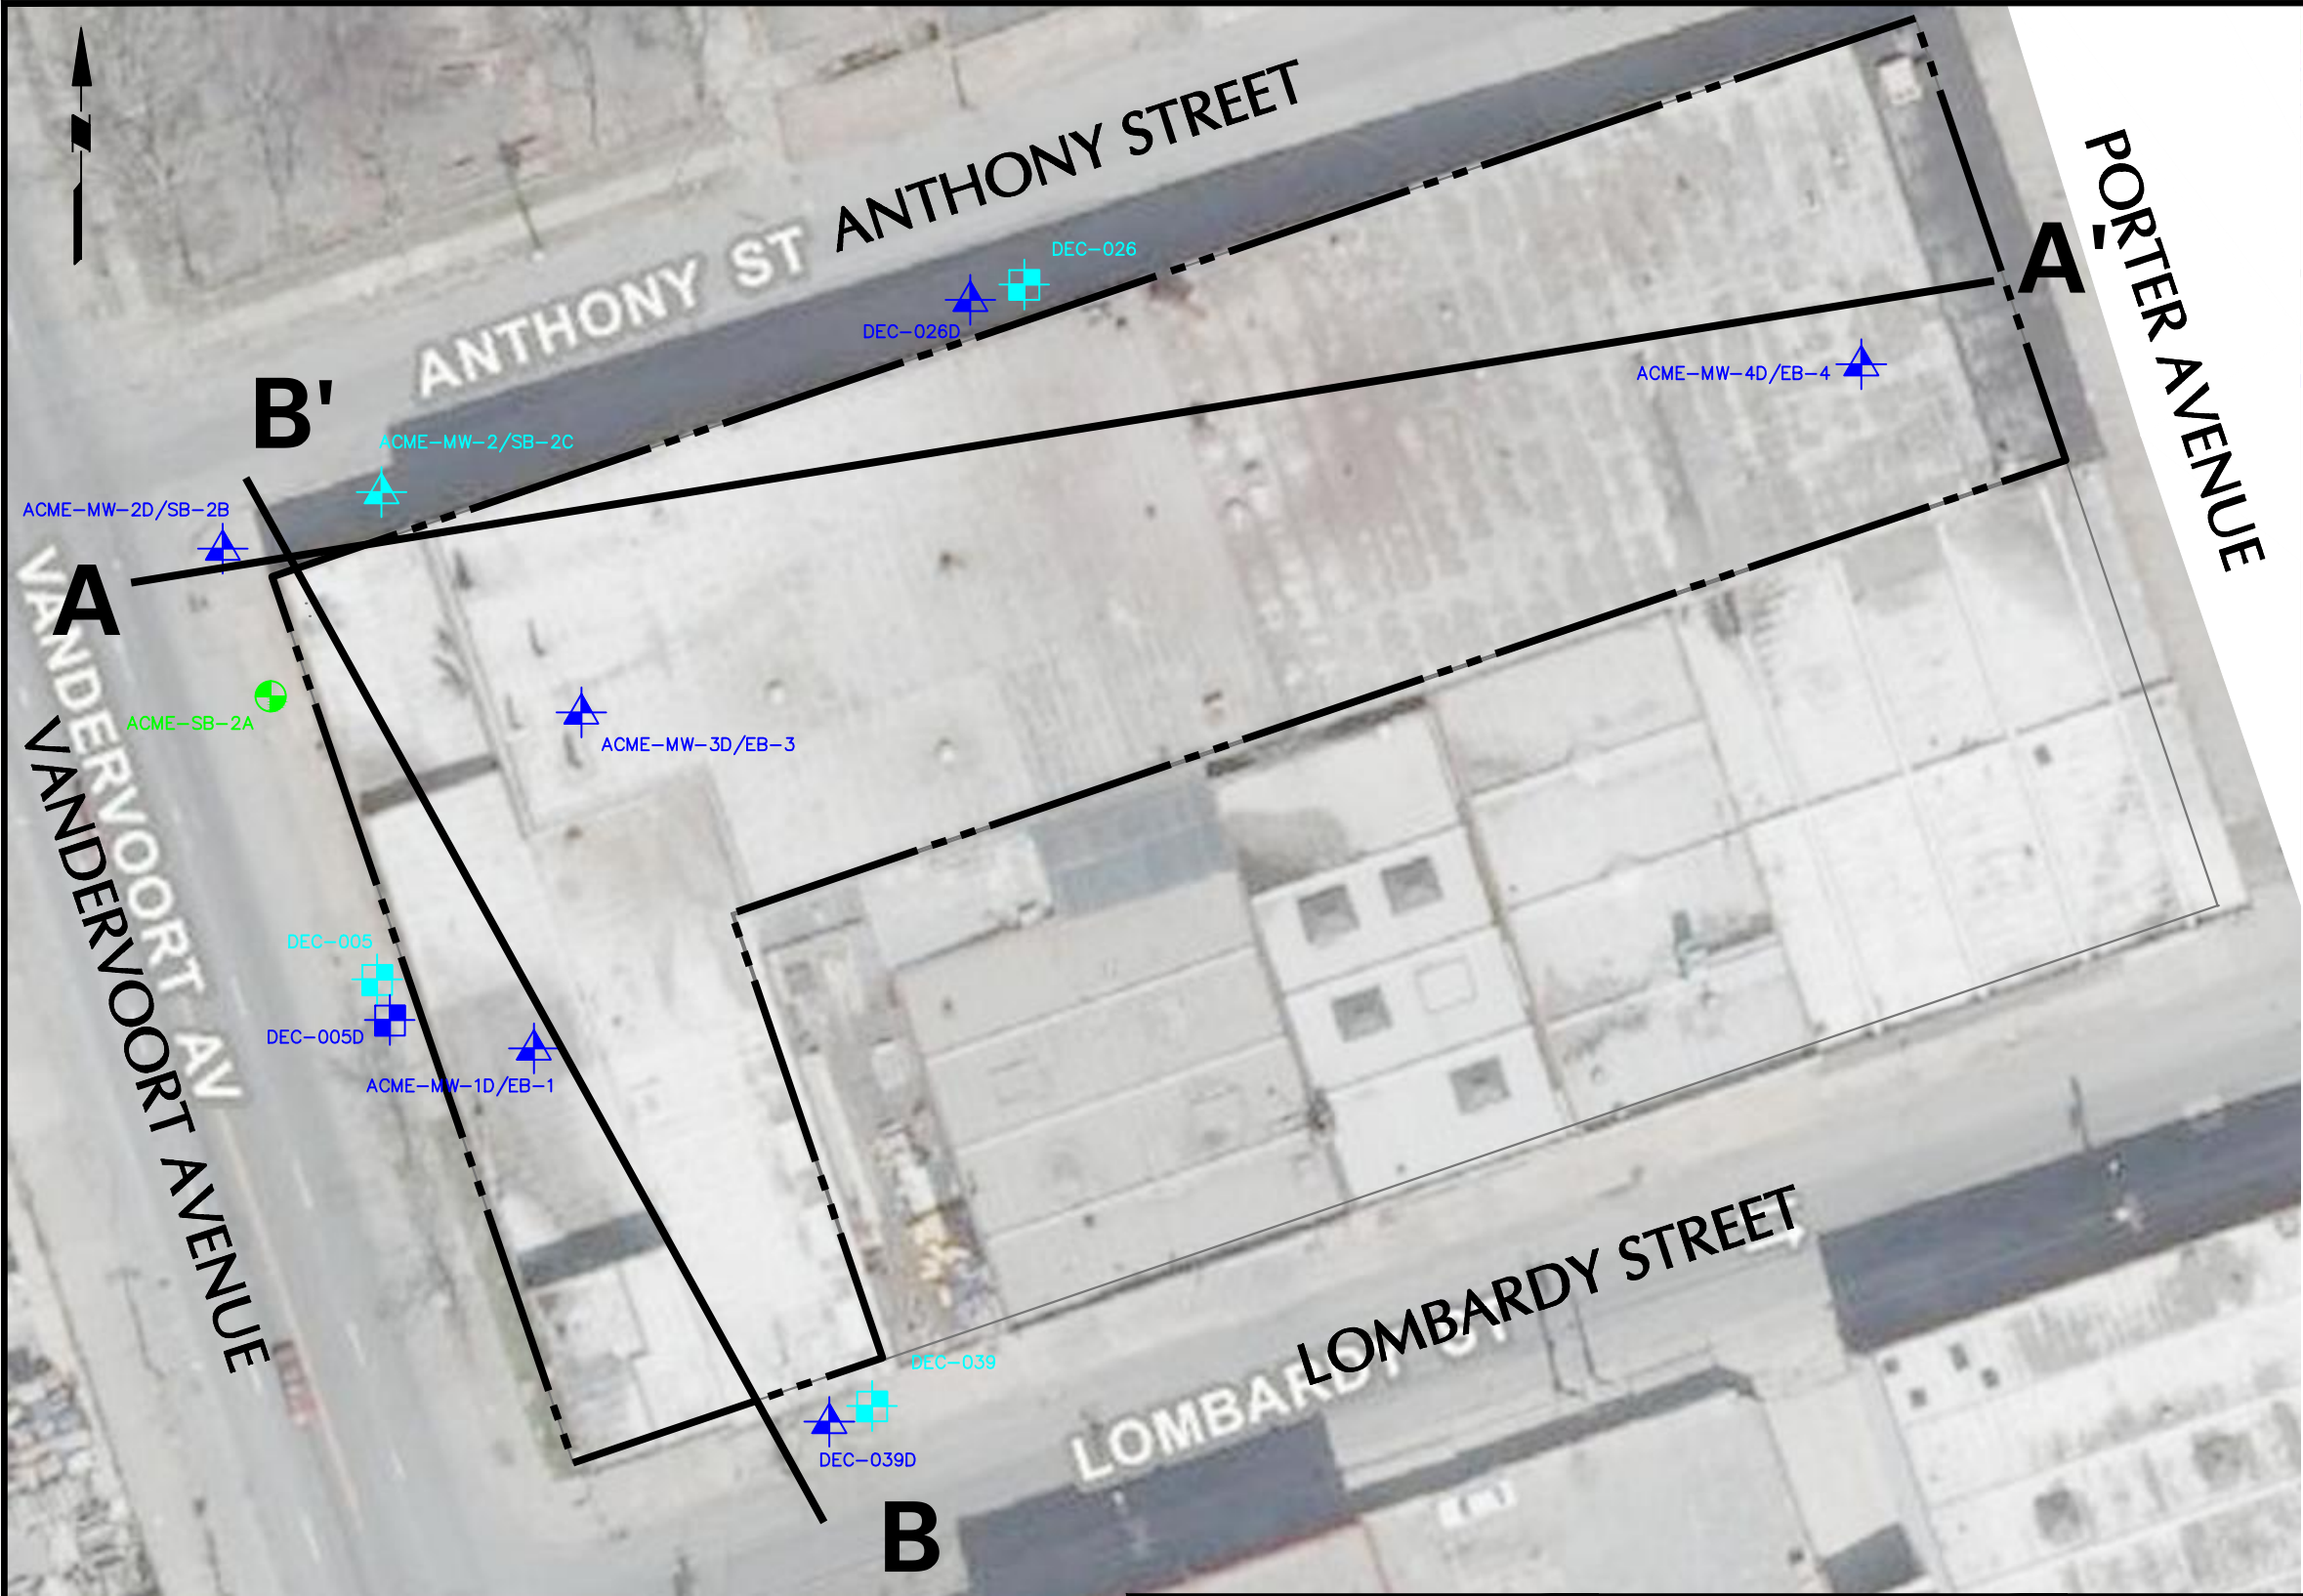
Project No. 170157201	Figure No.  <b>6</b>
Date 01/14/2012	
Scale 1" = 40'	
Drawn By EB	
Submission Date	Sheet 6 of 19

- SITE BOUNDARY
- BUILDING OUTLINE
- ACME-SB-2A RI SOIL BORING LOCATION
- ACME-MW-1D/EB-1 RI SOIL BORING AND DEEP GROUNDWATER MONITORING WELL LOCATION
- ACME-MW-1 RI SHALLOW GROUNDWATER MONITORING WELL LOCATION
- DEC-005 EXISTING SHALLOW GROUNDWATER MONITORING WELL LOCATION
- A-A' PROFILE TRANSECT

**CROSS SECTION  
PLAN VIEW**

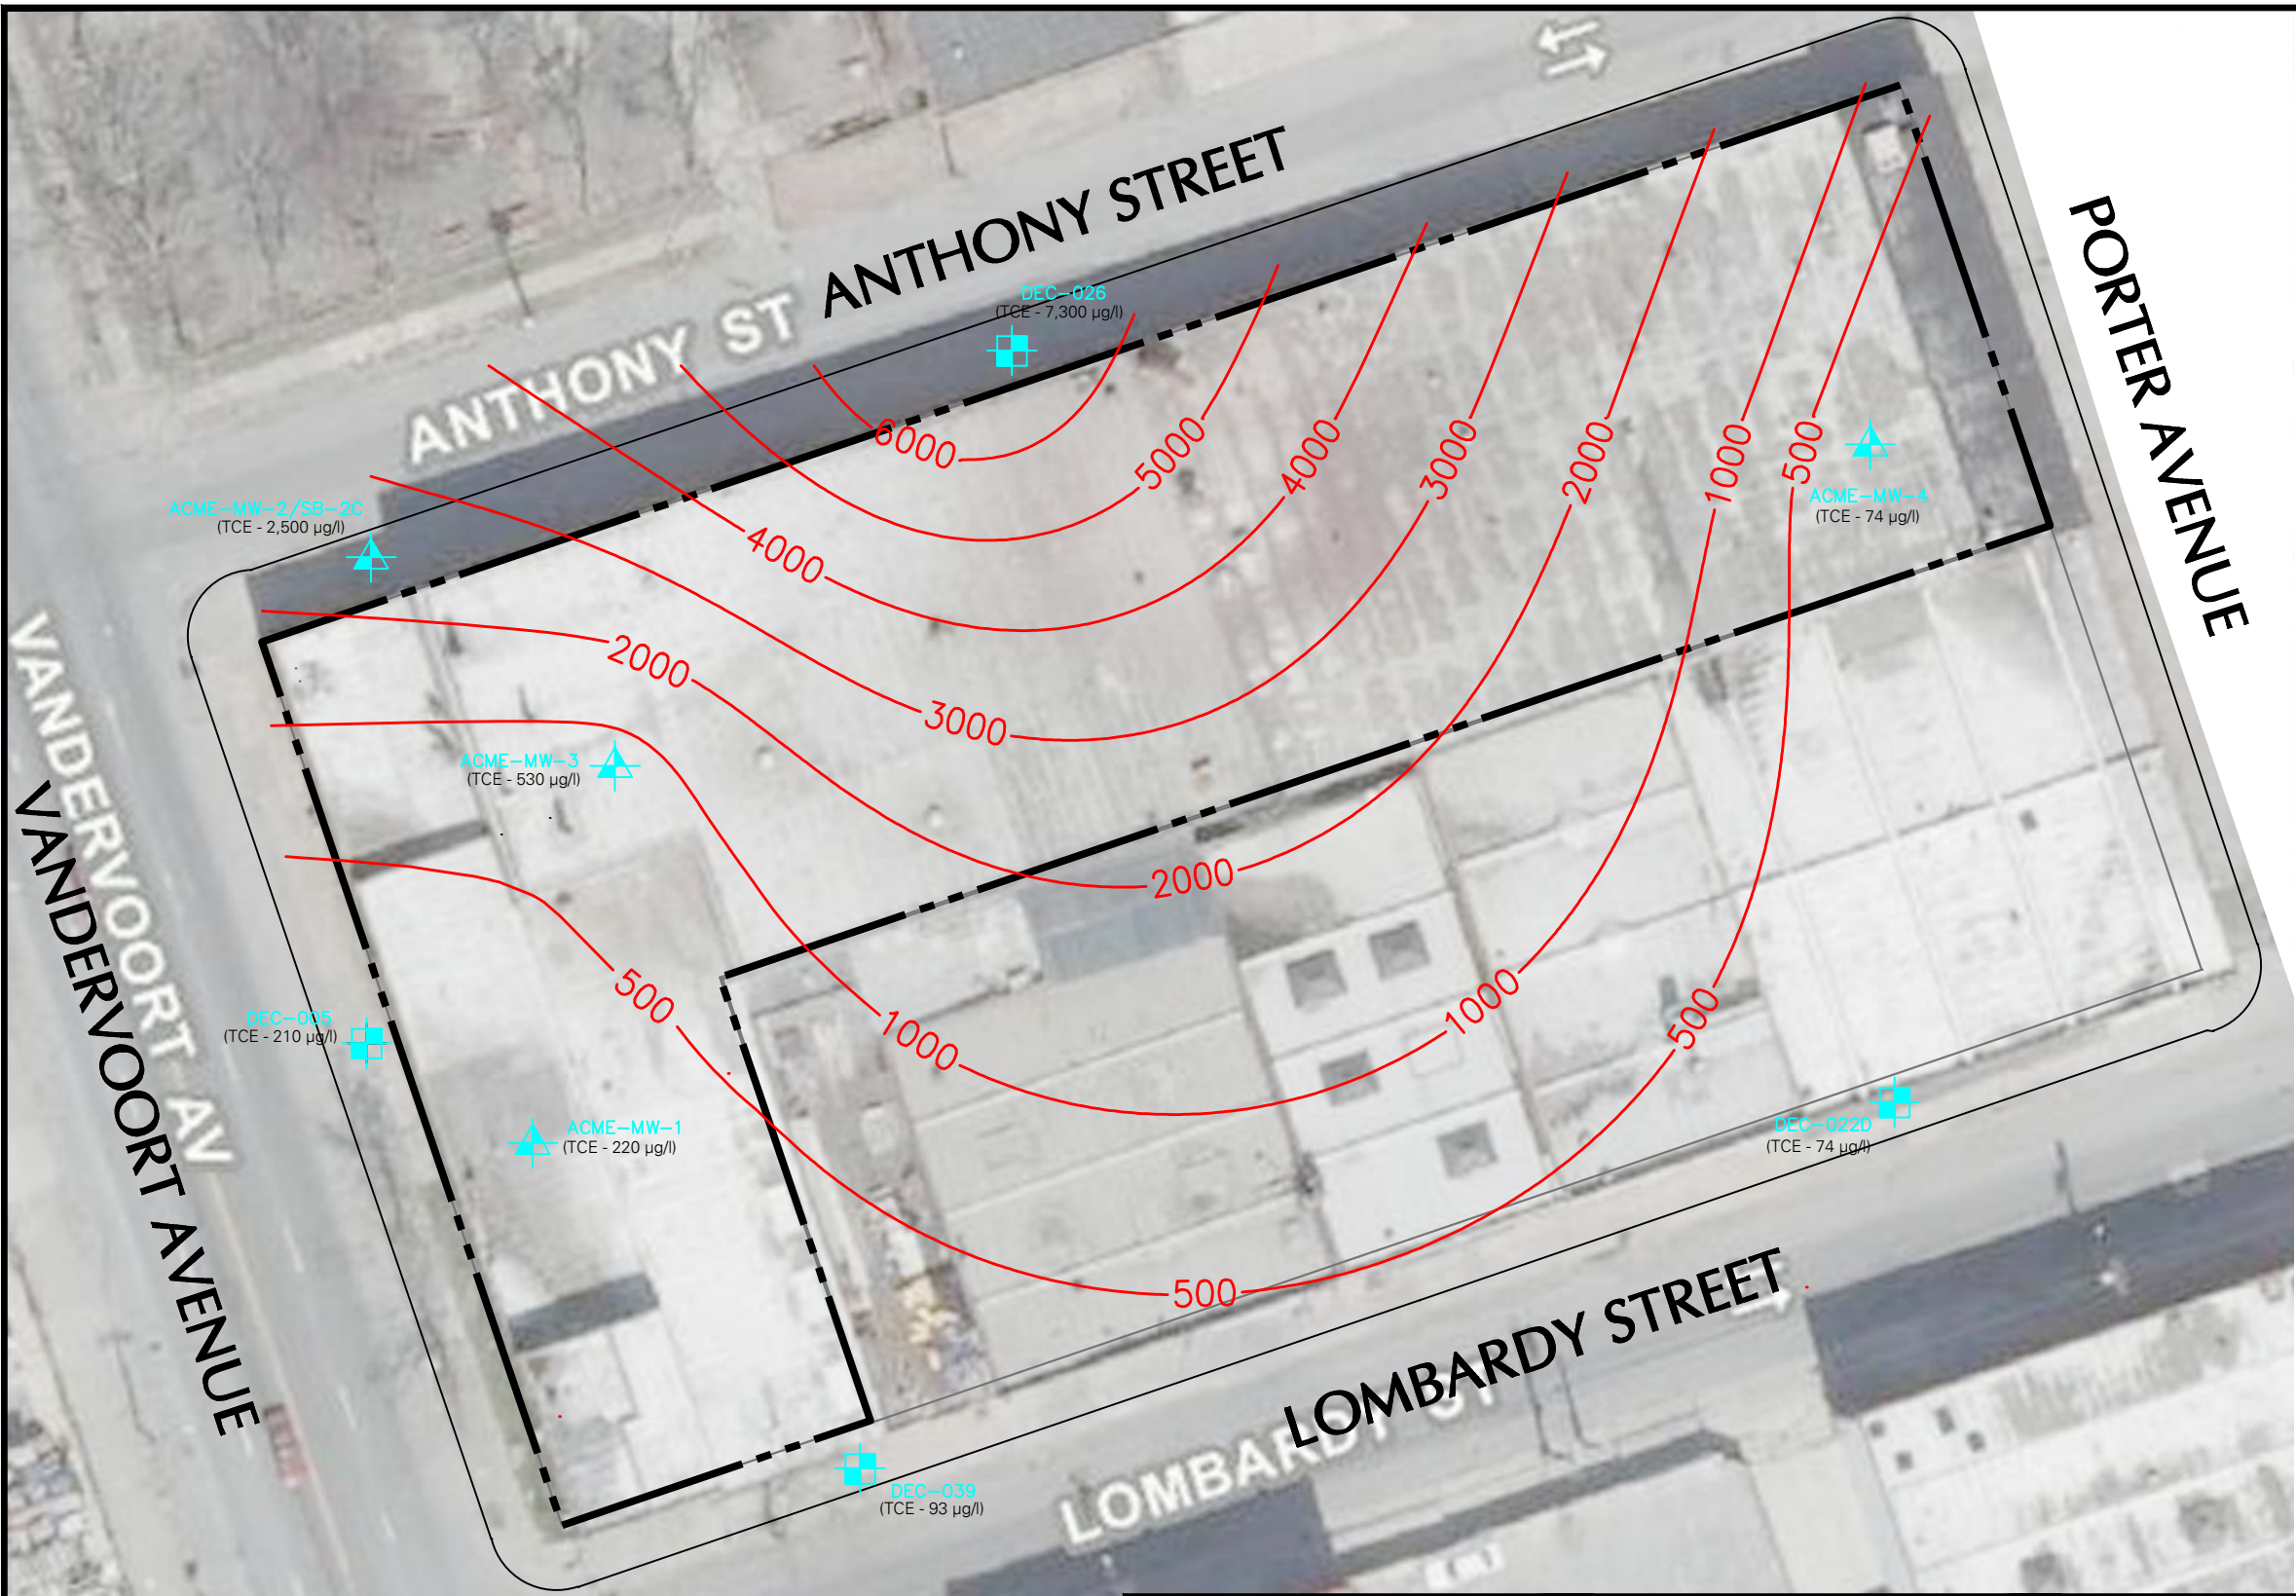
Project No. 170157201	Figure No.  <b>15</b>
Date 01/10/2013	
Scale 1" = 40'	
Drawn By EB	
Submission Date	Sheet 15 of 19

**SHALLOW OVERBURDEN GROUNDWATER TCE ISOCONCENTRATION MAP**

In general, TCE concentrations measured during this RI were higher in the northern and northwestern part of the Site near AOC 3 and in a downgradient monitoring well (DEC-026). These results are not consistent with historical URS groundwater sample results. TCE concentrations at the Site are one to two orders of magnitude higher than PCE concentrations, which indicate that TCE is not the result PCE degradation but is likely from a separate source. A source of dissolved TCE has not been identified.

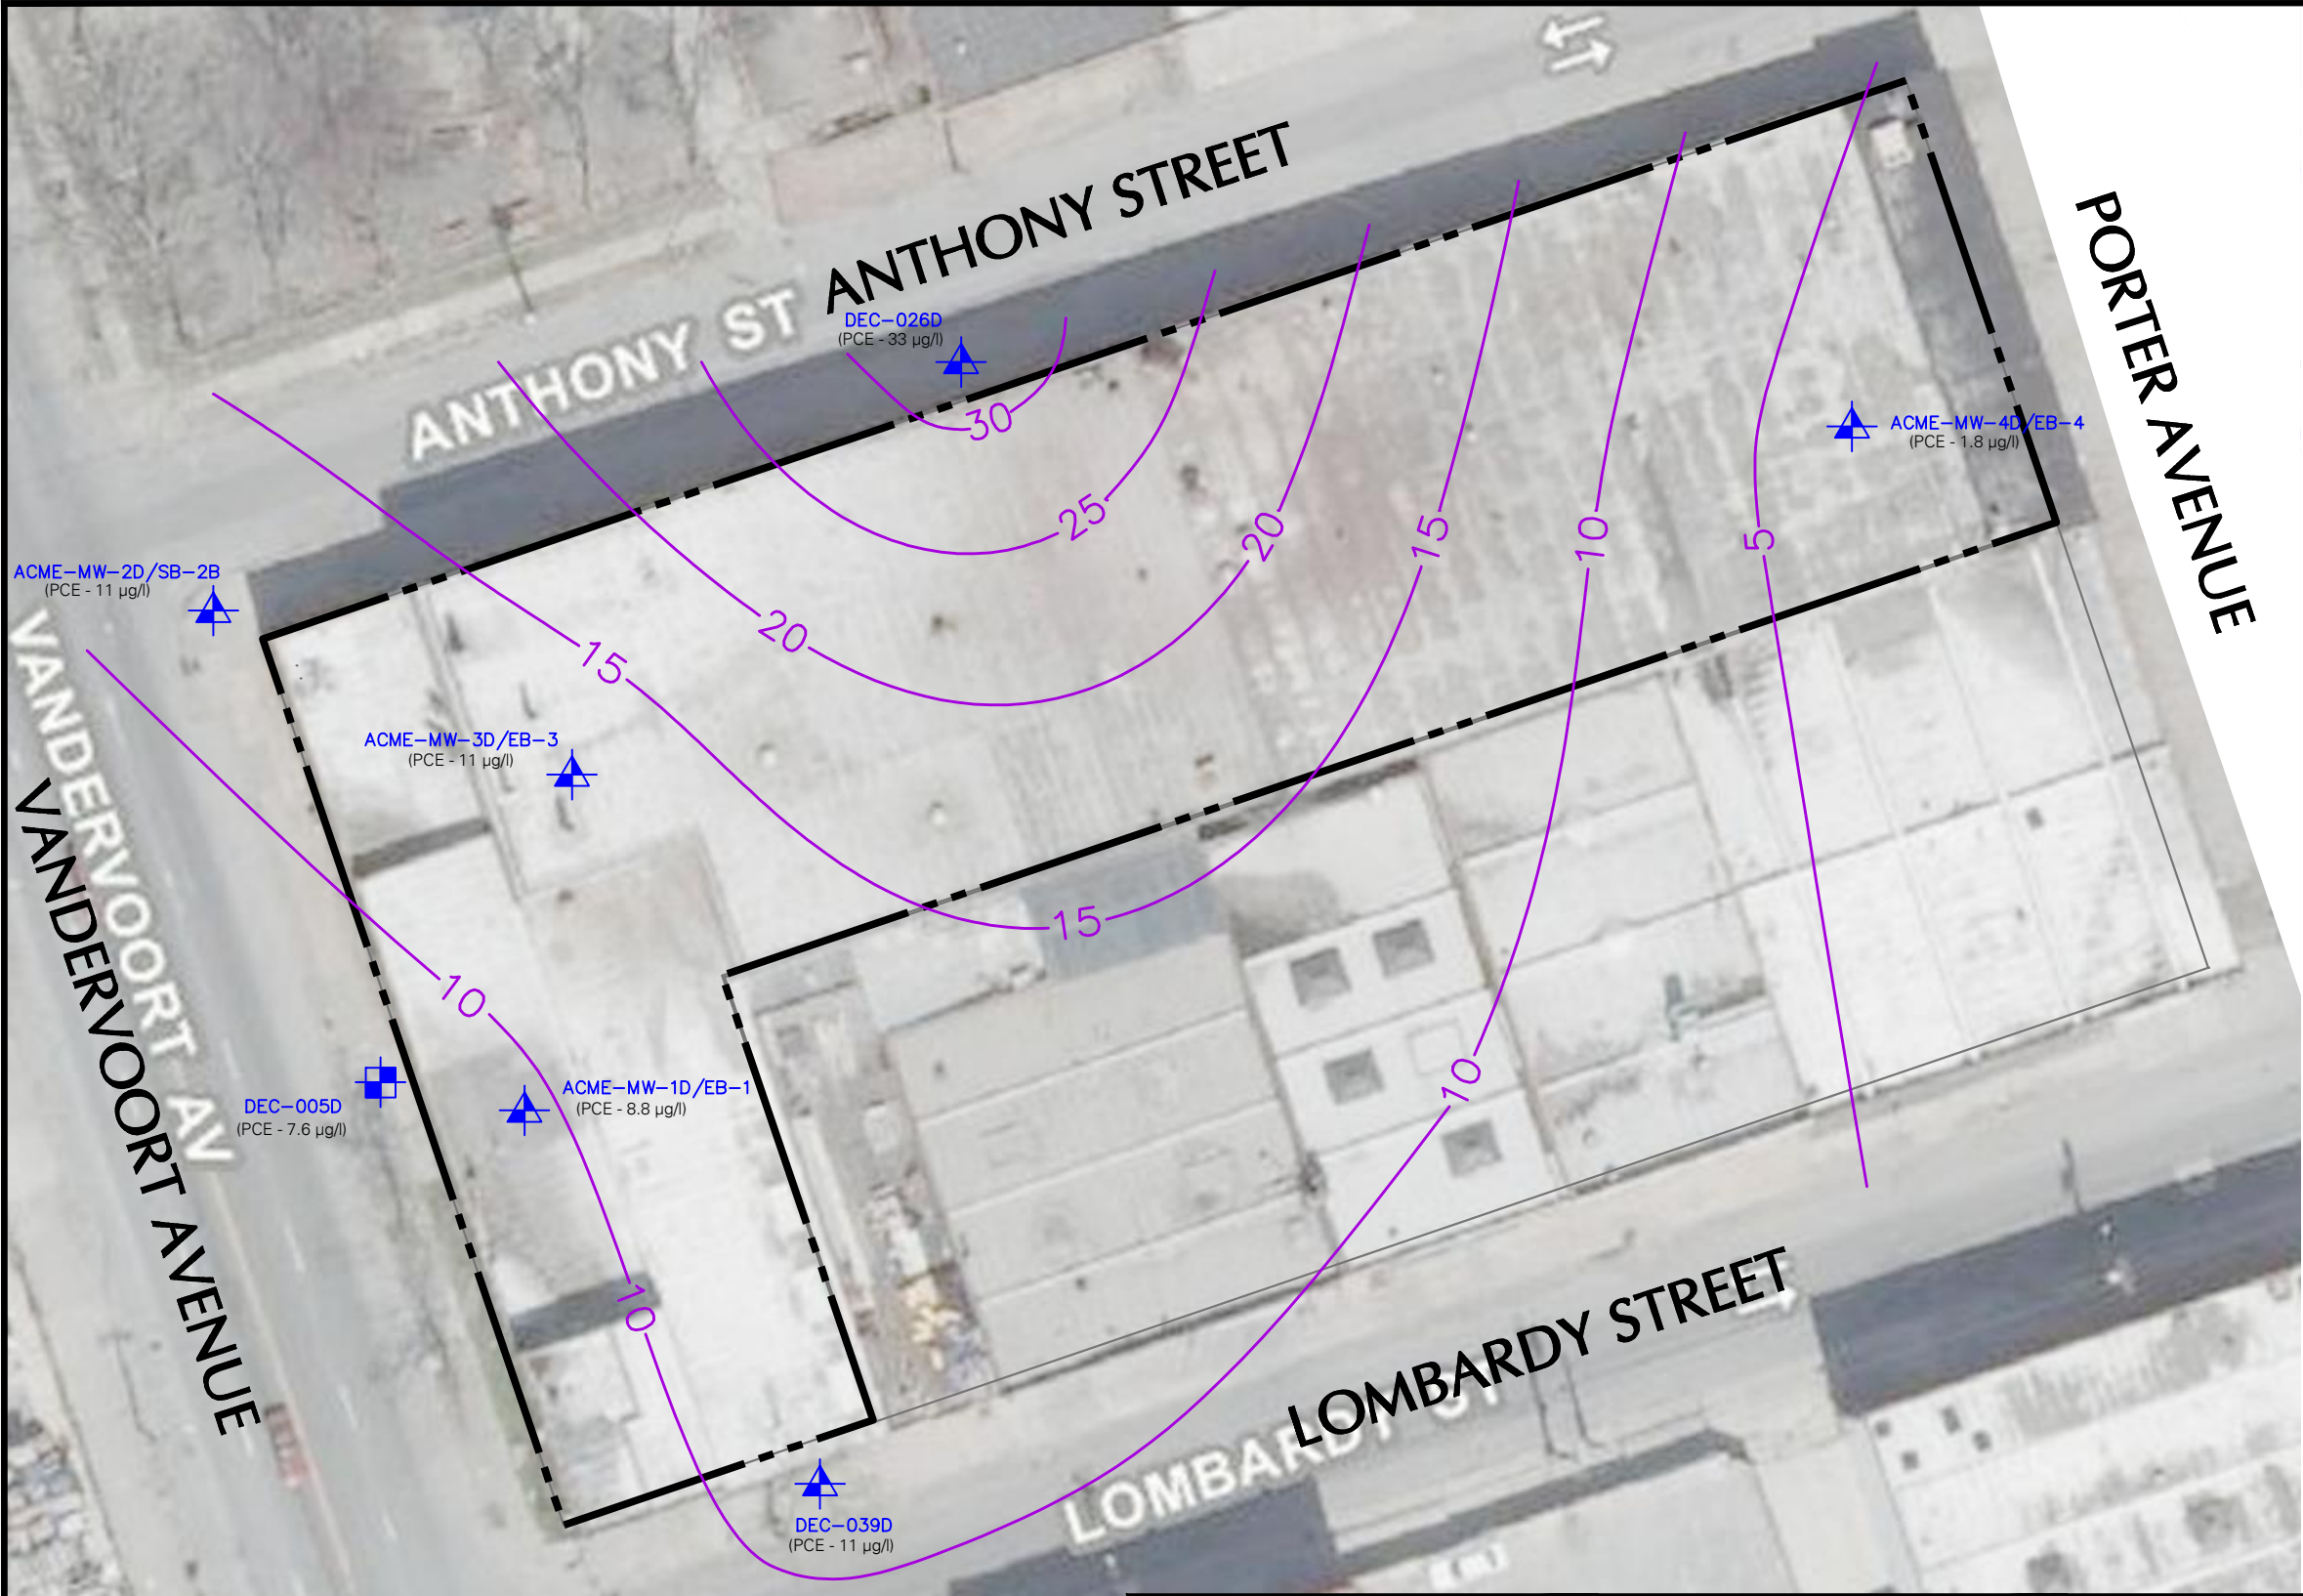
Project No. 170157201	Figure No.  <b>16</b>
Date 01/10/2013	
Scale 1" = 40'	
Drawn By EB	
Submission Date	Sheet 16 of 19

**DEEP OVERBURDEN  
GROUNDWATER  
PCE ISOCONCENTRATION  
MAP**
