**WEEKLY PROGRESS REPORT
RTA1 REMEDIAL CONSTRUCTION**

**GOWANUS CANAL SUPERFUND SITE
BROOKLYN, NEW YORK**

PERIOD: October 03 to October 07, 2022

Weekly Progress Report No. 112
Period 10/03/2022 to 10/07//2022
Submittal Date: October 17, 2022

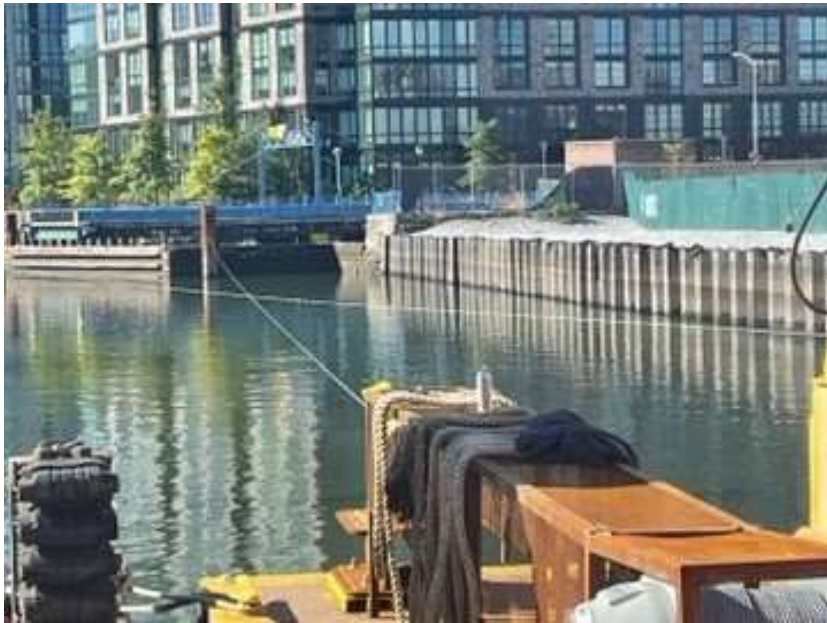
Client Name: Gowanus Environmental Remediation Trust		Site Location: Gowanus Canal	Project No.: 271
Photo No. 004	Date 10/6/2022

Description Dredging on Wires North of the Carroll Street Bridge

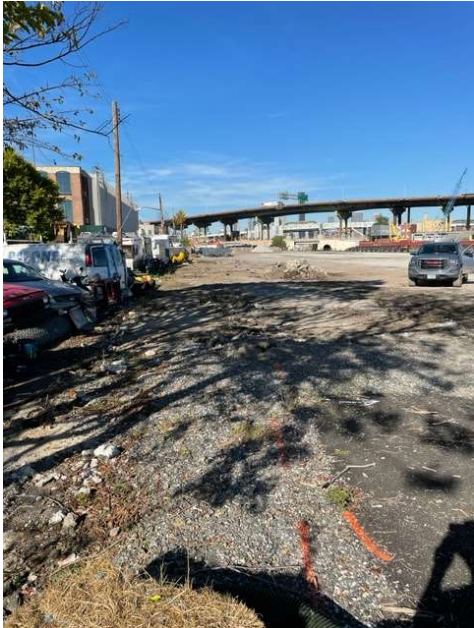
Client Name: Gowanus Environmental Remediation Trust		Site Location: Gowanus Canal	Project No.: 271
Photo No. 004	Date 10/6/2022

Description Fence Removal at the Smith Street Site

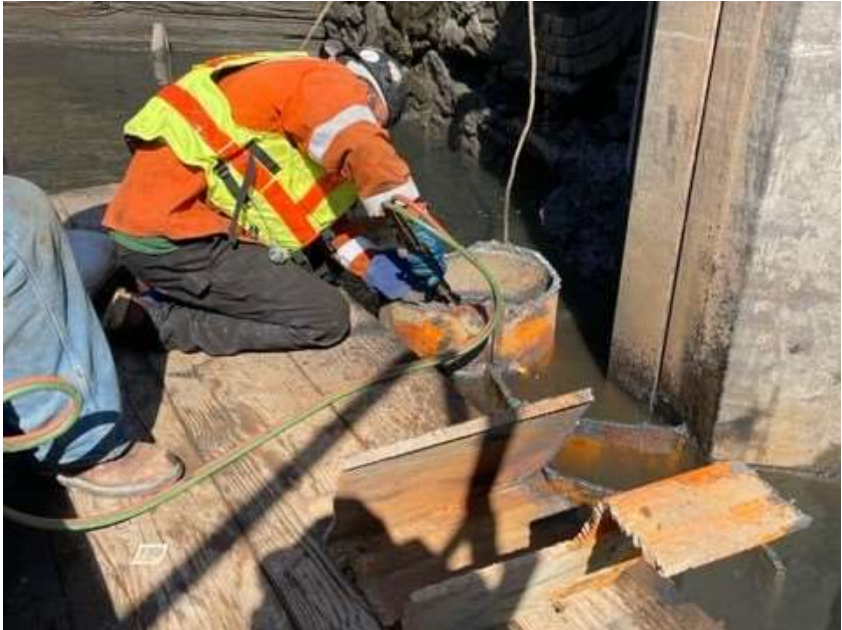
Client Name: Gowanus Environmental Remediation Trust		Site Location: Gowanus Canal	Project No.: 271
Photo No. 004	Date 10/7/2022

Description Trimming Closure Sheets at the Carroll Street Bridge

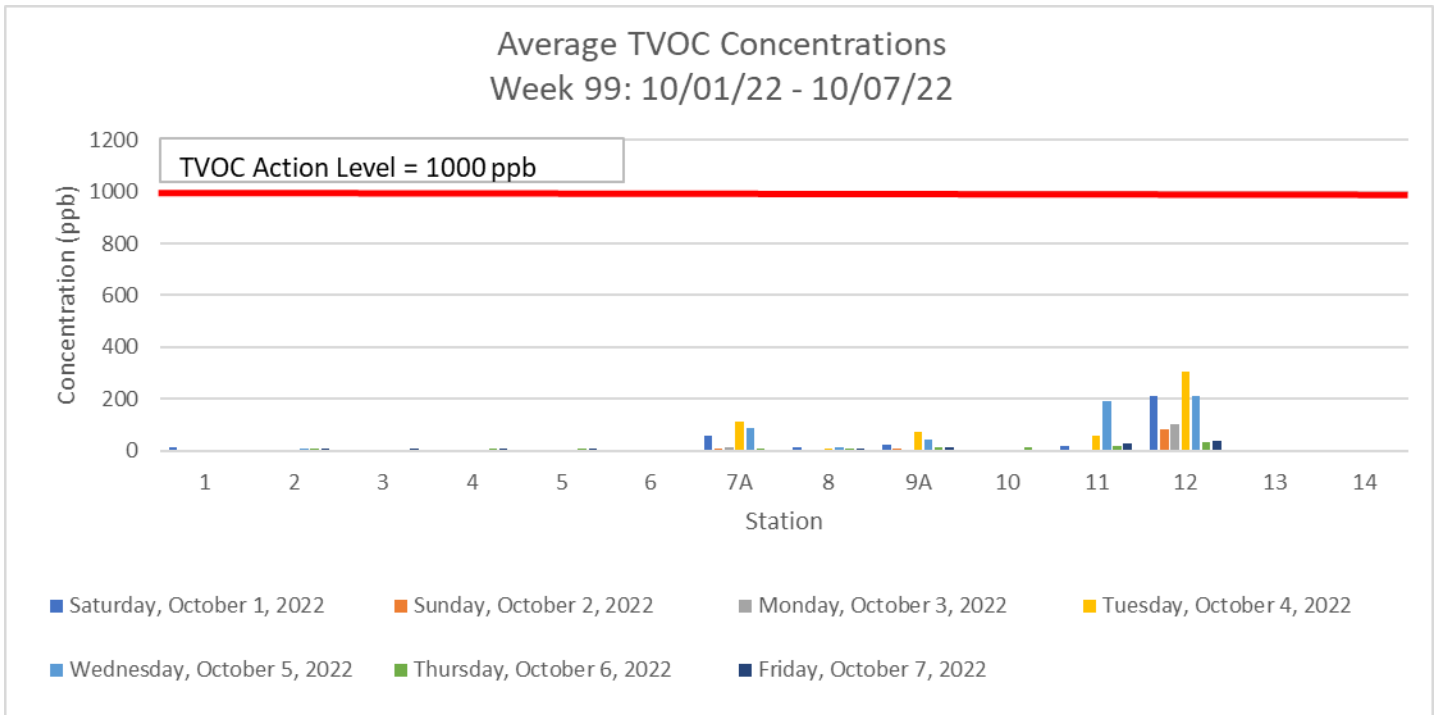
Figure 2: Average 15-Minute TVOC Concentrations

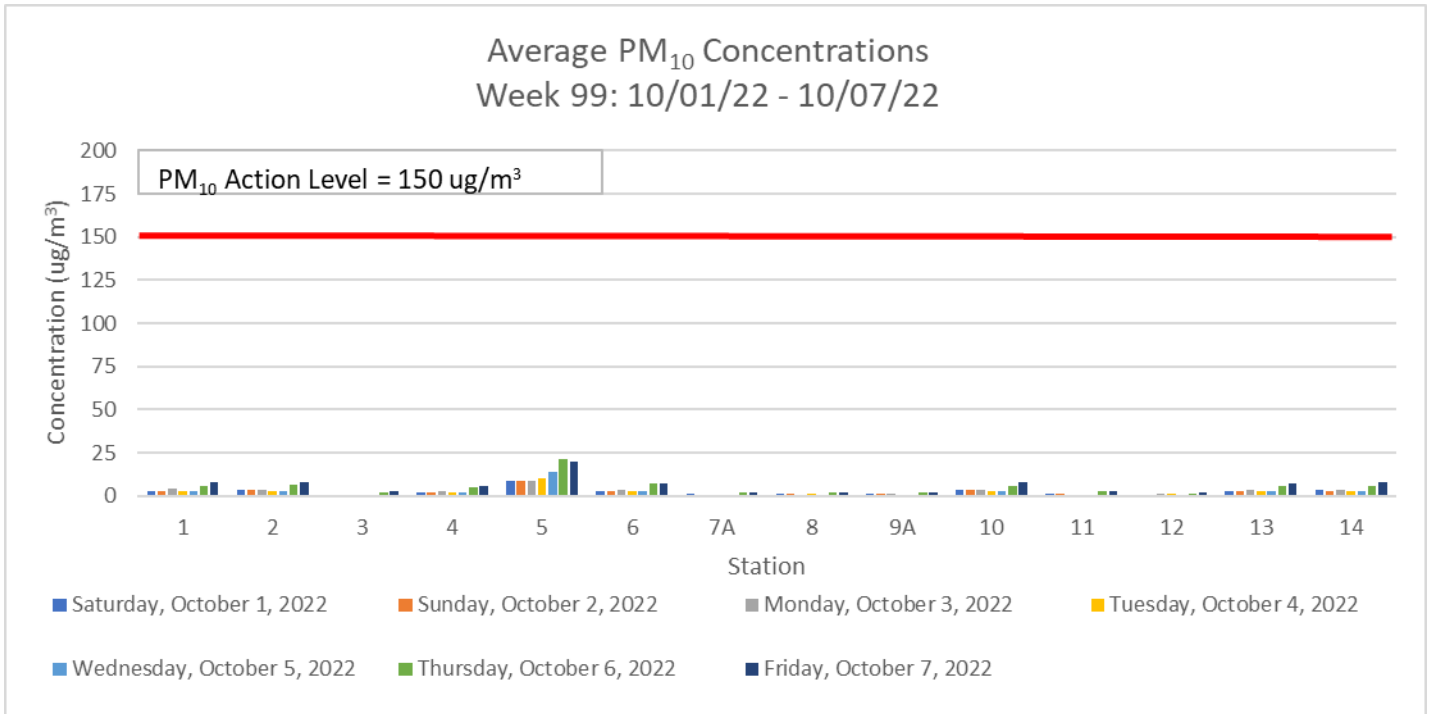
Figure 4: Average 15-Minute PM₁₀ Concentrations
