**WEEKLY PROGRESS REPORT
RTA1 REMEDIAL CONSTRUCTION**

**GOWANUS CANAL SUPERFUND SITE
BROOKLYN, NEW YORK**

Weekly Progress Report No. 113
Period 10/11/2022 to 10/14/2022
Submittal Date: October 24, 2022

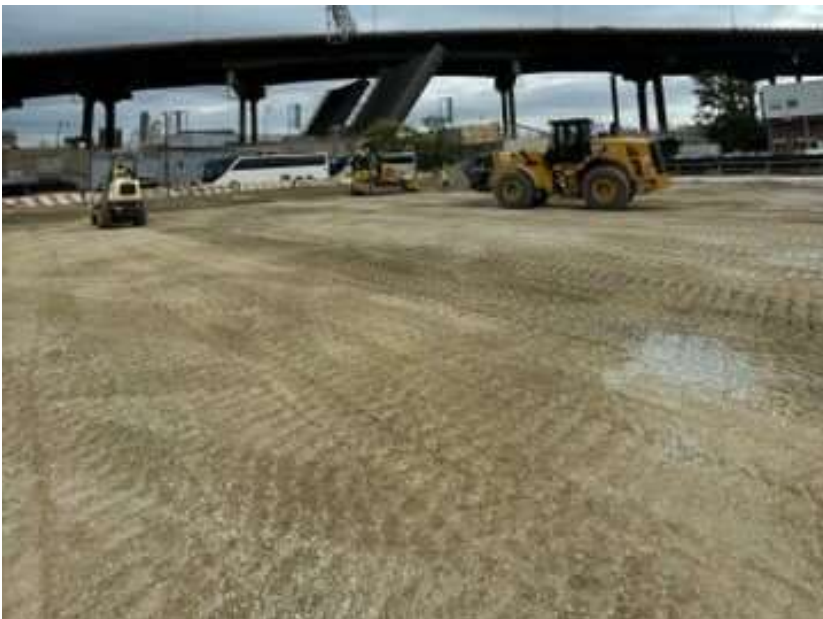
Client Name: Gowanus Environmental Remediation Trust		Site Location: Gowanus Canal	Project No.: 271
Photo No. 004	Date 10/13/2022

Description Preparing Finished Grade for Material Stockpile Area at the Smith Street Site

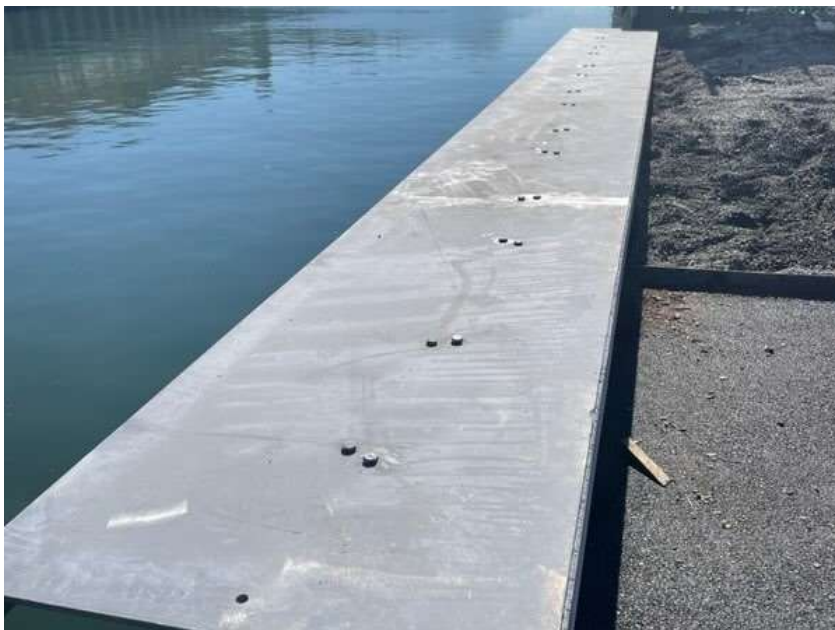
Client Name: Gowanus Environmental Remediation Trust		Site Location: Gowanus Canal	Project No.: 271
Photo No. 004	Date 10/7/2022

Description Cap Plate Installed at DeGraw Street

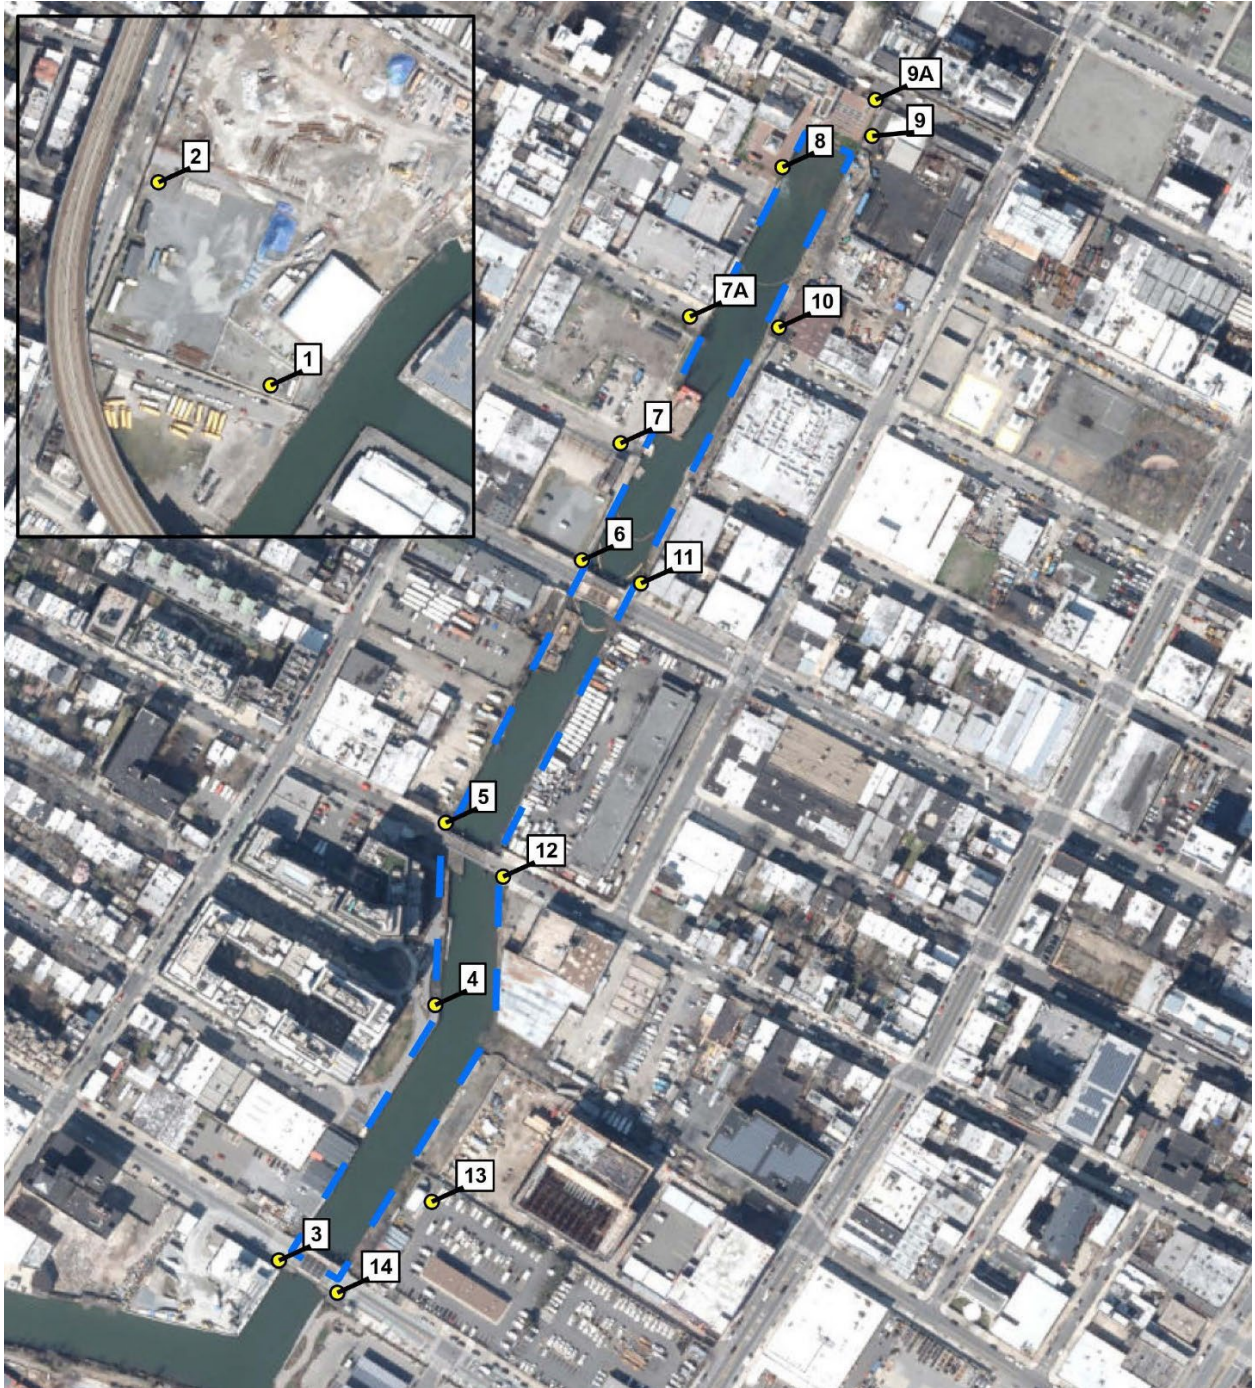
Figure 1: Station Location Map

Station #	Location
1	Southeast corner of Staging Area
2	Northwest corner of Staging Area
3	Southwest side of 3 rd Street Bridge
4	Bond Building promenade near 1 st Street
5	Northwest side of Carroll Street Bridge
6	Northwest side of Union Street Bridge
7	Sackett Street (no longer in use)
7A	Degraw Street (west end)
8	Douglass Street
9	Northeast of Flushing Tunnel (no longer in use)
9A	Northeast of Flushing Tunnel on Butler Street
10	Degraw Street (east end)
11	Northeast side of Union Street Bridge
12	Southeast side of Carroll Street Bridge
13	Verizon property (153 2 nd Street)
14	Southeast side of 3 rd Street Bridge
