Re: Former NuHart Plastic Manufacturing - Site No. 224136
Response to Comments regarding the RIWP (October 2011)
ESI File: SB09110

Figure 1: Site Location & Features Map
 Hazardous Waste Site No. 224136
 280 Franklin Street
 Borough of Brooklyn
 Kings County, New York

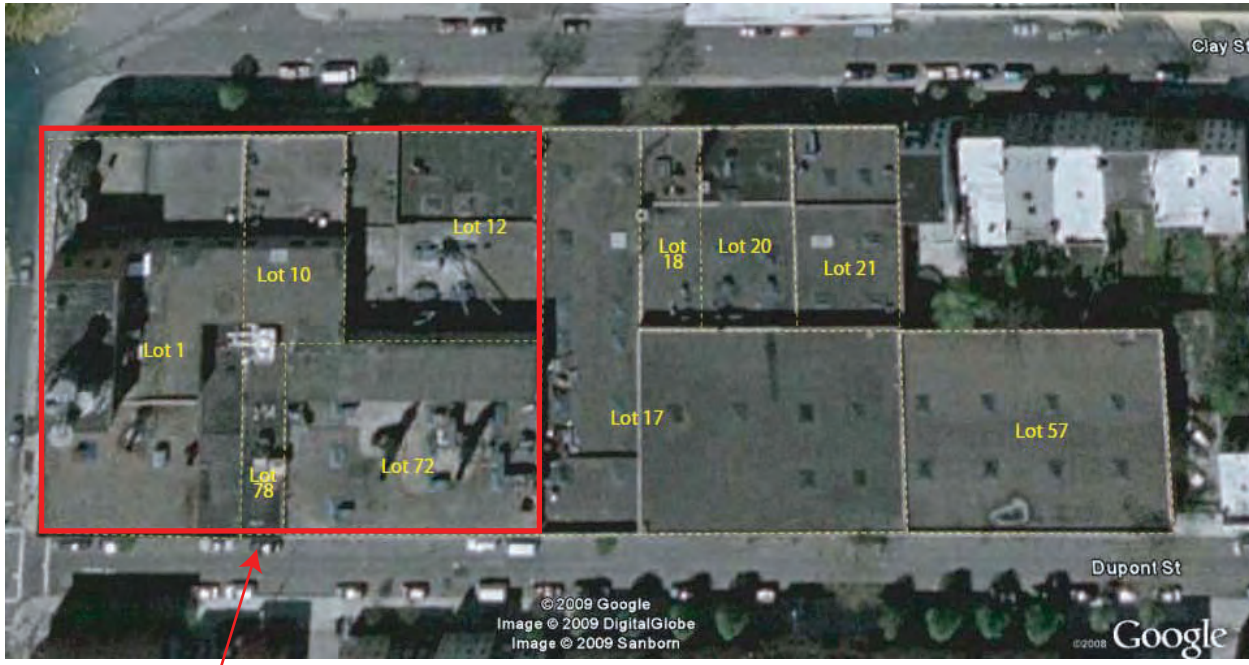
The Site

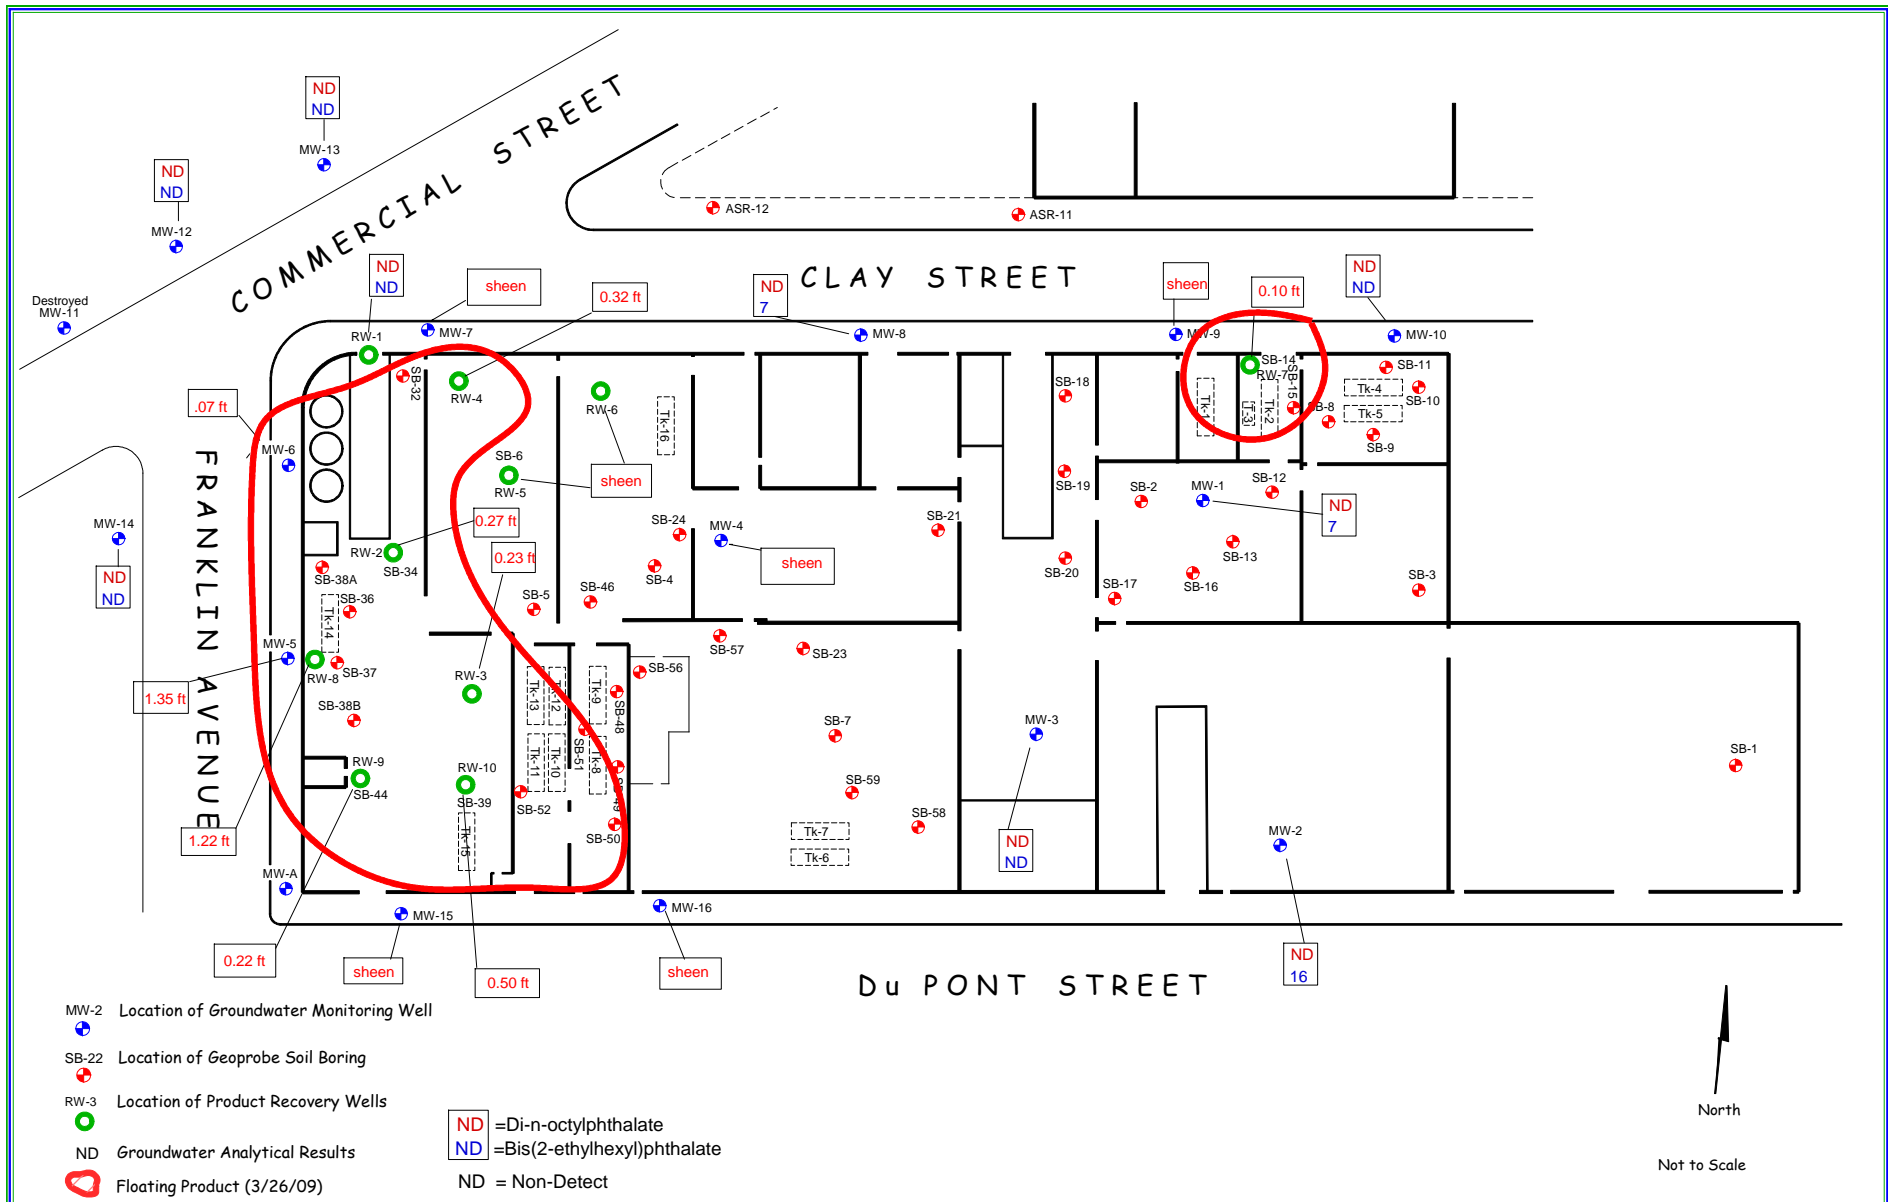
Figure - 3
Groundwater Gradient Map
March 26, 2009

During this groundwater monitoring event, groundwater monitoring wells were gauged as previously described. The gauging information and the calculated water level elevations are provided in Monitoring Well Gauging Data (Table 1). The groundwater elevation measurements are plotted on the Groundwater Gradient Map, (Figure 3).
