# Construction Completion Report Operable Unit 5 (OU-5)

Sunnyside Yard  
Queens, New York  
(241006)

February 12, 2025

**Roux Environmental Engineering  
and Geology, D.P.C.**  
209 Shafter Street  
Islandia, New York 11749

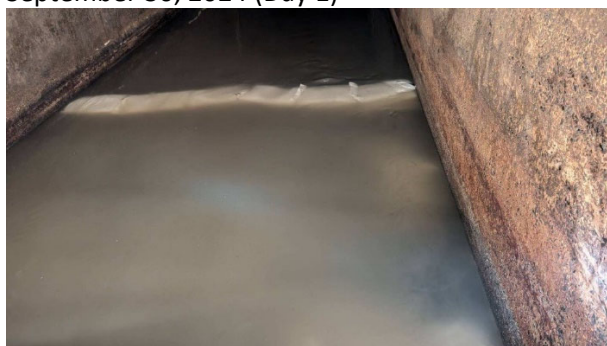
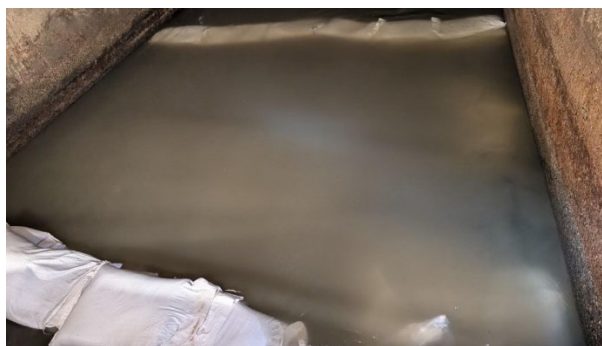
September 30, 2024 (Day 1)

September 30<sup>th</sup> (Day 1): Contractor (KNR Management) attempted to sandbag the sewer but due to unknown flow issues at the siphon the contractor was unsuccessful.

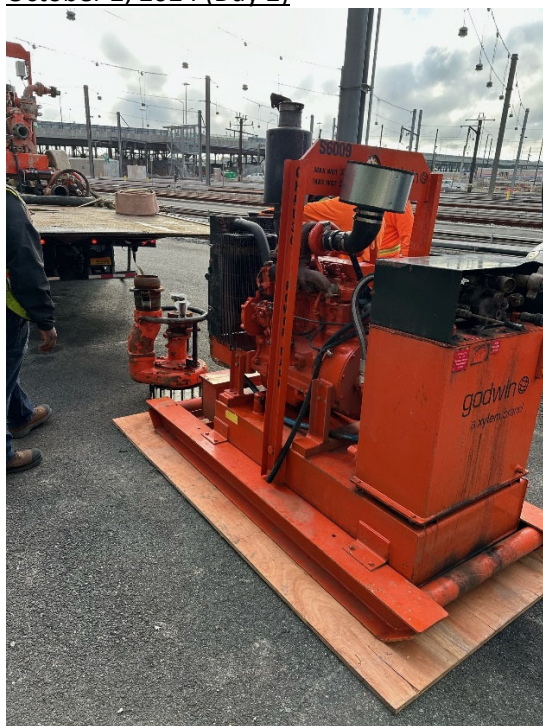
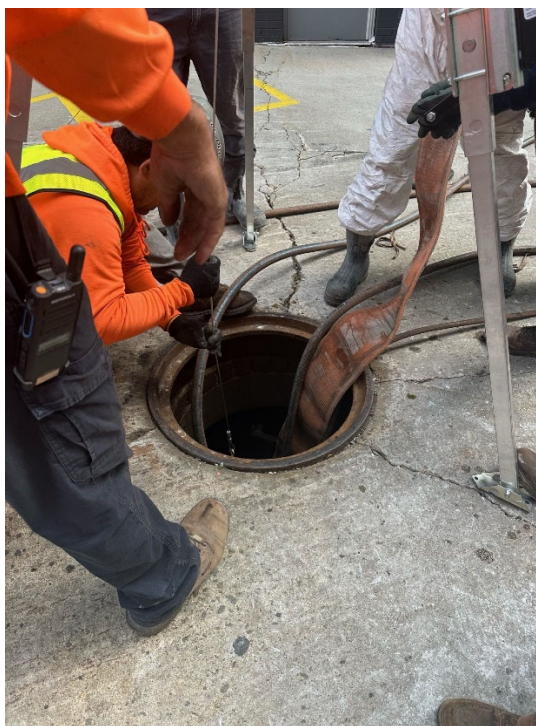
October 2, 2024 (Day 2)

October 2<sup>nd</sup> (Day 2): Two (2) six (6) inch hydraulic pumps were sent to the site and set up in hopes of solving the flow issue at the siphon.

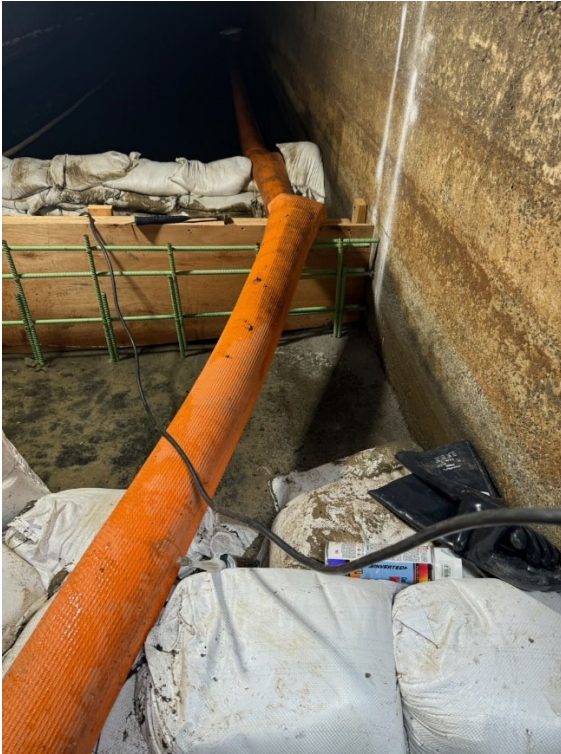
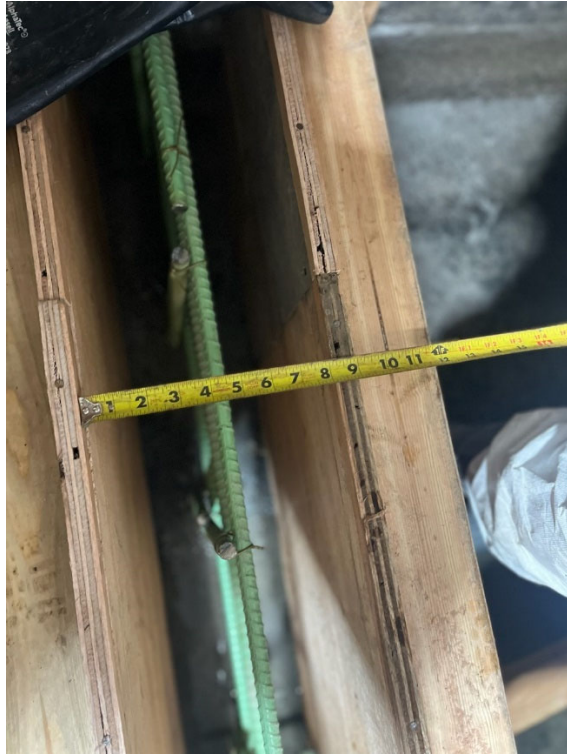
October 3, 2024 (Day 3)

October 3<sup>rd</sup> (Day 3): Utilization of the pumps on day two was successful and the contractor (KNR Management) doweled in rebar and installed form work in the sewer as per the design documents.

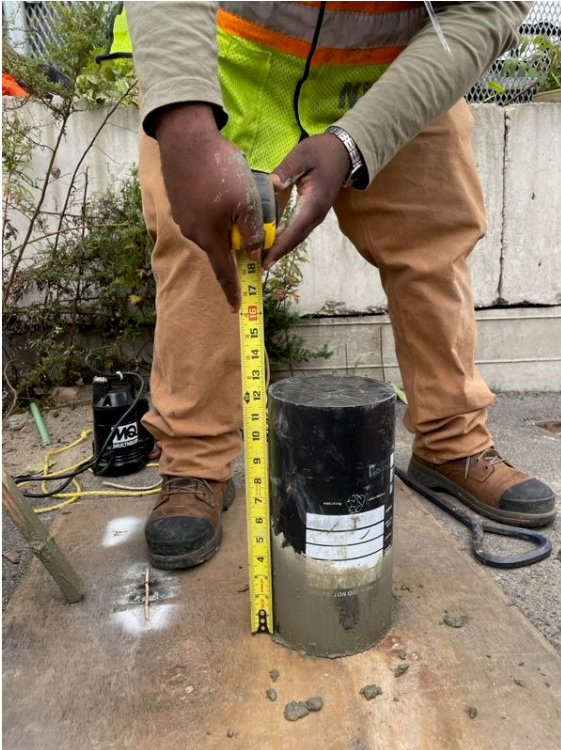
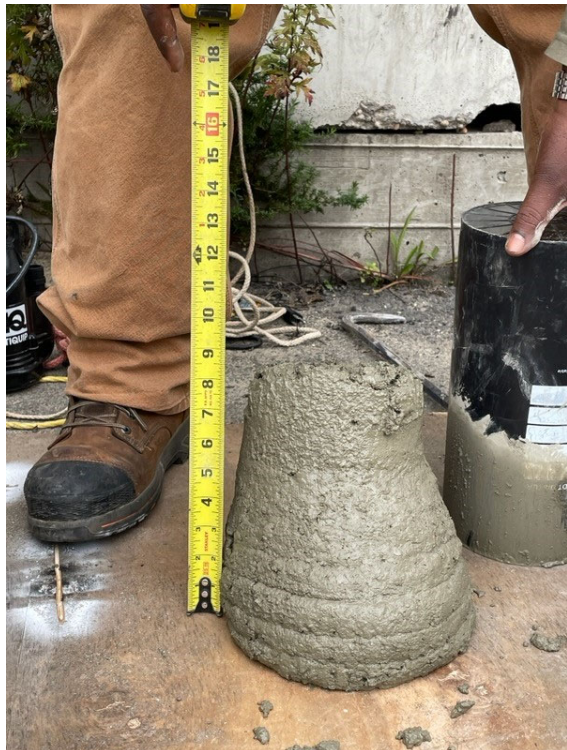
Concrete was mixed and slump test performed. Three (3) inch slump was observed.

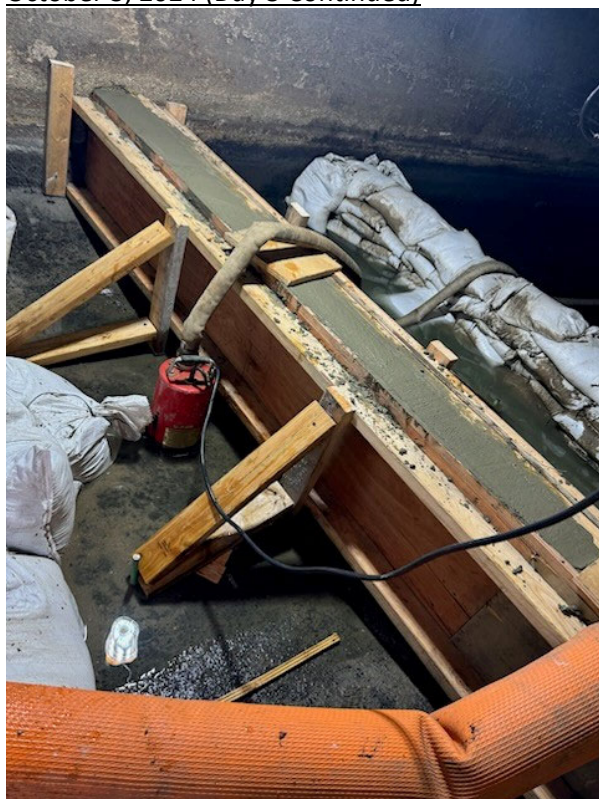
October 3, 2024 (Day 3 Continued)

Contractor (KNR) poured the concrete weir wall.

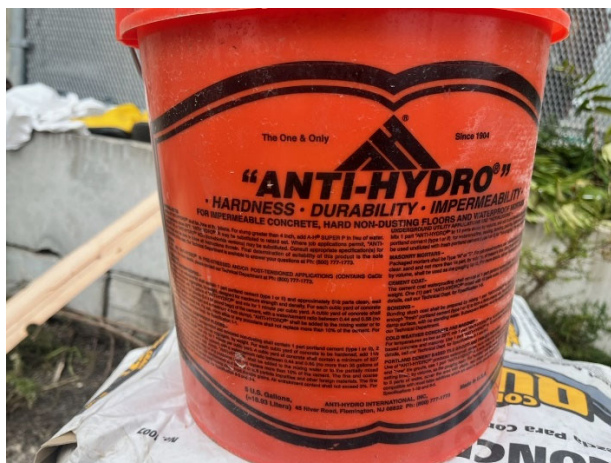
Anti-Hydro concrete admixture was used to boost workability and stability in the wet environment.

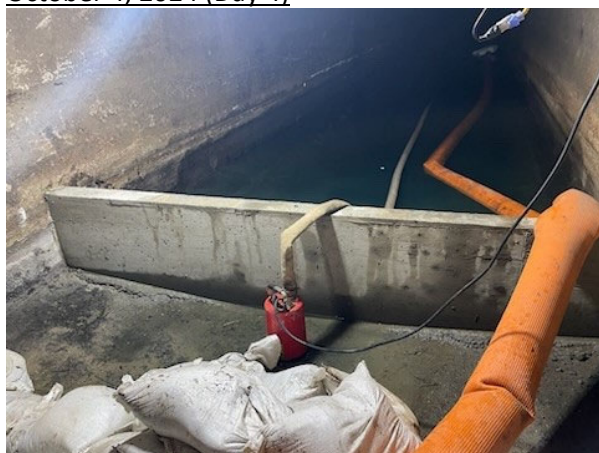
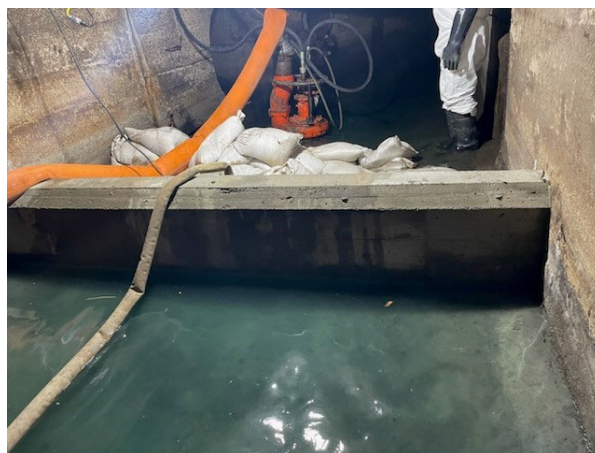
October 4, 2024 (Day 4)

October 4 (Day 4): Contractor stripped the form work, removed sandbags, pumps, and cleaned up the site before leaving.
