PERIODIC REVIEW REPORT JANUARY 2020 – DECEMBER 2020

**KLIEGMAN BROTHERS SITE
GLENDALE, QUEENS, NEW YORK 11385**
NYSDEC Site No. 241031
Work Assignment No. D009812-04

JULY 2021

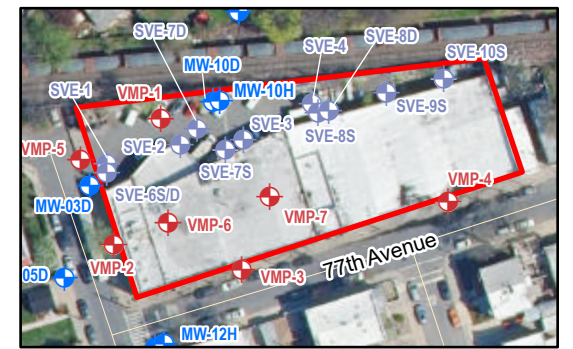
- NOTES:**
1. BASE MAP IMAGERY RETRIEVED FROM ESRI AND NEW YORK STATE GIS CLEARING HOUSE.
 2. LOCATIONS AND DIMENSIONS OF PHYSICAL FEATURES ARE APPROXIMATE, UNLESS STATED OTHERWISE.
 3. MONITORING LOCATIONS TAKEN FROM THE OCTOBER 2016 SITE MANAGEMENT PLAN, PREPARED BY URS CORPORATION.
 4. PCE RESULTS SHOWN ARE FROM SAMPLES COLLECTED ON NOVEMBER 16, 2020.

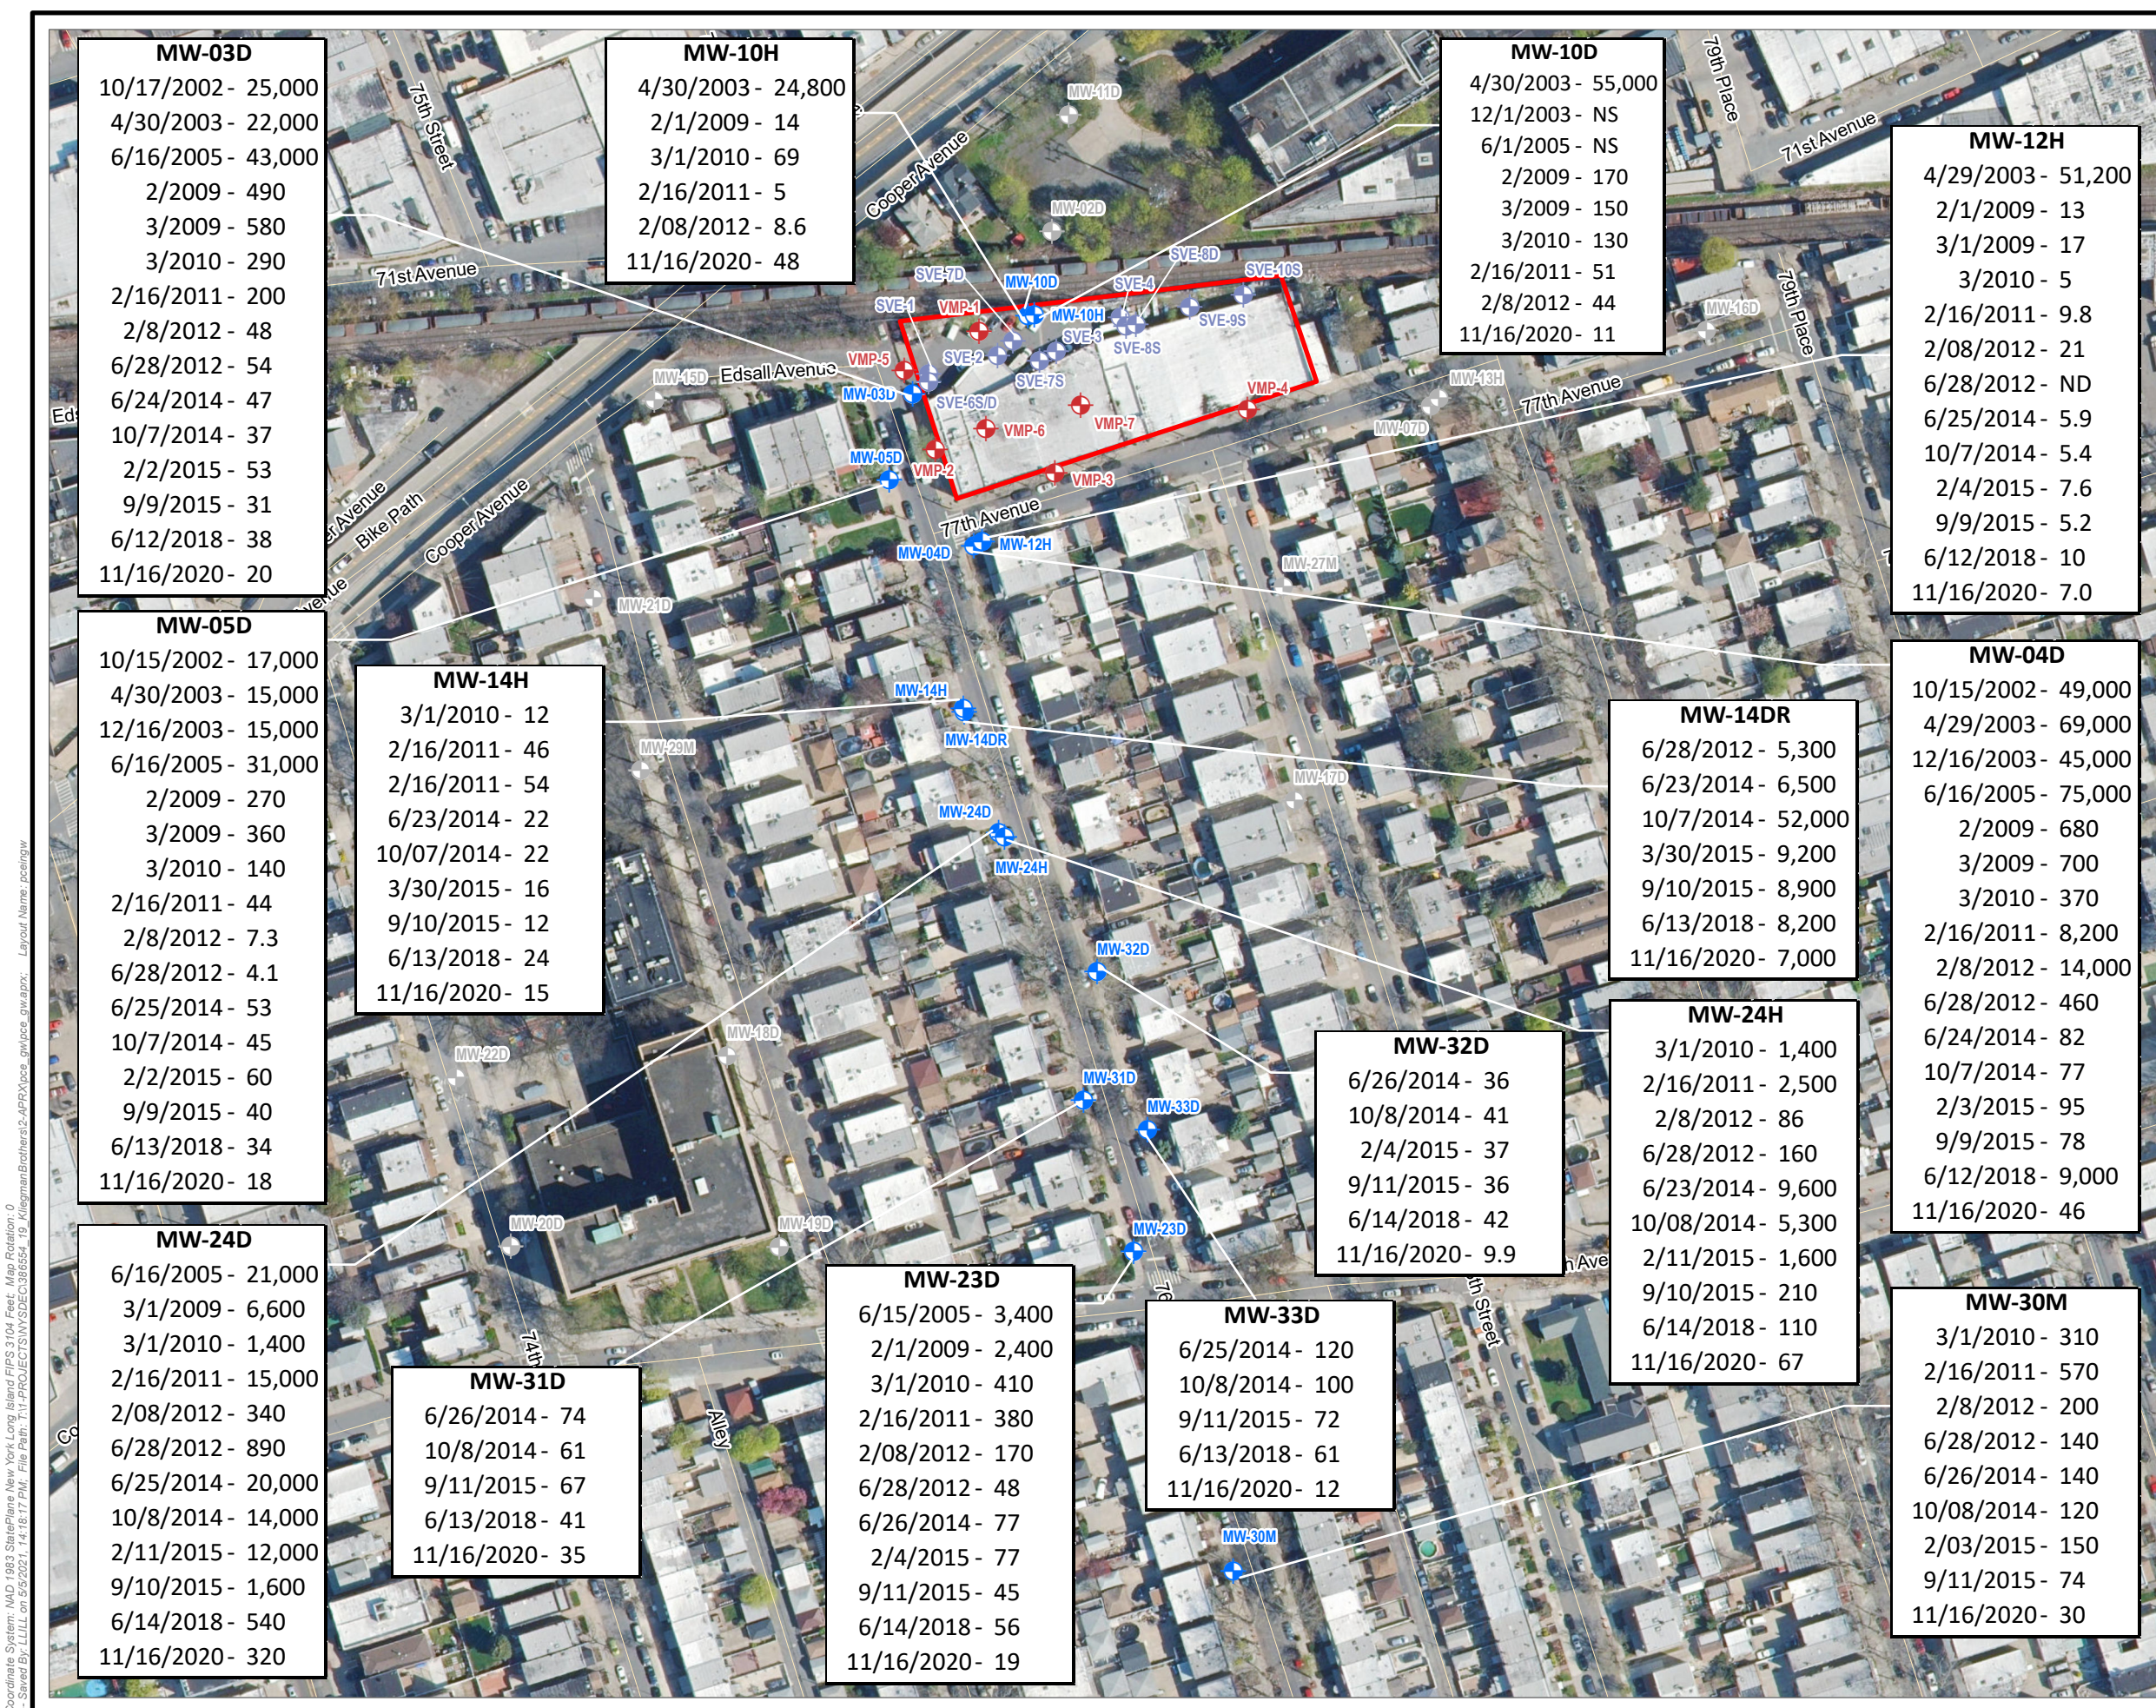
Figure 4 – PCE in Groundwater

Groundwater analytical data for VOCs can be found in **Table 2**. The Data Usability Summary Reports (DUSR) can be found in **Appendix G**. PCE was detected at concentrations greater than the applicable SCG in groundwater samples collected from all wells sampled. Additionally, TCE was detected at concentrations greater than the applicable SCG in groundwater samples collected from two monitoring wells (MW-30M and MW-31D). Detected compounds exceeding their respective SCGs for each well are illustrated on **Figure 4**. A summary of the November 2020 groundwater analytical results is presented below:

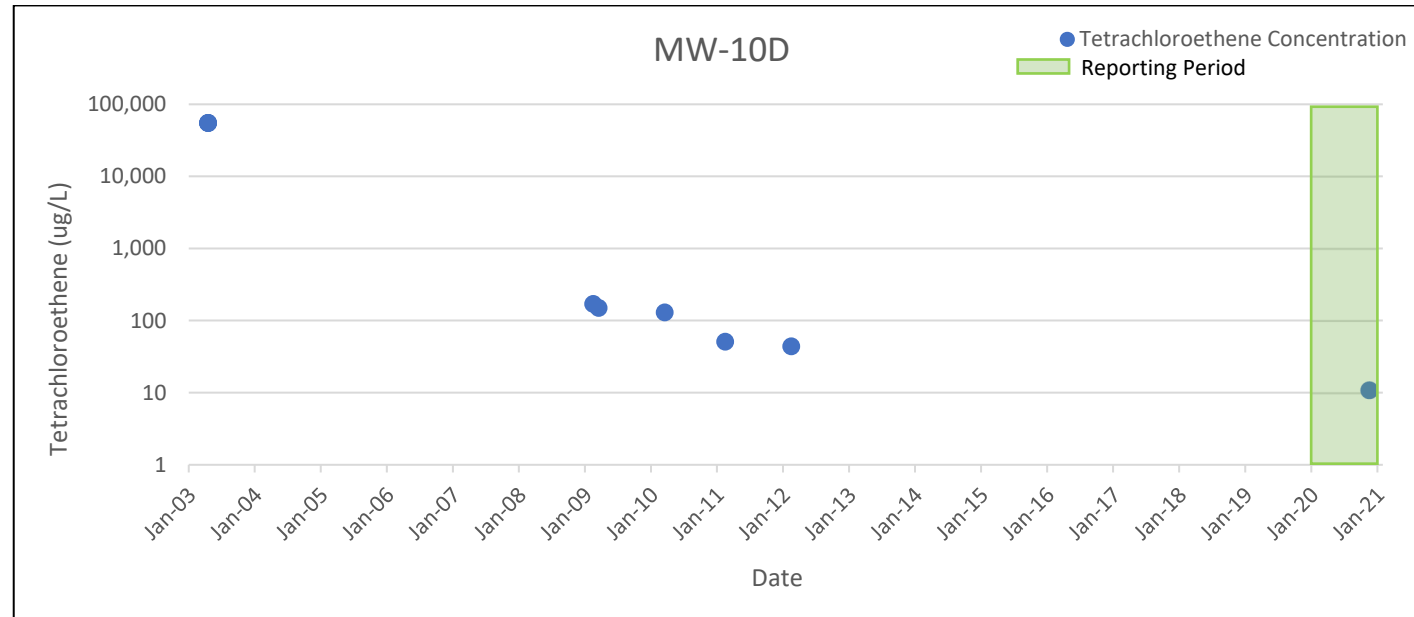
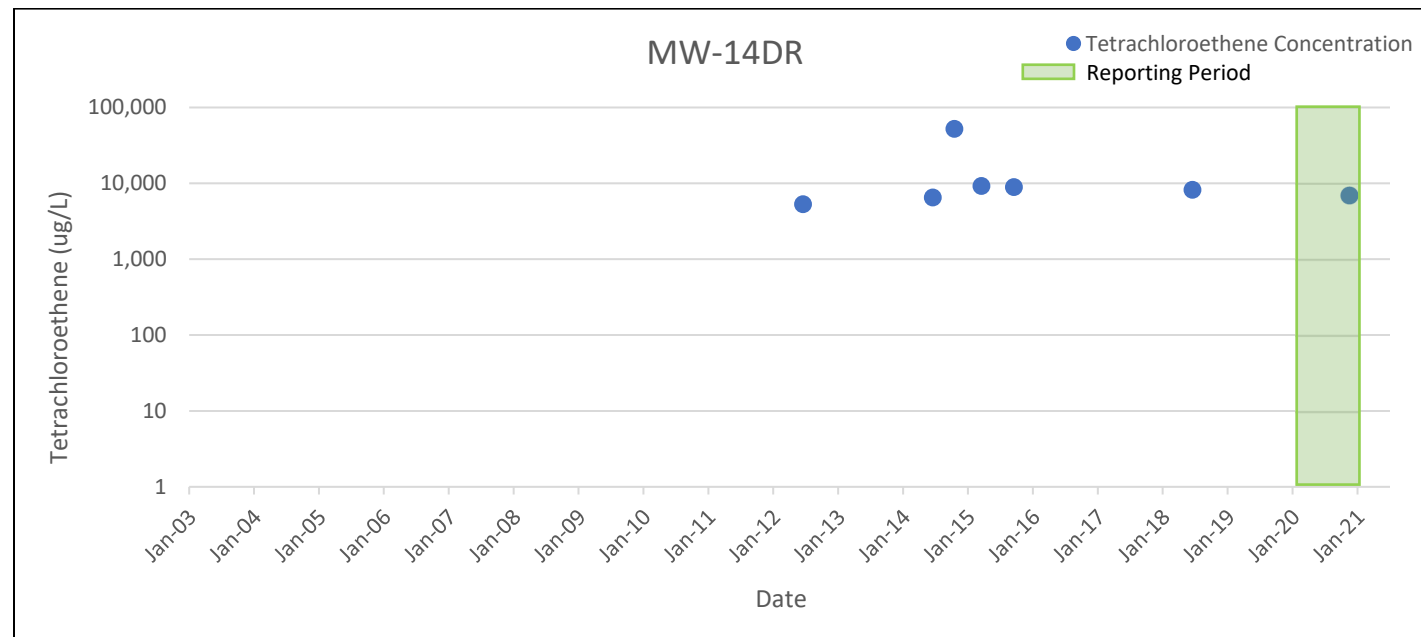
Figure 6

New York State Department of Environmental Conservation
SMP B - Kliegman Brothers - Site No. 241031
Periodic Review Report
Glendale, Queens, New York
PCE in Groundwater Trend Charts

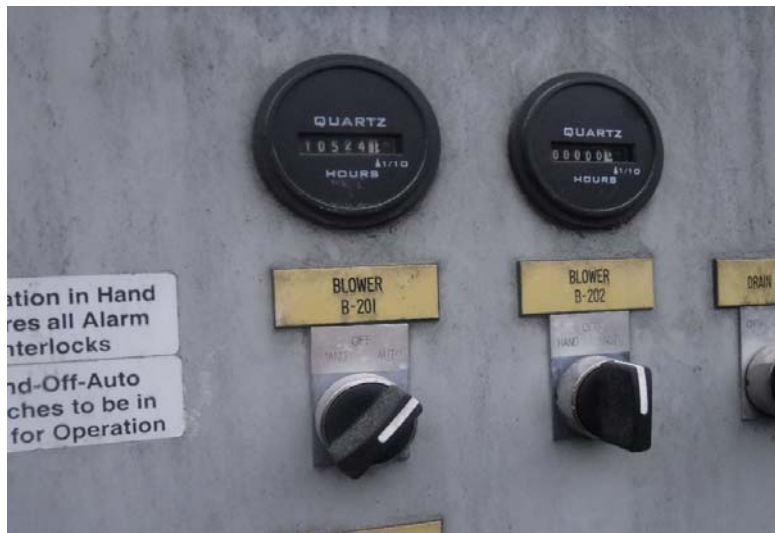
DSCF2448- The meter hours were found to read 10,524.1 hours, indicated that the blower had been in operation for a total 6.9 days since the last O&M event on December 12, 2019.

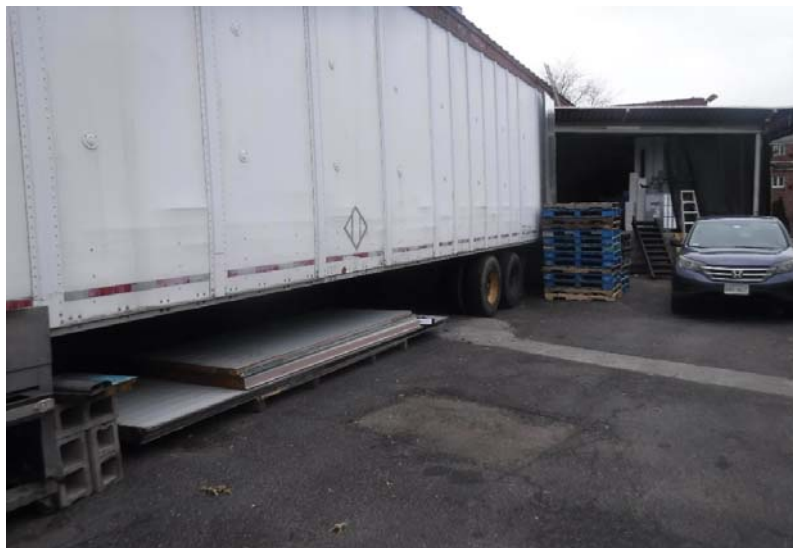
DSCF2466- View of the trailer which was observed to be parked on top of SVE-7S.
