College Point 3
QUEENS COUNTY, NEW YORK

Final Engineering Report

NYSDEC Site Number: 241122

MAY 2022

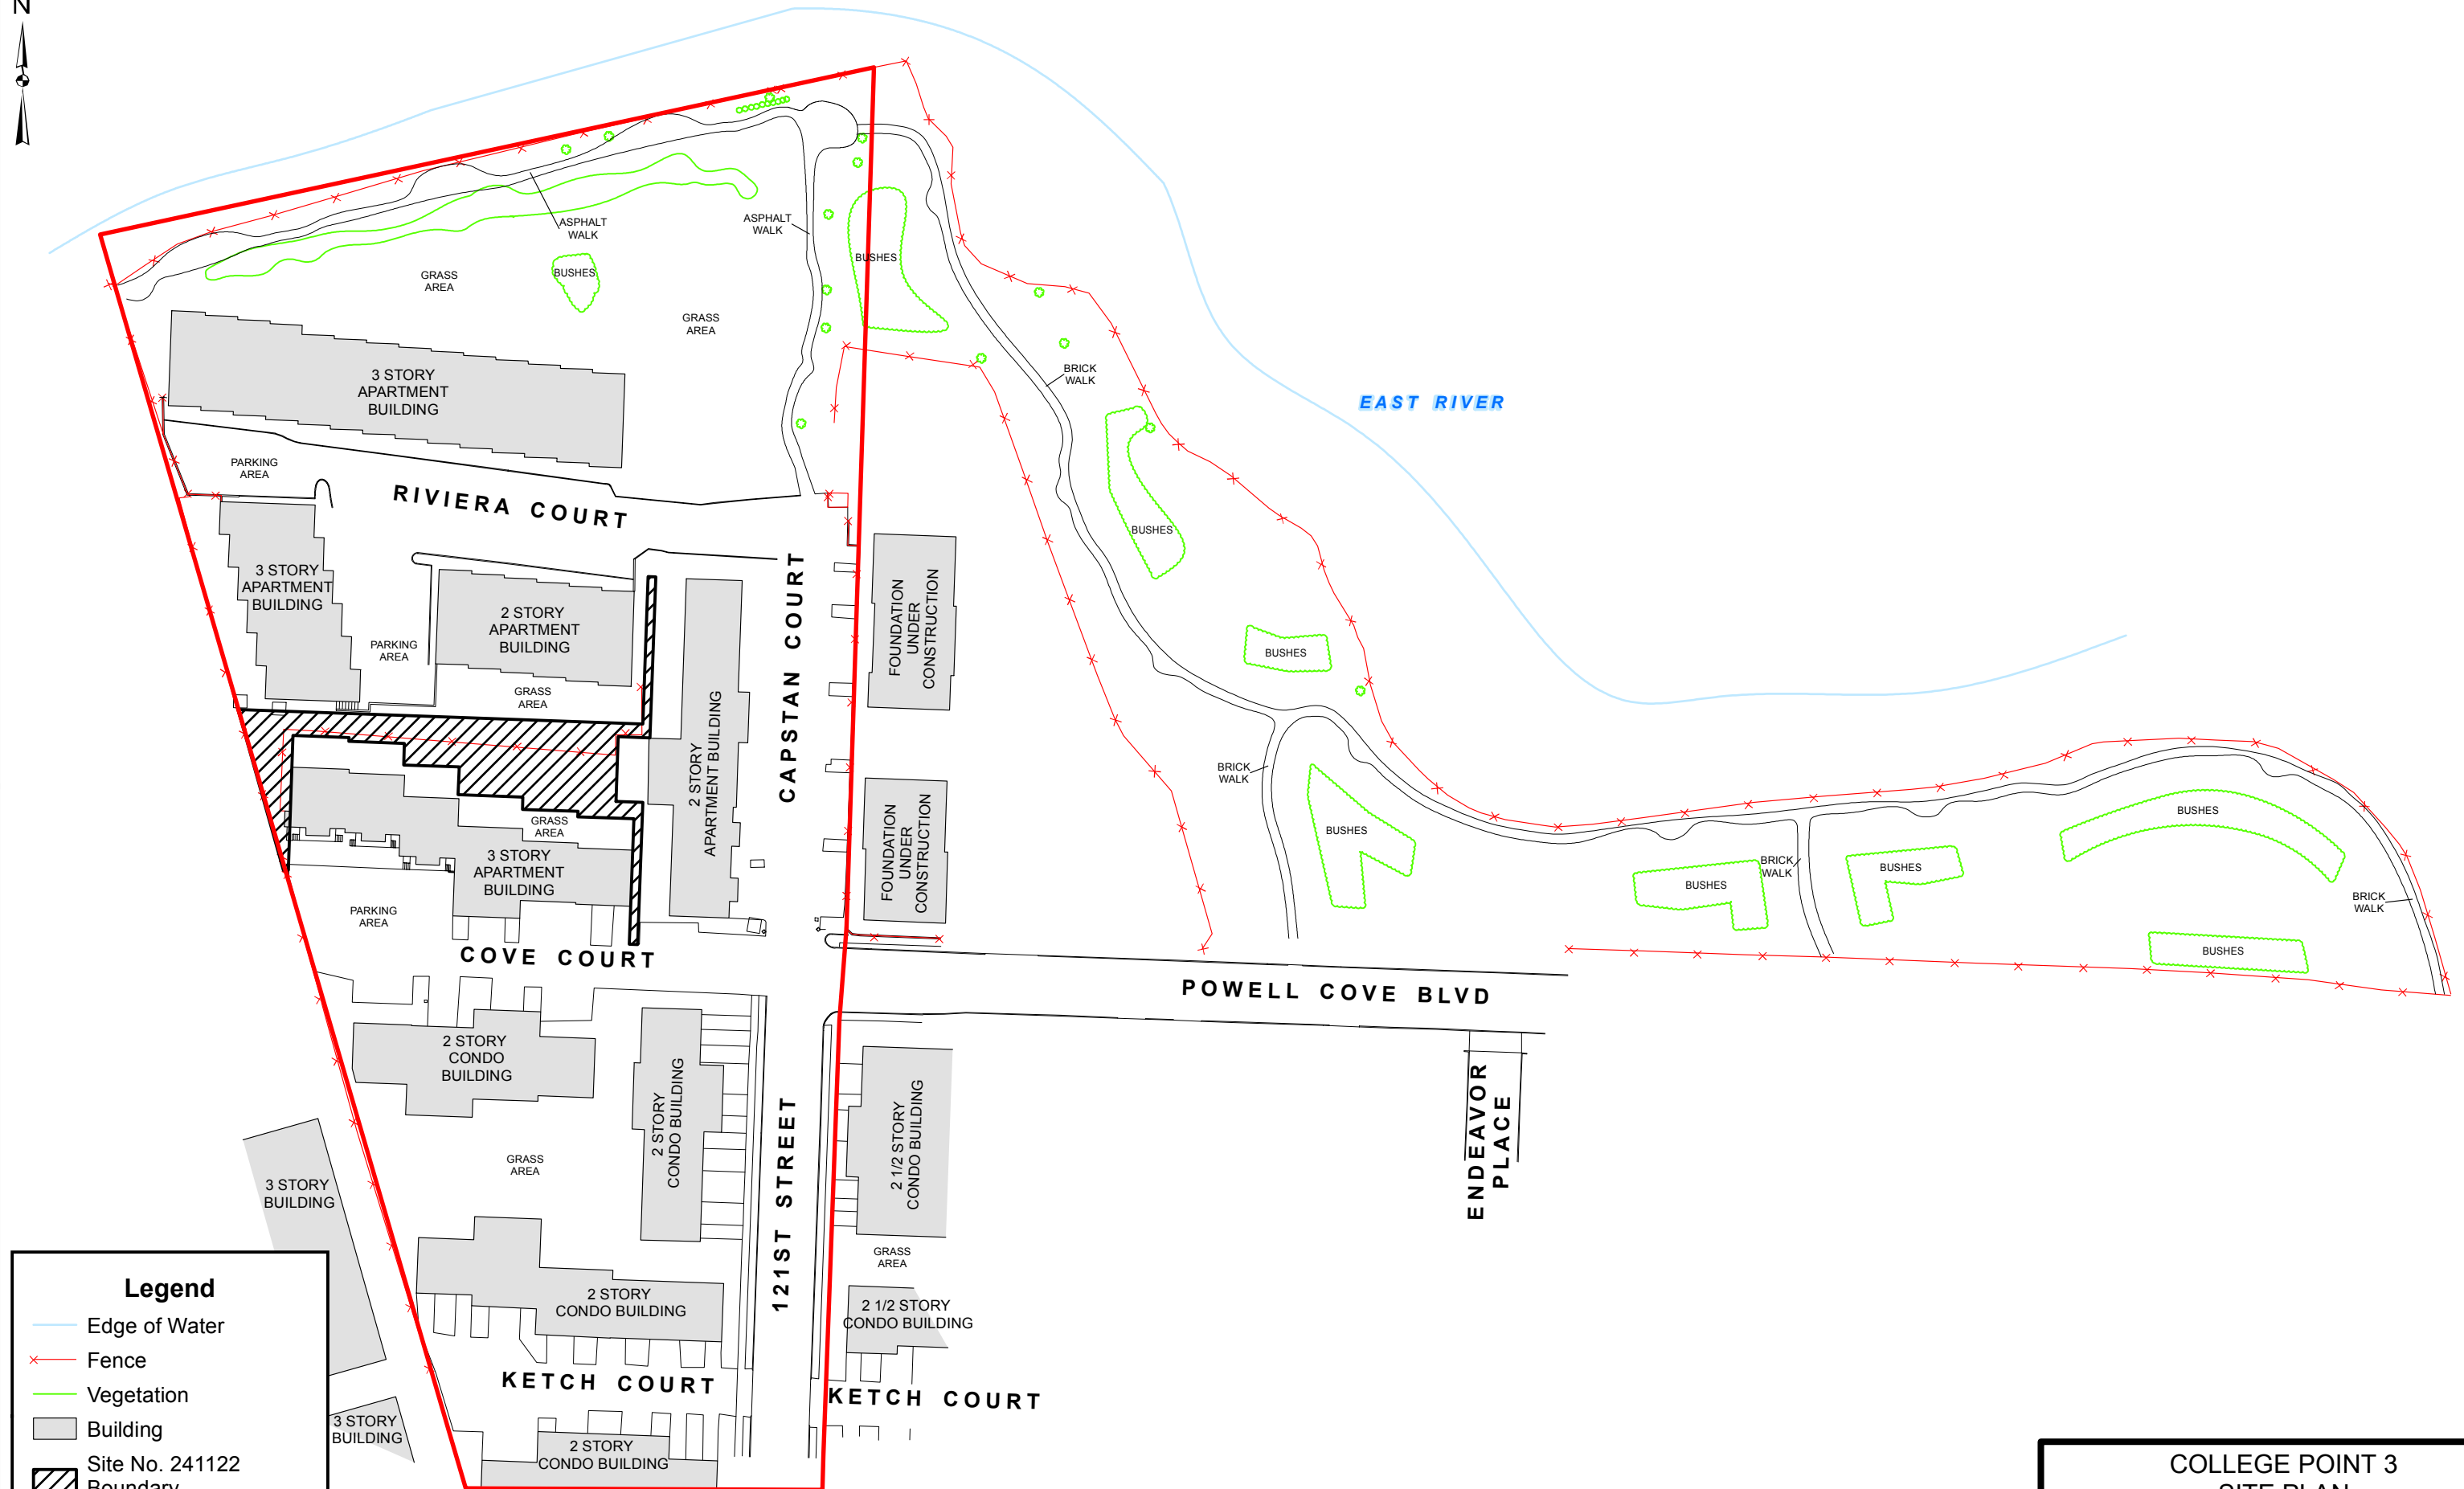
FIGURE 2

The Site as is a mix of 2 to 3 story condominium buildings, pavement and grassy areas. Grassy areas are found between the condominium buildings (i.e., between Riviera Court, Capstan Court and Cove Court and Cove Court, 121st Street and Ketch Court) and between Riviera Court and the East River. The Site was separated into three separate areas, depicted on Figure 2, for the purposes of the interim remedial measure (IRM).

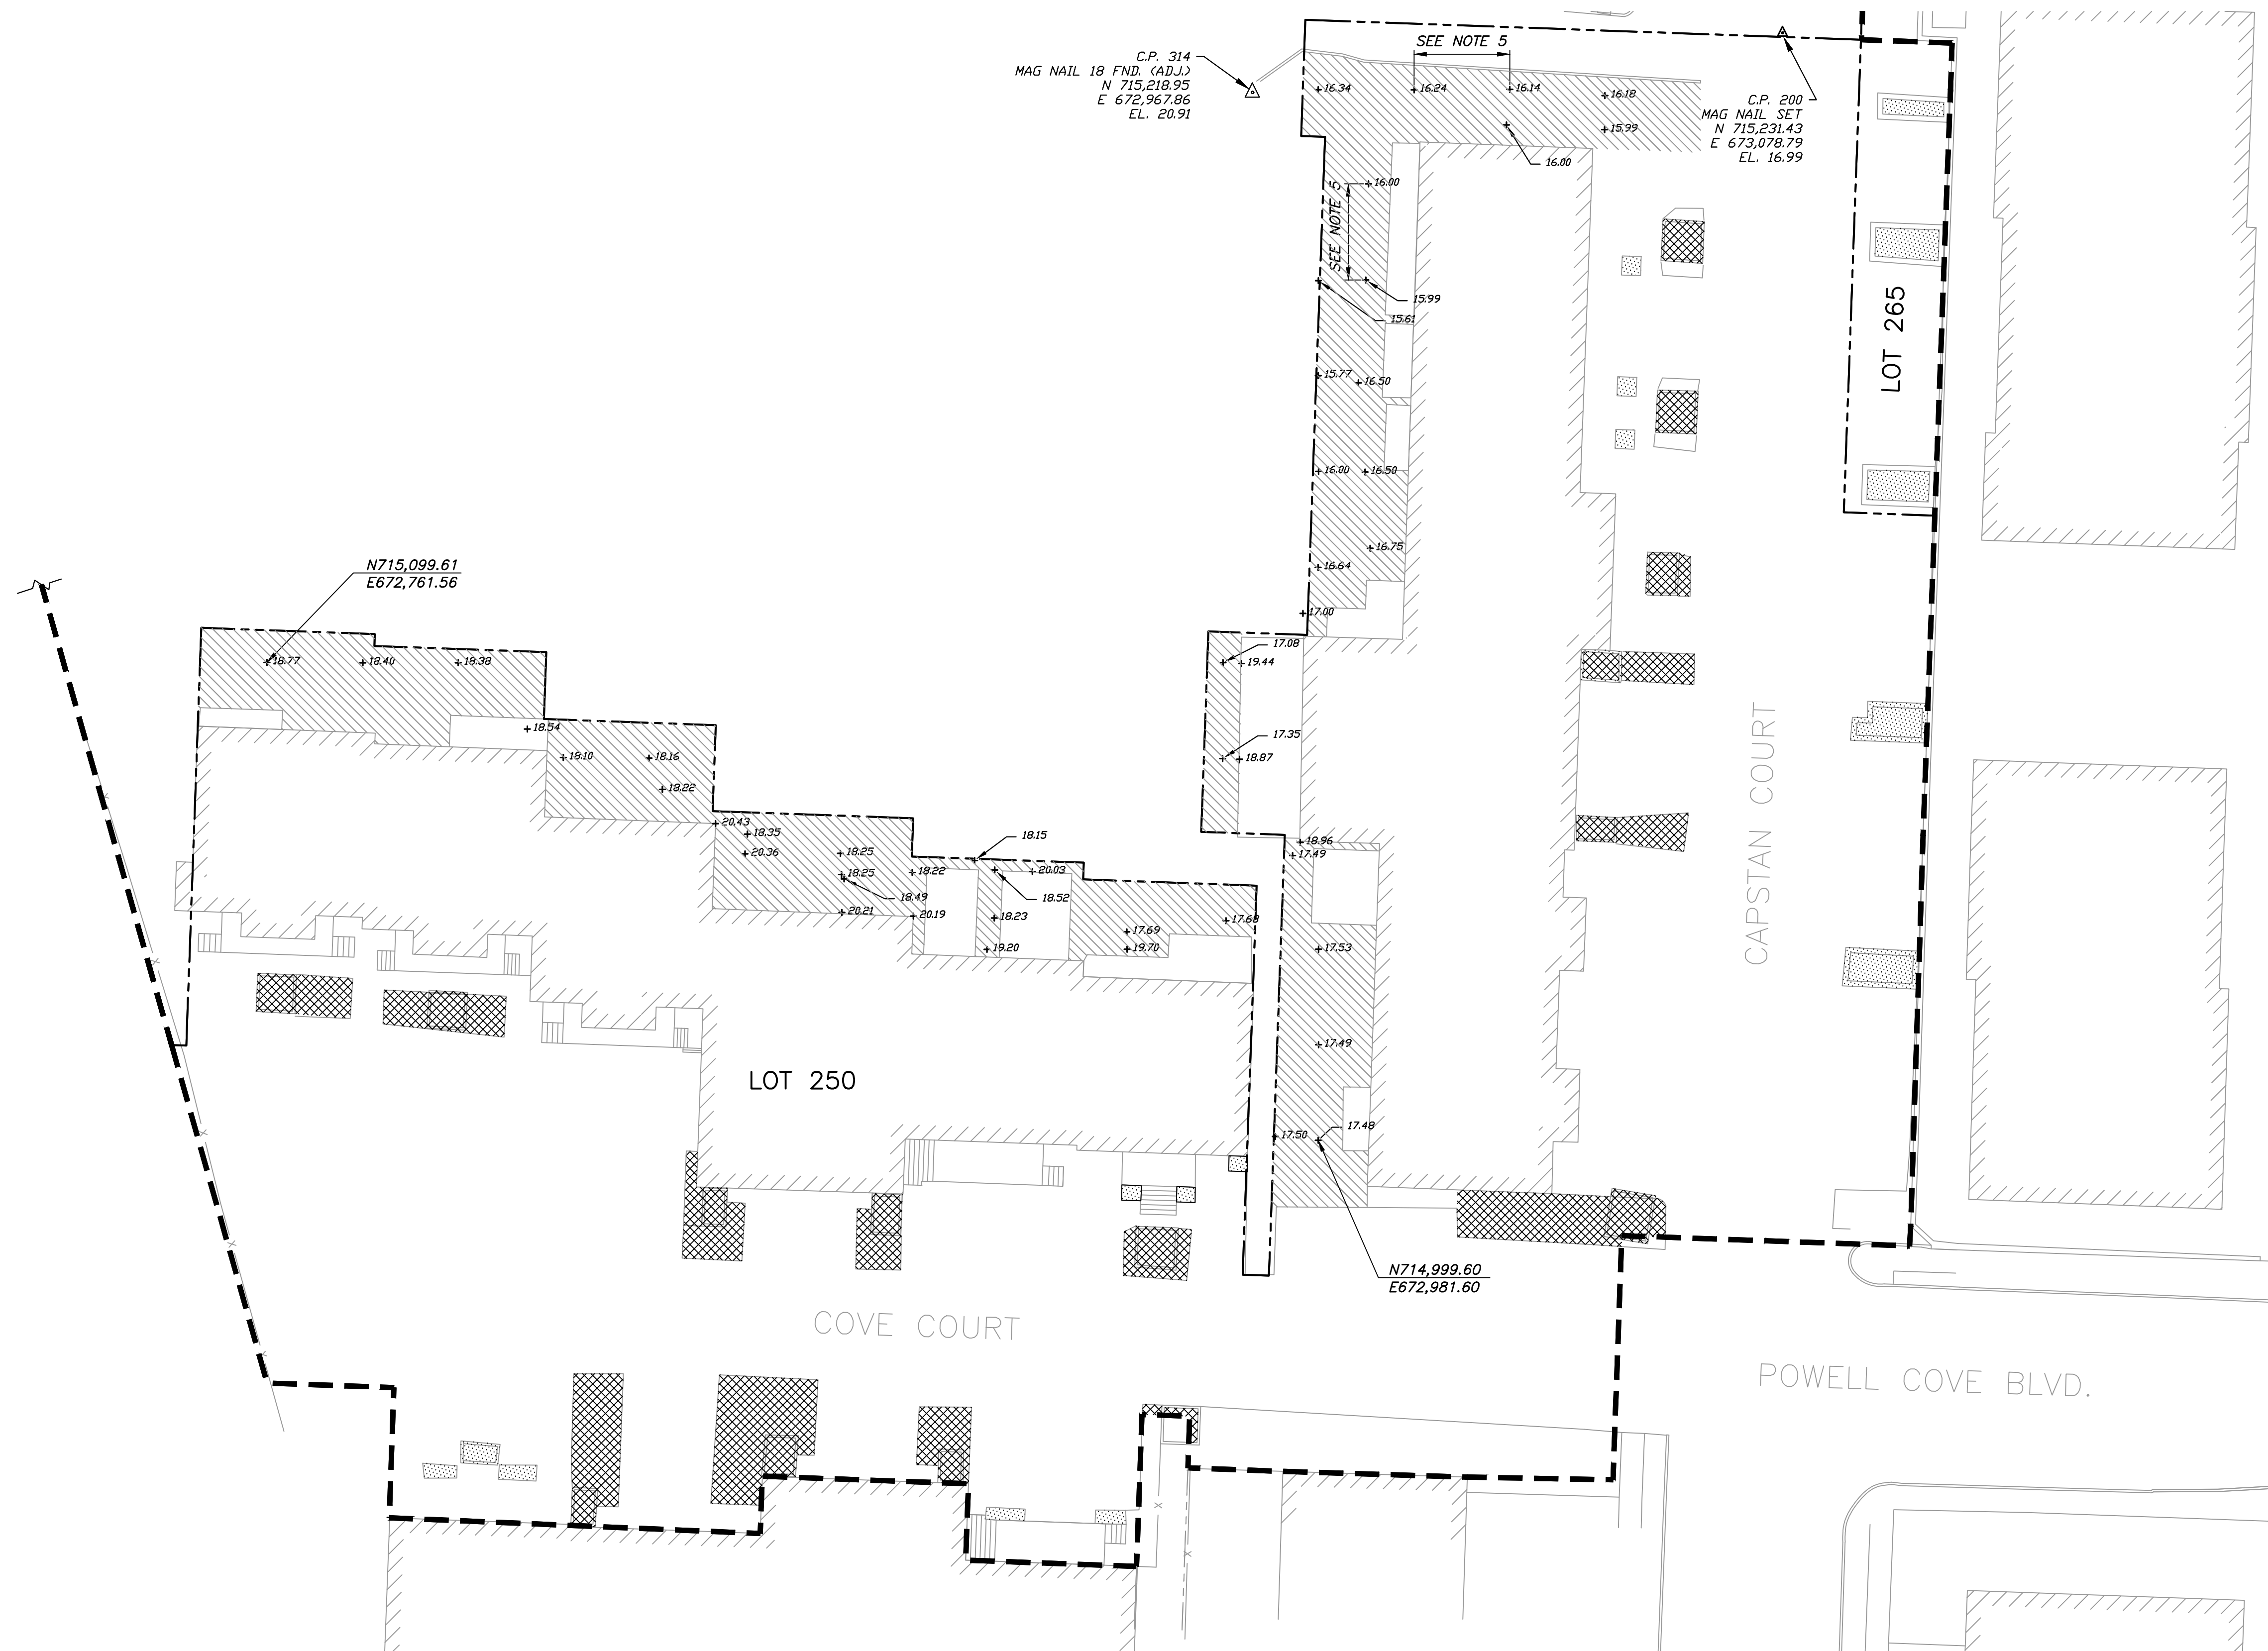
AS BUILT EXCAVATION
LOT 250

1. AECOM HAS DEVELOPED THIS DRAWING TO SHOW RELEVANT ELEVATIONS AND DIMENSIONS OF THE SOIL COVERS CONSTRUCTED BY THE NYSDEC ON BLOCK 3916 LOT 250 UNDER CONTRACT D007622-47. THIS LOT IS A PORTION OF NYSDEC SITE 241122, AND THAT SITE IS NOT SHOWN FULLY ON THIS DRAWING. THE OTHER COMPONENT LOTS OF THE SITE ARE SHOWN ON OTHER DRAWINGS DEVELOPED SIMILARLY BY AECOM.

2. THE RELEVANT INFORMATION SHOWN IS TAKEN FROM SURVEY DRAWINGS DEVELOPED BY L. K. McLEAN ASSOC., P.C. FROM NOV. 2018 THROUGH MAY 2019 (FILE. NO. 18031.000), WHICH REFLECT THE SITE CONDITIONS AT THE TIME OF SURVEY.
