**Phase III Environmental Site Assessment Report
Asia Offset and Lithograph Printing, Inc.
52-25 Barnett Avenue
Long Island City, New York**

May 2010

**CA RICH CONSULTANTS, INC.
17 Dupont Street
Plainview, NY 11803**

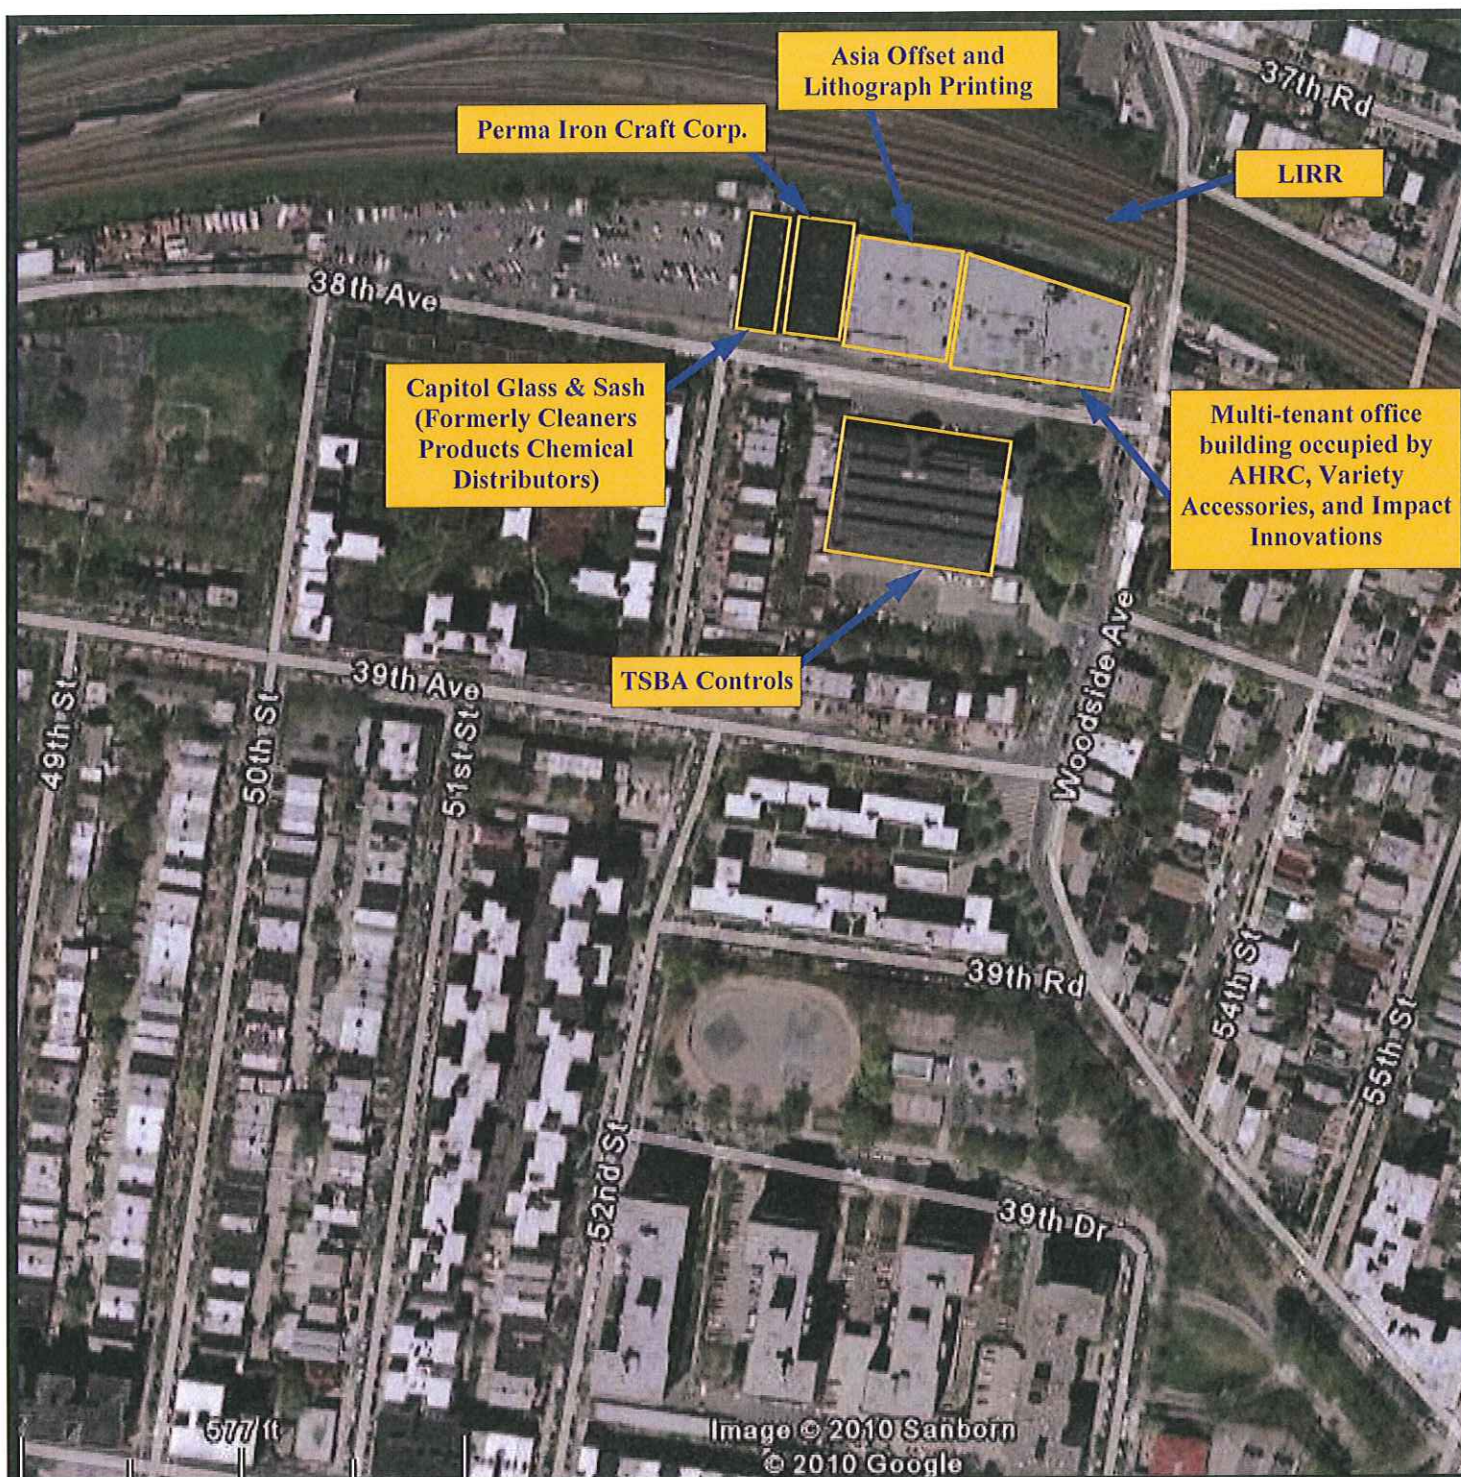
*Adapted from 2010 Sanborn Map
And Google Earth*

As shown on Figure 1, the neighbor directly to the east is a multi-tenant building occupied by AHRC, Variety Accessories, and Impact Innovations (Ref. 1). The neighbor to the south is TSBA Controls. To the north are train tracks operated by the Long Island Rail Road. The neighbors to the west are Perma Iron Craft and Capitol Glass and Sash. The building occupied by Capitol Glass and Sash was formerly occupied by Cleaners Products Chemical Distributors. A Phase I Environmental Site Assessment (ESA) prepared by Preferred Environmental Services (Preferred) identified the former Cleaners Products Chemical Distributors as having been listed on a NYSDEC database and having the potential to impact subsurface conditions in the general site vicinity ^(Ref. 1).

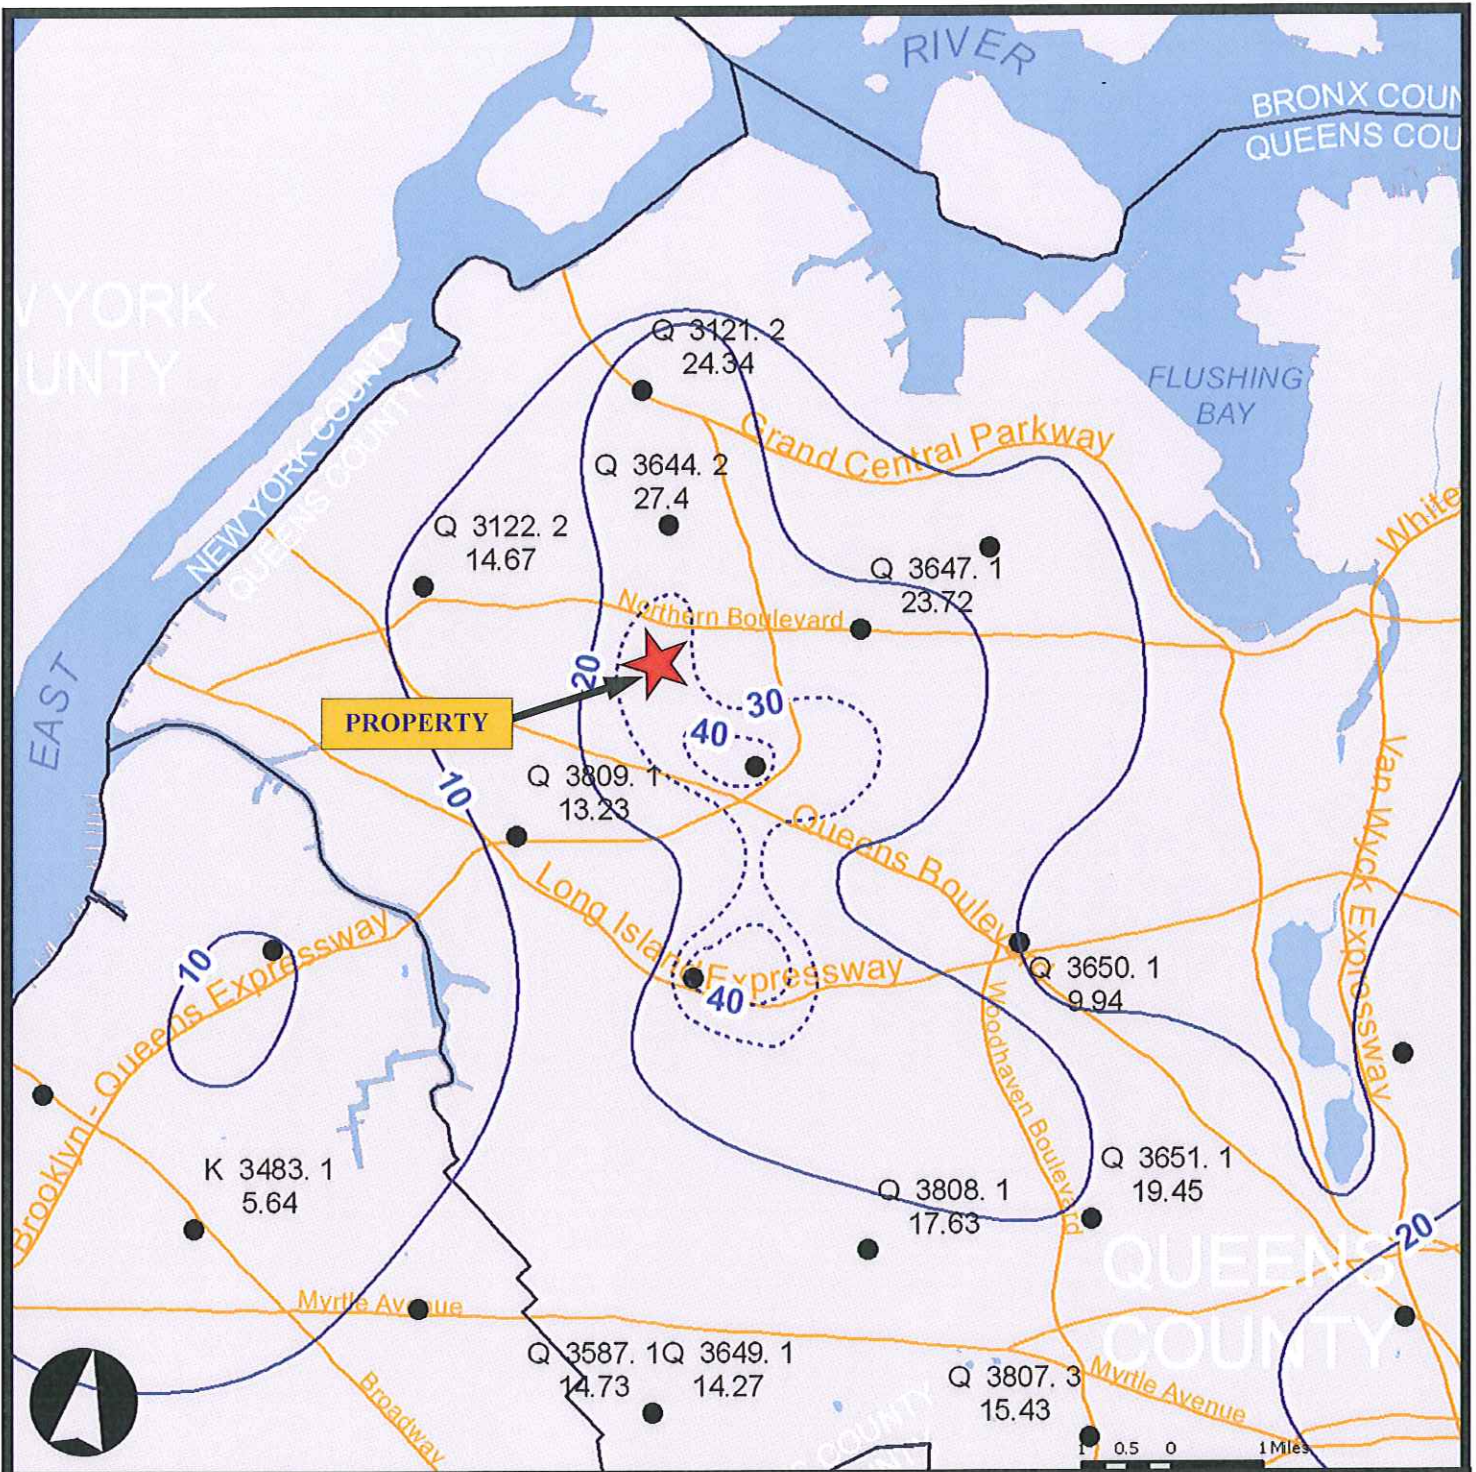
Adapted from USGS Water Table Map of Long Island 2006

Based on the water table map compiled by the USGS, the anticipated direction of groundwater flow is to the northwest and in the direction of the East River. Regional and localized water table maps are included as Figures 2 and 3. The soil immediately underlying the property consists of sand and gravel of the Pleistocene Age Upper Glacial formation. This section of Queens is sewered and serviced by municipal water derived from the reservoir system located in upstate New York. The building is presently heated by natural gas, but was previously heated by fuel oil.

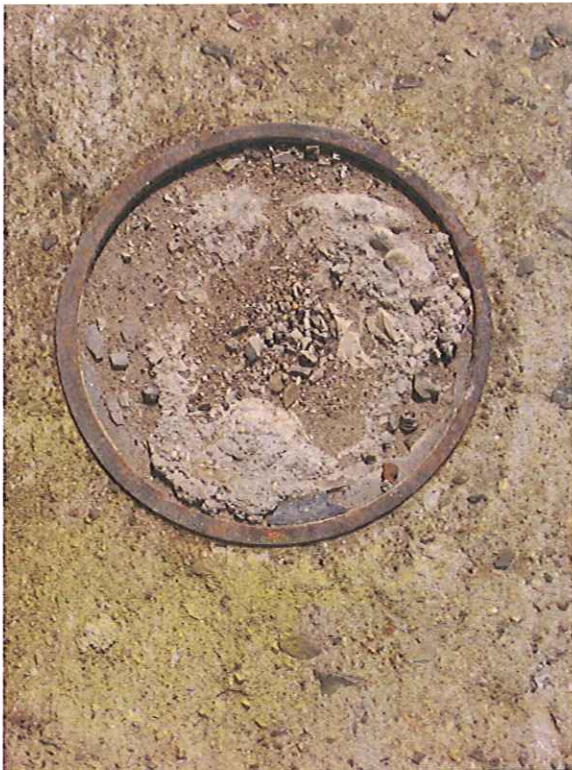
Remote fill port to gasoline UST filled with concrete

On March 23, 2010, a field crew from X-Ray Locating Services met a CA RICH field technician at the property. The locations of the tops of the two USTs were determined using a combination of magnetics and ground penetrating radar. The remote and direct fill ports to the former gasoline tank were located and inspected. Both were observed to have been filled in with concrete. The remote and direct fill ports to the 5,000 gallon out-of-service heating oil tank were also located. The heating oil tank had approximately 664 gallons of product in it and was observed to be in good condition. Pictures of the abandoned USTs are included in Appendix G.

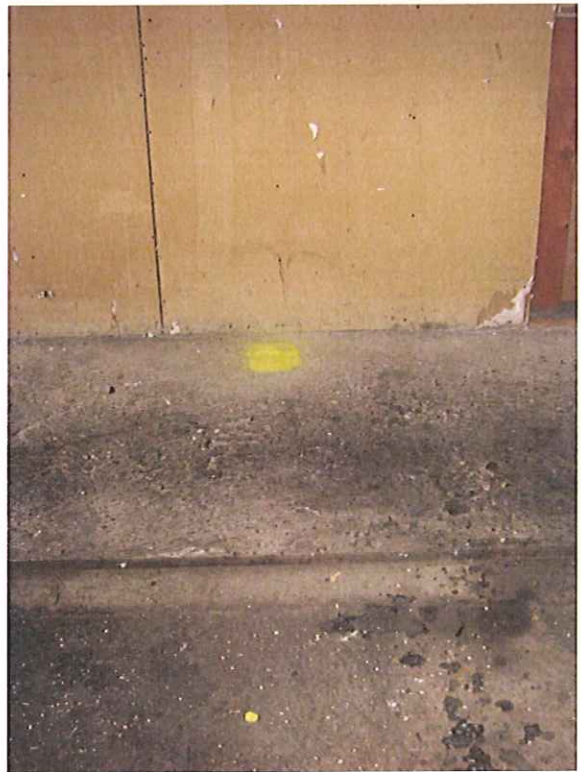
Direct fill port to gasoline UST (marked in yellow) filled with concrete

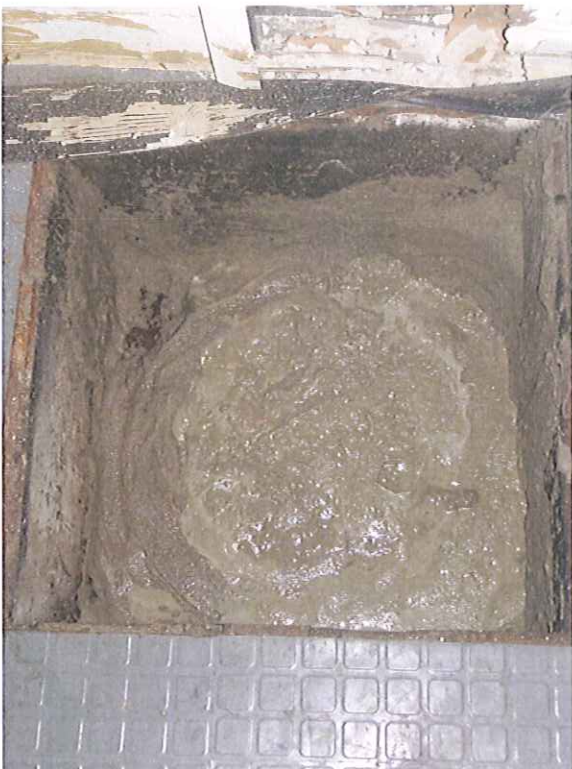
Heating oil UST filled with concrete

Aarco Environmental Services and Mercury Tank & Pump, Inc. were retained to properly abandon the out-of-service heating oil tank. The remaining product was pumped out and the inside was cleaned. The tank was then filled with a concrete slurry. A copy of the disposal manifests and NYC Fire Marshal's Affidavit are attached to this report as Appendices E and F.

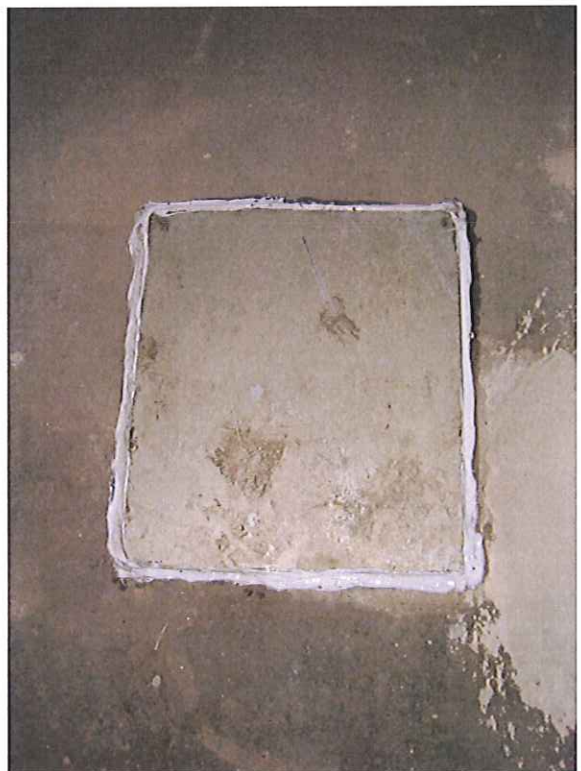
Metal cover sealed over floor pit

The metal floor plates mentioned in the Phase II ESA are access covers to clean-out plugs installed in the building's sewer line. Pictures of the floor pits are included in Appendix G. The pits below these plates were screened during the Phase II ESA and were determined not to present a suspect condition. Since access to these pits must be maintained in the event the sewer line has to be cleared, the pits were not filled in with concrete. Instead, the metal covers were sealed to the floor using silicone caulking to ensure an air tight seal for the SSD system. The cracks in the floor were also sealed using an epoxy caulking material.

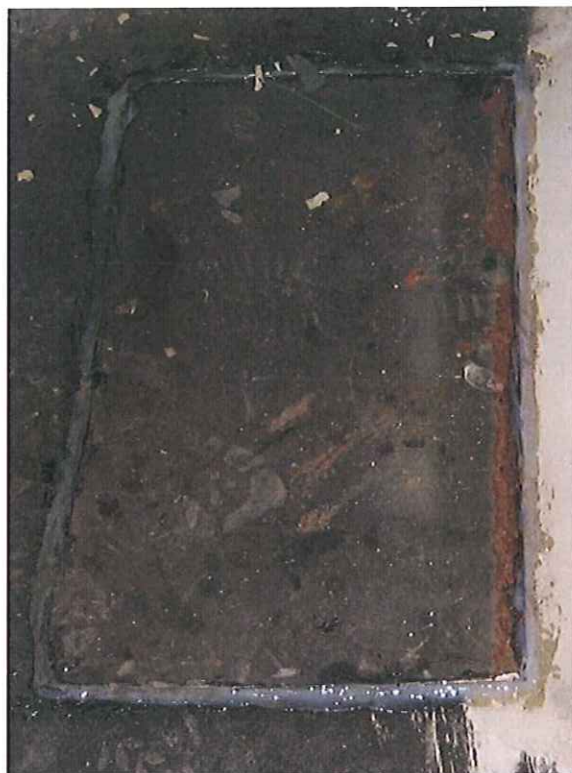
Metal cover sealed over floor pit

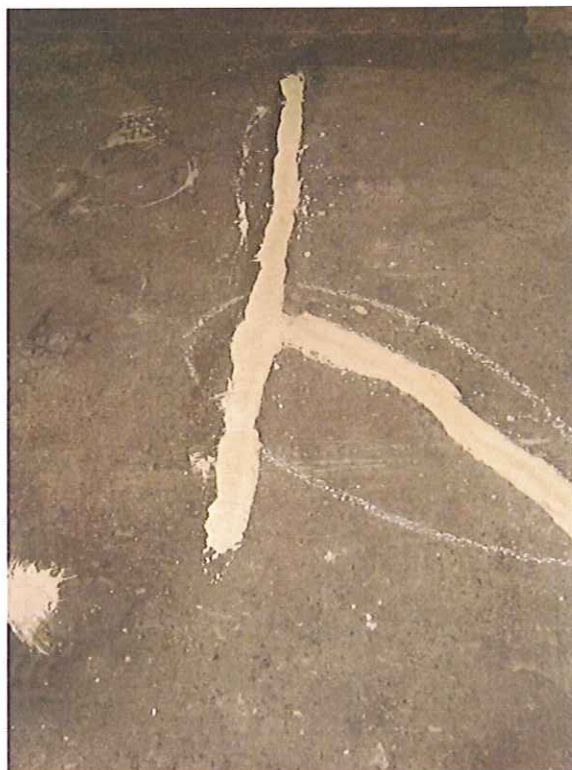
Sealed cracks in floor

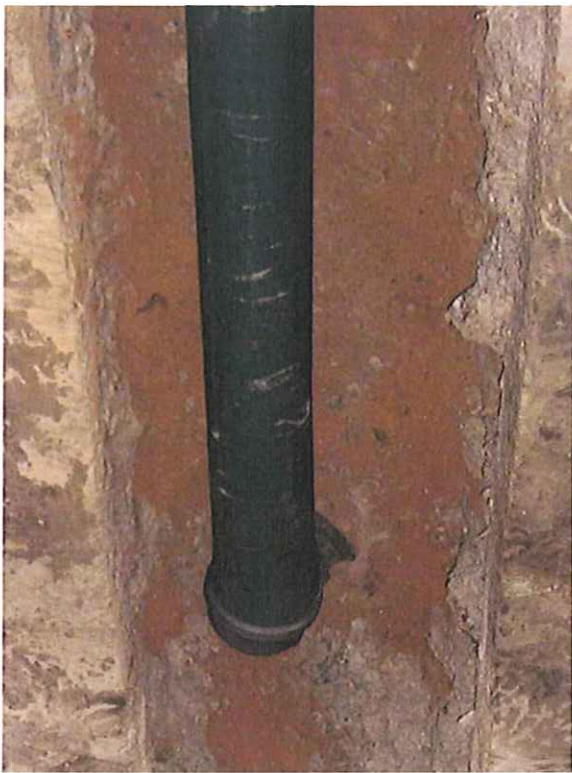
Perforated pipe and filter fabric in trench

To address the sub-slab soil vapor issue at the property, a Sub-Slab Depressurization (SSD) system was installed at the site. Details of the layout of the SSD system are presented on Figure 6. Trenches one-foot deep by one-foot wide were excavated in the floor of the building as shown. Four-inch diameter perforated PVC pipe surrounded by filter fabric was set into the trenches. The pipe was then surrounded with one-half inch diameter, washed, rounded gravel. New concrete was then poured completing the surface of the trenches. Pictures of the SSD installation are included in Appendix G.

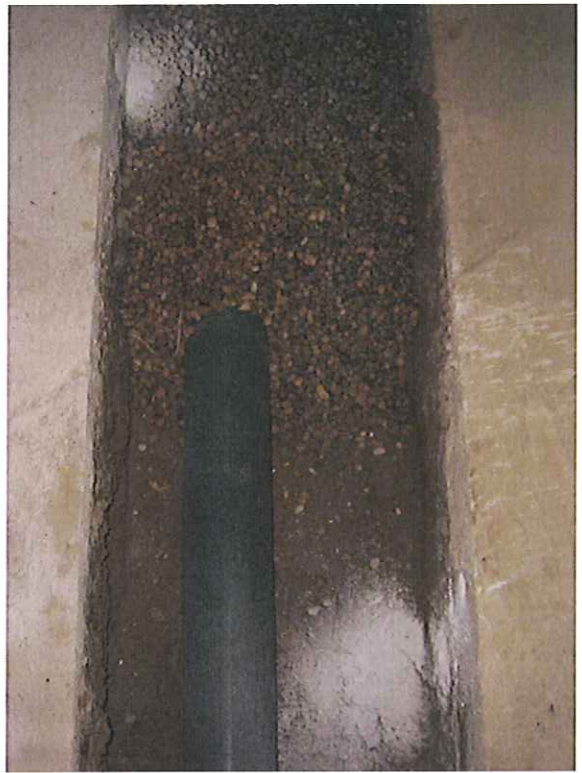
One-half inch diameter gravel placed over pipe in trench

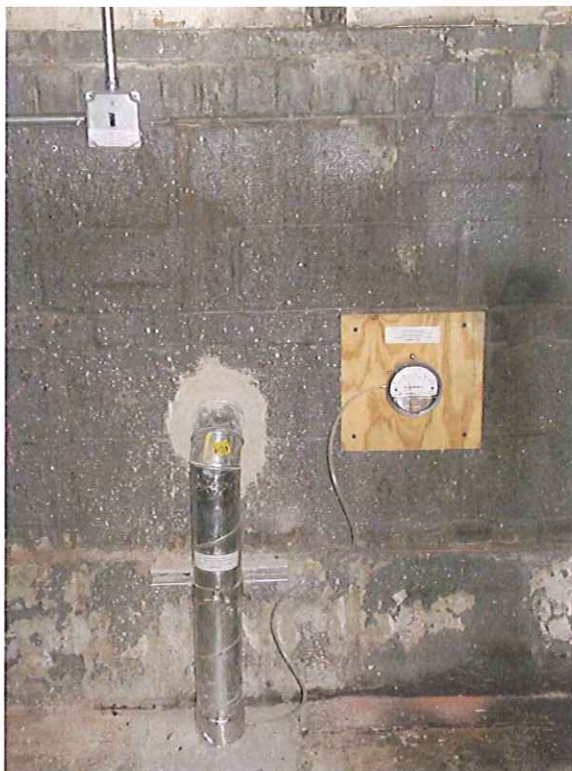
Interior riser pipe with magnehelic guage

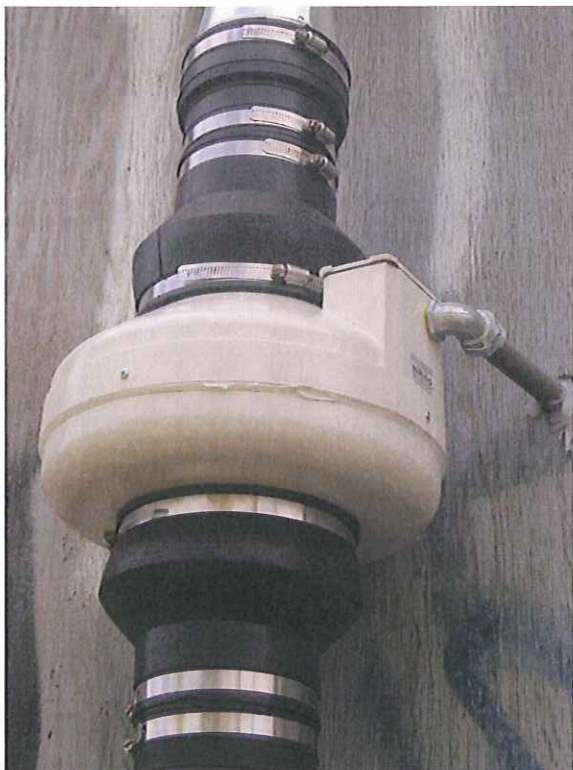
Close-up of Fantech vapor abatement fan

Based on the pilot test, a Fantech Model HP220 fan was selected. The fan was installed on the exterior exhaust pipe of the system. The exhaust duct was extended to the roof with a rain cap. The fan was then connected to the electric panel by a licensed electrician. A permanent magnehelic vacuum gauge was mounted on the wall inside the building adjacent to the exhaust stack. Upon start up of the system on April 20, 2010, a vacuum reading of one and one-half inches of water vacuum was measured on the gauge. It is believed that this vacuum will be sufficient to prevent sub-slab vapors from entering the building.
