Project	Former Port Mobil Terminal –	Report No.	19	
	IRM #1			
NYSDEC Site	#243016	Date	10/17/2024	
Location	4101 Arthur Kill Road	File No.	0208988	
	Staten Island, NY			
Client	NP Staten Island Industrial, LLC	Temperature	46-57°F	
Contractor	Entact, Haley & Aldrich	Wind Direction	NW to SE up to 8 mph	
Weather	Partly Sunny	Personnel on Site	S. Sotomayor,	
			K. O'Connor	
Humidity	74%	Time on Site	6:45 am to 5:00 pm

H&A of New York Engineering and Geology, LLP (Haley & Aldrich) was present to document the implementation of the August 2024 NYSDEC-approved Interim Remedial Measures 1 Work Plan (IRM 1 Work Plan) prepared by Haley & Aldrich for the Former Port Mobil Terminal, located at 4101 Arthur Kill Road, Staten Island, NY. Site Observations are summarized below.

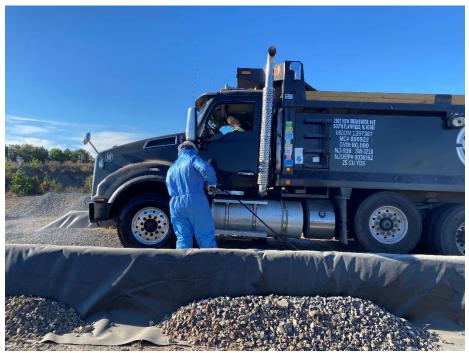
Photo 1: View of truck washing activities in IRM 1 Central Area, facing south.

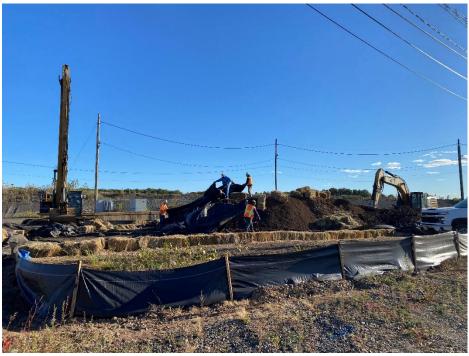
Photo 2: View of excavated soil stockpile containment and tarp covering at the end of the work shift, IRM 1 Eastern Area, facing east.
