**REMEDIAL INVESTIGATION REPORT  
FORMER CHARLTON CLEANERS FACILITY  
FOREST AVENUE SHOPPERS TOWN  
BOROUGH OF STATEN ISLAND  
CITY OF NEW YORK  
NYSDEC VCP SITE NO. V-00252-2,  
INDEX NO. W3-0891-01-06**

KIOP Forest Avenue, LP

November 2010

**LEGGETTE, BRASHEARS & GRAHAM, INC.**  
Professional Groundwater and Environmental Engineering Services  
110 Corporate Park Drive, Suite 112  
White Plains, NY 10604  
(914) 694-5711

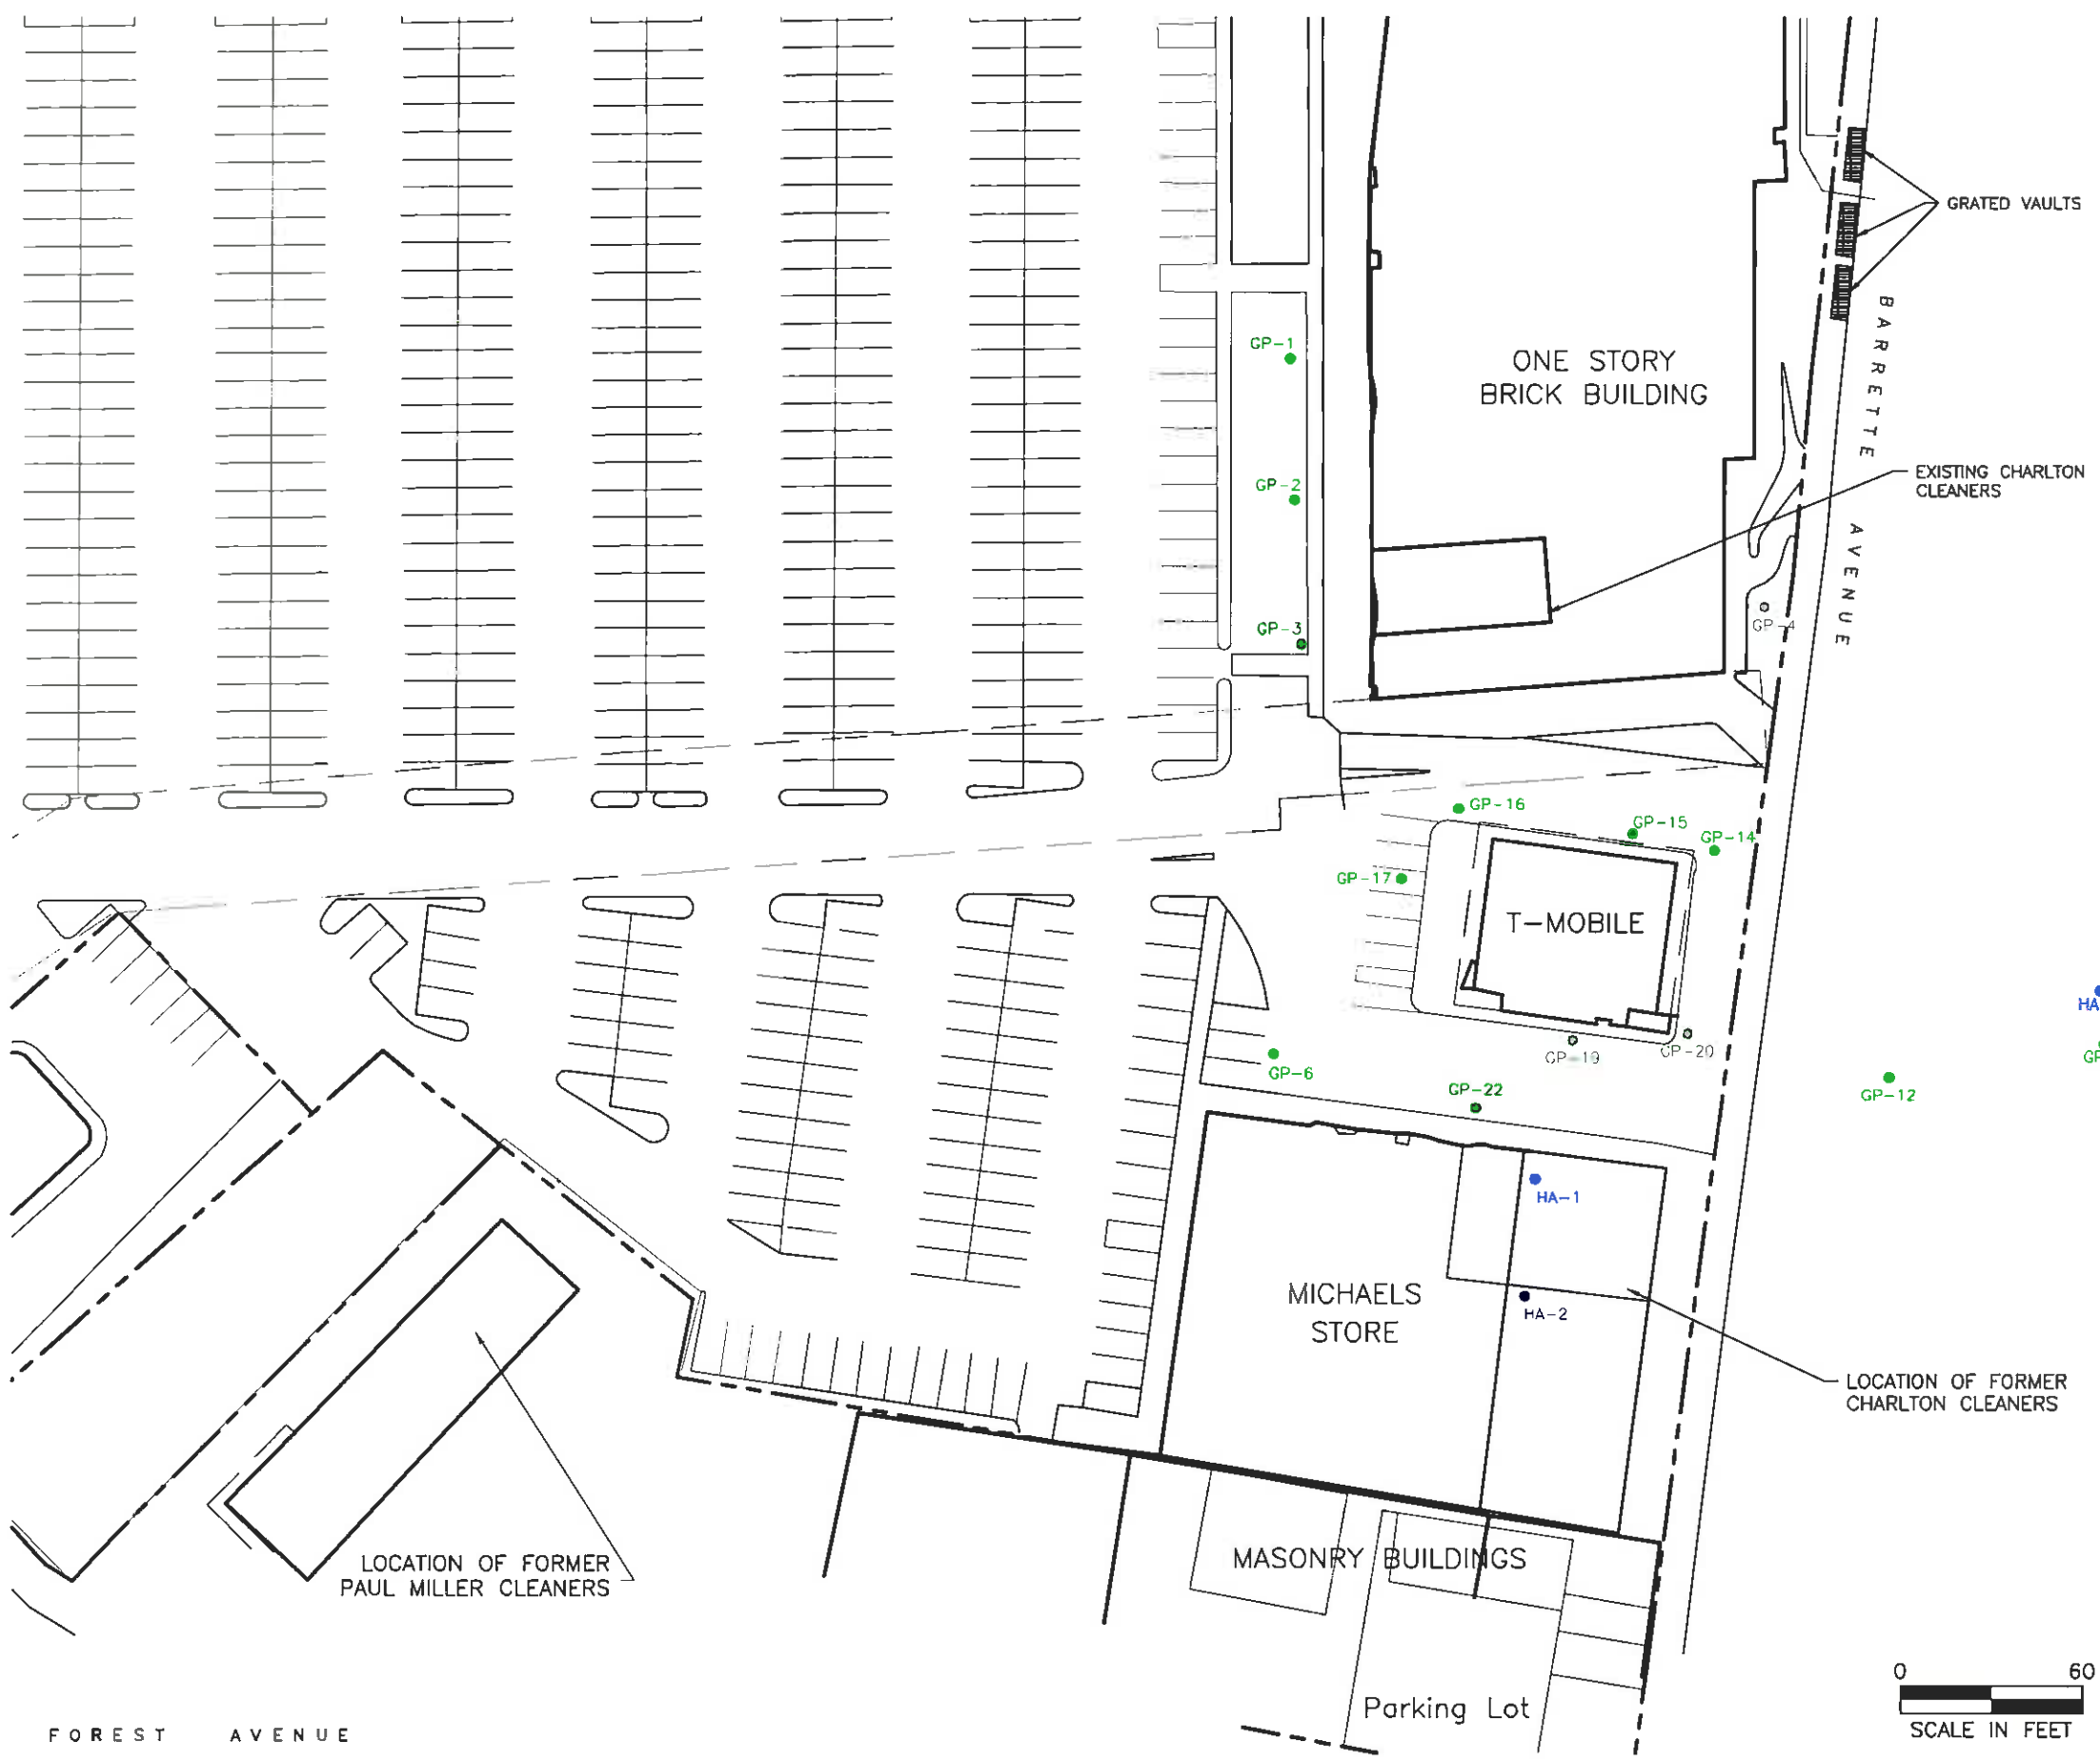
DATE	REVISED	PREPARED BY:
		<b>LEGGETTE, BRASHEARS &amp; GRAHAM, INC.</b> Professional Groundwater and Environmental Engineering Services 110 Corporate Park Drive Suite 112 White Plains, NY 10604 (914) 694-5711
<b>DRAWN:</b>	RAC	<b>CHECKED:</b> PW <b>DATE:</b> 05/06/10 <b>FIGURE:</b> 11

G:\BWWG\Chem\B08\Files for pdf\0-16-1-fig 15 gw sample locations 2000.dwg, layout, 01/02/2011 12:48:24 PM, AutoCAD

- HA-2 HAND AUGER GROUNDWATER SAMPLE LOCATION (2000)
- GP-1 GEOPROBE GROUNDWATER SAMPLING LOCATION (2000)

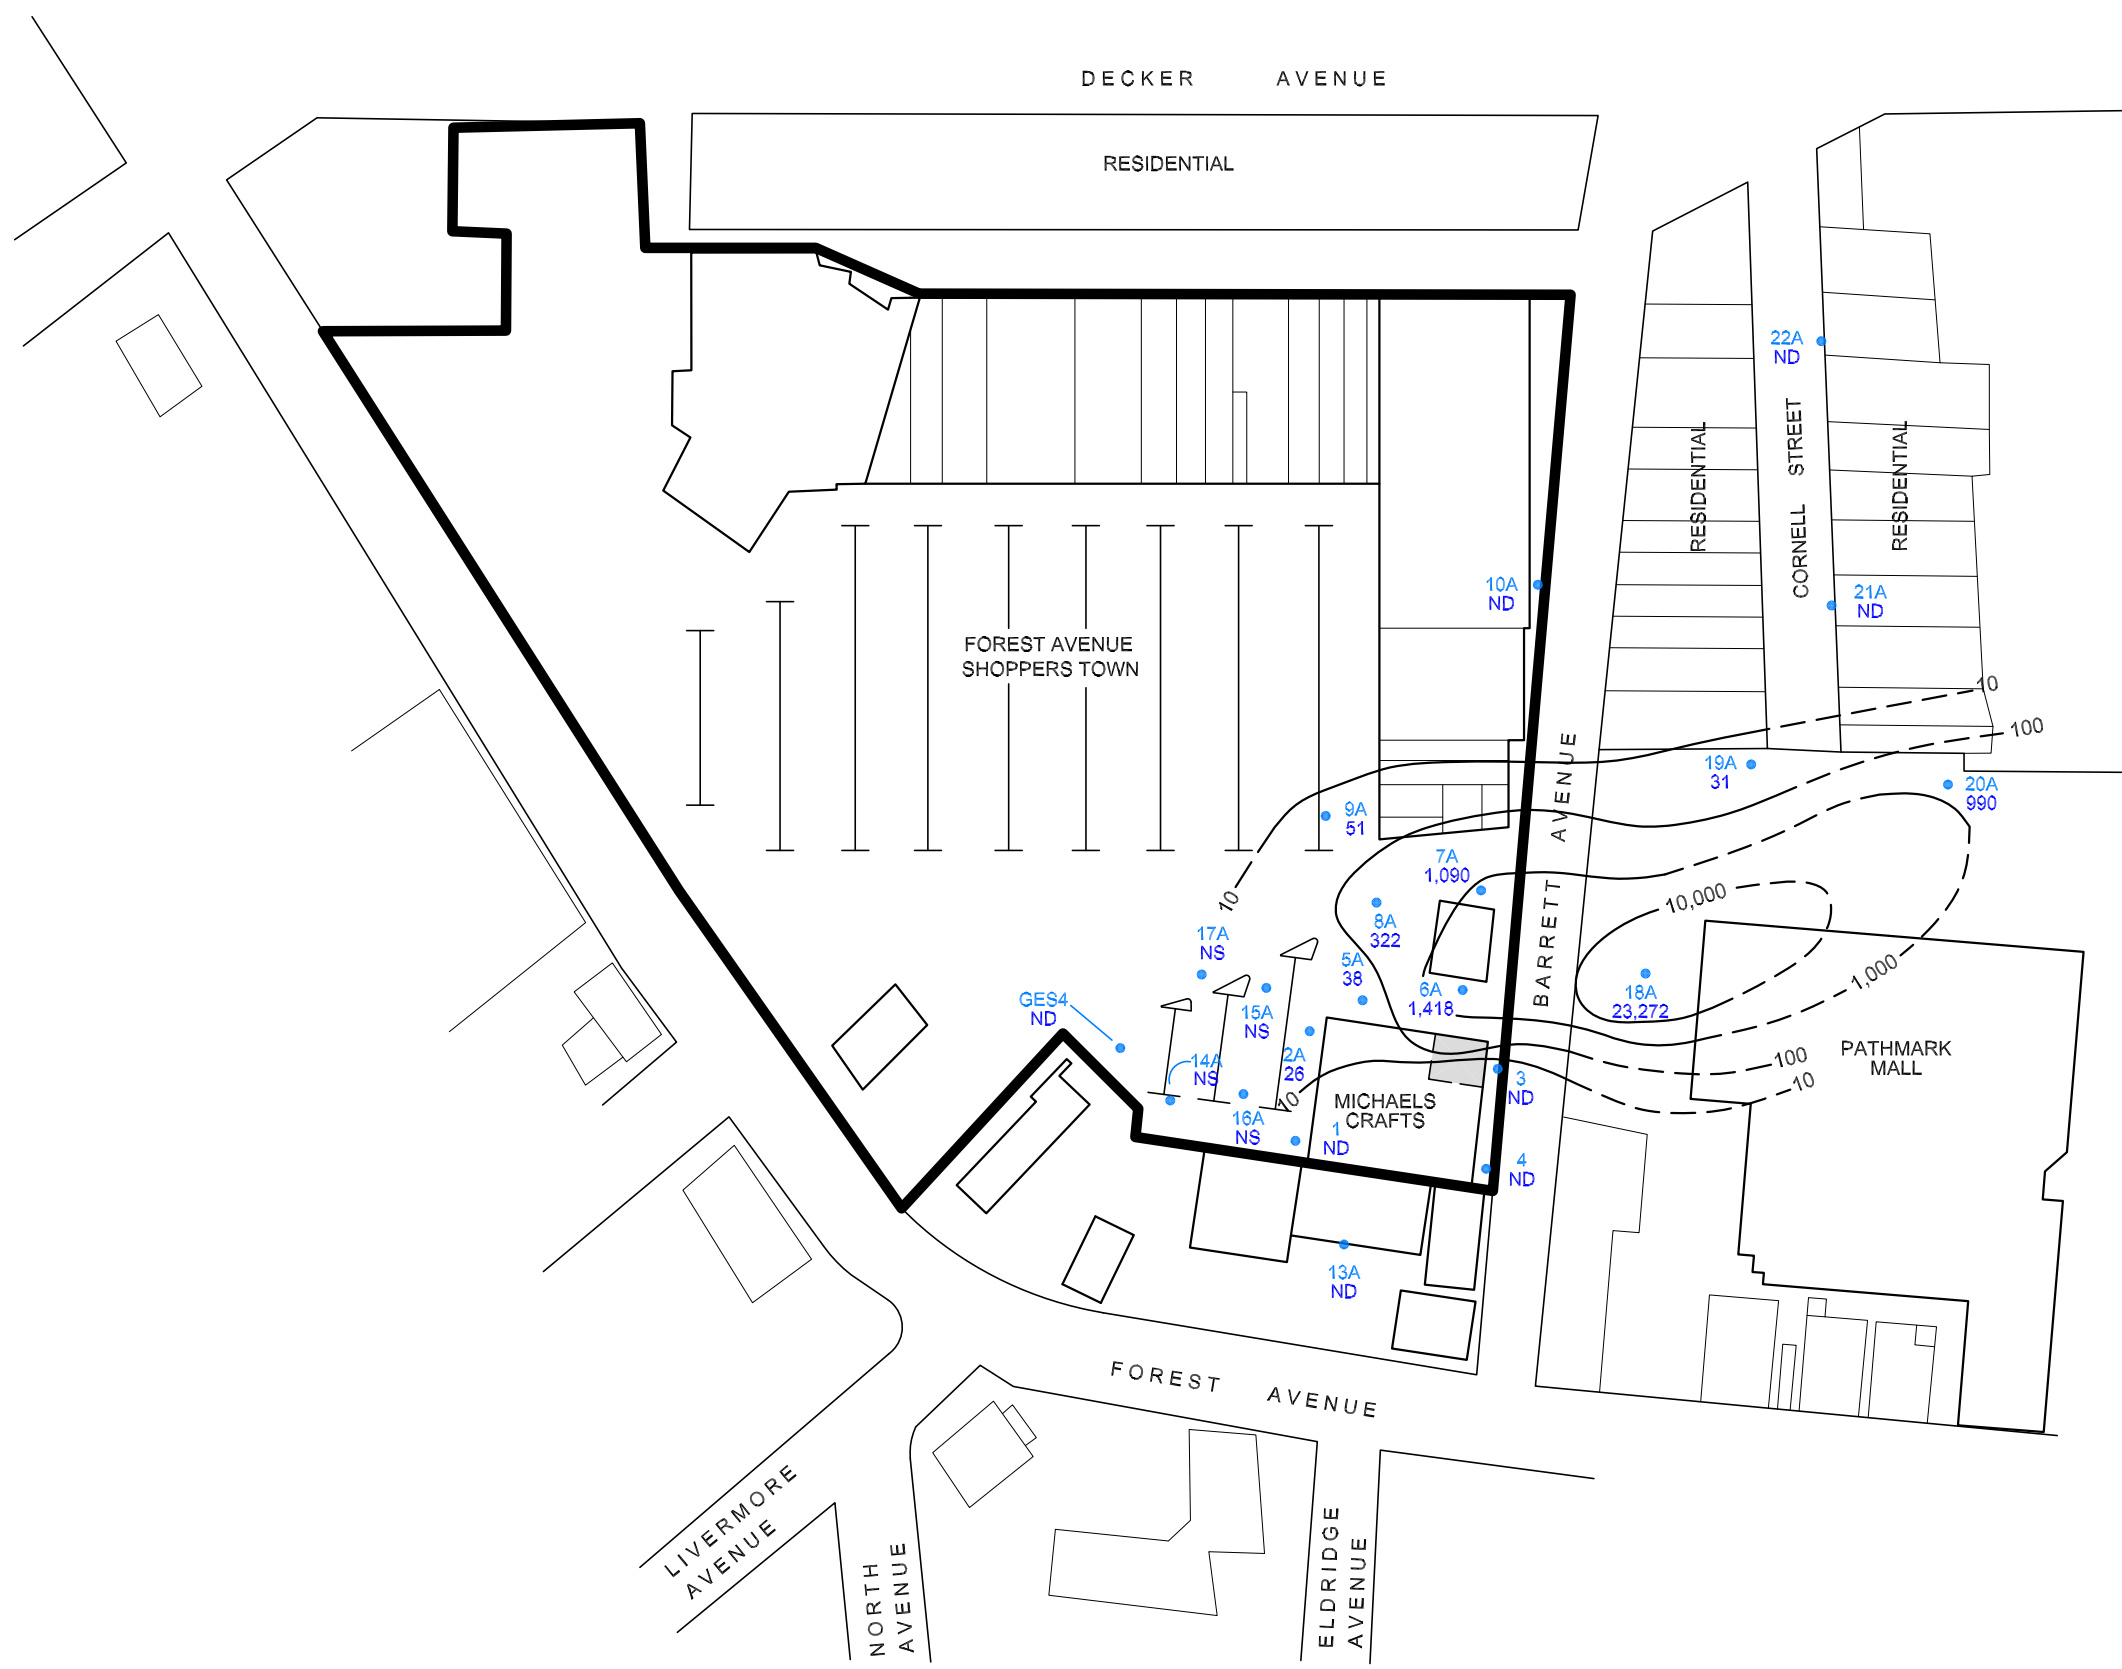
DRAWN:	MRV	CHECKED:	PW	DATE:	09/09/10	FIGURE:	16
--------	-----	----------	----	-------	----------	---------	----

SITE BOUNDARY
	GROUNDWATER MONITORING WELL LOCATION
1,418	TOTAL CVOCs IN GROUNDWATER (MICROGRAMS PER LITER (ug/l))
ND	NOT DETECTED
NS	NOT SAMPLED
10 ———	TOTAL CVOCs ISOCONCENTRATION LINE (ug/l) (DASHED WHERE INFERRED)
