Subject: Interim Remedial System Optimization Measures Workplan
Former Charlton Cleaners
24 Barrett Avenue
Staten Island, Richmond County, New York
Site ID No. 243018

Camp Dresser McKee & Smith (CDM Smith) has prepared this Interim Remedial System Optimization Measures (IRSOM) Workplan to detail the actions to be conducted at the former Charlton Cleaners site, hereinafter referred to as “the Site,” located at 24 Barrett Avenue in Staten Island, Richmond County, New York. The measures detailed in this Workplan are intended to restore the existing groundwater and soil vapor treatment system at the Site to operation, as well as expand the vapor extraction portion of the system. This scope of work is based on a Site inspection performed on May 9, 2023, sampling performed on May 25, 2023, and a site visit with NYSDEC’s on-call contractor on February 9, 2024. This project is part of the New York State Department of Environmental Conservation (NYSDEC) Work Assignment # D009805-20 under the NYSDEC Standby Contract No. D009805.

DAILY INSPECTION REPORT

Report No. **Former Charlton Cleaners- NYSDEC Site No. 243019**

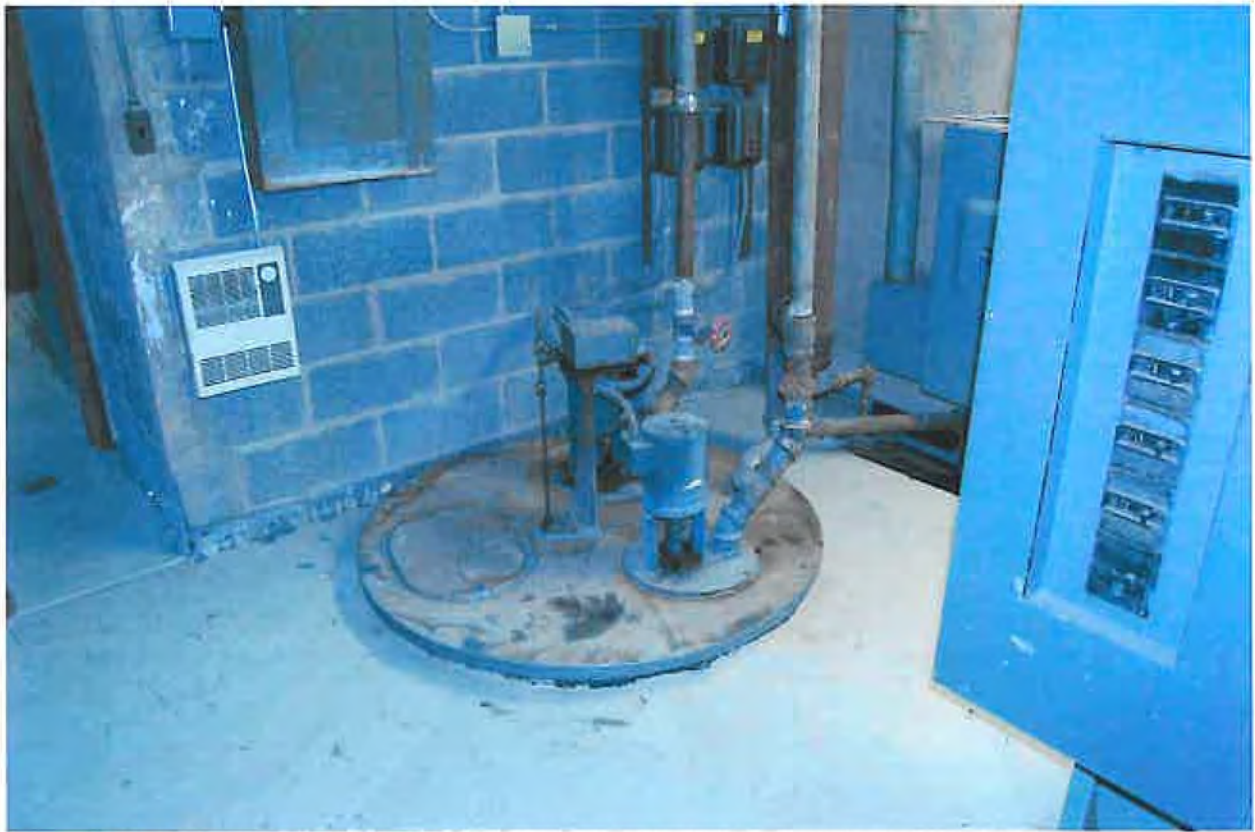
LARGE NORTH SUMP PIT IN EQUIPMENT ROOM, PRIOR TO 2009 IRM

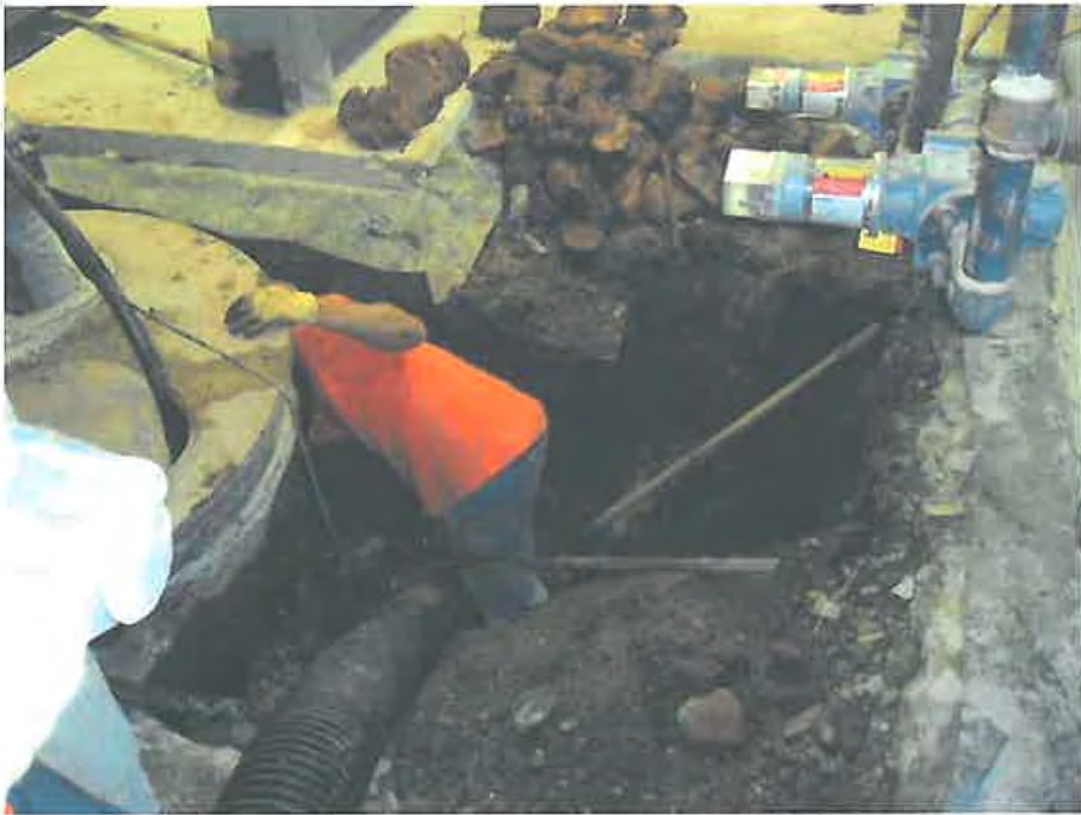
Between September 17 and 22, 2009, Metro excavated soil from beneath the floor of the equipment room and west room. The west room excavation was extended to the interior walls and outer foundation wall. Also, the west room excavation was extended halfway to the B-1 location which analyses had proven to meet Part 375 Cleanup Standards. Similarly, the equipment room excavation was extended to the interior wall and foundation wall, the base support for the electrical panels and to the location of B-4, soil from which met Part 375 Cleanup Standards.

EXCAVATING SOIL IN EQUIPMENT ROOM

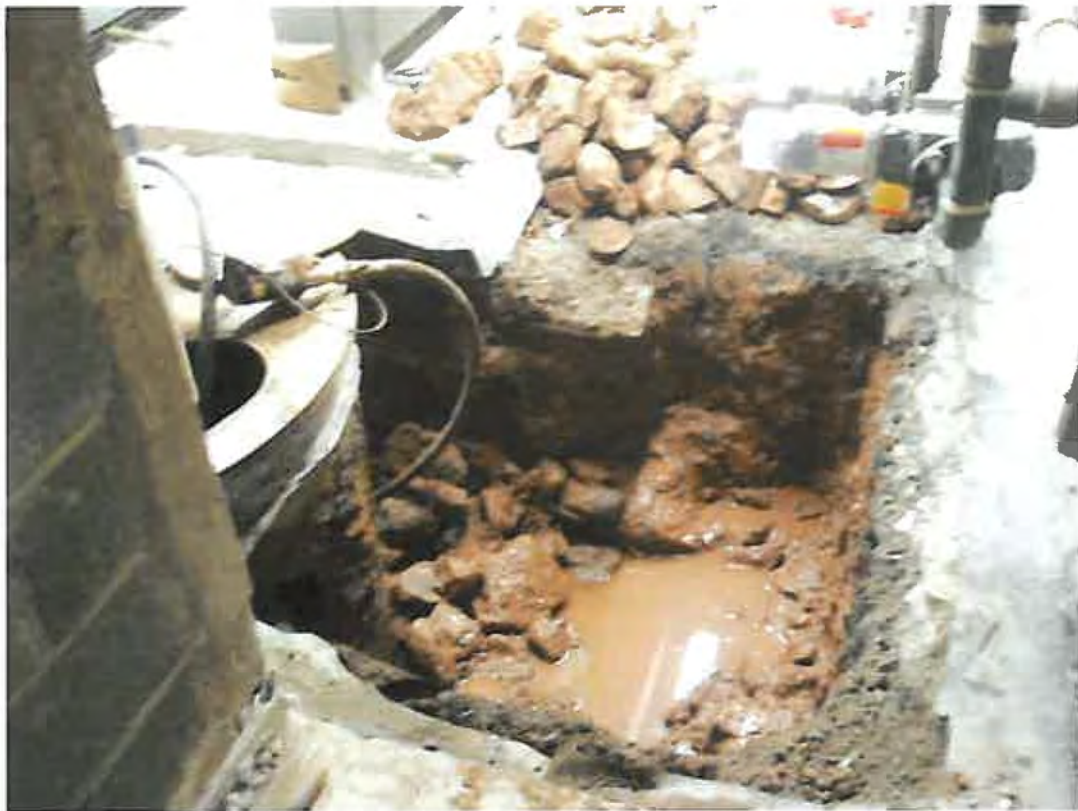
The sub floor geology consisted of saturated sandy silt with many 4 to 8-inch cobbles. The static groundwater level was approximately 4 inches below the bottom of the floor slab. The excavations in both rooms were terminated at a depth between 5 and 6 feet below the floor which was the practical limit based on the excavation method, the rate of groundwater infiltration and safety of the workers.

CONTINUED EXCAVATION, NOTE COBBLES

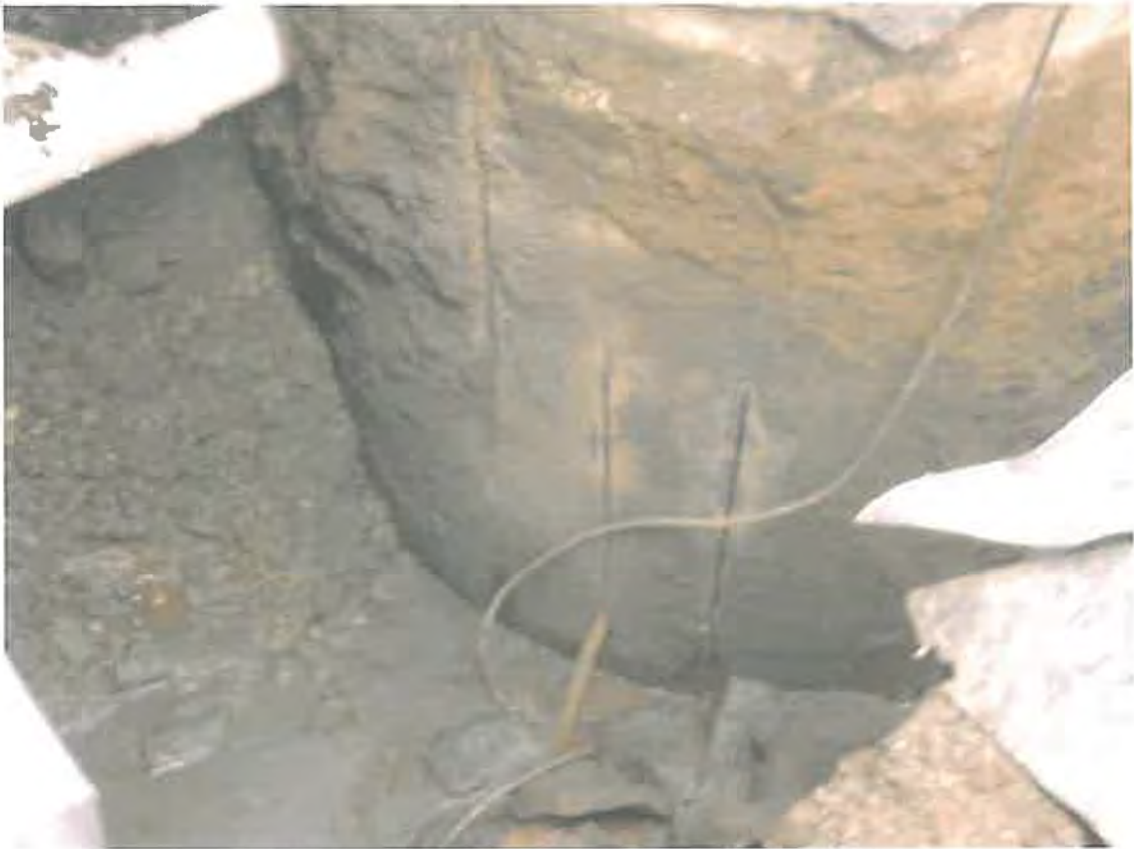
SLOTS CUT IN SIDE OF LARGE SUMP PIT

The floor of the west room and the basement stairwell has been observed to periodically flood due to the shallow static groundwater level. This water, being contaminated with VOCs, is a potential source of indoor air contamination. The original Work Plan described the installation of a small sump at the bottom of the outside stairwell in order to mitigate the problem. During preparatory work however, a floor drain was discovered in the stairwell. The drain was cleared of debris and was determined to be functional. It drains into the large sump pit in the equipment room.

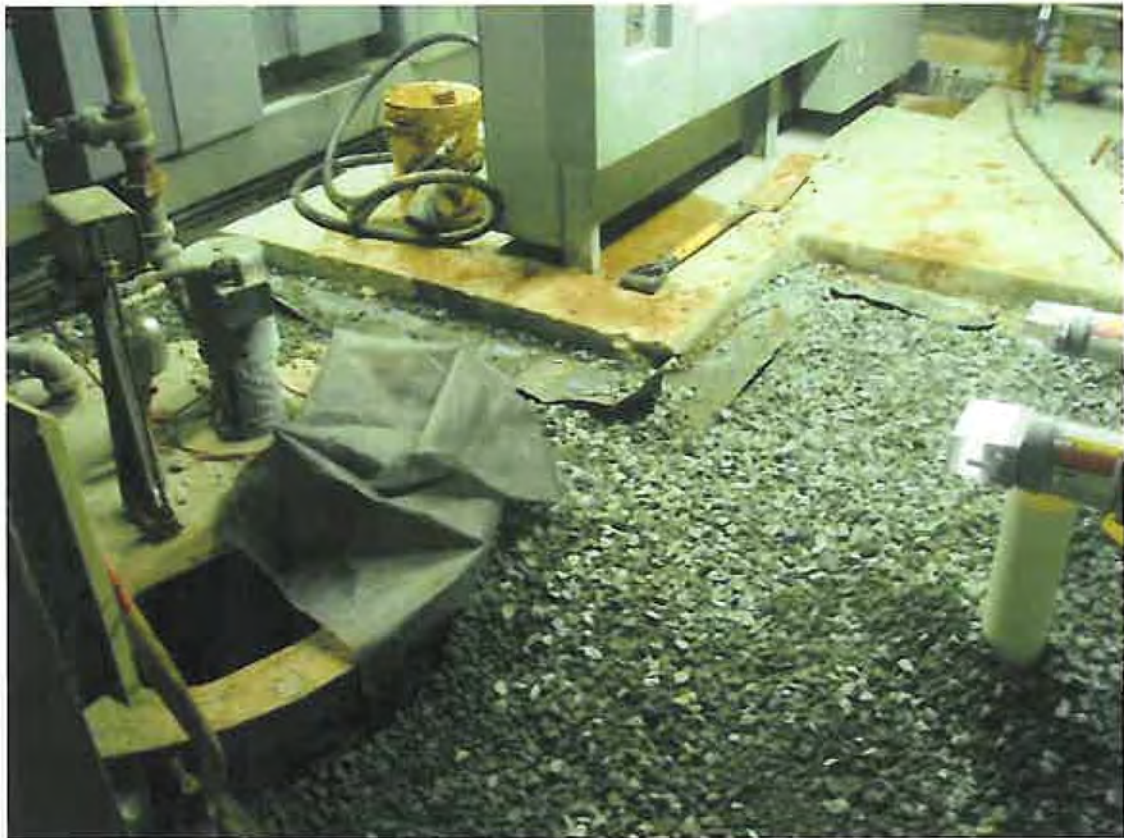
Also prior to backfill, a 4-inch diameter slotted PVC well screen was placed vertically in each excavation. The well screen extends above the floor grade after floor repair. The well screens can be used for future monitoring and remedial activities. Further, a length of 2-inch diameter slotted PVC well screen was laid horizontally directly beneath the floors in both rooms. The horizontal pipe was elbowed vertically and terminated just above the finished floor grade. The horizontal pipe can be used for future passive or active sub slab vapor venting.

EQUIPMENT ROOM BACKFILLED, NOTE VERTICAL PIPE

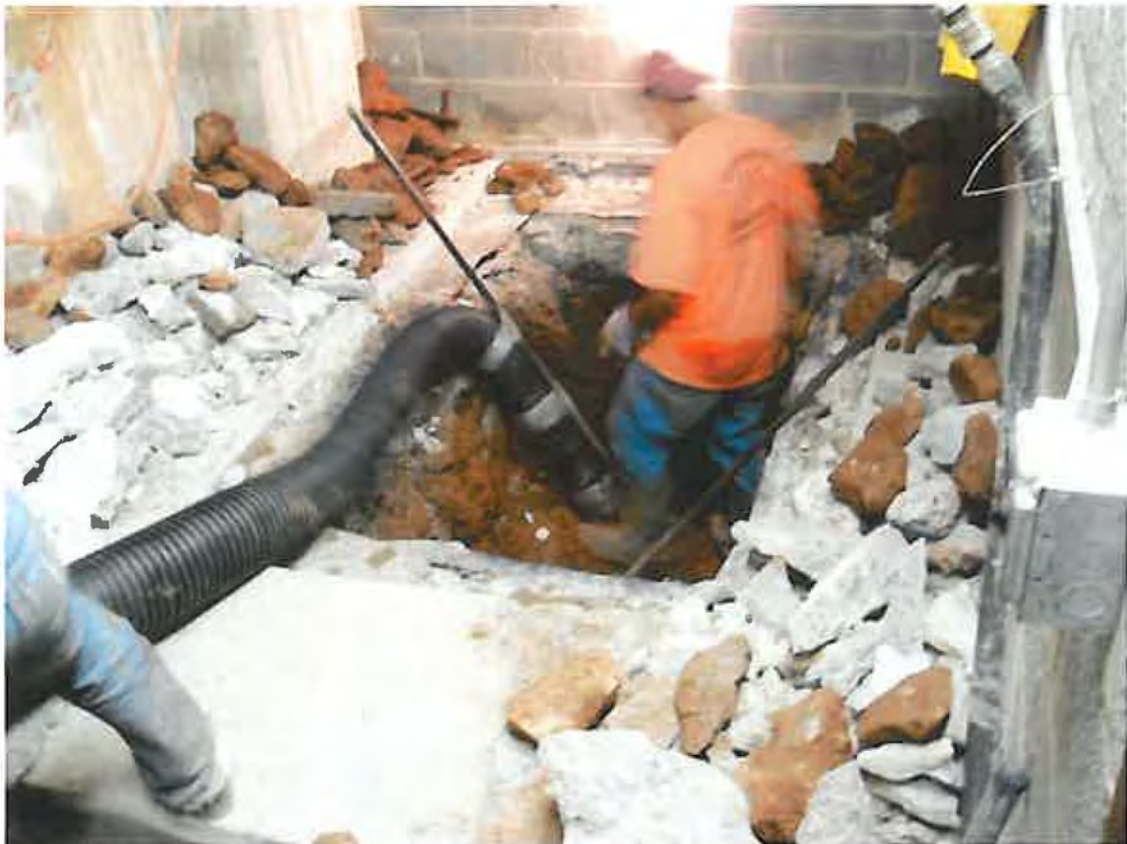
EXCAVATING WEST ROOM

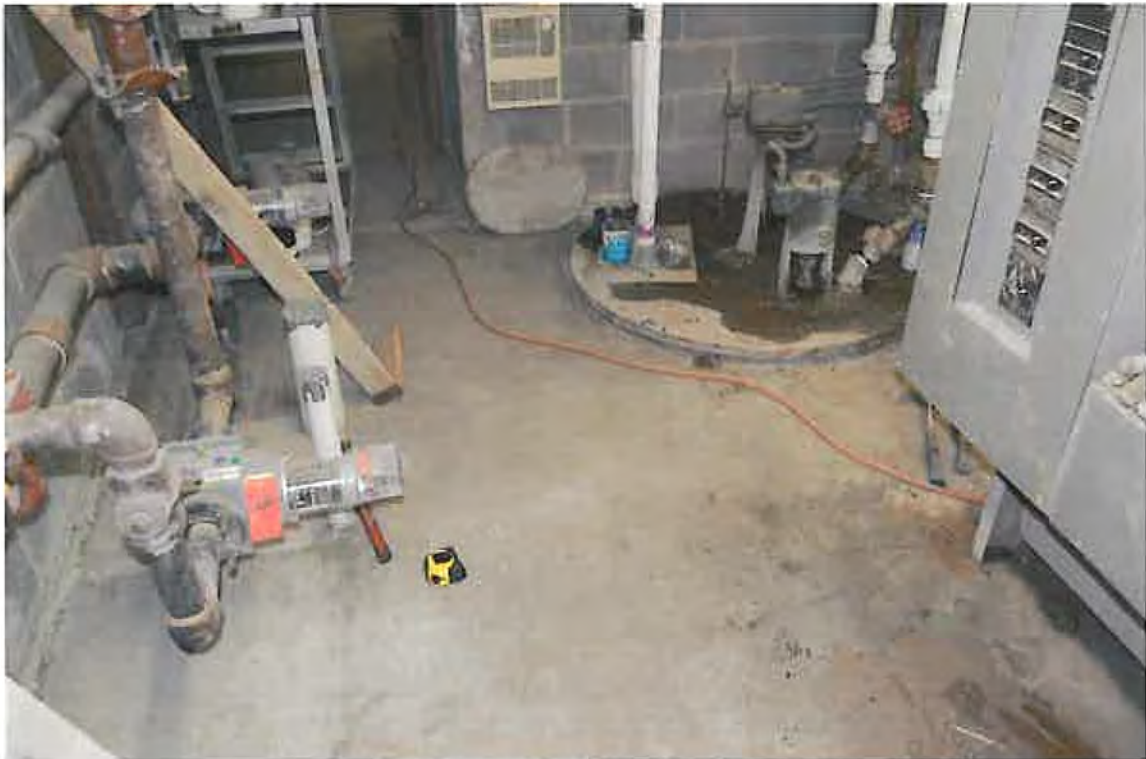
EQUIPMENT ROOM RESTORED

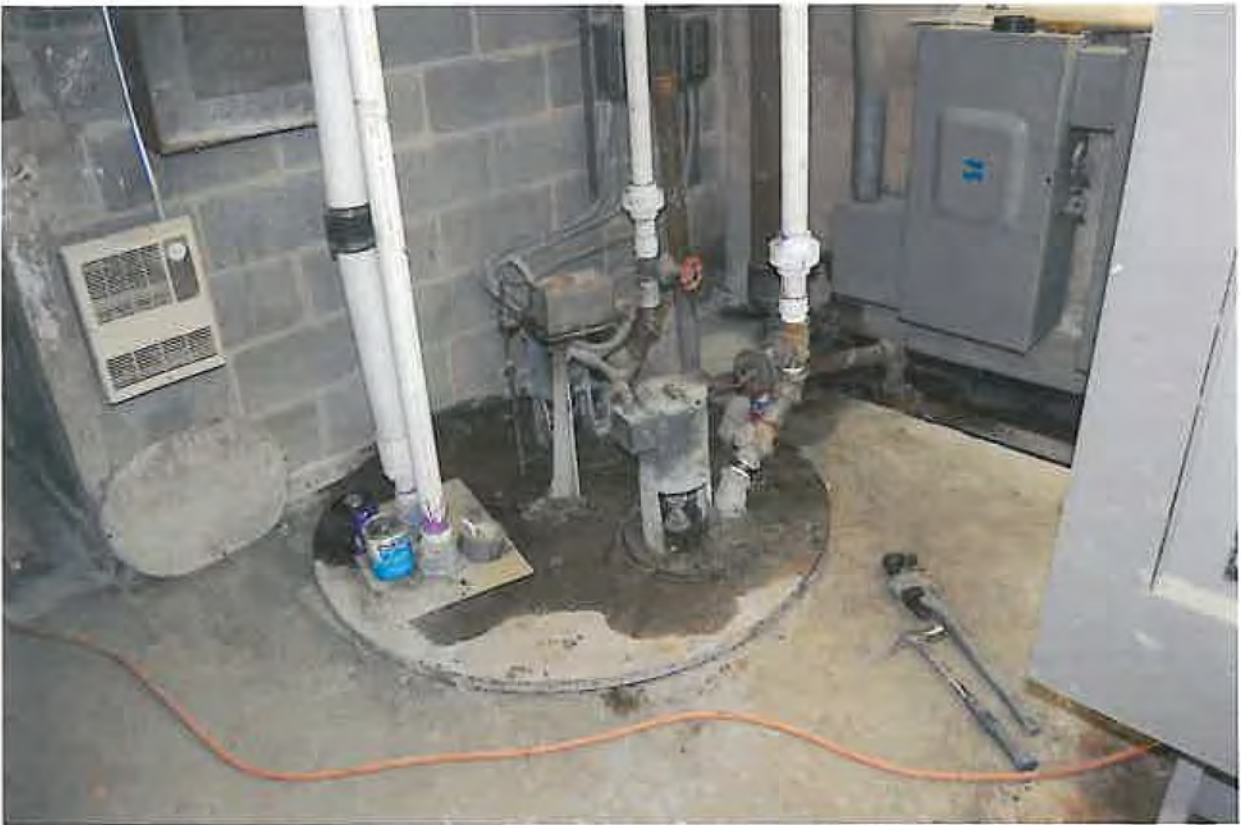
LARGE SUMP PIT WITH NEW PLUMBING

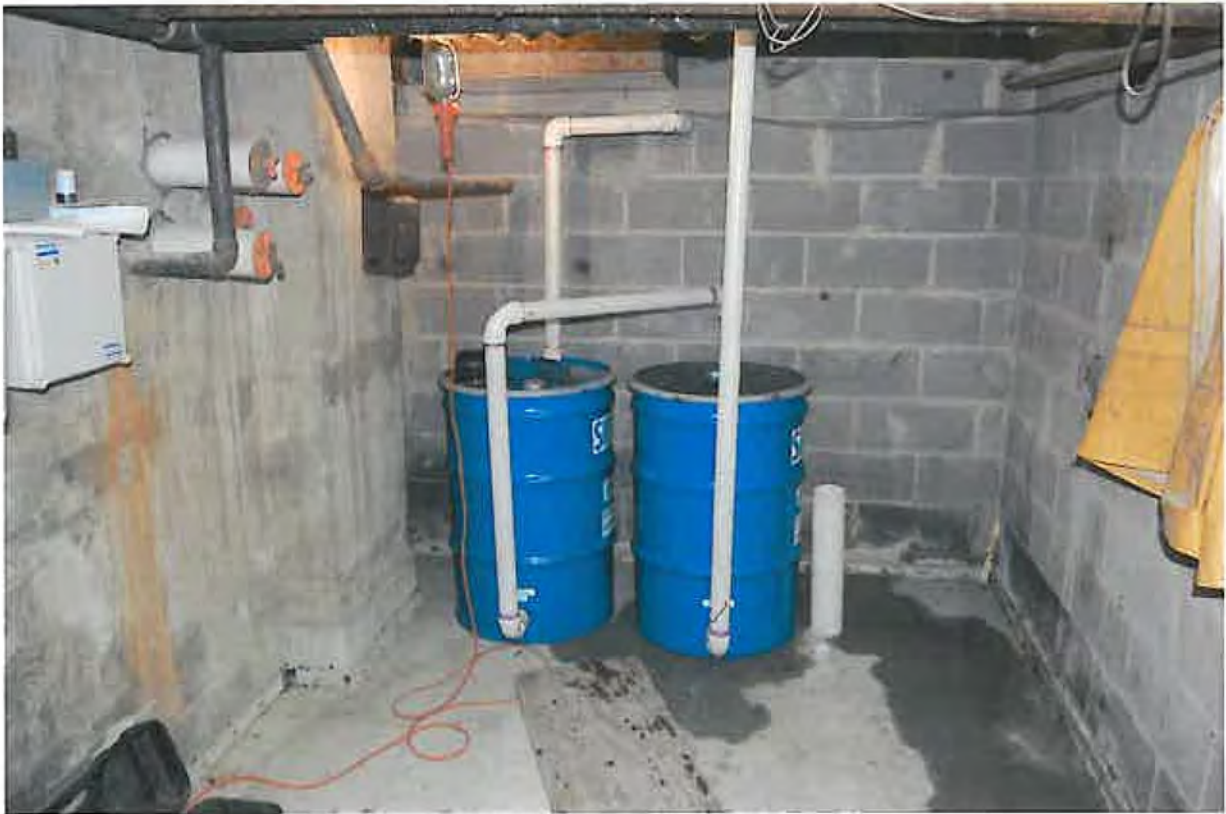
TWO LIQUID-PHASE CARBON FILTERS IN SERIES

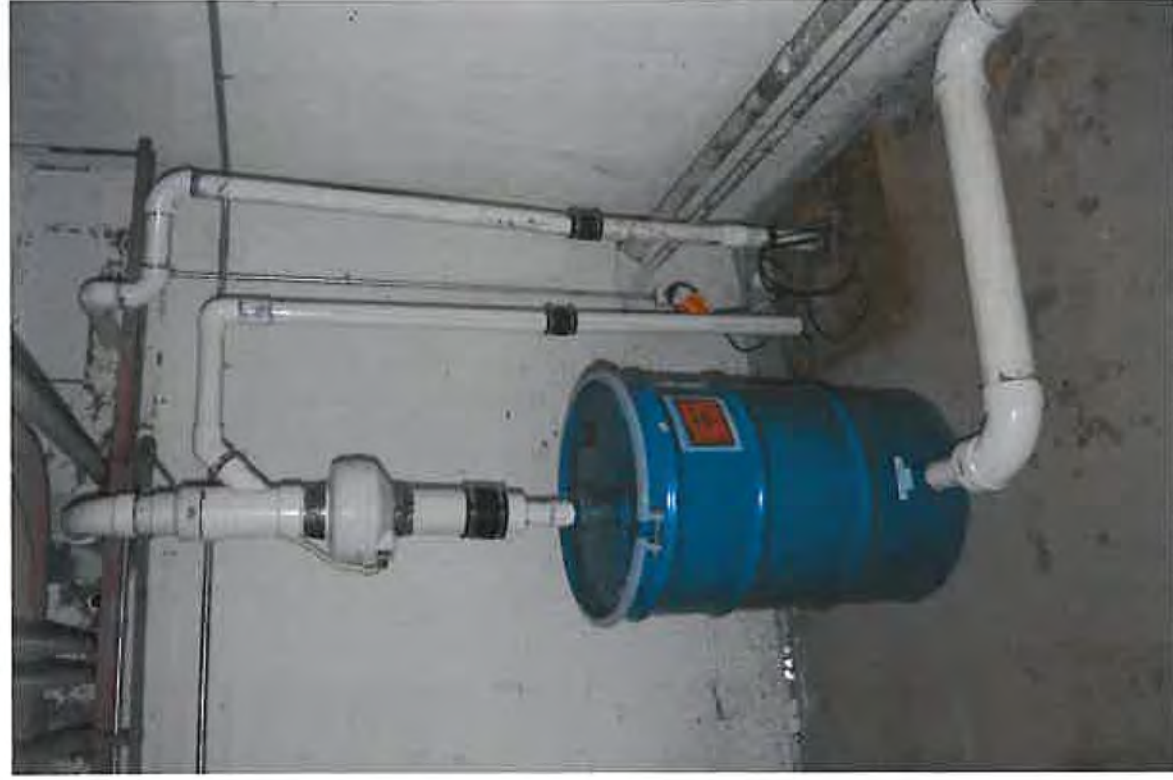
In order to prevent vapor infiltration from the sumps into the basement air, a ventilation system was added to both the large sump in the equipment room and a smaller sump in the northeast corner of the main basement (figure 6). Three-inch diameter PVC pipe was attached to the lids of both sumps and routed to an inline vent fan and vapor-phase activated carbon filter in the main basement. The treated air is ducted through 4-inch PVC pipe out the east basement wall and up to the roof of the Michaels building where it exhausts to the atmosphere (see photographs in the Appendix).

**DUCT FAN, VAPOR PHASE CARBON
FILTER, SMALL NORTH SUMP PIT**

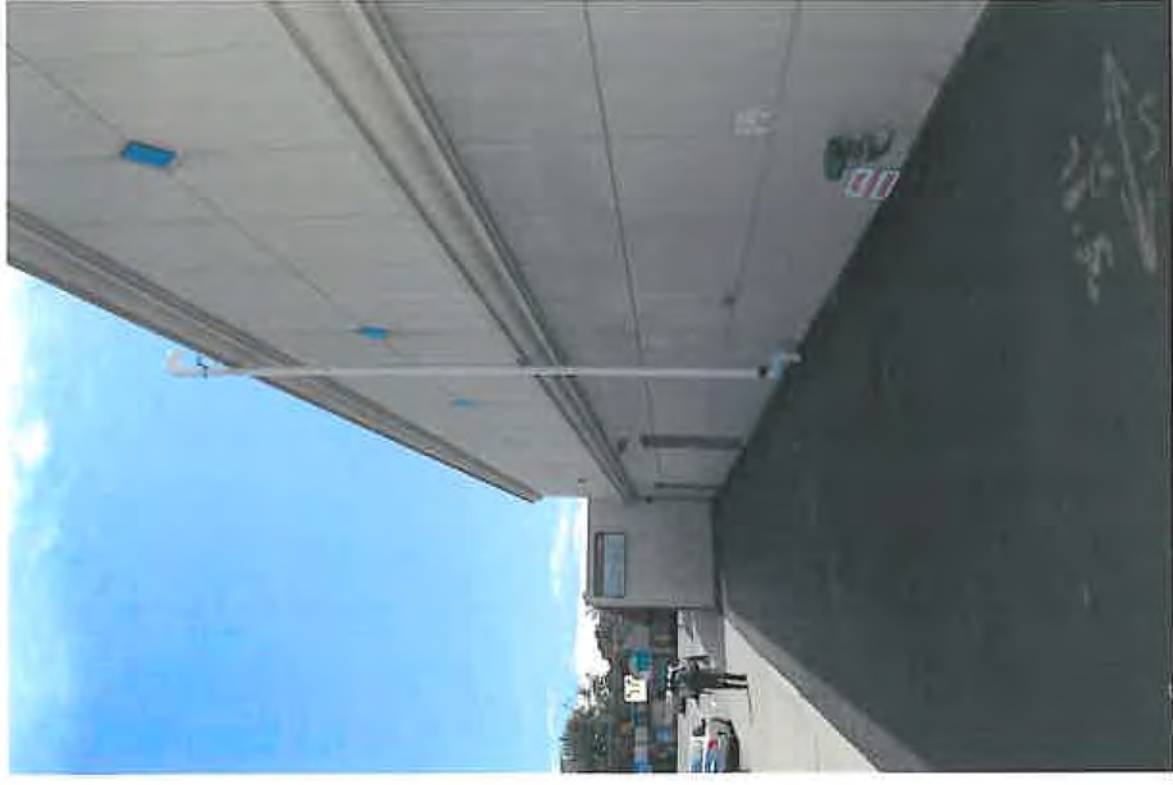
EXHAUST PIPING FROM CARBON FILTER

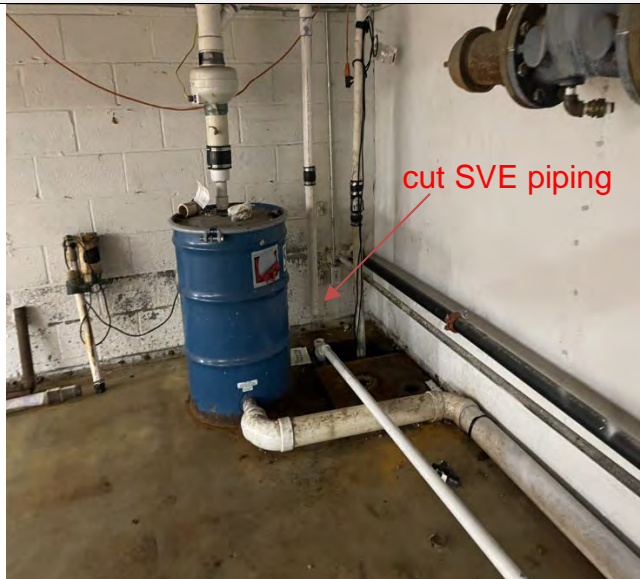
Photo 1 - Second north sump pit in basement: VPGAC vessel next to the cut SVE piping that is now no longer pulling air directly from the sump.

- Repair and cut the vapor piping at the second northern sump in the Main Basement area. All piping will be inspected in the system to determine if any sections or elbows need to be replaced.

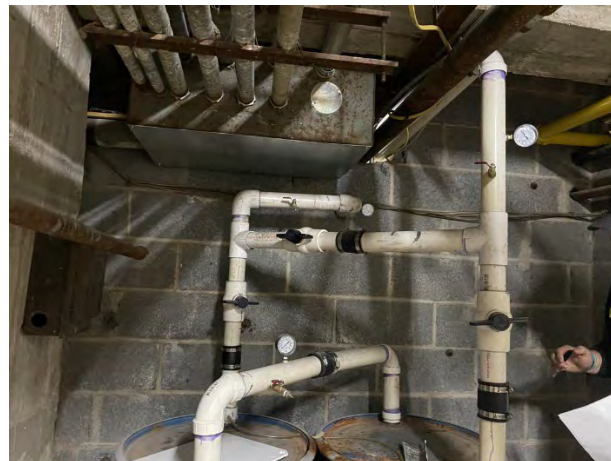
Photo 2: West Room: Piping from the large north sump into the LPGAC vessels have been valved closed. Therefore, water extracted from the sump bypasses the LPGAC and flows untreated into the sewer system

- Replace the GAC and LPGAC drums. The spent drums will be disposed of properly at an off-site approved licensed facility. Confirmation that both the extracted vapor and extracted groundwater are being treated through the GAC drum prior to the discharge to the air and sewer, respectively, will be documented.

- Inspection of piping network for the water treatment system for corrosion and build up. Determine if piping can be reused or if replacement is necessary.

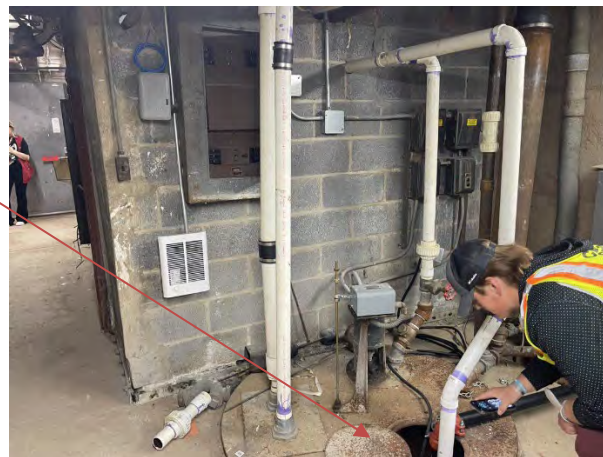
Photo 4: Large north sump pit in Equipment Room: Cover is off of the main GW extraction point in the sump, so the sump is not sealed.

- The sump lids will be replaced and sealed to prevent vapor from entering the basement.
- A negative pressure test will be conducted to confirm the effectiveness of the vapor extraction system.

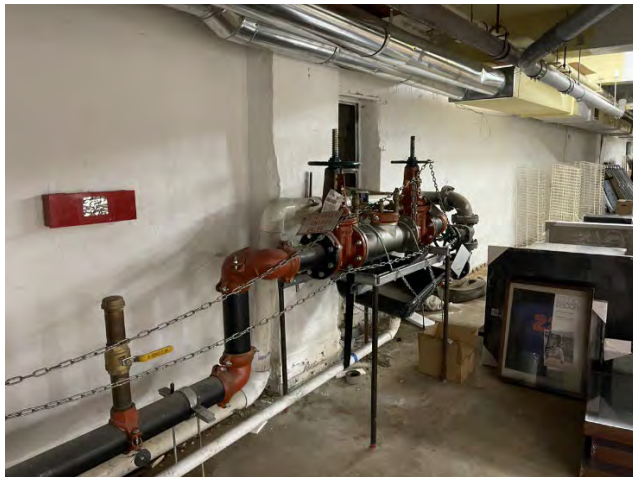
- A drainage system for a leak in the sprinkler system was installed by others and is draining into the second northern sump pit.

Photo 5: Temporary drain that was installed under the sprinkler system that drains into the second north sump pit

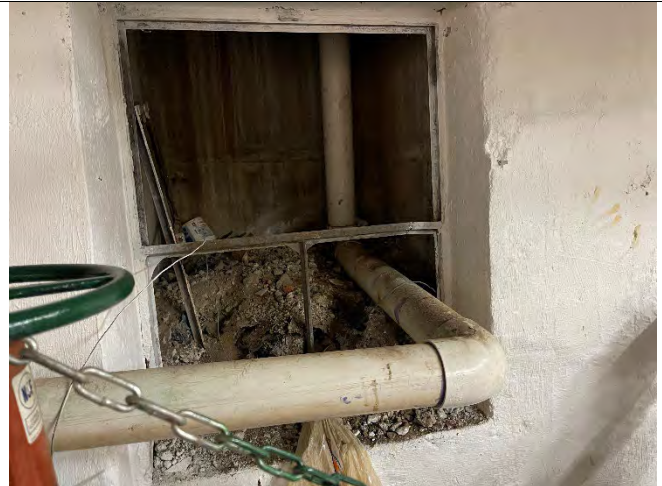
Photo 6: SVE exhaust piping to roof.

The SVE system is in operation and the piping out to the atmosphere looks to be in good condition. John did not know when the secondary sump pit's seal was taken off or when the air piping was cut.

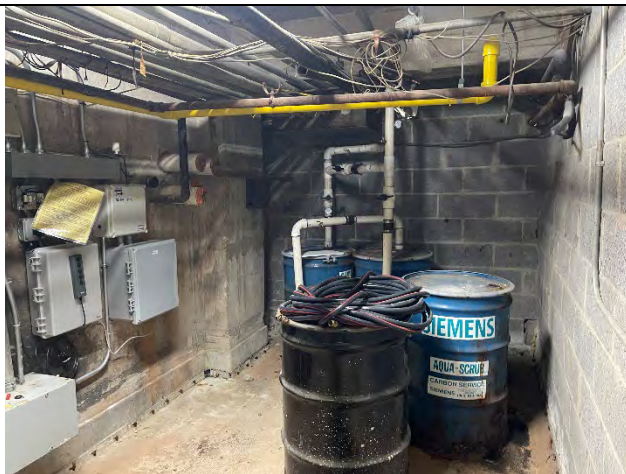
Photo 7: LPGAC vessels in the West Room
