REPORT OF FINDINGS
BUILDING 003 VOC SOURCE ASSESSMENT

*IBM Poughkeepsie Facility
Poughkeepsie, New York*

*Prepared for IBM Corporation
File No. 3463.00
May 2013*

Prepared by
Sanborn, Head Engineering, P.C.

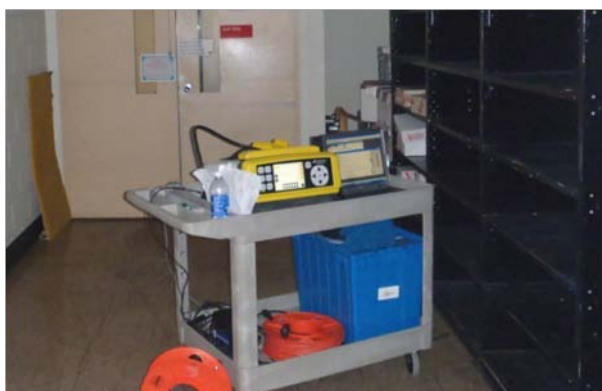
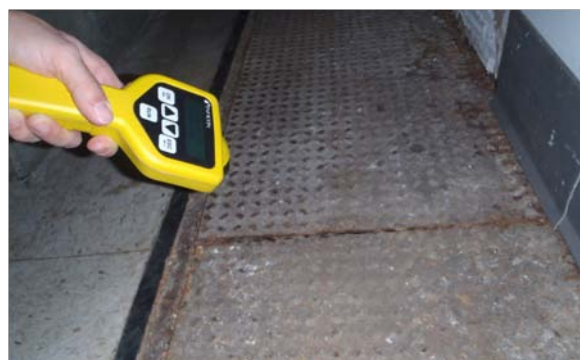
Exhibit 3.1 – Field screening with HAPSITE (portable GC/MS)

Exhibit 3.1 shows the HAPSITE in use for indoor air and targeted screening.

View of the HAPSITE during indoor air screening

Example of targeted air screening with the HAPSITE: trench in AHU room 3-1-5

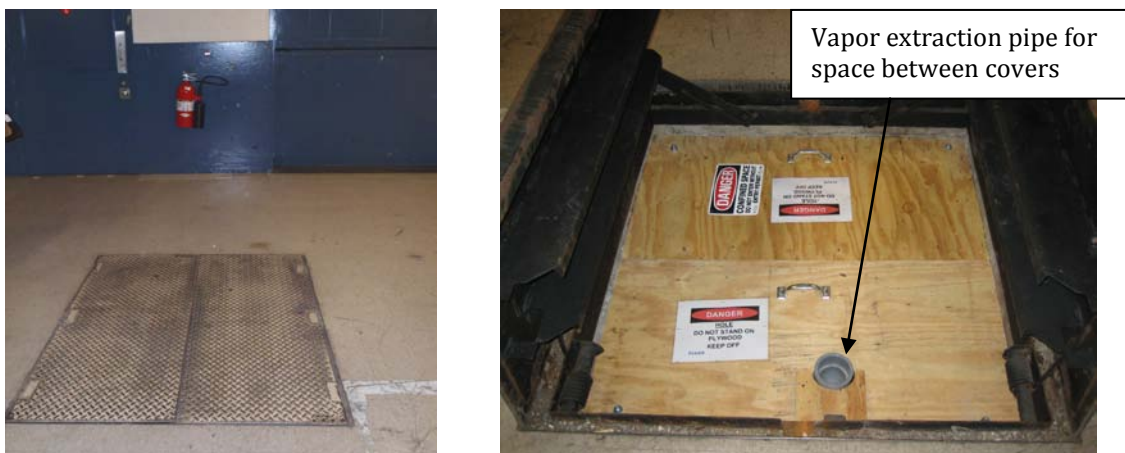
Exhibit 5.4 – Manhole No. 30. Double-door cover (left) and internal cover (right).

As previously described in Section 2, the foundation drain network was converted to a capture/collection system for VOC-containing groundwater. The foundation drain system includes 4 interior manholes in Building 003 that are a potential source for VOC vapors to enter the building. Vapor extraction testing was conducted at manhole No. 30 (MH-30), which is located in the north-central area of the building (see Figure 6 and Exhibit 5.4 below). The purpose of the testing was to evaluate the feasibility of reducing the air pressure below the manhole cover so that the indoor air pressure is higher than the pressure below the cover. To limit the extraction rate required to achieve the manhole air pressure reduction, MH-30 was equipped with an internal cover below the double-door surface hatch, and vapor extraction was conducted from the space between the internal cover and the surface hatch.

The testing showed that vapor extraction from the manhole can reduce the air pressure in the space between the internal and surface covers to less than the building air pressure. The vacuum measured below the surface cover was about 0.01 in. wc during vapor extraction from the manhole. Thus, the test results demonstrated that it would be feasible to modify the air pressure gradients at the manhole covers by vapor extraction and thereby prevent VOC vapors originating from the groundwater collection system from entering the building through the manhole covers.

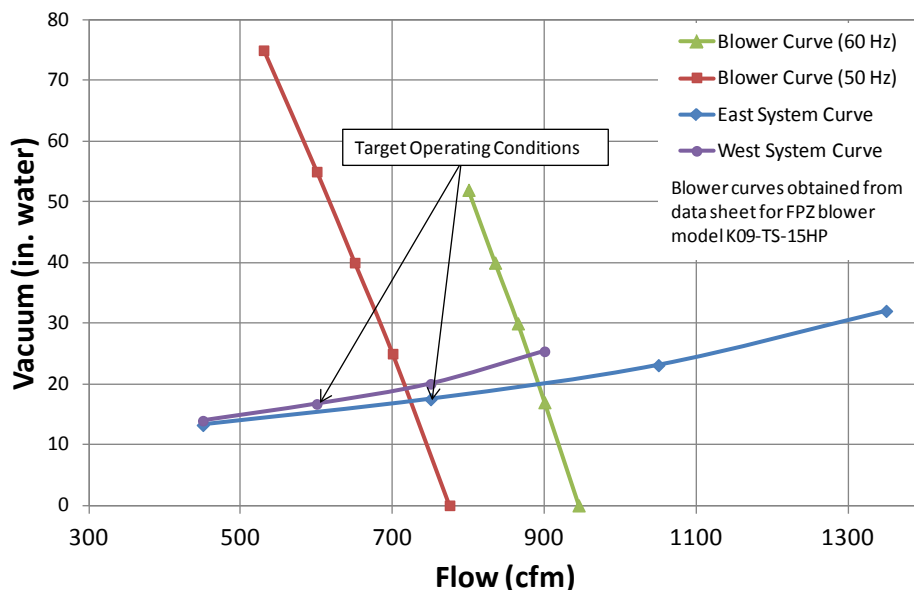
Exhibit 6.4 – Trench Blower Design Conditions

The blowers will be sized to achieve the design target vacuum at vapor extraction rates of 600 cfm (west side) and 750 cfm (east side). Exhibit 6.4 below shows the system curves and the blower performance curves for a FPZ Model K09-TS, 15 horsepower regenerative blower at operating frequencies of 50 and 60 Hz. The estimated design operating conditions for each system fall below the 60 Hz curve. Thus, this blower would meet the design target and have some additional capacity for future additional ports if appropriate.

To allow for flexibility and efficiency in blower operation, the motors will be equipped with VFDs. The VFDs will allow for lower power consumption when operating at conditions less than the capacity of the blower.

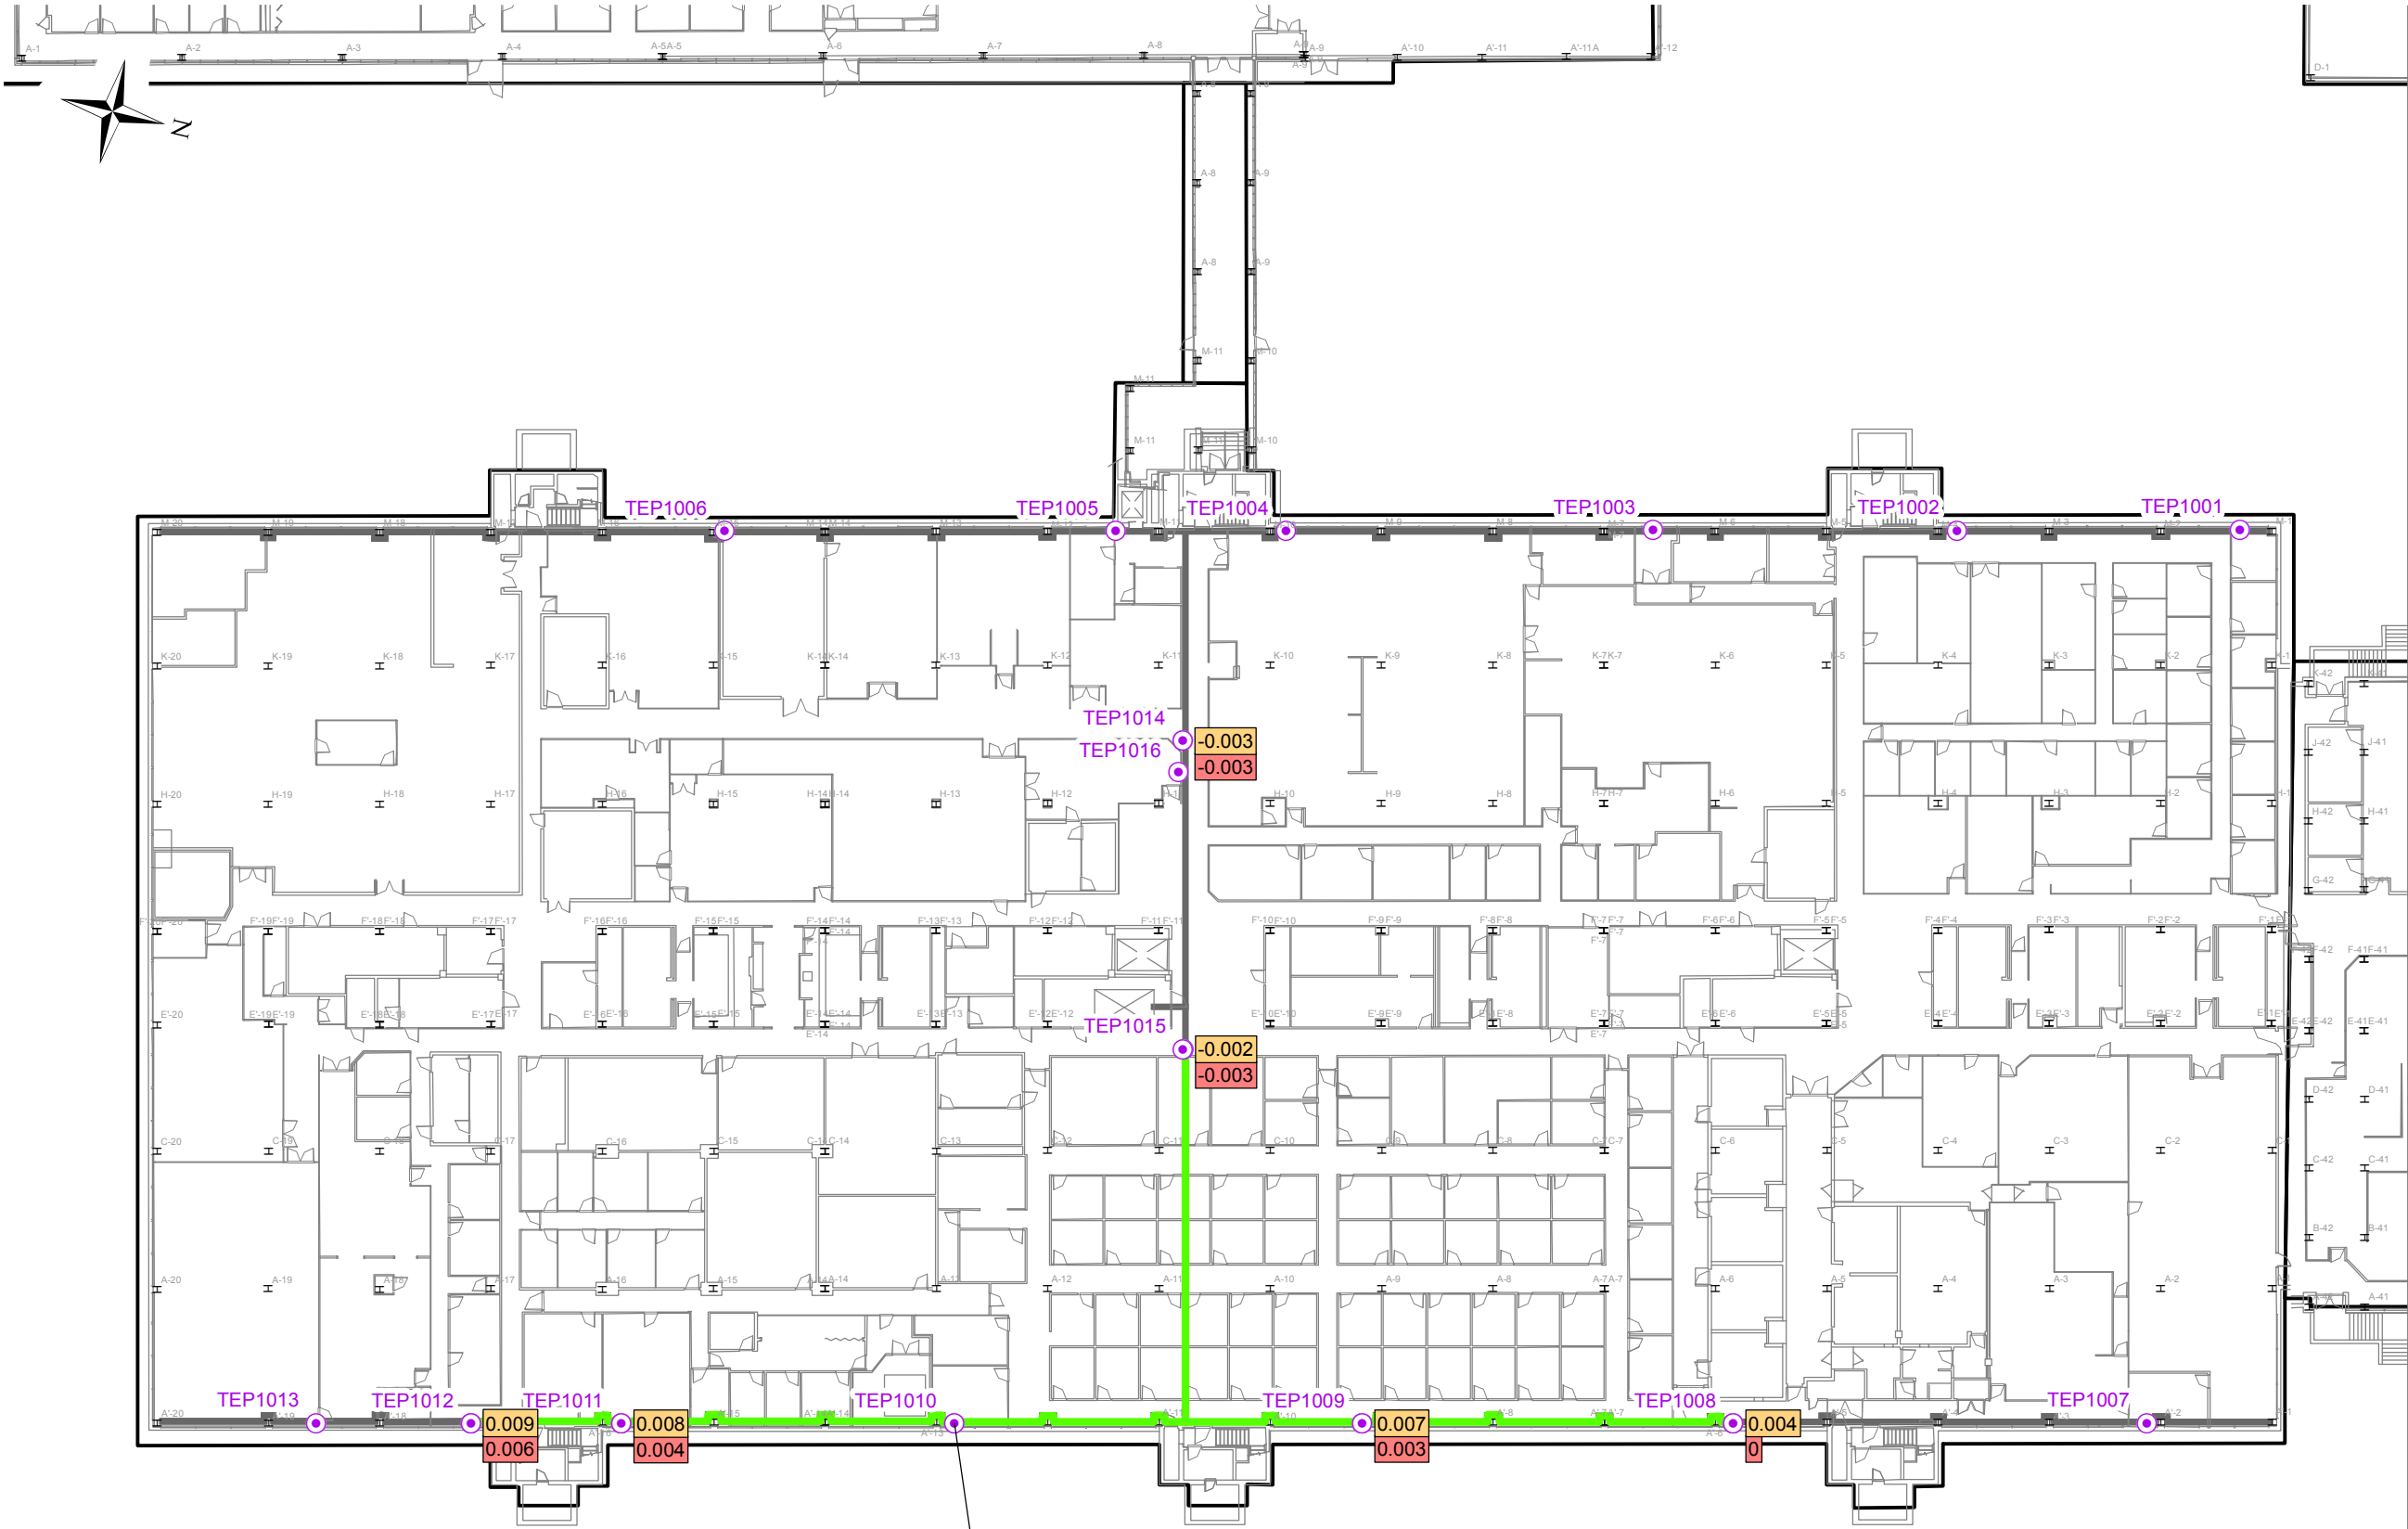
Figure Narrative
This figure shows the extraction test data and observed pressure response within the floor trench at the locations indicated. The pressure differential between the trench and indoor air was monitored using a digital manometer referenced to the indoor pressure. Negative values indicate pressure within the trench less than room air pressure. Positive values indicate pressure within the trench greater than room air pressure.

0.003 Observed baseline equilibrium pressure differential (in. water) between the trench and room prior to vapor extraction from trench

-0.005 Observed equilibrium pressure differential (in. water) between the trench and room during vapor extraction from trench.

Figure C-36
**Pressure Response from
Floor Trench Vapor
Extraction TEP1010**
