**ENGINEERING INVESTIGATIONS
AT INACTIVE HAZARDOUS
WASTE SITES**

PHASE 1 INVESTIGATION

**Pawling Rubber Company
Site No. 314002
Pawling, Dutchess County**

Final - June, 1988

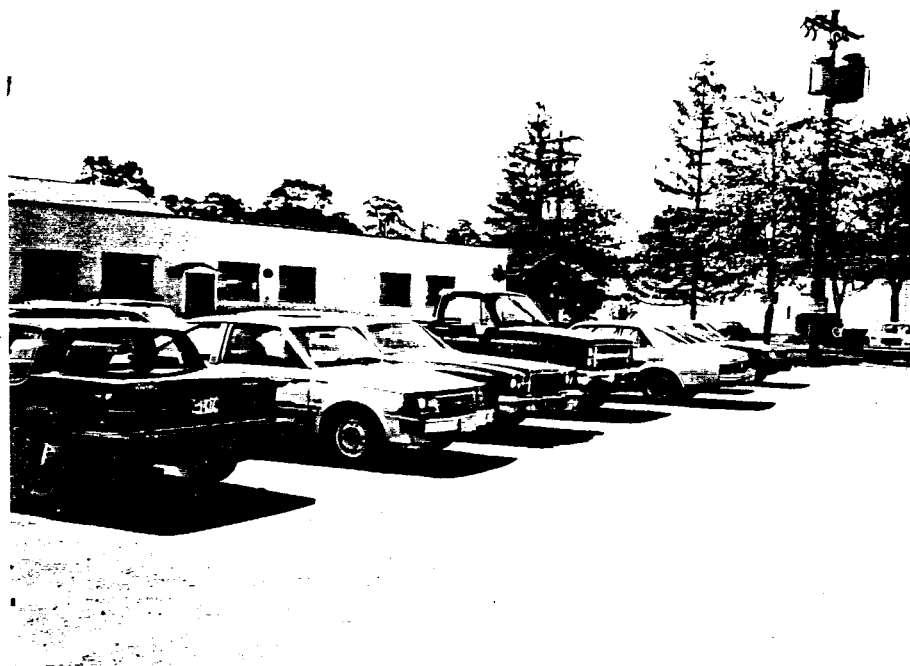
PHOTO # 1

The Pawling Rubber Company site (New York I.D. No. 314002, EPA I.D. NYD001354349) is located at 157 Charles Colman Boulevard (formerly Maple Boulevard), Pawling, Dutchess County, New York (Figure 1). The Pawling Corporation is made up of the Pawling Rubber Company and Preray, and has been at this location since 1946. The Pawling Rubber Company is an extruded and molded rubber manufacturing plant. On the property is an inactive landfill which is covered by a parking lot [A-1, Photo #1]. The property is in a wetlands area [A-1, Photo #2&3].
