CLOSURE REPORT

PHASE II RCRA FACILITY ASSESSMENT – SAMPLING VISIT INTERIM CORRECTIVE MEASURE: INACTIVE LINE ABANDONMENT Former Texaco Research Center Beacon, New York

SITE ID# 314004

October 2006

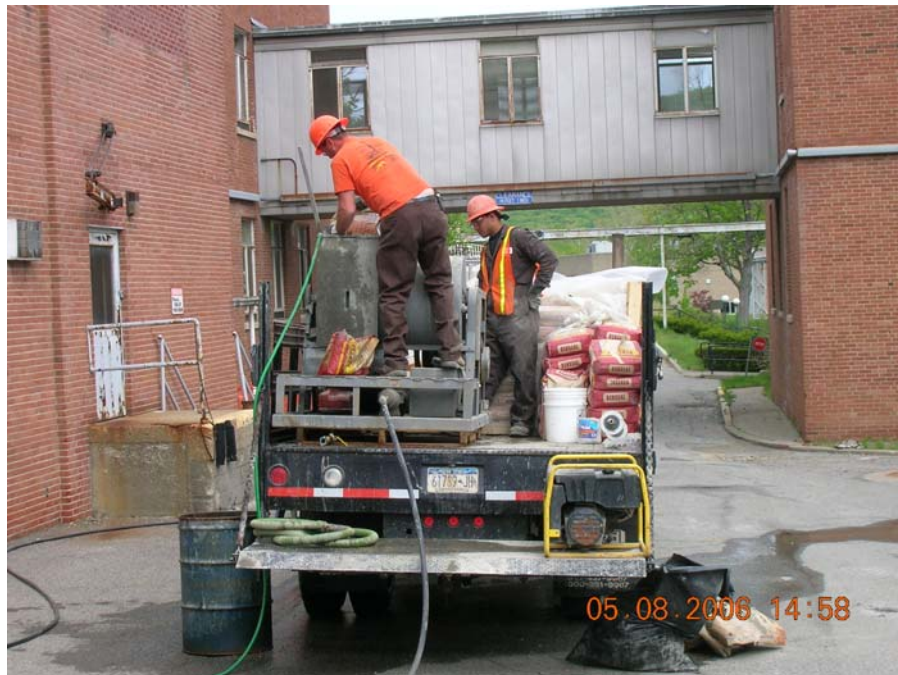
DSCN0310: Mixing Grout.

During excavations to access the piping for video inspection, it was determined that the presence of other utilities would make excavation of the ISS piping difficult. A series of construction progress photographs documenting the original site construction was found and showed the location of utilities such as product lines, gas lines, water, sewer, and communication lines. In many cases the ISS piping was installed first with the other utility lines installed over the top of, or parallel to, the ISS pipe sections. Based on this information, the decision was made to close all of the ISS lines in place by completely grouting the lines with a cement/bentonite grout.

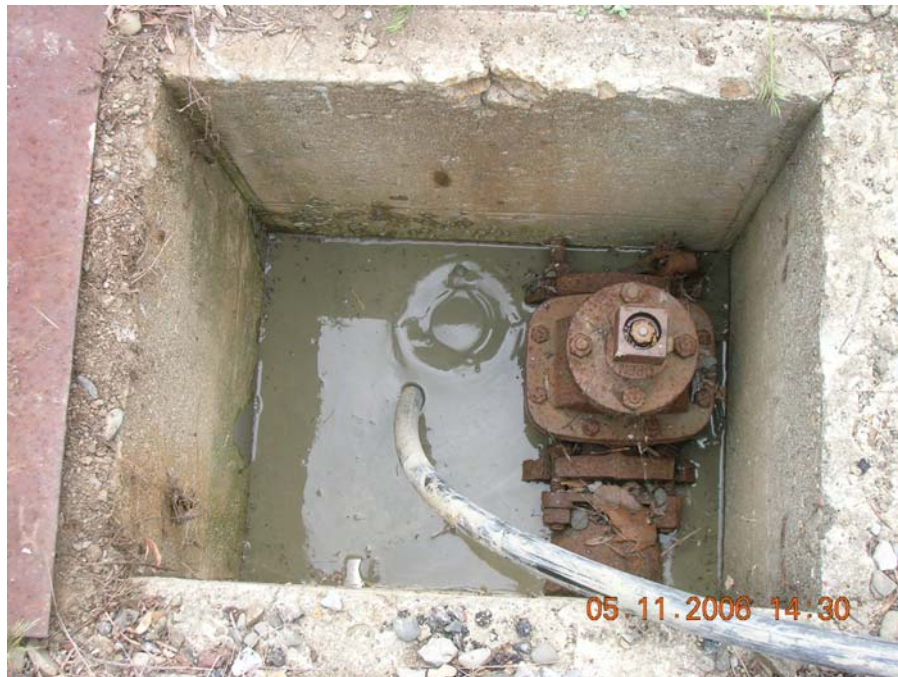
DSCN0370: Grouting valve pit from ASTs to ISS-3.

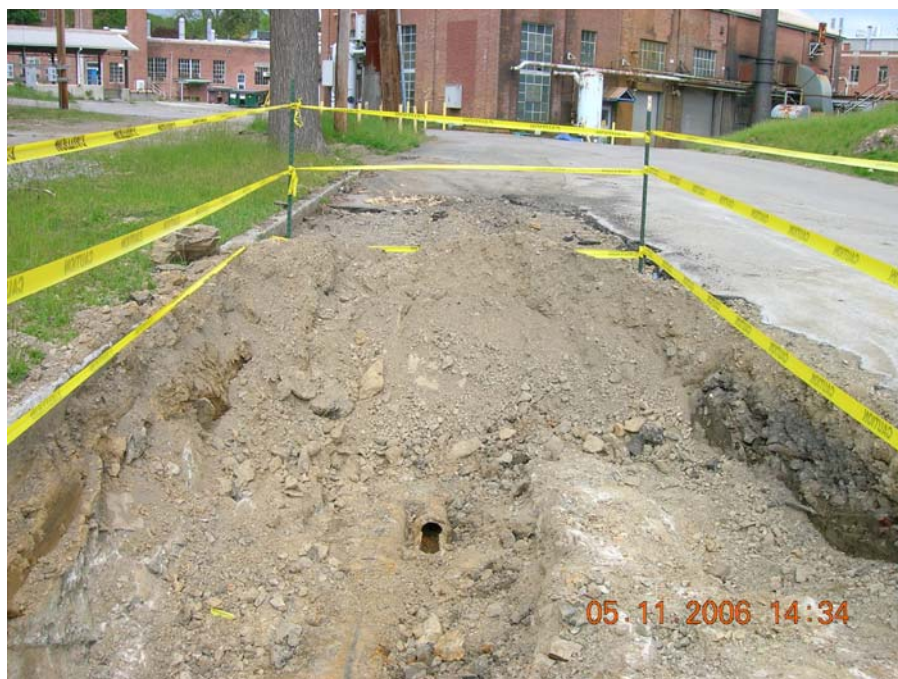
DSCN0371: ISS-5 attempted soil excavation.

Based on the results of the soil samples an attempt was made to excavate soils in the vicinity of SS-020 and SS-021. The former ISS-5 line was exposed and was found to have been installed within a trench cut into the shallow bedrock at a depth of approximately 2.5 feet. Also within the trench was an 8-inch diameter freshwater fire line. The size of the trench and the need to keep the fire line intact prevented the excavation of any additional material in this area.

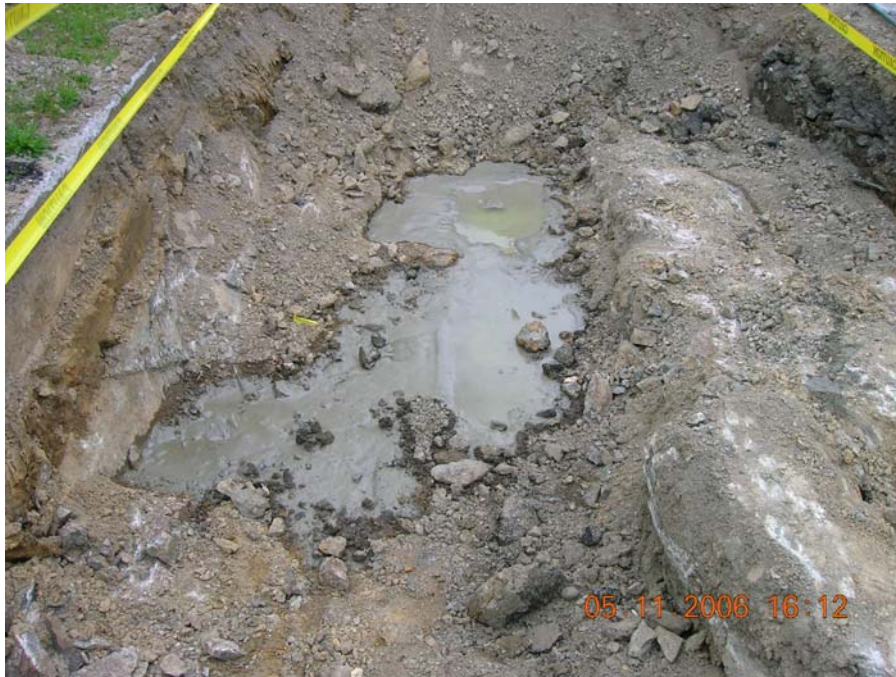
DSCN0378: ISS-5 excavation grouted.

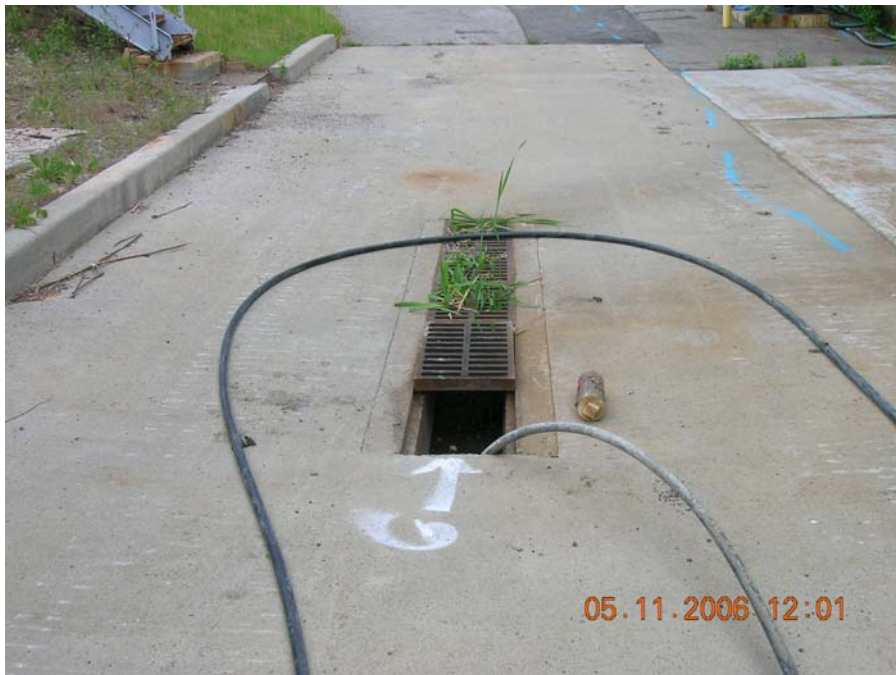
DSCN0366: Grouting spill containment basin for boiler house ASTs. (ISS-5)

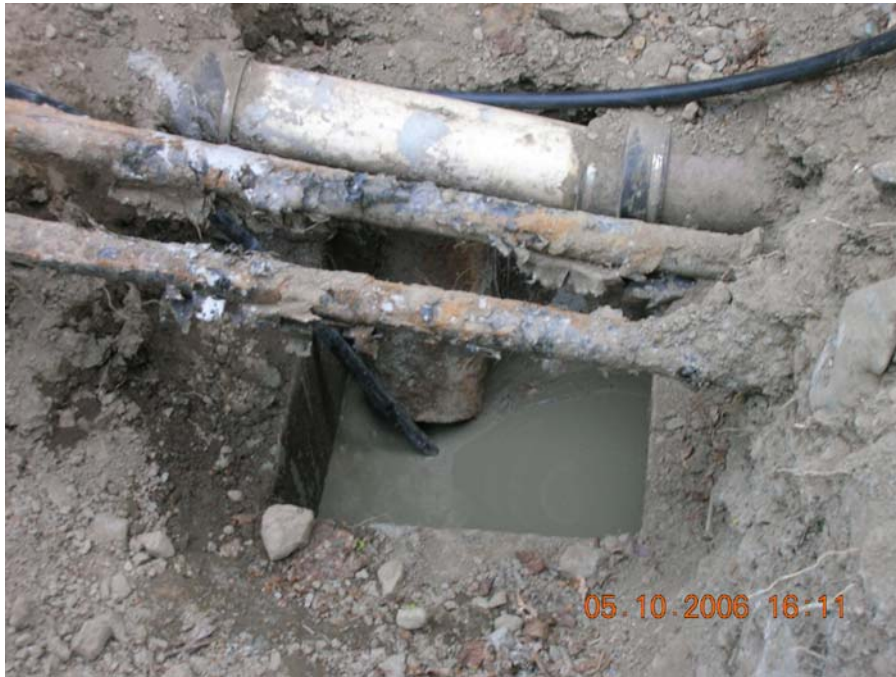
DSNC353: Grouting the 3x3 vault south of Building 55. (ISS-5, B-line)

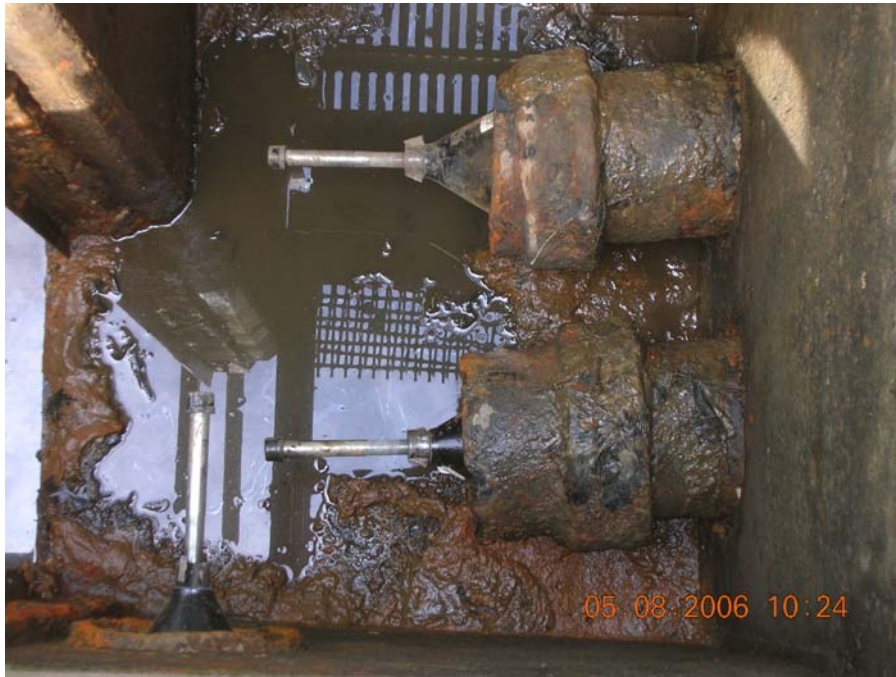
DSCN0303: Plugged outlets to the grit chamber. ISS-5, ISS-6, ISS-8.

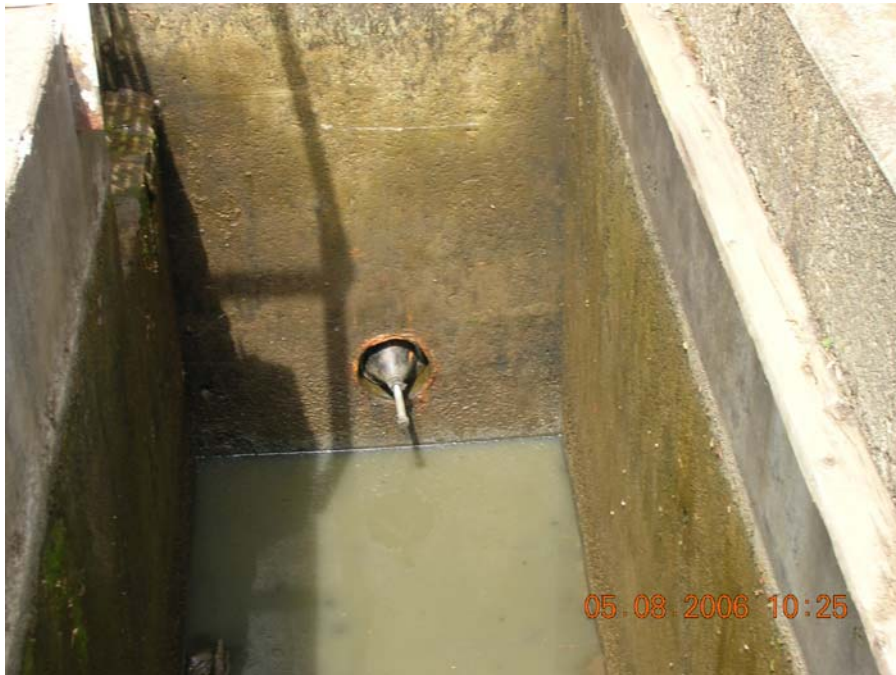
DSCN0304: Plugged outlet to the grit chamber. A-line.

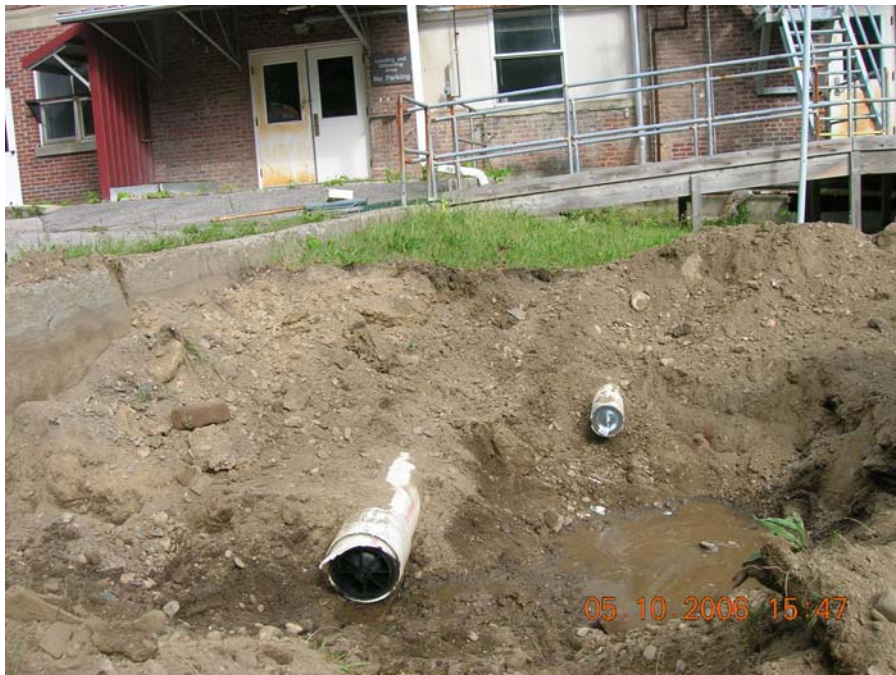
DSCN0349: Plugged PVC lines from ISS-7.

ISS-7 was replaced in 1997 and consists of one 6-inch PVC line and one 4-inch PVC line running together from Building 3 to Building 45 (grit chamber). During excavation of impacted soils to the northeast of Building 45, the two PVC pipes were exposed.

During the removal of soils from the northeast corner of Building 45 as a result of elevated SVOCs in SS-042 (3-7'), the two pipes from ISS-7 were uncovered. These pipes were found to be overlying a concrete slab. Soil in the area was removed and disposed of in a secure landfill. Two soil samples (SS-B45slabNorth, SS-B45slabSouth) were collected from underneath the slab. The results from these samples show the presence of elevated PAH concentrations.

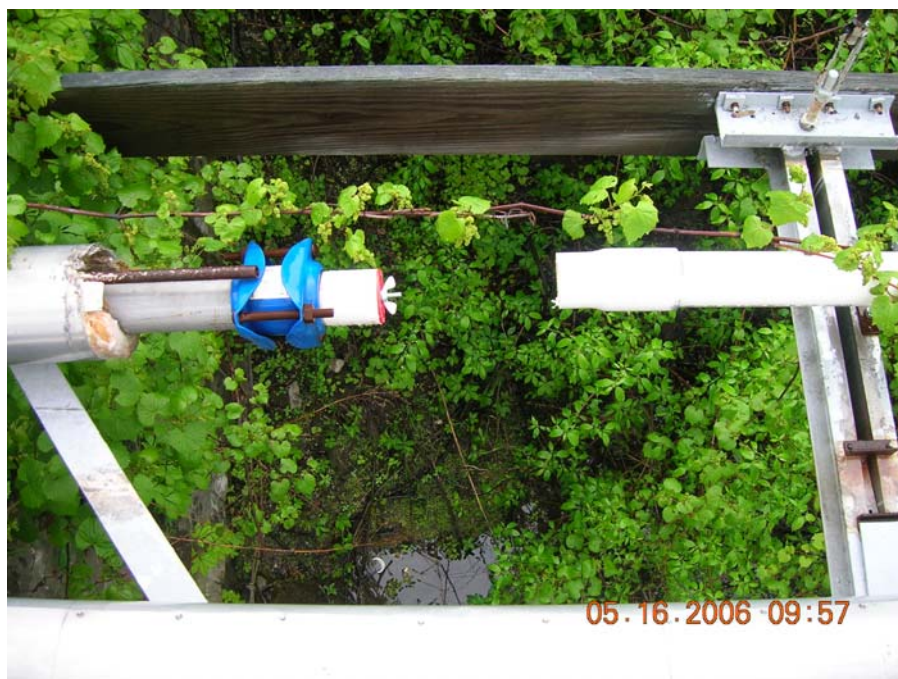
DSCN0386: Disconnected and plugged ISS-9 across the walk bridge.

The ISS-9 line was replaced in 1999 with a cast iron line. The section transiting Fishkill Creek was replaced with Sch. 40 PVC. In accordance with the approved Work Plan, no cleaning or performance sampling of the ISS-9 was completed during the Phase II work

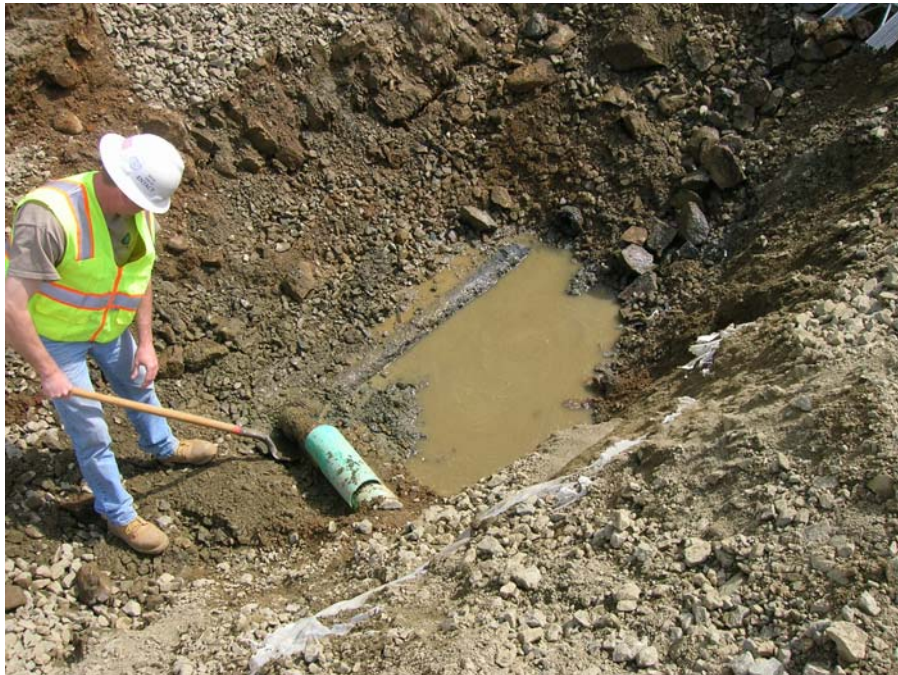
DSCN0281: Failed connection from Building 56 wash rack area.

Chlorobenzene was detected in samples that were collected in MH-B2 of water coming from the connection to the Building 29/56 floor drains (RW-005-BG). As a result of this flow, the sample from MH-B2 to the grit chamber also indicated detectable chlorobenzene concentrations. Following the collection of performance samples, it was noted that there was a continuous water flow entering MH-B2 from the former Building 30 service line. The source of this flow was identified as coming from a break in the connection coming from the Building 56 area.

The source of the water that was sampled from MH-B2 during the performance sampling was identified as coming from a failed piping connection in the ISS piping in the area of the clean-out in the Building 29/56 courtyard. Additional work in this area will be included in the Building 56 AOC work plan. There were no VOCs detected in the performance samples from other ISS-6 piping. In the soil samples, PAHs and mercury were detected at elevated concentrations.

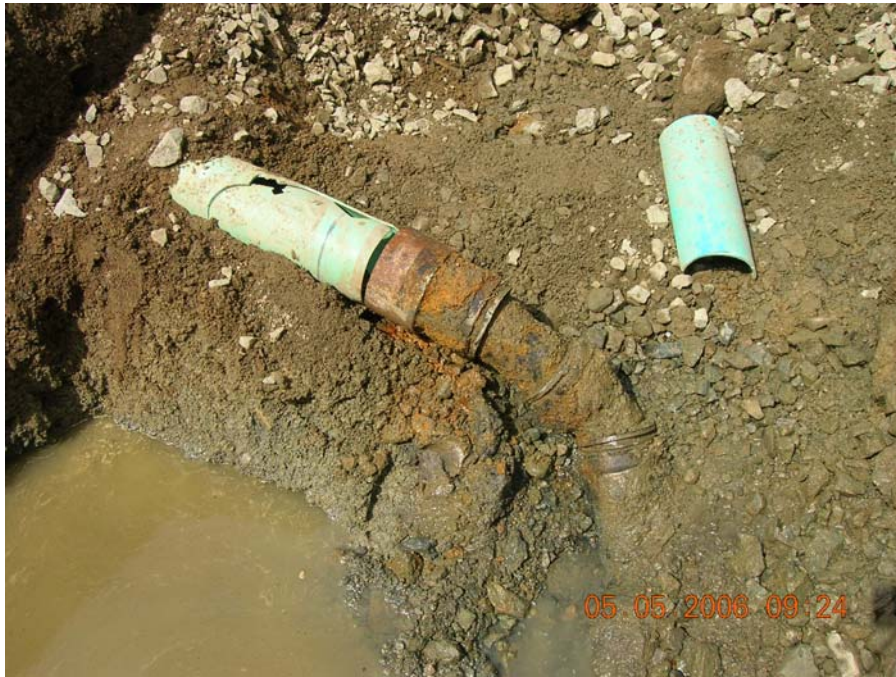
DSCN0293: Failed joint in ISS line from Building 56 area.

There were several observed deficiencies during the video camera inspection of the ISS-6 branch piping, as summarized in Section 2. In addition to the deficiencies noted in the video inspection, there was an observed breach in a rubber “Fernco” piping connection near the Building 56 wash rack area. This breach created a gap in the piping sections and, as a result, groundwater infiltration continuously entered the ISS piping at that location. The remaining segments of the ISS-6 Branch were observed to be in good condition with no apparent structural deficiencies or breaches.

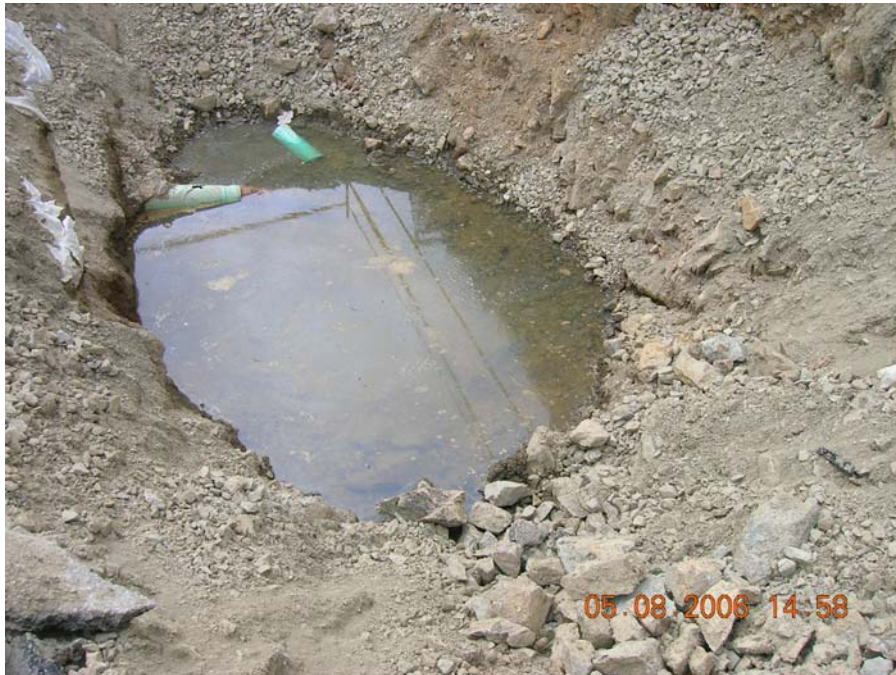
DSCN0309: Building 56 excavation with groundwater.

Benzene was detected in the RW-005-BG sample in exceedance of the Class GA guidance. This water was found to originate from the groundwater in the Building 56 AOC.

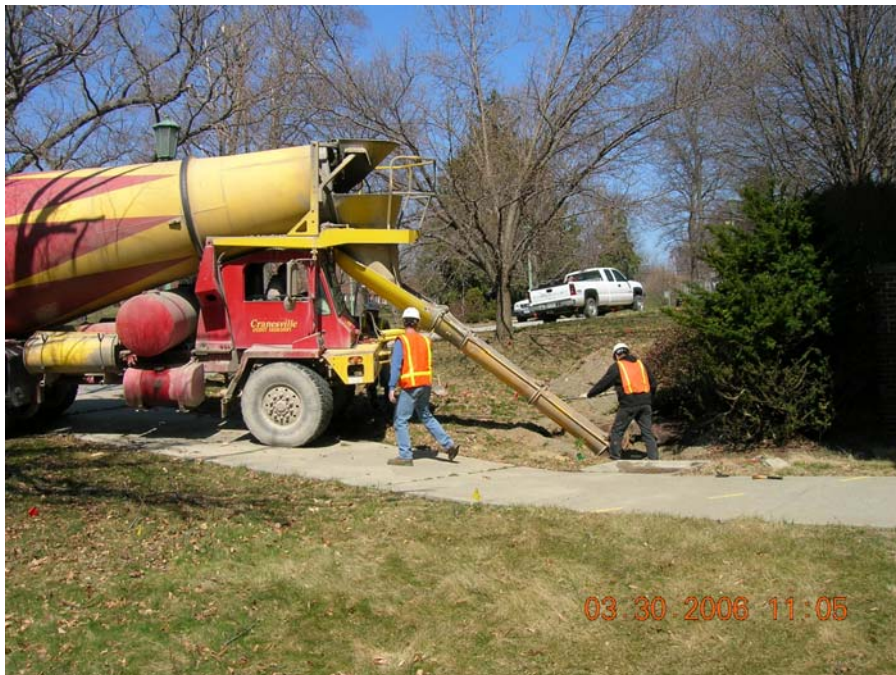
DSCN0218: Grouting manho-Line
