# REMEDIAL INVESTIGATION REPORT ADDENDUM 1

Former Texaco Research Center Beacon  
Glenham, New York

Site ID# 314004  
NYSDEC ID# 3-1330-48/16-0  
EPA ID# 091894899

November 2, 2020

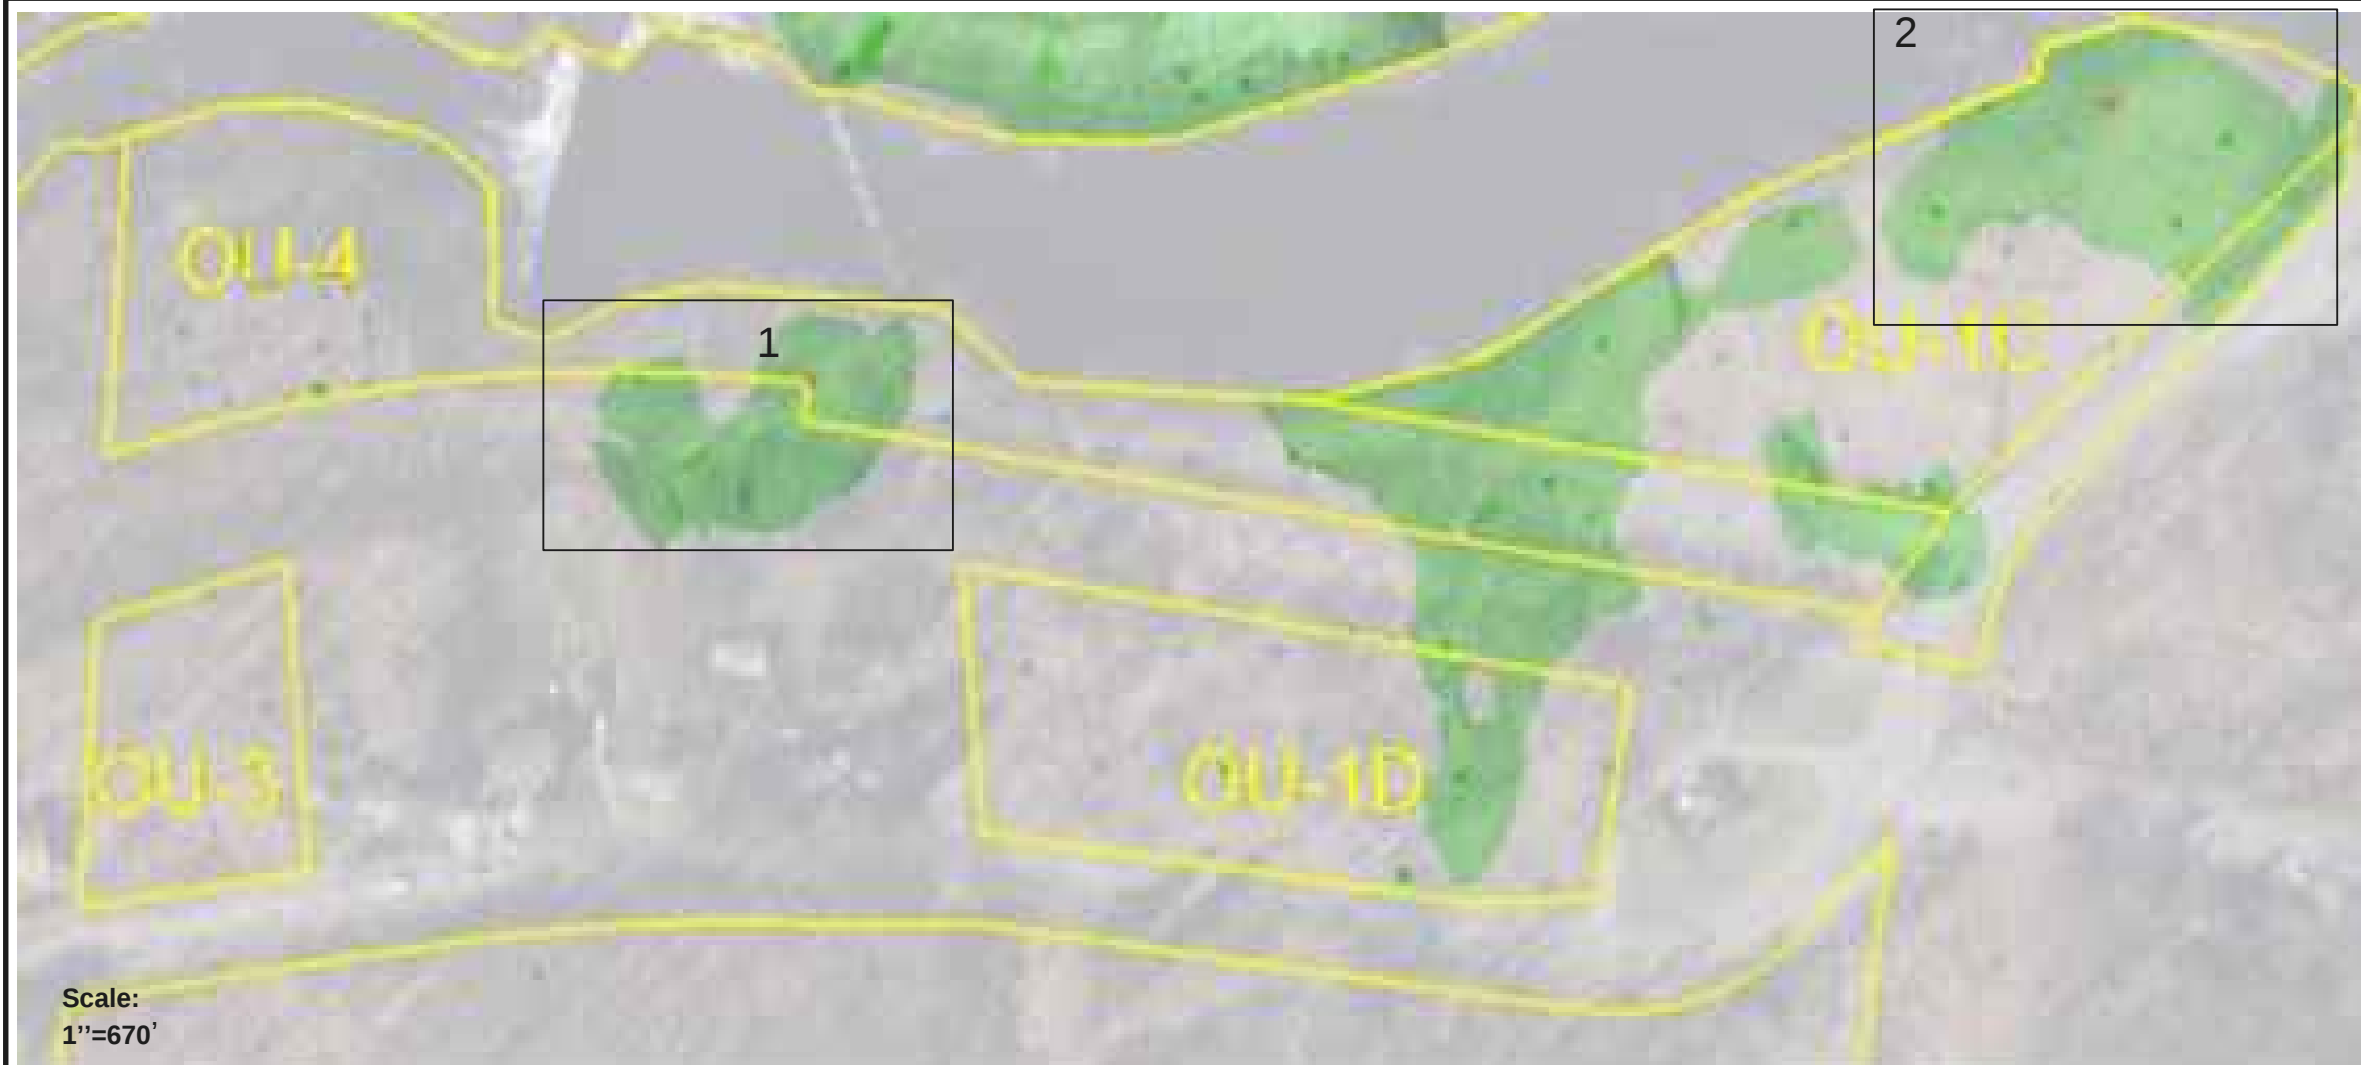
LEAD SOIL SCREENING LEVEL  
EXCEEDANCES

- Results colored by least restrictive screening level exceeded
- Scales are approximated.
  - Key Map: 1 inch = 670 feet
  - Focused areas: 1 inch = 100 feet
- Ground surface digital elevation model (DEM) from United States Geological Service (USGS) accessed from Global Mapper
- Aerial imagery from Environmental Systems Research Institute (ESRI) World Imagery (accessed April 2020)
- Non-detect samples colored at their reporting limit (RL) and modeled at 1/10 of their RL.
- mg/kg: milligram per kilogram
- OU: Operable Unit
- SL: Screening Level

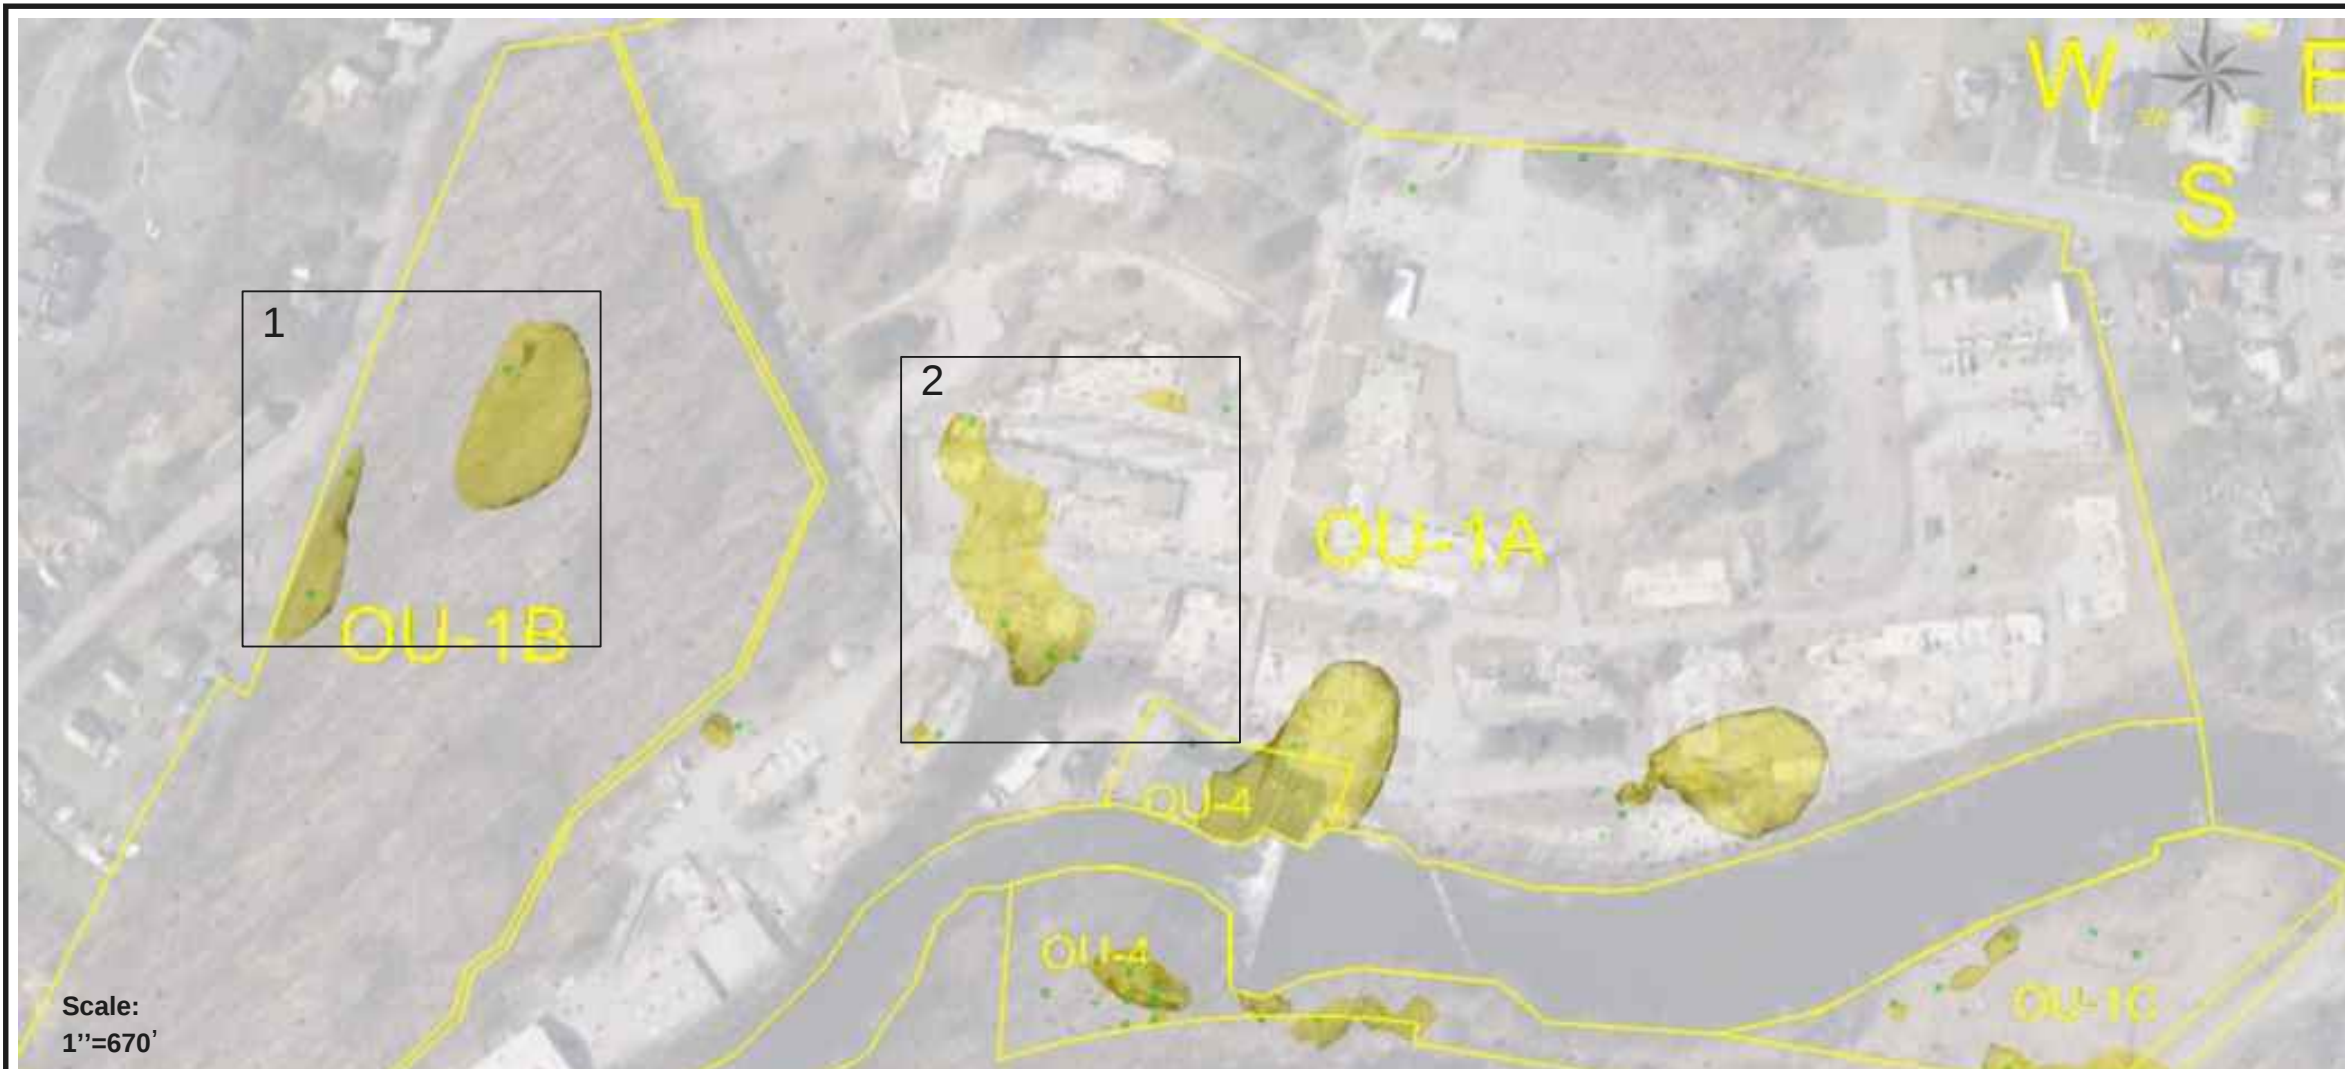
### NICKEL SOIL SCREENING LEVEL EXCEEDANCES

Figure 2-8ABCDEF. Nickel Soil Screening Level Exceedances

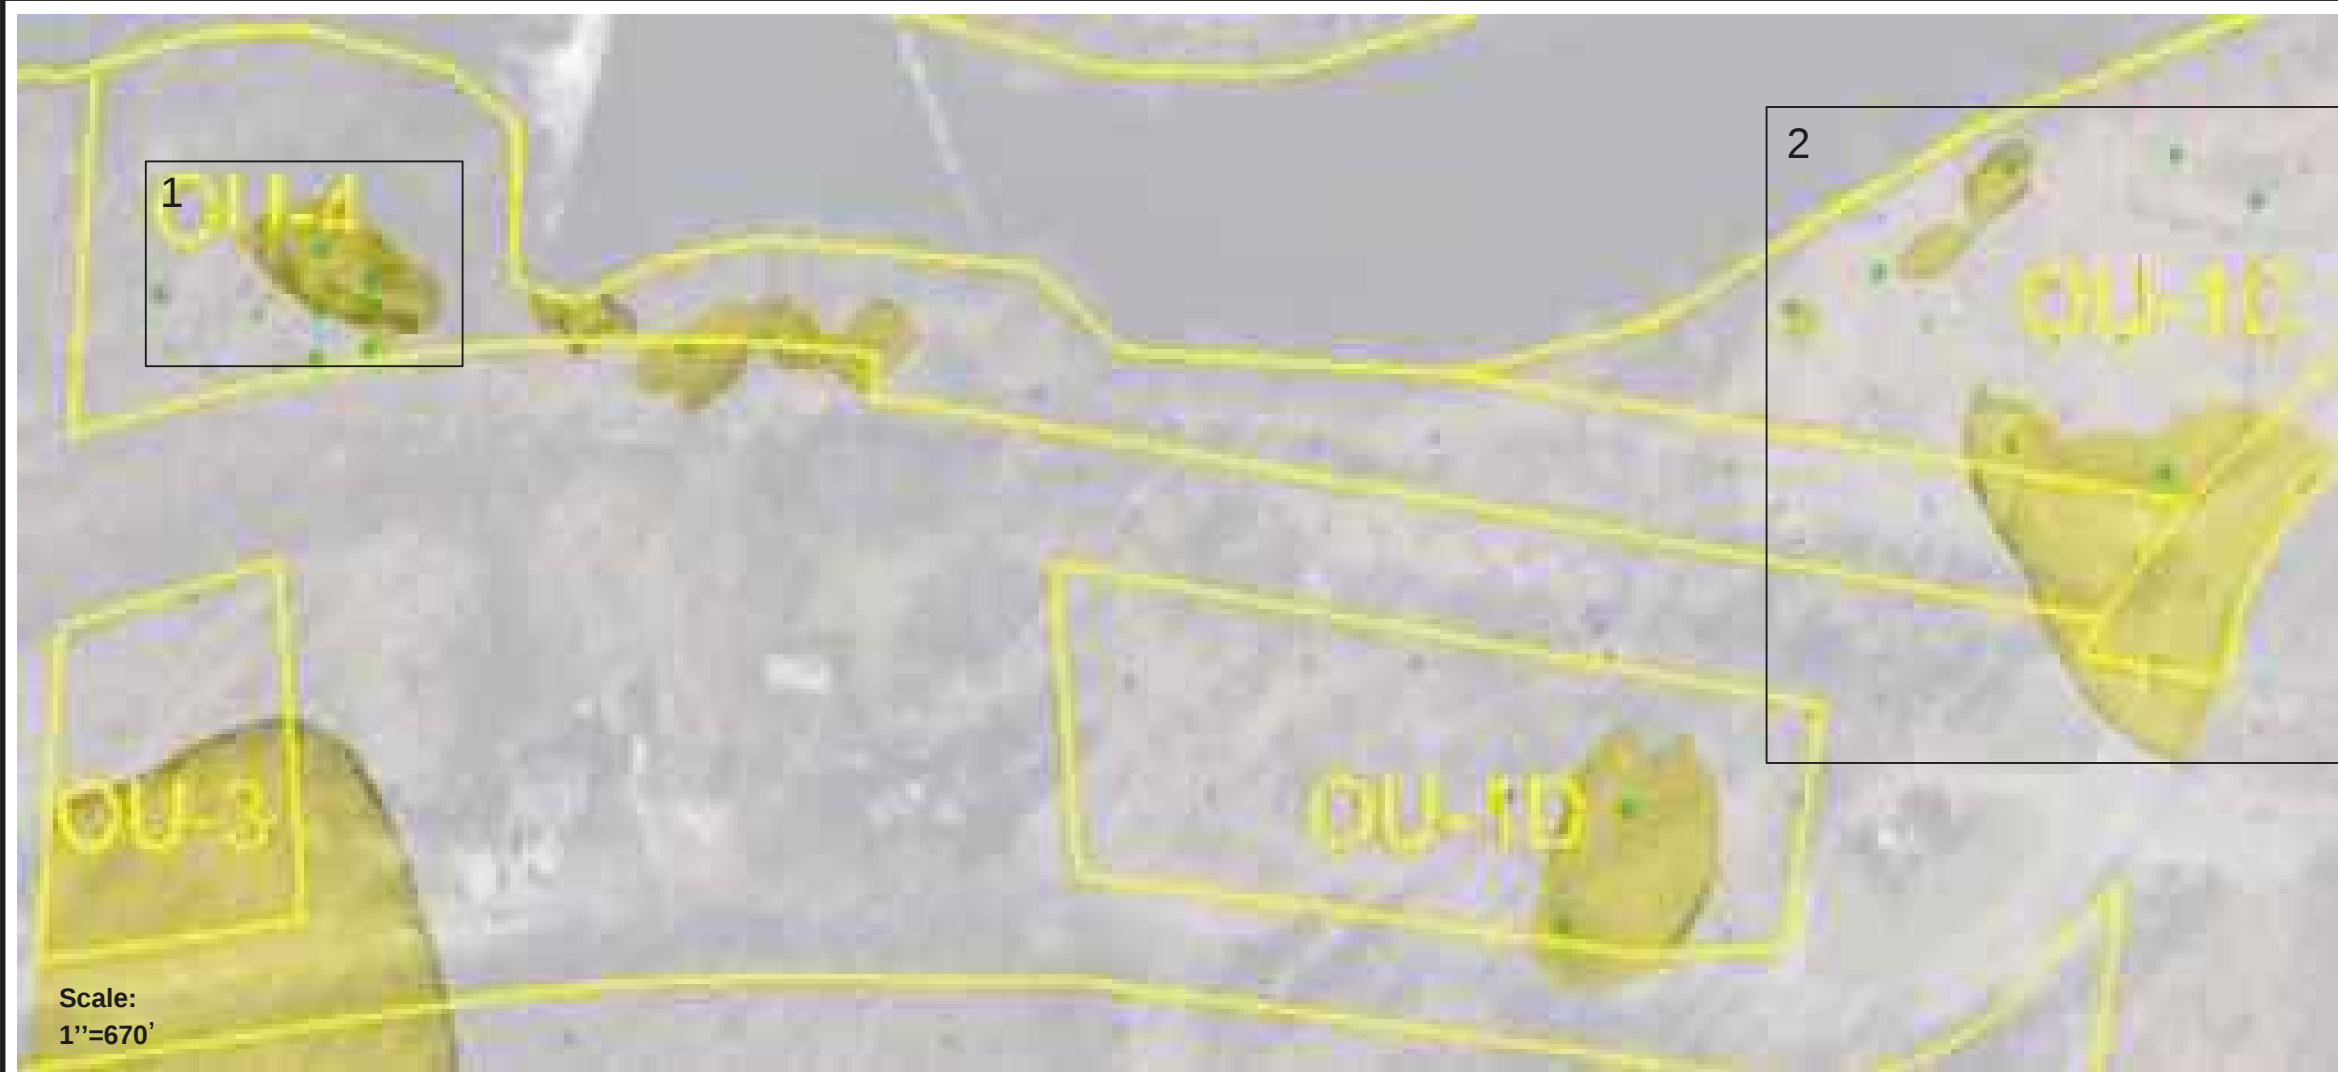
MANGANESE SOIL SCREENING LEVEL  
EXCEEDANCES

Figure 2-9ABC. Manganese Soil Screening Level Exceedances

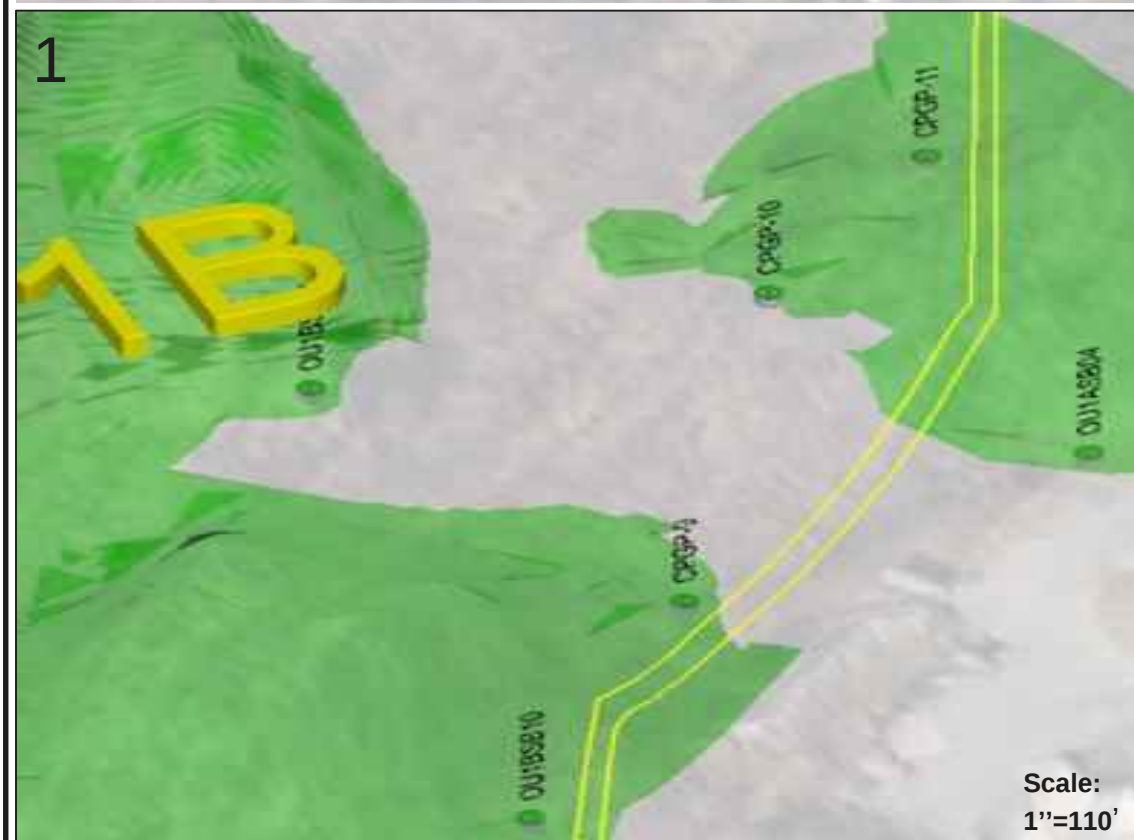
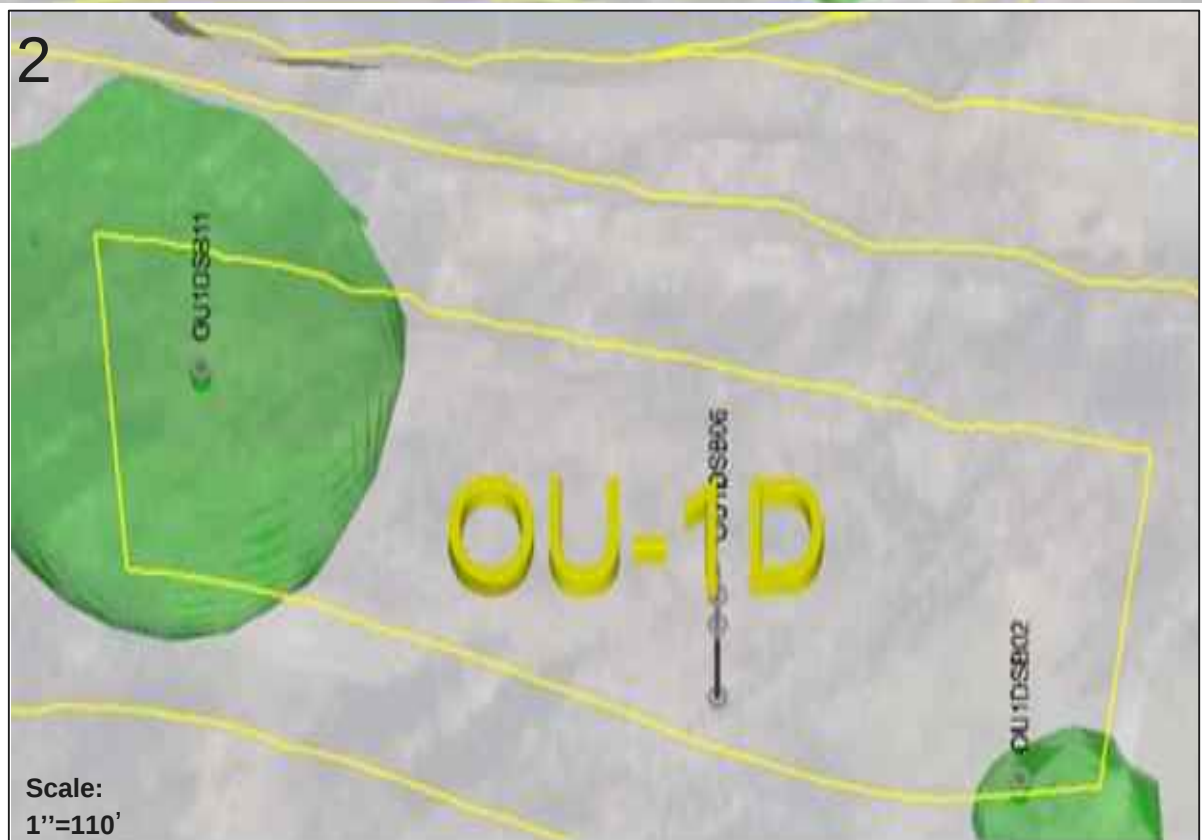
FIGURE  
2-12A

- Results colored by least restrictive screening level exceeded
- Scales are approximated.
  - Key Map: 1 inch = 385 feet
  - Focused areas: 1 inch = 110 feet
- Ground surface digital elevation model (DEM) from United States Geological Service (USGS) accessed from Global Mapper
- Aerial imagery from Environmental Systems Research Institute (ESRI) World Imagery (accessed April 2020)
- Non-detect samples colored at their reporting limit (RL) and modeled at 1/10 of their RL.
- mg/kg: milligram per kilogram
- OU: Operable Unit
- SL: Screening Level

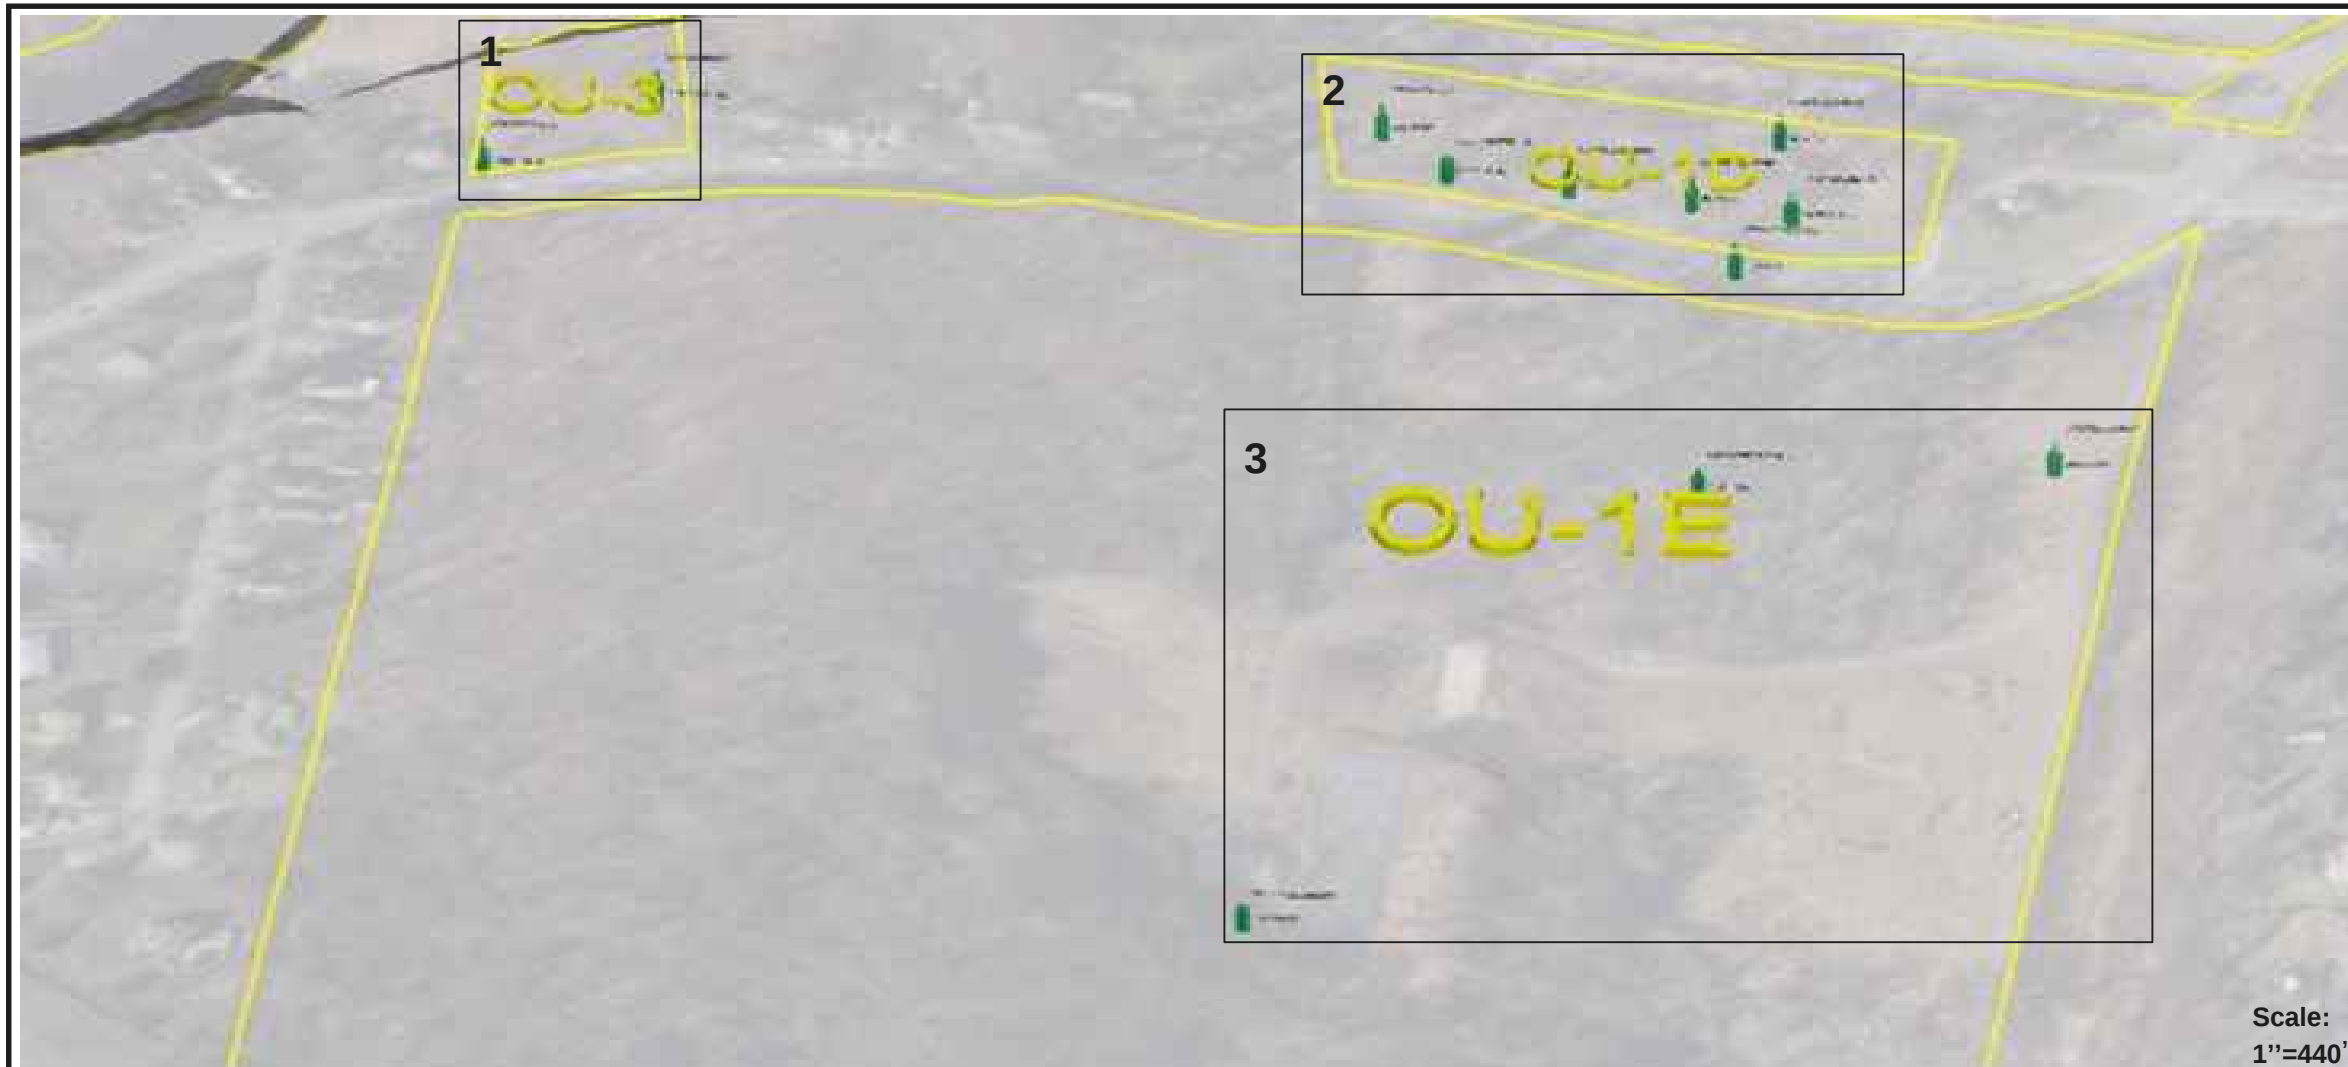
2-24B

- Results colored by least restrictive screening level exceeded
- Scales are approximated.
  - Key Map: 1 inch = 440 feet
  - Focused areas: 1 inch = 190 feet
- Ground surface digital elevation model (DEM) from United States Geological Service (USGS) accessed from Global Mapper
- Aerial imagery from Environmental Systems Research Institute (ESRI) World Imagery (accessed April 2020)
- Non-detect samples colored at their reporting limit (RL) and modeled at 1/10 of their RL.
- ug/L: microgram per liter
- OU: Operable Unit
- NY TOGS: New York Technical and Operational Guidance Series

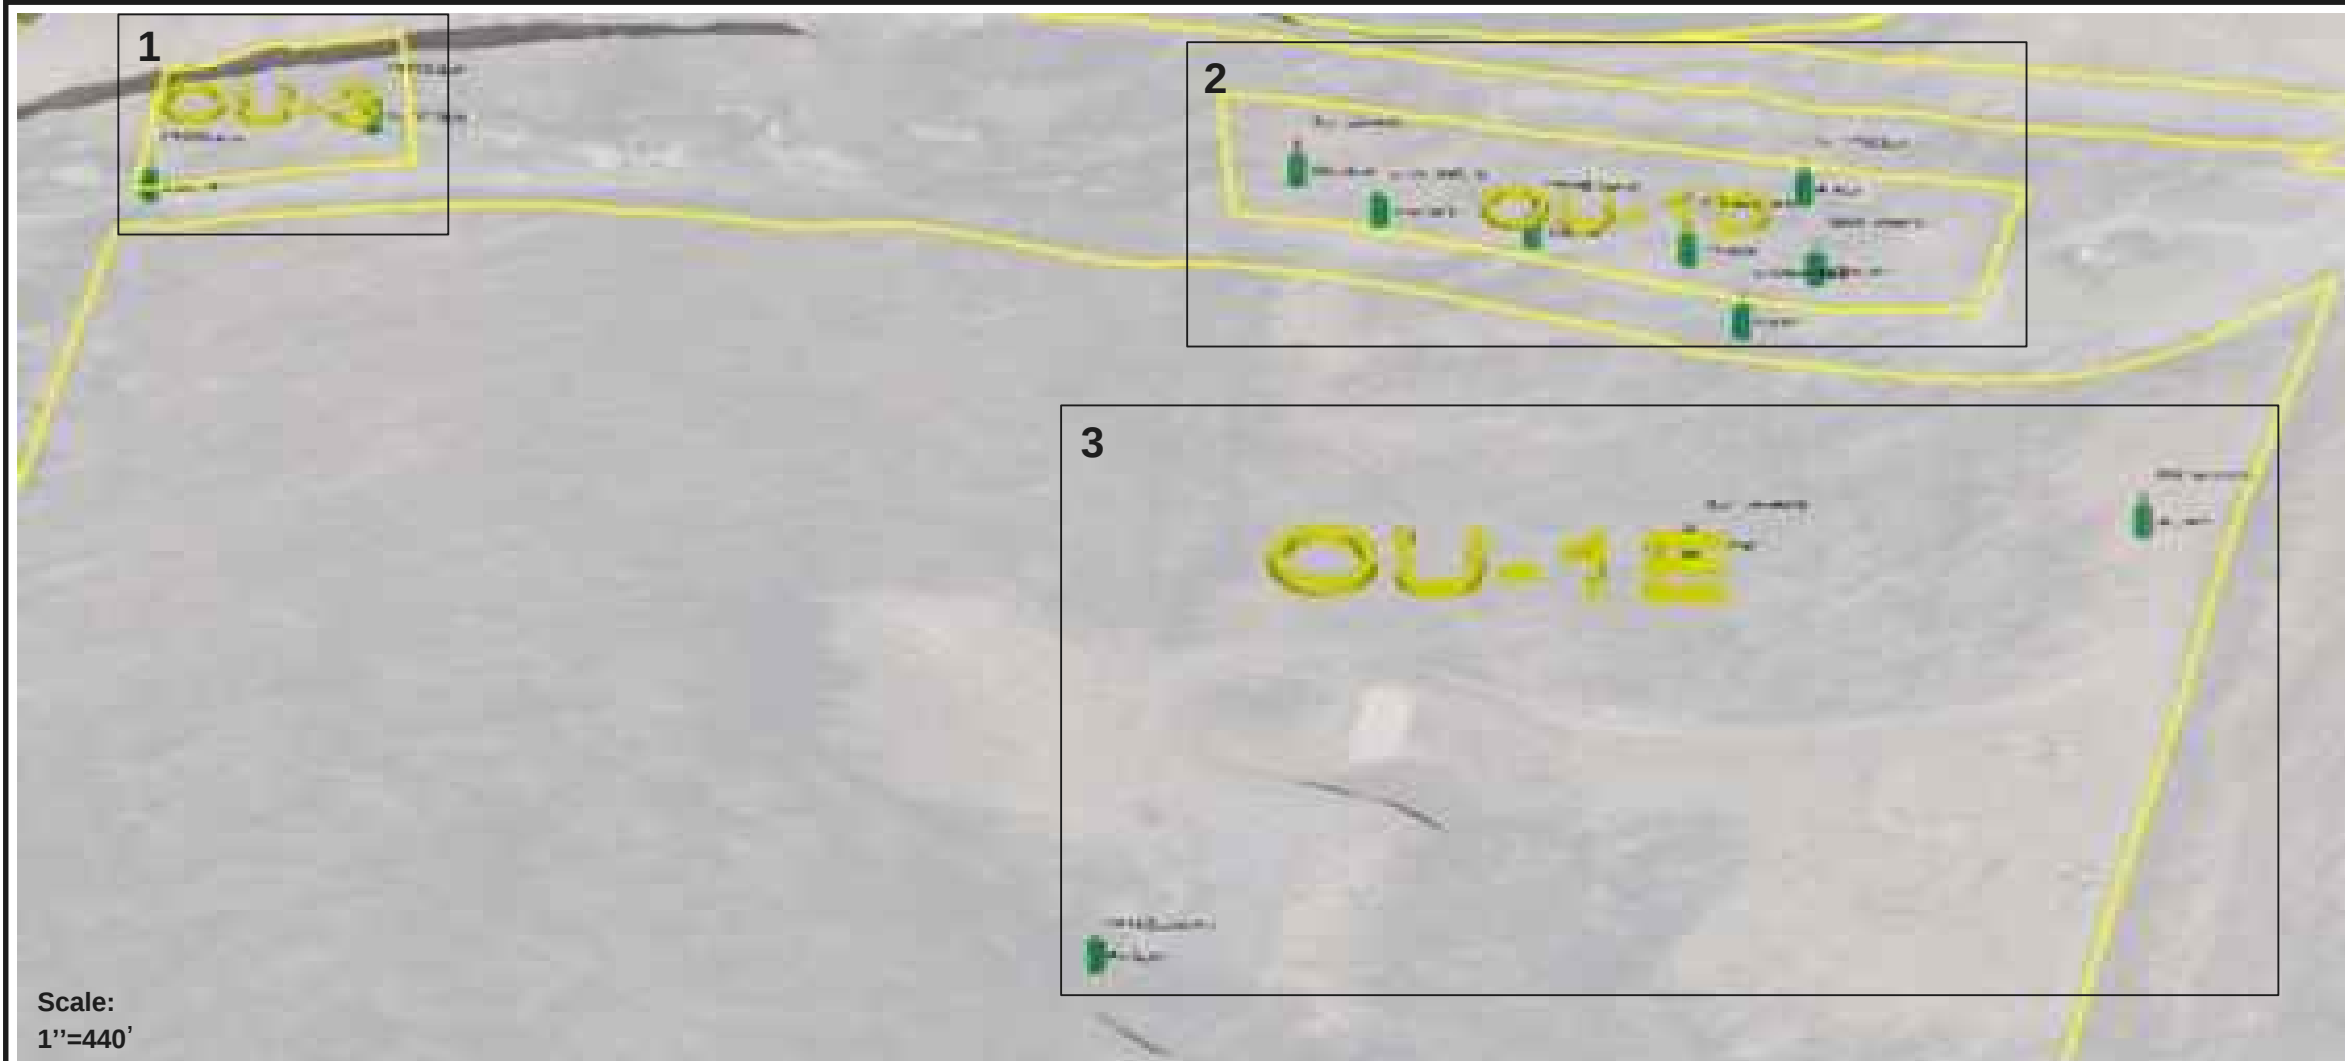
FIGURE  
2-25B

- Results colored by least restrictive screening level exceeded
- Scales are approximated.
  - Key Map: 1 inch = 440 feet
  - Focused areas: 1 inch = 190 feet
- Ground surface digital elevation model (DEM) from United States Geological Service (USGS) accessed from Global Mapper
- Aerial imagery from Environmental Systems Research Institute (ESRI) World Imagery (accessed April 2020)
- Non-detect samples colored at their reporting limit (RL) and modeled at 1/10 of their RL.
- ug/L: microgram per liter
- OU: Operable Unit
- NY TOGS: New York Technical and Operational Guidance Series

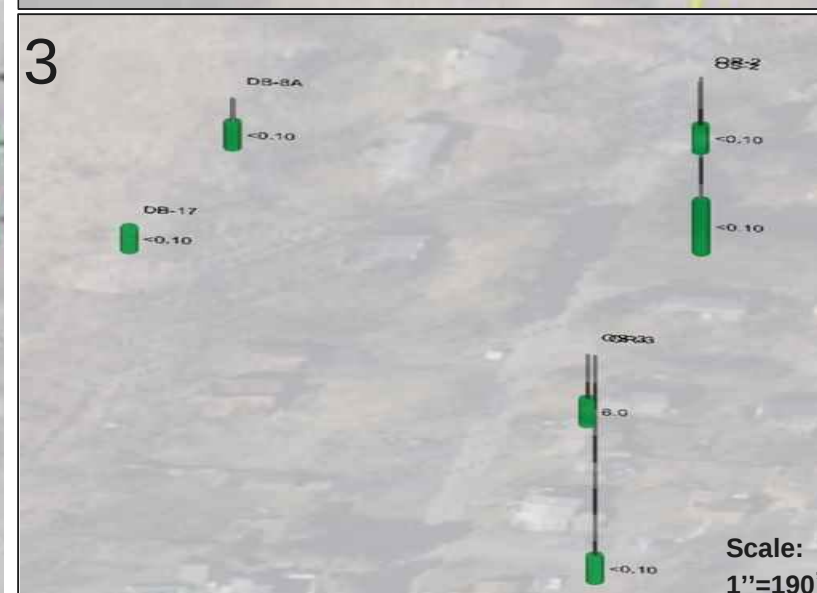
FIGURE  
2-29B

Figure 2-29ABC. Benzo(b)fluoranthene Groundwater Screening Level Exceedances 2012-2013
