**RE: DC Airport Joint Landfill, Town of Wappinger, Dutchess County
2015 Annual Report - Post-Closure Monitoring and Facility Maintenance
MA # 202412.415**

**2015 ANNUAL REPORT
POST-CLOSURE MONITORING AND FACILITY MAINTENANCE
DUTCHESS COUNTY AIRPORT JOINT LANDFILL
TOWN OF WAPPINGER
DUTCHESS COUNTY, NY**

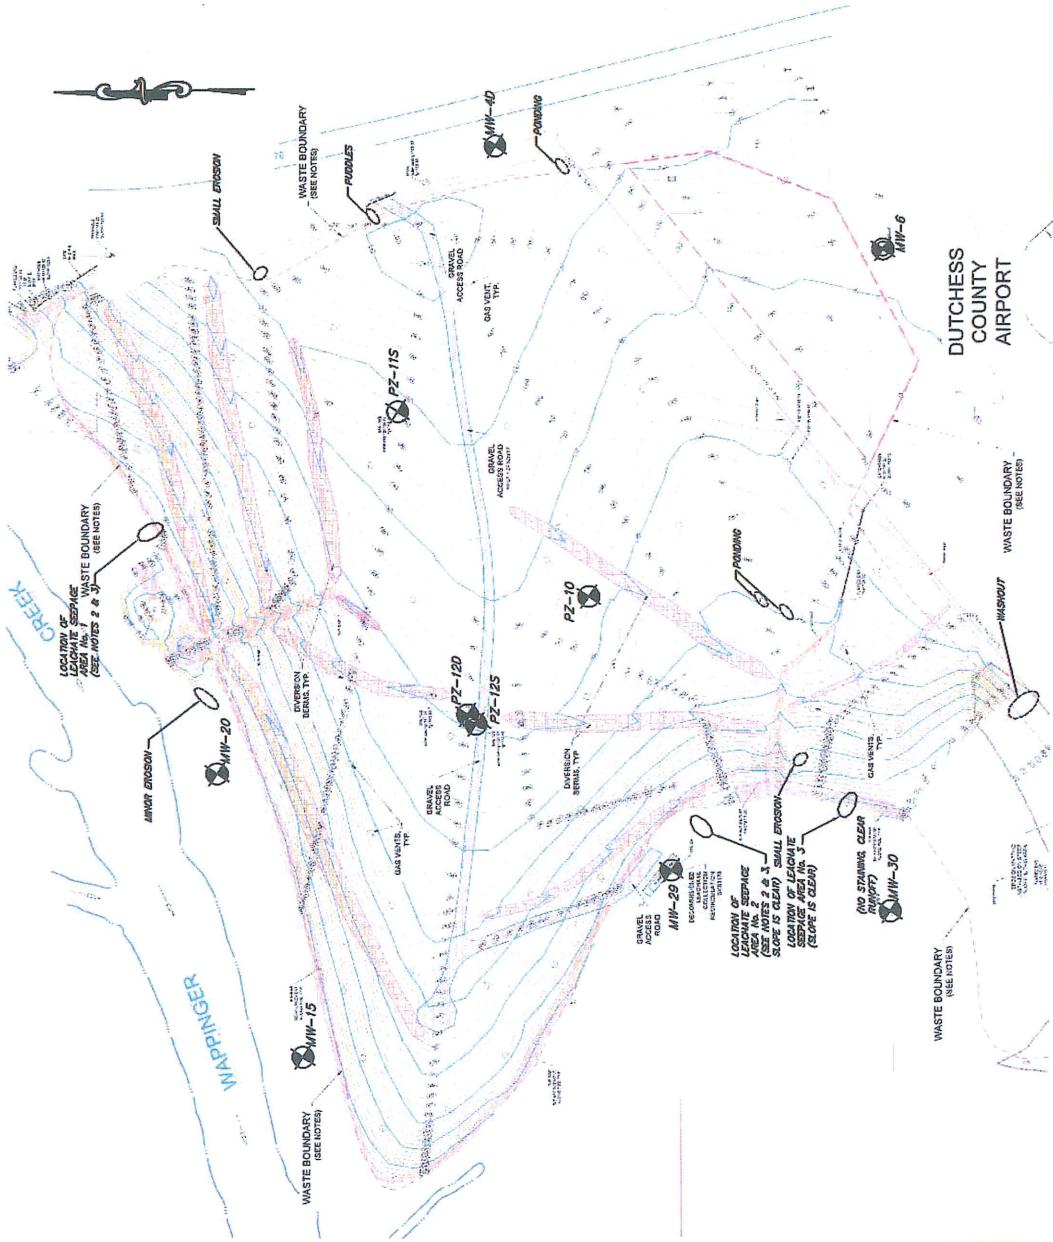
SURFACE SEEP LOCATIONS FOR AREAS #1 AND #2 AS
OBTAINED BY PAGGI, MARTIN AND DEL BENE INC. ON JANUARY 12,
2007. THE LOCATION OF SEEP AREA #3 IS APPROXIMATED.

Around the time of the substantial completion of Closure Construction, in January 2007, two locations of leachate seepage were observed. These locations are noted as Areas 1 and 2 on the site plan within Appendix A. These locations received a soil cover consisting of approximately six inches of compacted clay and six inches of soil suitable to support vegetation. This capping activity was performed in January 2007. A third area of leachate seepage was identified in June 2007. This area was covered in a similar manner in September 2007. The locations of all three locations are depicted on the site map.

Since these locations have been covered, Area 1 has exhibited no evidence of further seepage. The locations of seepage at Areas 2 and 3 were identified as areas that needed repair and were addressed in the summer of 2009. The areas were scraped off and a six inch layer of sand was placed on them. Top soil was then brought in and placed over the sand layer and hay and seed were placed on the two areas. As per the PCM&FMM, these locations will continue to be monitored as part of upcoming quarterly events. Any dramatic change in conditions or additional breakouts will be reported to the Department, as warranted.

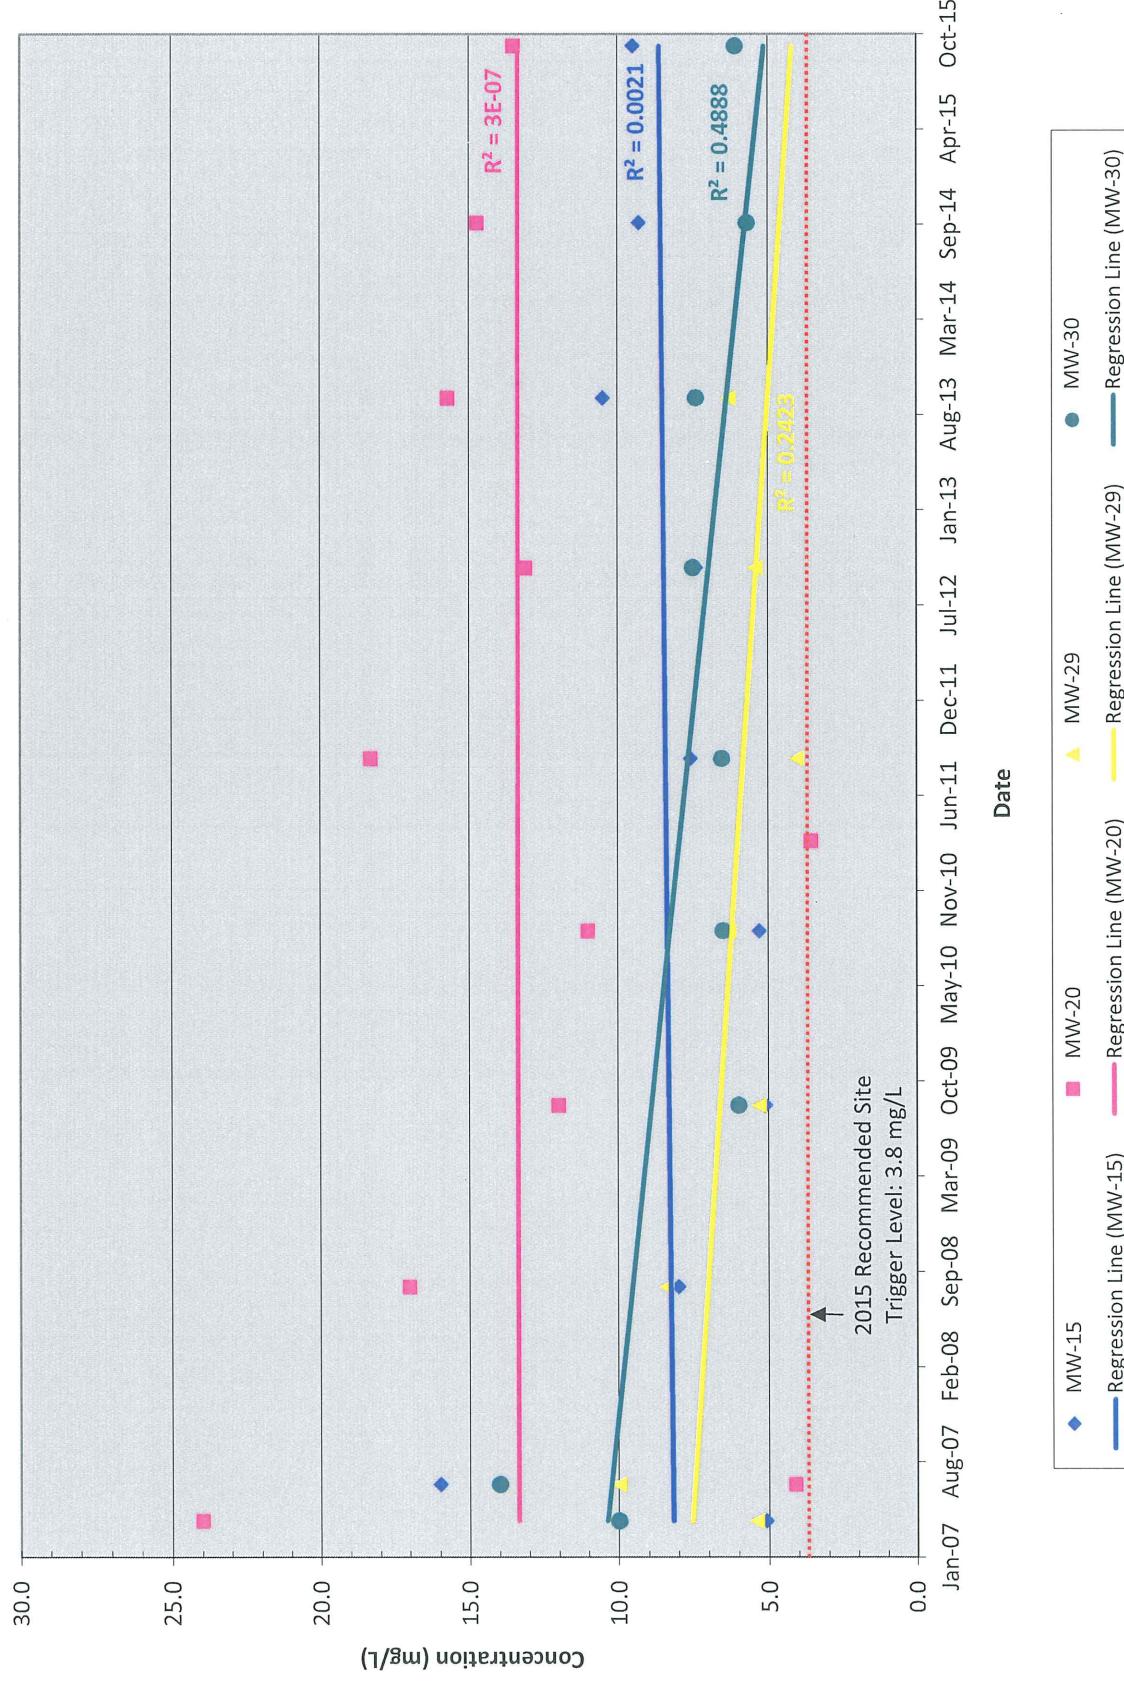
Graph 2E: Total Dissolved Solids in down-gradient groundwater
 Dutchess County Airport Landfill
 N.Y.S. Route 376, Town of Wappinger, New York

1. Values exceeding a 2015 recommended site trigger value of 659 mg/L are shown in bold.
2. Laboratory non-detects display lab reporting limit followed by the "u" data qualifier. Summary statistics were calculated using detection limit values.
3. MW-6 was not sampled in April 2007 due to snow obscuring well cover location.
4. Wells MW-15, MW-20, MW-29 and MW-30 were installed during 2006 landfill closure. Wells MW-4D and MW-6 were installed during the Closure Investigation.
5. MW-30 was dry during the August 2008 sampling event, so no sample was collected.

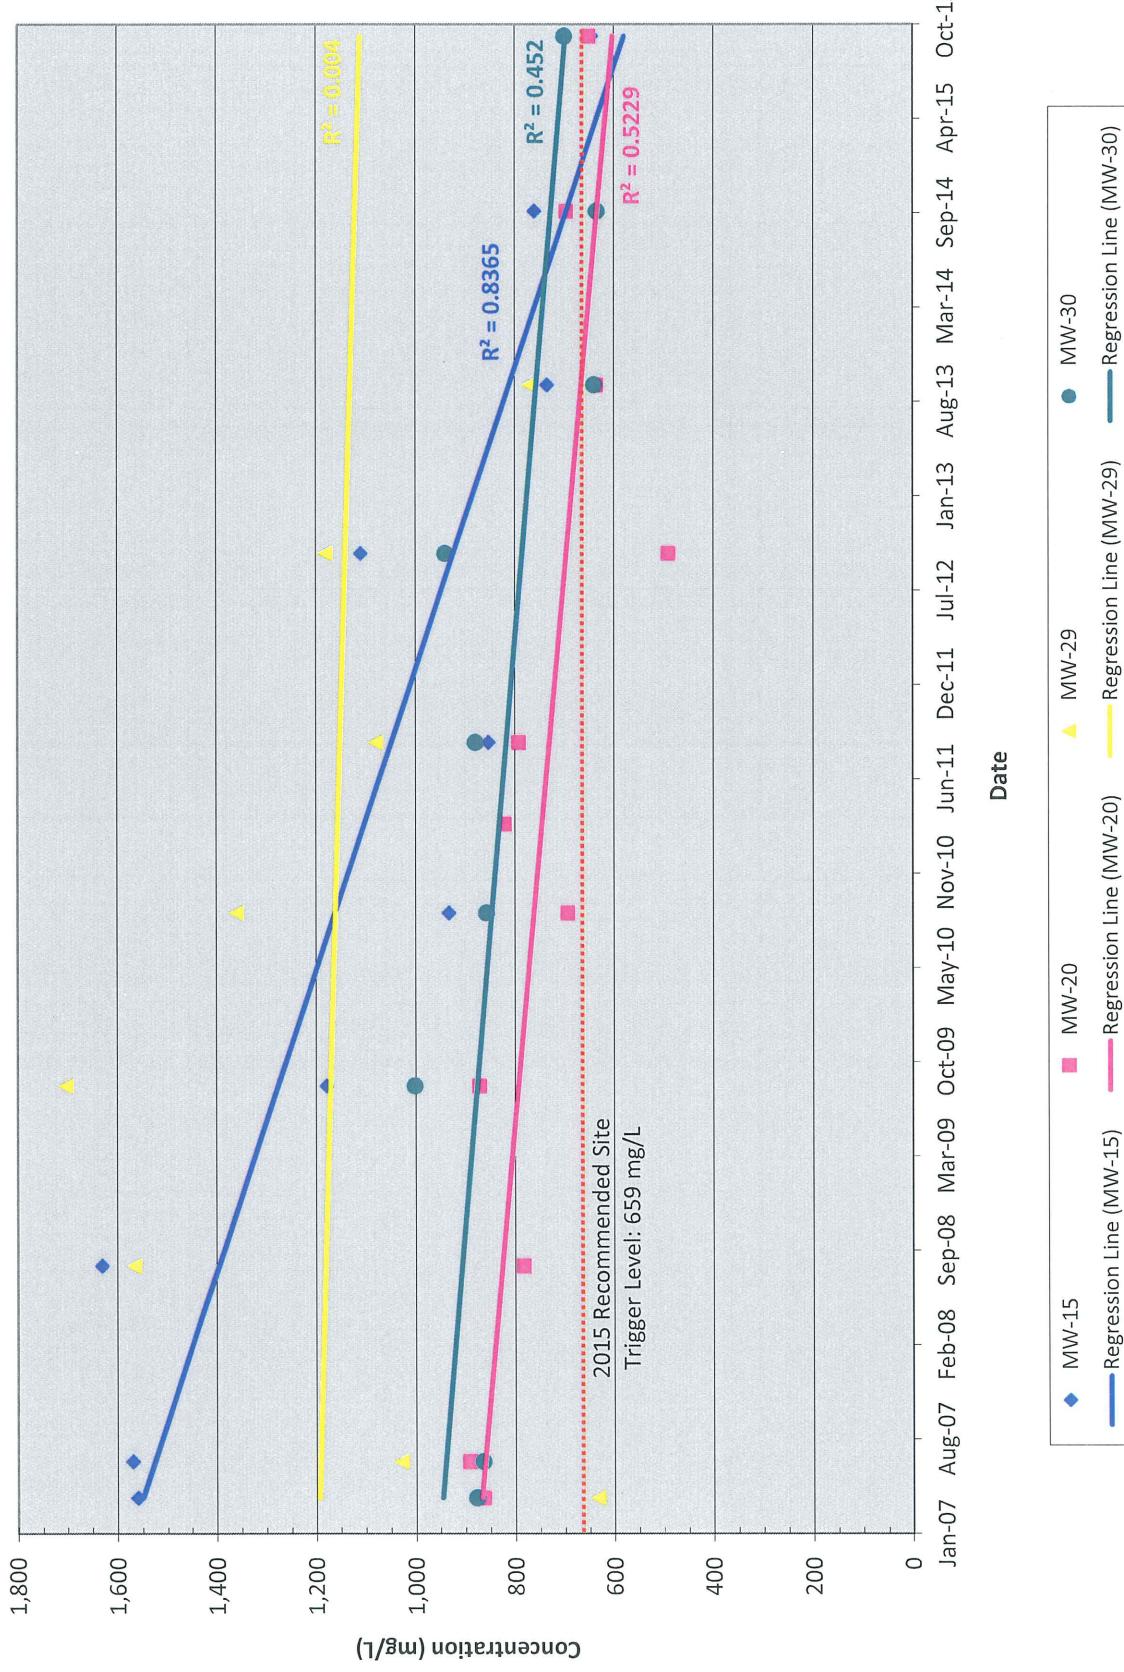
Graph 2F: Sulfate in down-gradient groundwater
Dutchess County Airport Landfill
N.Y.S. Route 376, Town of Wappinger, New York

1. Values exceeding the applicable water quality standard for sulfate (250,000 ug/L) from TOGS 1.1.1 are shown in bold.
2. Laboratory non-detects display lab reporting limit followed by the "u" data qualifier. Summary statistics were calculated using detection limit values.
3. MW-6 was not sampled in April 2007 due to snow obscuring well cover location.
4. Wells MW-15, MW-20, MW-29 and MW-30 were installed during 2006 landfill closure. Wells MW-4D and MW-6 were installed during the Closure Investigation.
5. MW-30 was dry during the August 2008 sampling event, so no sample was collected.

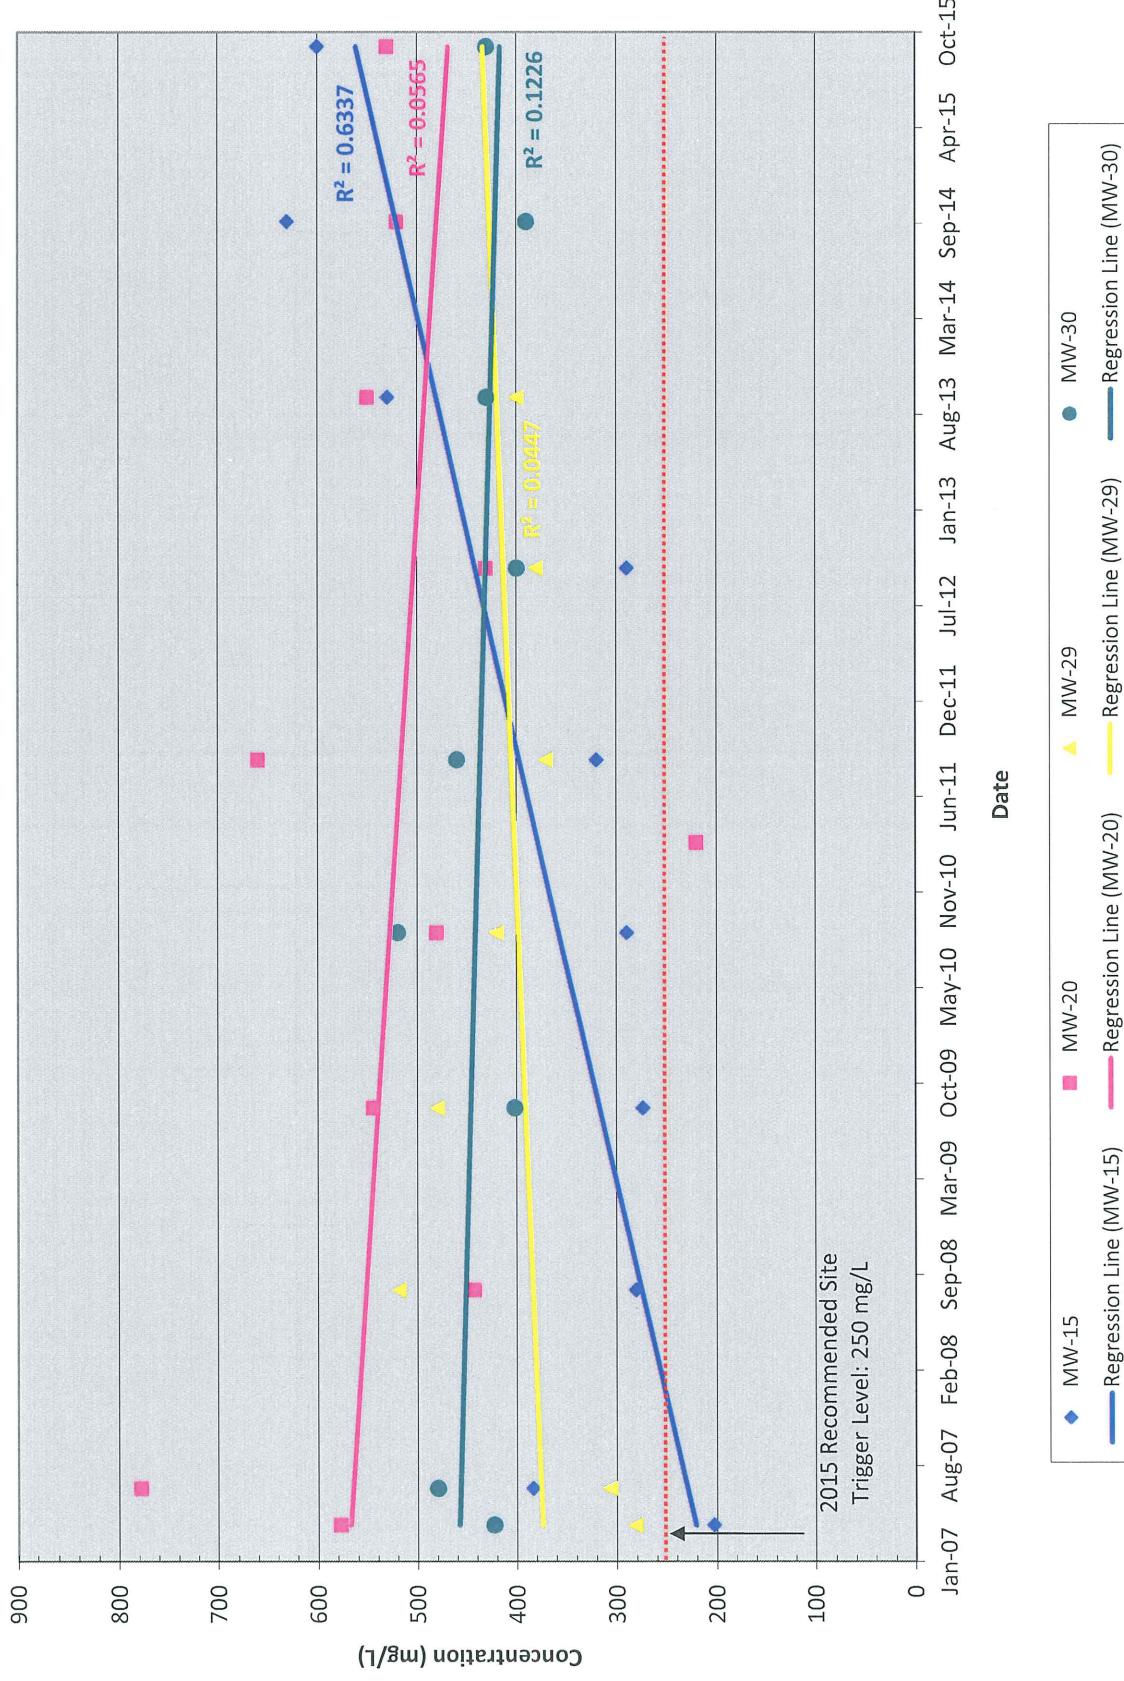
Graph 21: Total Hardness in down-gradient groundwater
 Dutchess County Airport Landfill
 N.Y.S. Route 376, Town of Wappinger, New York

1. Values exceeding a 2015 recommended site trigger value of 460.0 mg/L are shown in bold.
2. Laboratory non-detects display lab reporting limit followed by the "u" data qualifier. Summary statistics were calculated using detection limit values.
3. MW-6 was not sampled in April 2007 due to snow obscuring well cover location.
4. Wells MW-15, MW-20, MW-29 and MW-30 were installed during 2006 landfill closure. Wells MW-4D and MW-6 were installed during the Closure Investigation.
5. MW-30 was dry during the August 2008 sampling event, so no sample was collected.

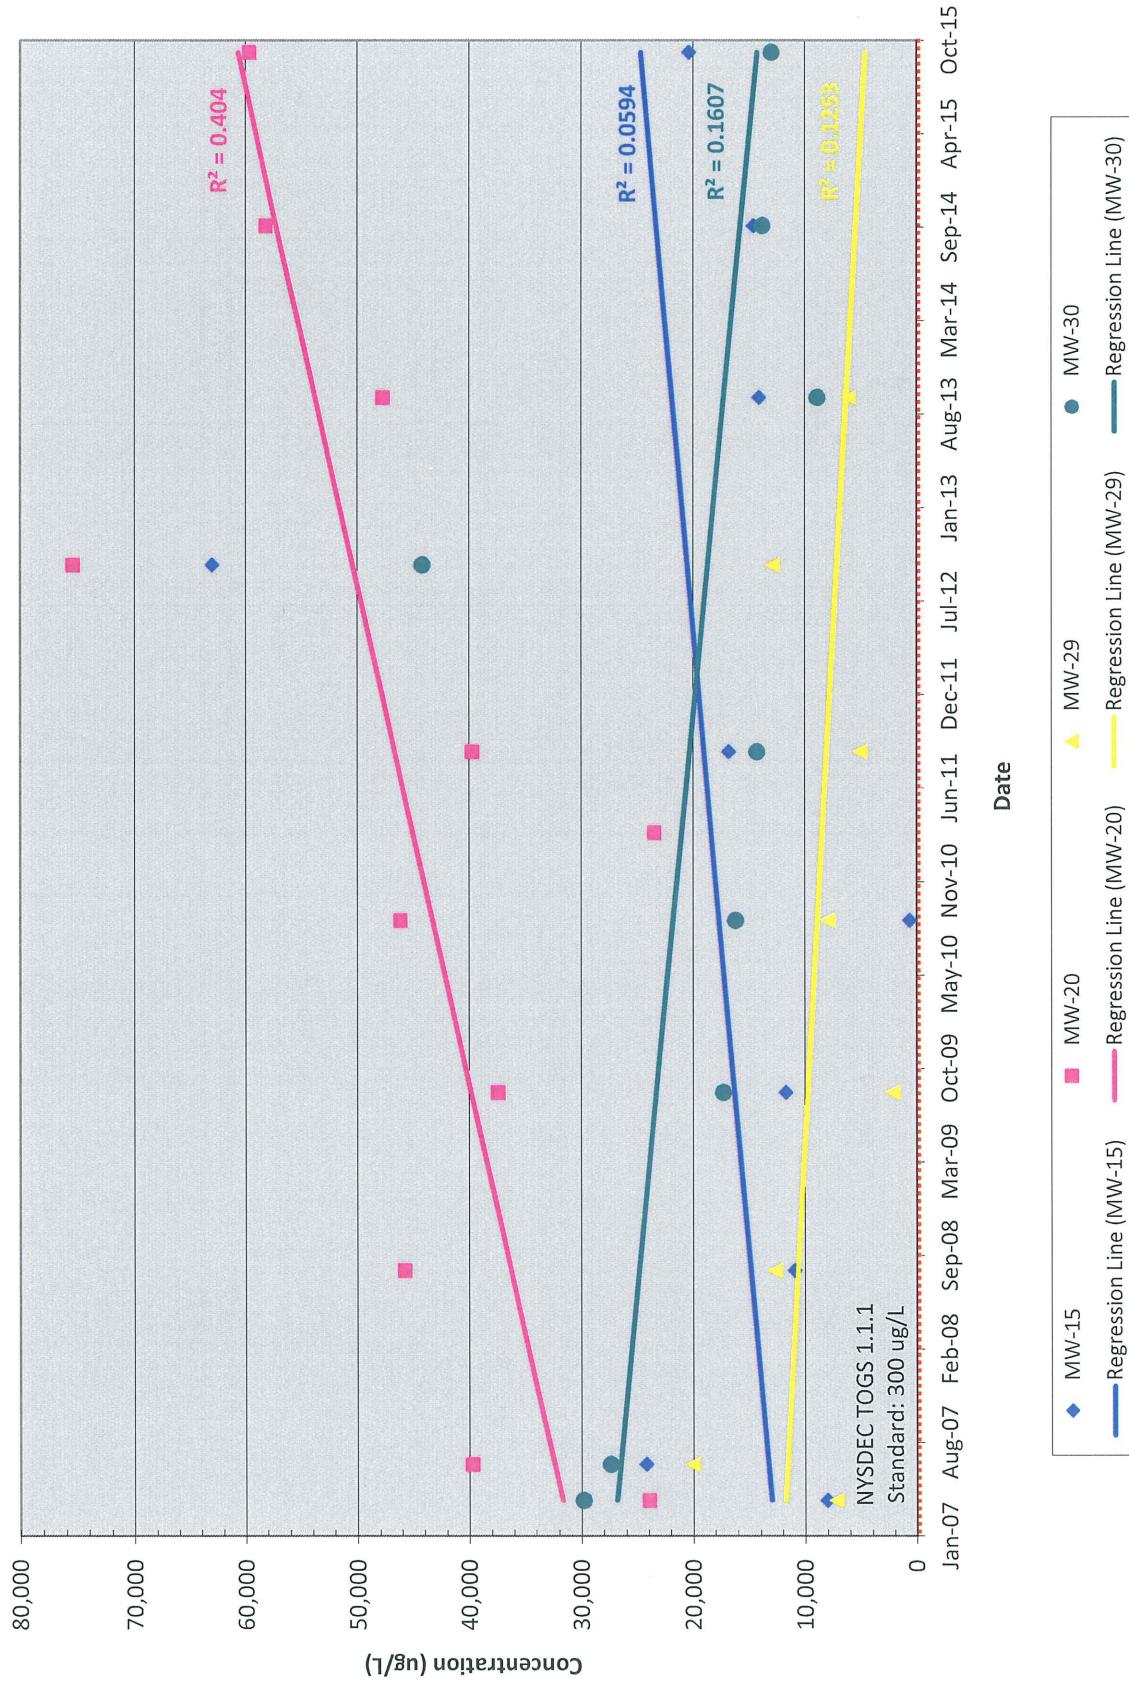
Graph 2L: Manganese in down-gradient groundwater
Dutchess County Airport Landfill
N.Y.S. Route 376, Town of Wappinger, New York

- Values exceeding the applicable water quality standard for manganese (300 ug/L) from TOGS 1.1.1 are shown in bold.
- Laboratory non-detects display lab reporting limit followed by the "u" data qualifier. Summary statistics were calculated using detection limit values.
- MW-6 was not sampled in April 2007 due to snow obscuring well cover location.
- Wells MW-15, MW-20, MW-29 and MW-30 were installed during 2006 landfill closure. Wells MW-4D and MW-6 were installed during the Closure Investigation.
- MW-30 was dry during the August 2008 sampling event, so no sample was collected.

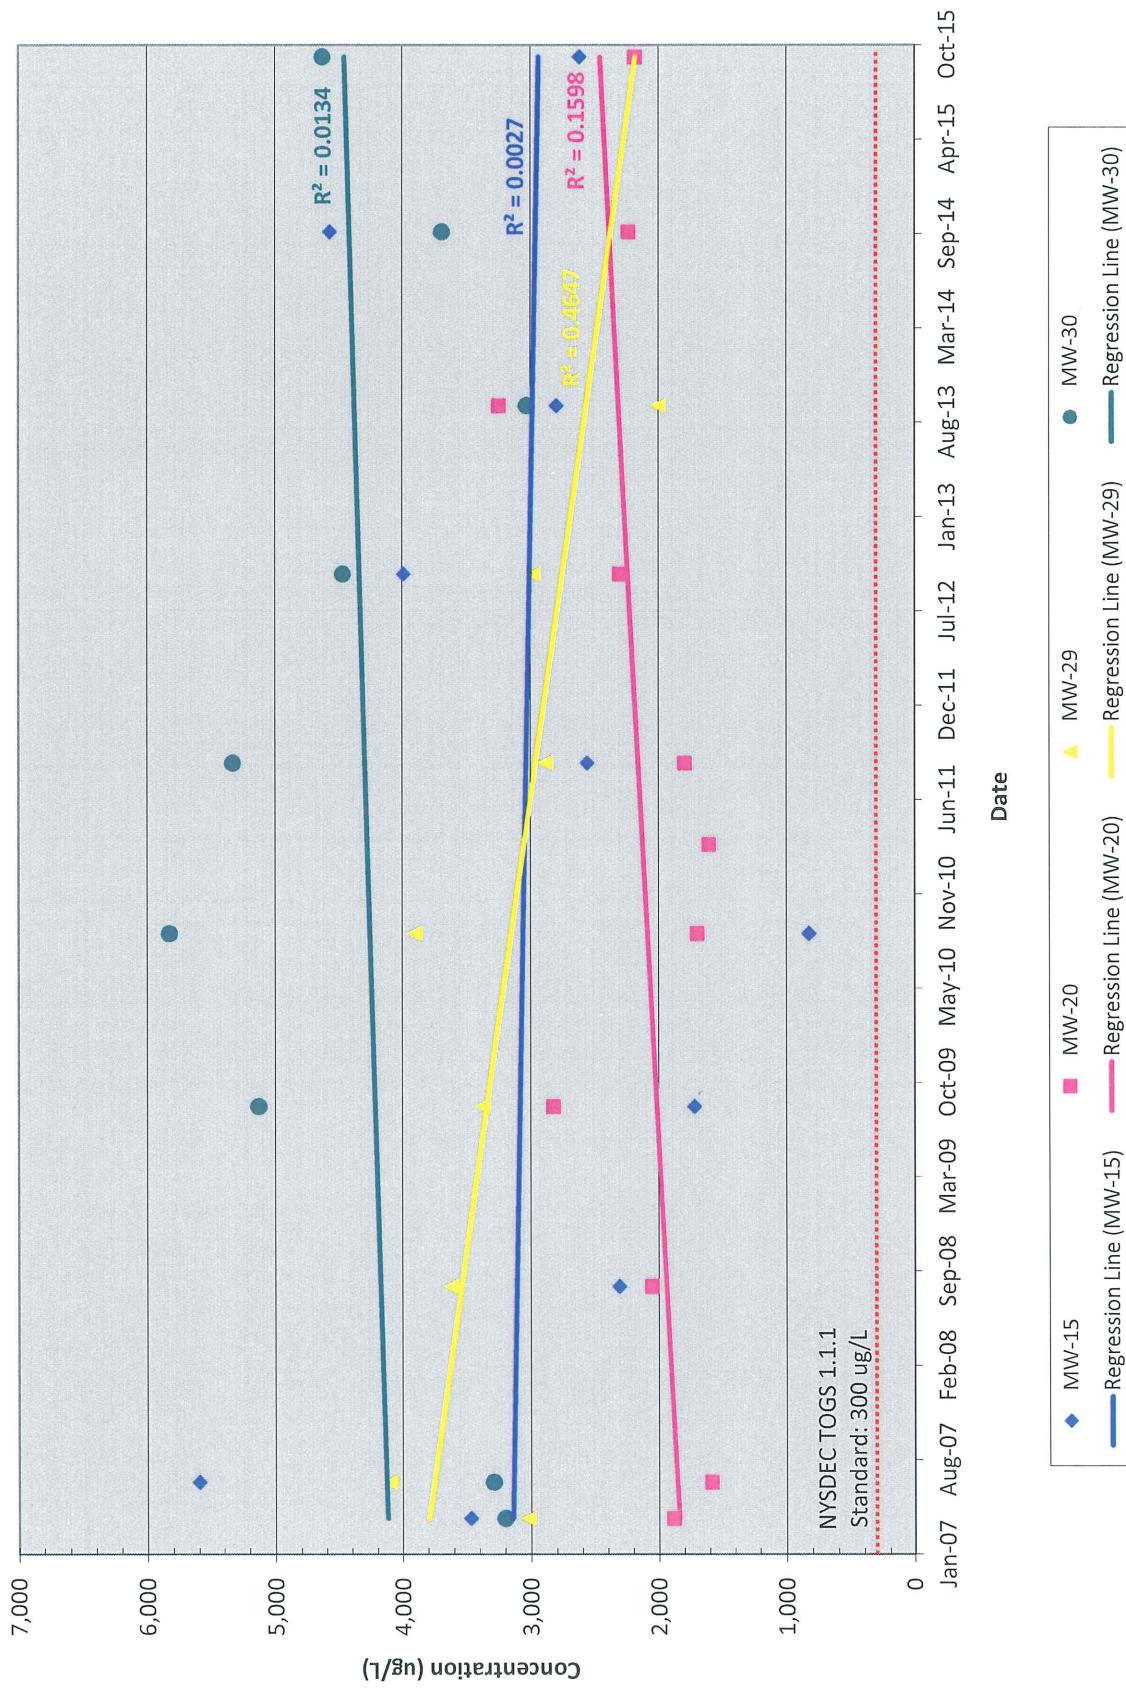
Graph 2M: Sodium in down-gradient groundwater
Dutchess County Airport Landfill
N.Y.S. Route 376, Town of Wappinger, New York

1. Values exceeding the applicable Class B surface water quality for sodium (20,000 ug/L) from TOGS 1.1.1 are shown in bold.
2. Laboratory non-detects display lab reporting limit followed by the "u" data qualifier. Summary statistics were calculated using detection limit values.
3. MW-6 was not sampled in April 2007 due to snow obscuring well cover location.
4. Wells MW-15, MW-20, MW-29 and MW-30 were installed during 2006 landfill closure. Wells MW-4D and MW-6 were installed during the Closure Investigation.
5. MW-30 was dry during the August 2008 sampling event, so no sample was collected.

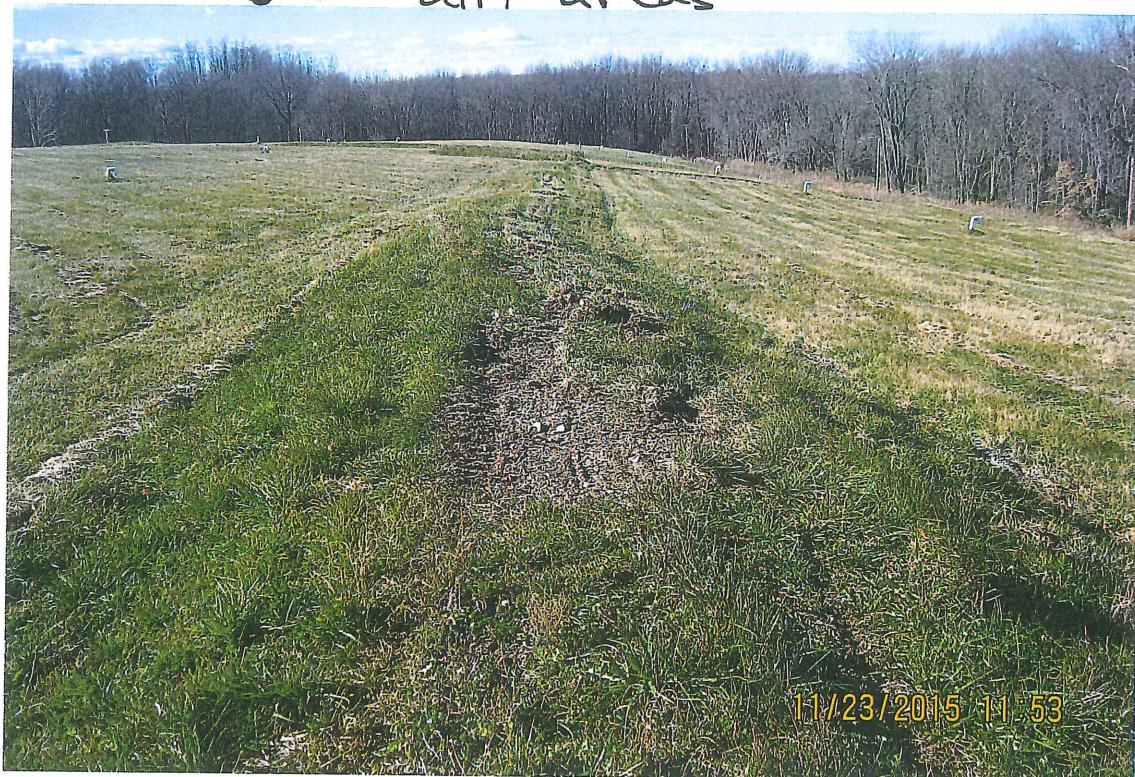
Bare dirt areas

- bare areas should be seeded
- outlet rip rap channels should be cut trimmed
- monitor wells should be re-secured & locked
- gas vent should be repaired
 > "rotten egg smell" southwest quadrant!

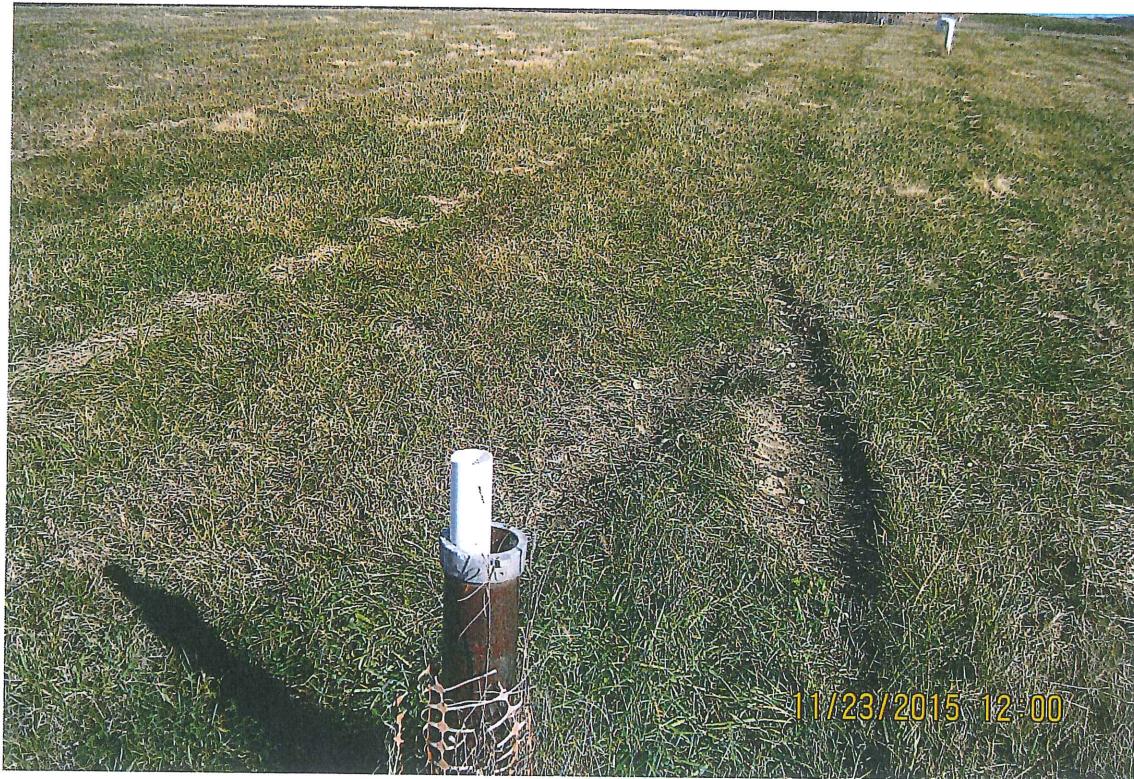
Mon. Well missing Cap & lock
PZ-100

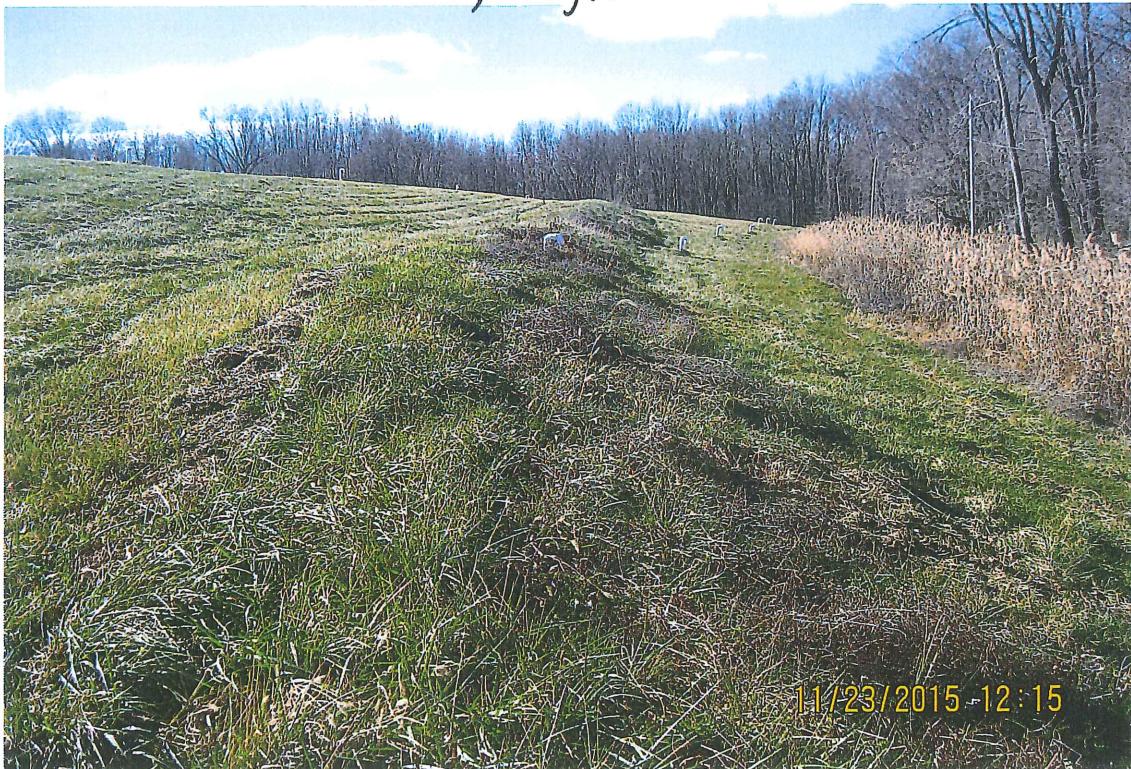
berm: high growth

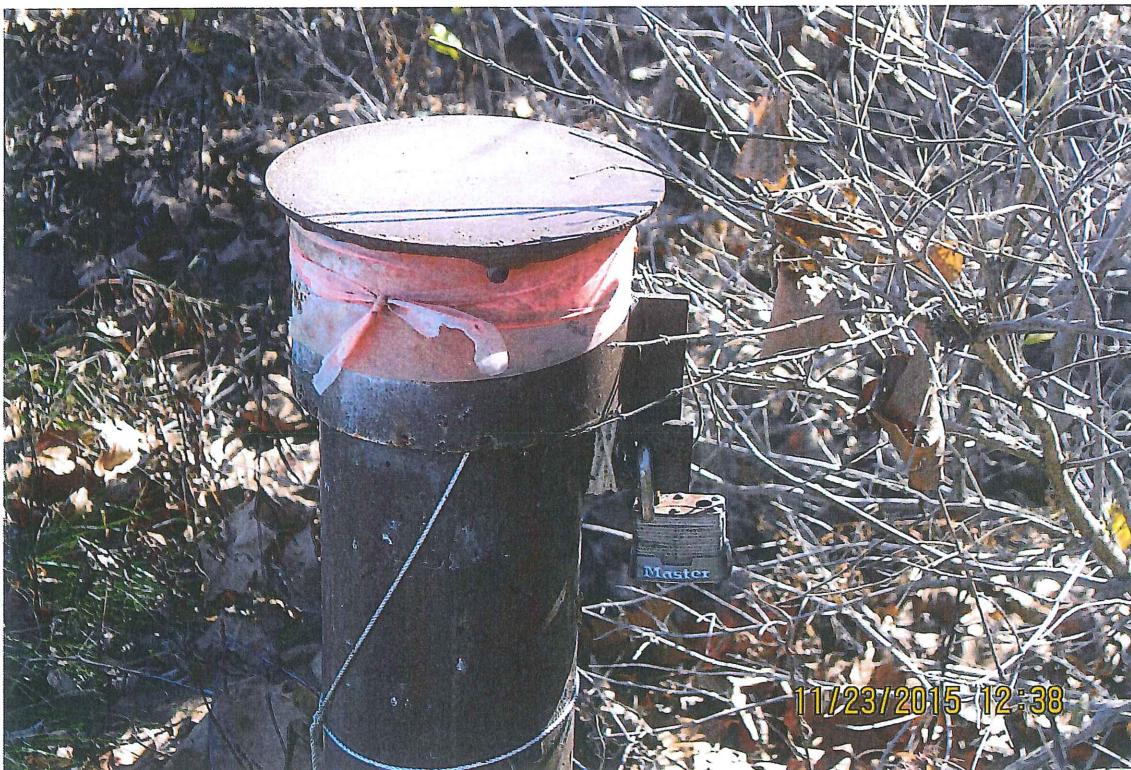
Monitor well unlocked

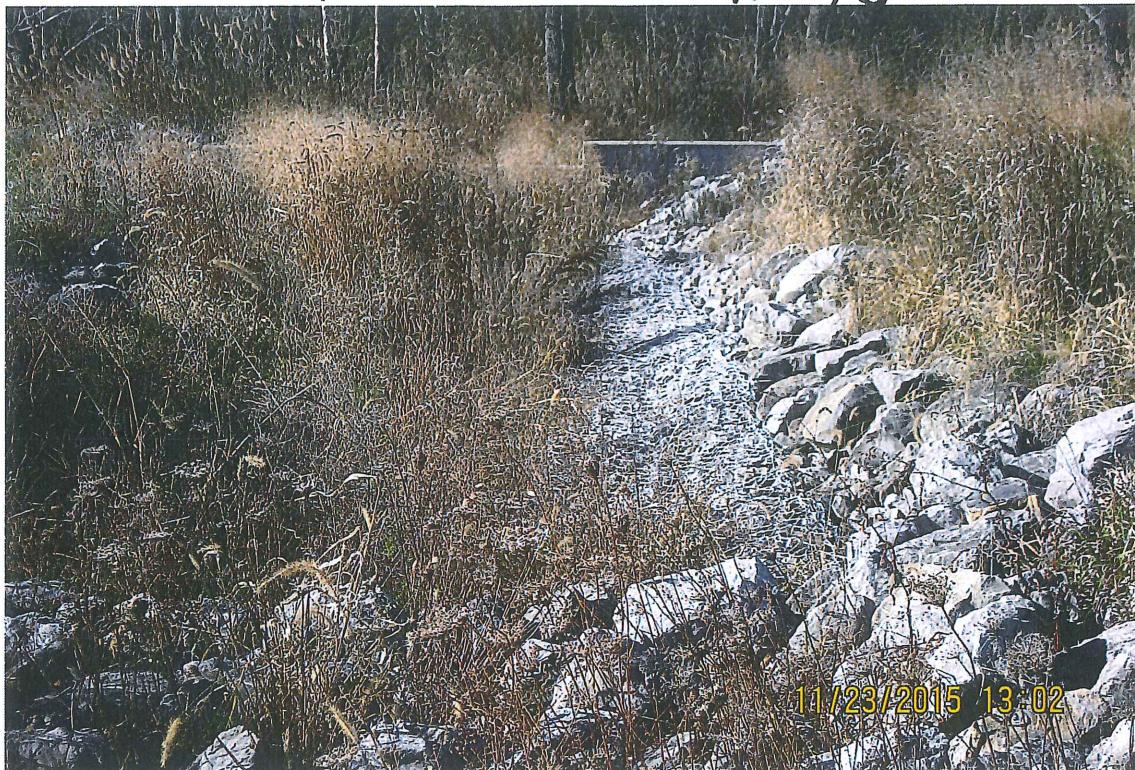
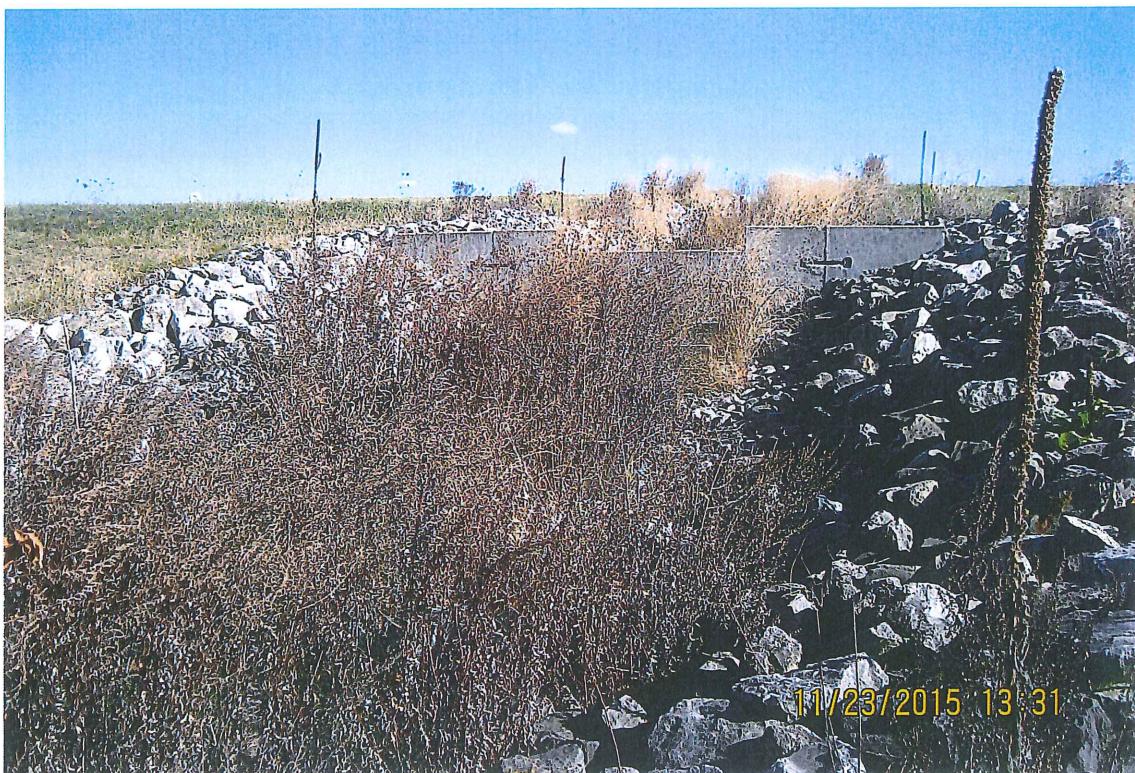
Outlet channel~~y~~-heavy growth

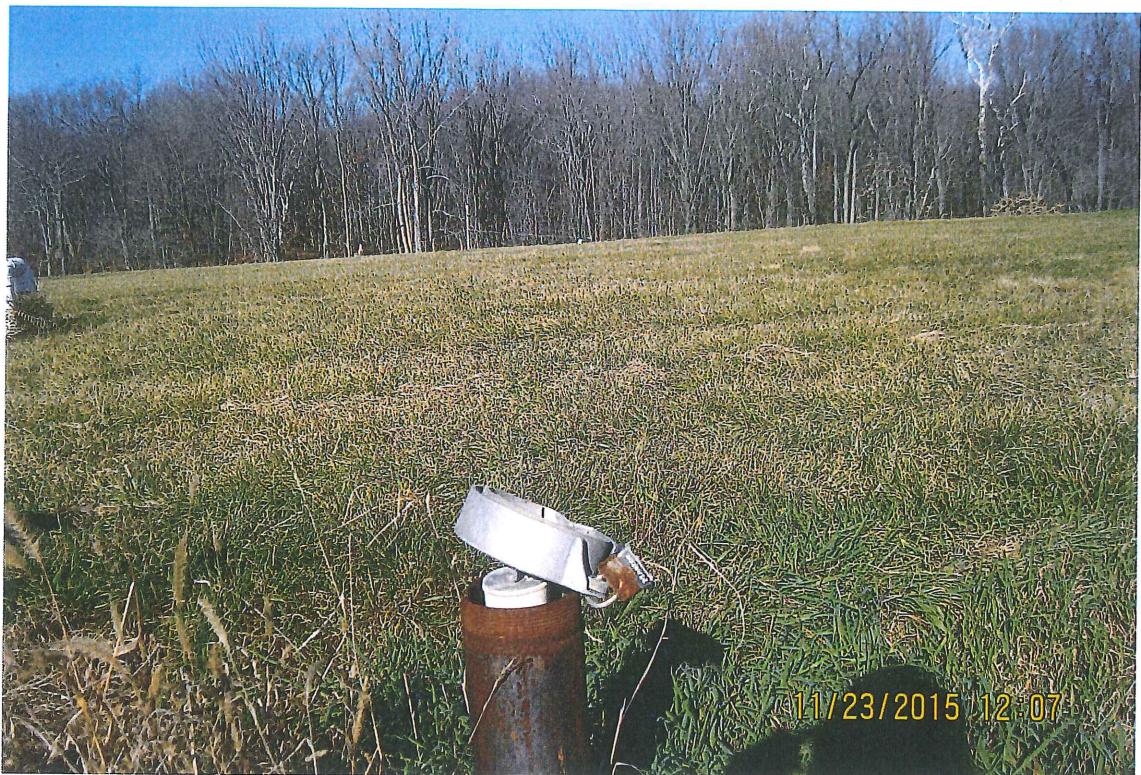
PZ-12 Mon well cap dislodged.

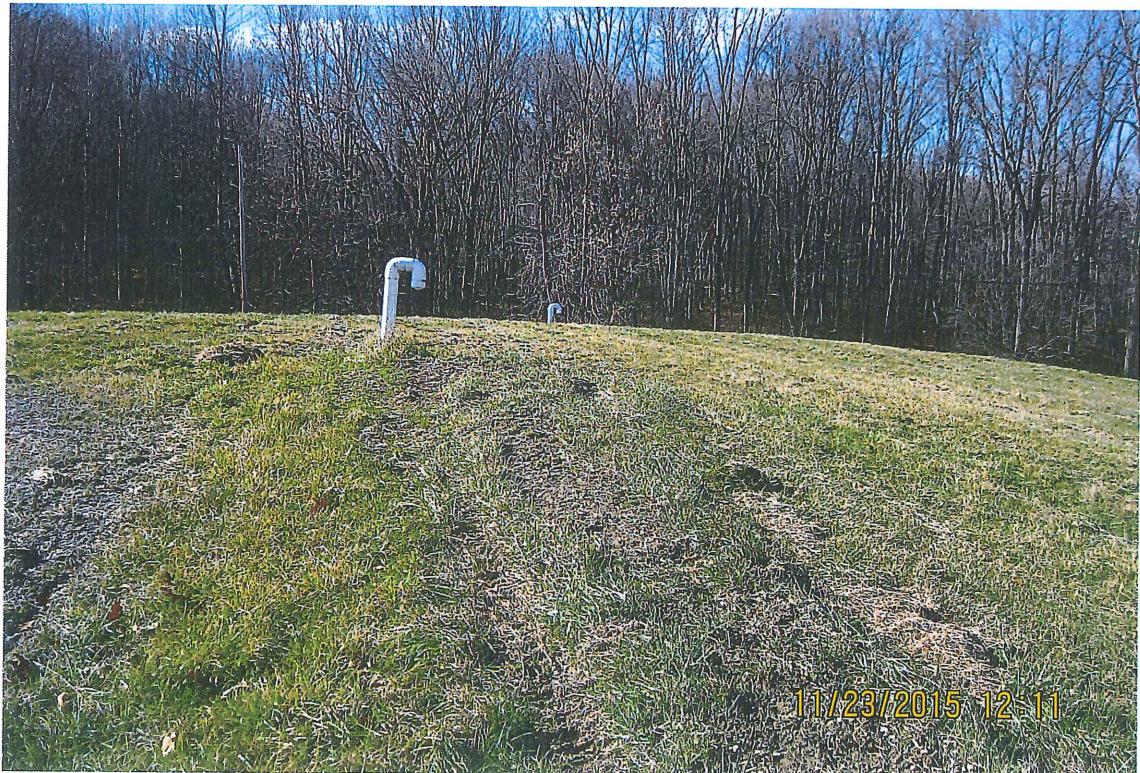
bare dirt areas

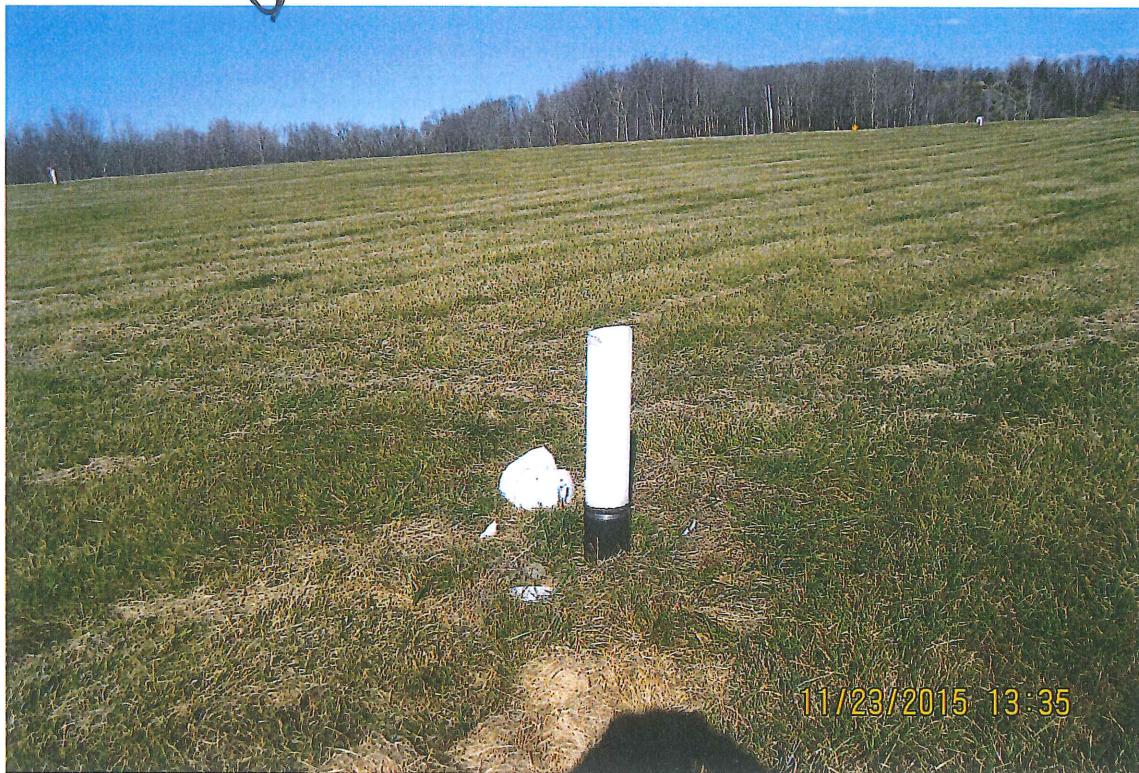
White 6 inch Schedule 40 vent is broke off
need end cap, two 90° elbows
drill & saw to REPAIR,
glue

gas vent broken

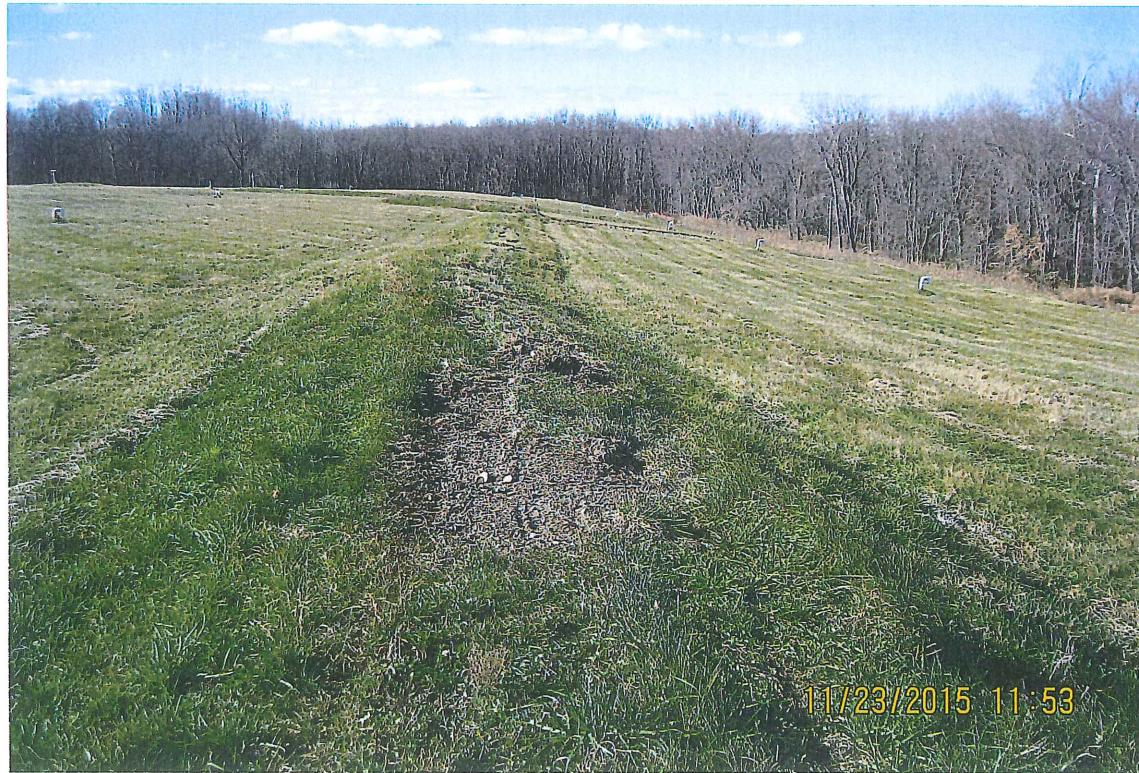
Scraped bare dirt areas
