**RE: DC Airport Joint Landfill, Town of Wappinger, Dutchess County
2015 Annual Report - Post-Closure Monitoring and Facility Maintenance
MA # 202412.415**

**2015 ANNUAL REPORT
POST-CLOSURE MONITORING AND FACILITY MAINTENANCE
DUTCHESS COUNTY AIRPORT JOINT LANDFILL
TOWN OF WAPPINGER
DUTCHESS COUNTY, NY**

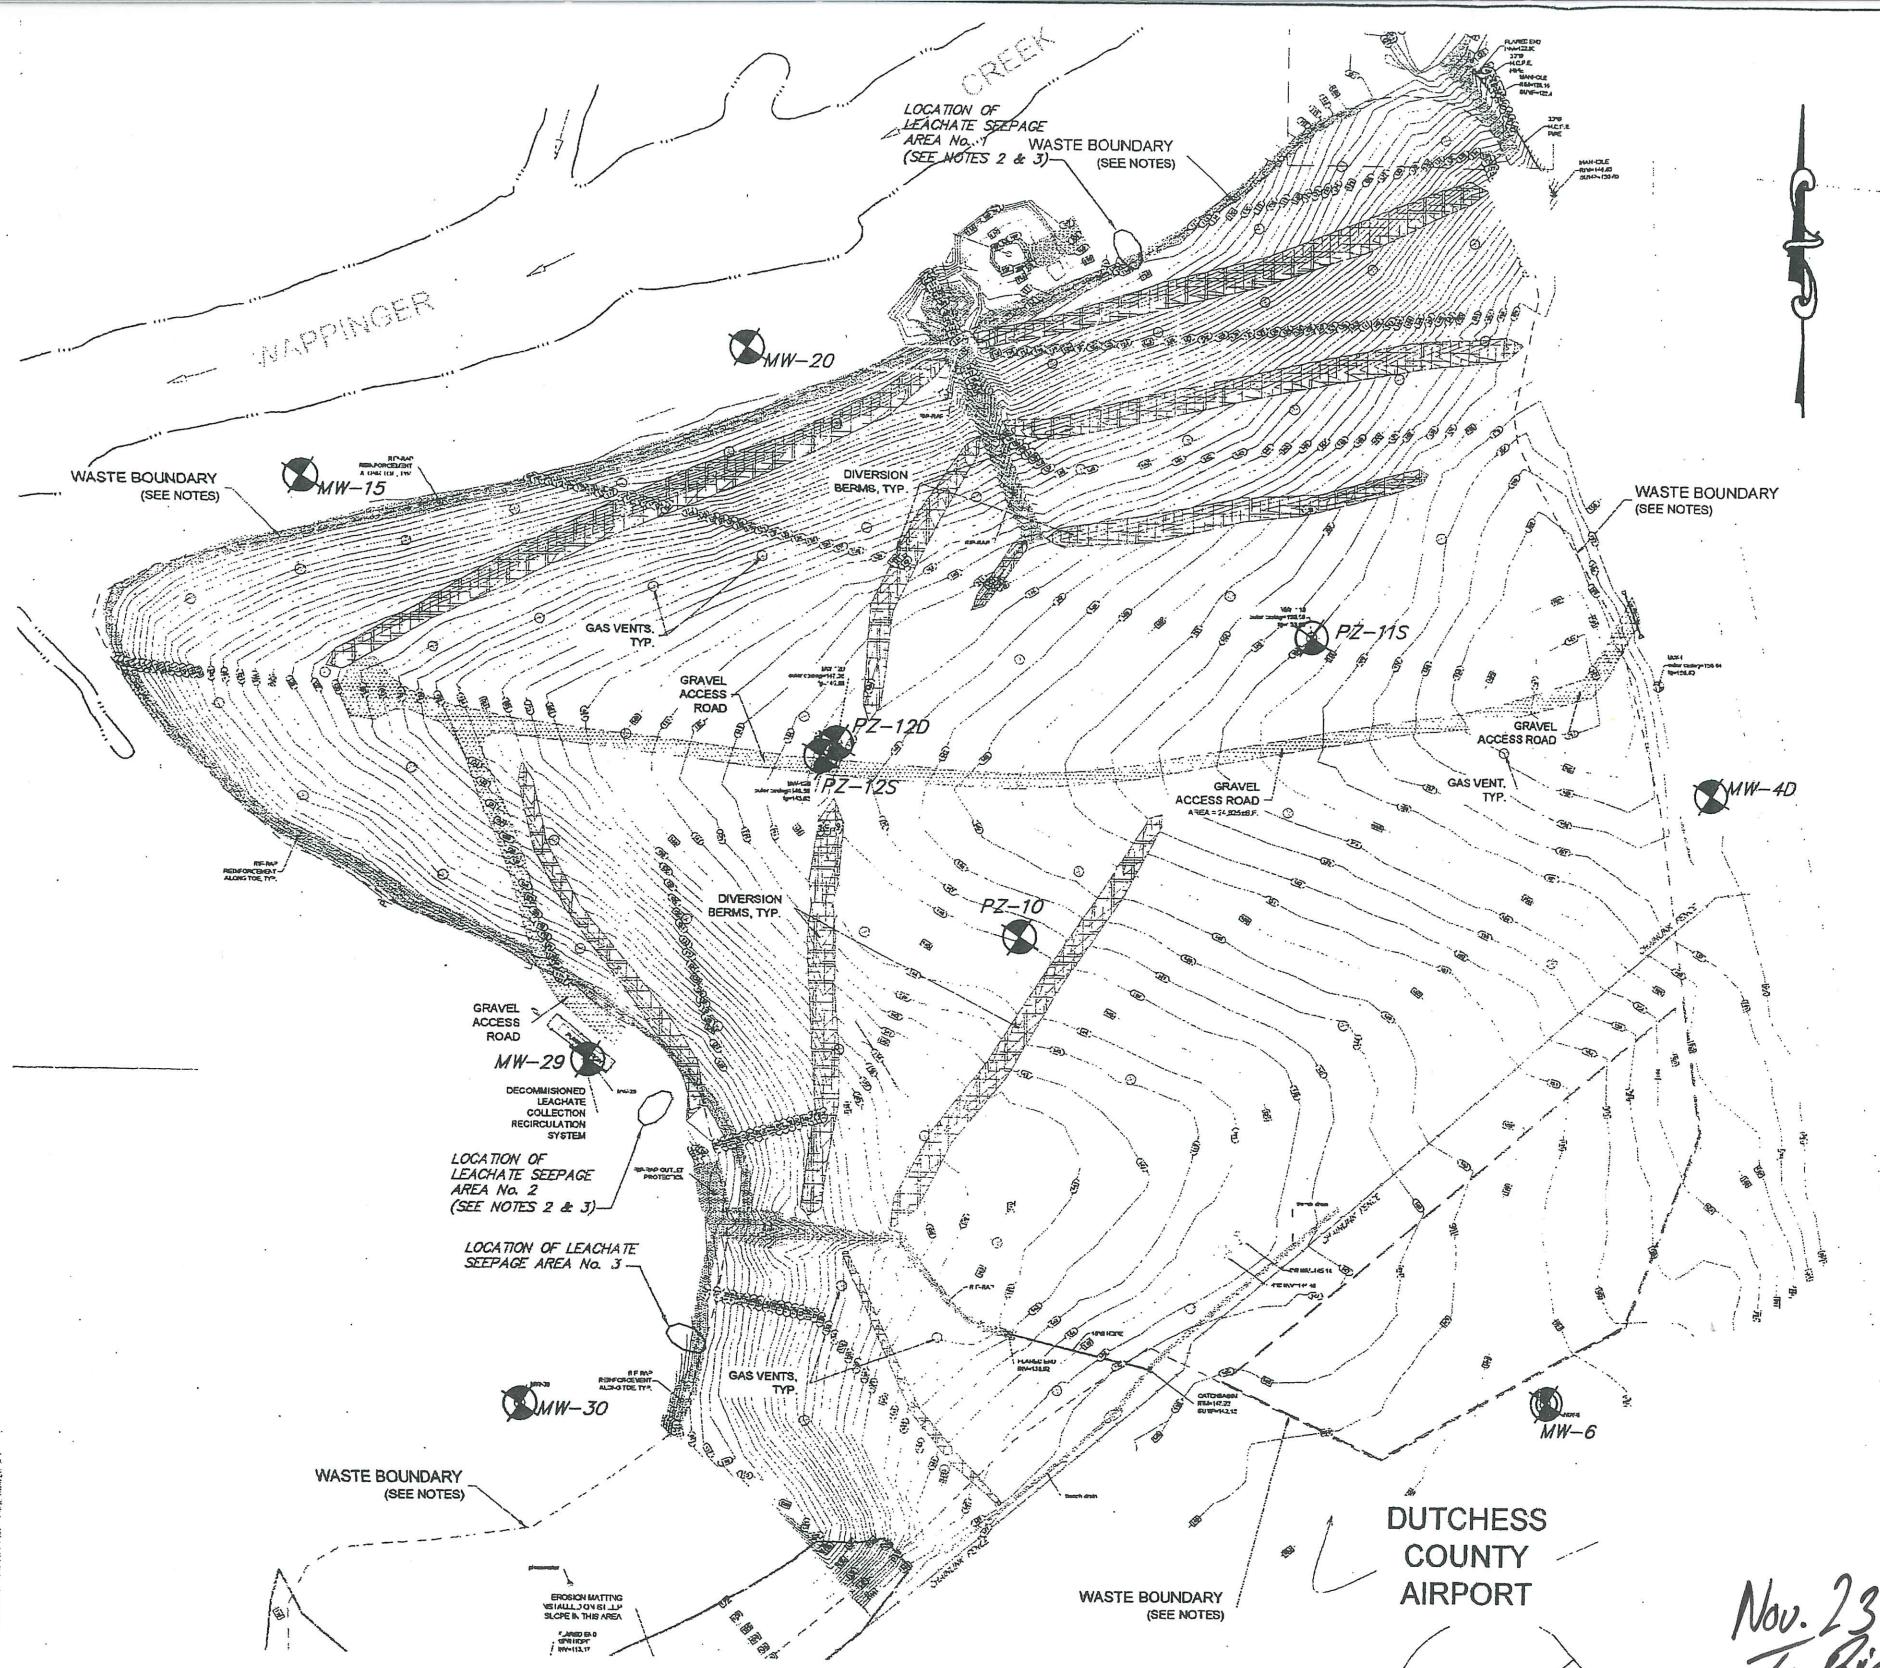
1. TOPOGRAPHY OBTAINED FROM SURVEY DATED JANUARY 25, 2007 PERFORMED BY PAGGI, MARTIN AND DEL BENE, LLP.
2. SURFACE SEEP LOCATIONS FOR AREAS No.1 AND No.2 AS OBTAINED BY PAGGI, MARTIN AND DEL BENE INC. ON JANUARY 12, 2007. THE LOCATION OF SEEP AREA No. 3 IS APPROXIMATED.
3. THE SURFACE SEEPS WERE COVERED WITH A MINIMUM 6-INCH LAYER OF COMPAKED CLAY AND APPROXIMATELY 6-INCHES OF SOIL TO SUPPORT VEGETATION. THE COVERING OF SEEP AREAS No. 1 AND No.2 PERFORMED BY URS CORP. ON JANUARY 17 AND 18, 2007 AND WITNESSED BY MORRIS ASSOCIATES. THE COVERING OF AREA No. 3 WAS ALSO PERFORMED BY URS ON SEPTEMBER 21, 2007.

Around the time of the substantial completion of Closure Construction, in January 2007, two locations of leachate seepage were observed. These locations are noted as Areas 1 and 2 on the site plan within Appendix A. These locations received a soil cover consisting of approximately six inches of compacted clay and six inches of soil suitable to support vegetation. This capping activity was performed in January 2007. A third area of leachate seepage was identified in June 2007. This area was covered in a similar manner in September 2007. The locations of all three locations are depicted on the site map.

Since these locations have been covered, Area 1 has exhibited no evidence of further seepage. The locations of seepage at Areas 2 and 3 were identified as areas that needed repair and were addressed in the summer of 2009. The areas were scraped off and a six inch layer of sand was placed on them. Top soil was then brought in and placed over the sand layer and hay and seed were placed on the two areas. As per the PCM&FMM, these locations will continue to be monitored as part of upcoming quarterly events. Any dramatic change in conditions or additional breakouts will be reported to the Department, as warranted.
