Request for Site Segmentation:  
Modification of the Van De Water Property  
NYSDEC Inactive Hazardous Waste Site No. 314040  
Van Wagner Road  
Town of Poughkeepsie  
Dutchess County, New York

Parcel E, Section II  
Subdivision of the Lands of  
Thomas R. Espie, Jr. and Betty Espie

Morris Associates  
Engineering Consultants  
367 Violet Avenue  
Poughkeepsie, New York 12601

October 27, 1994

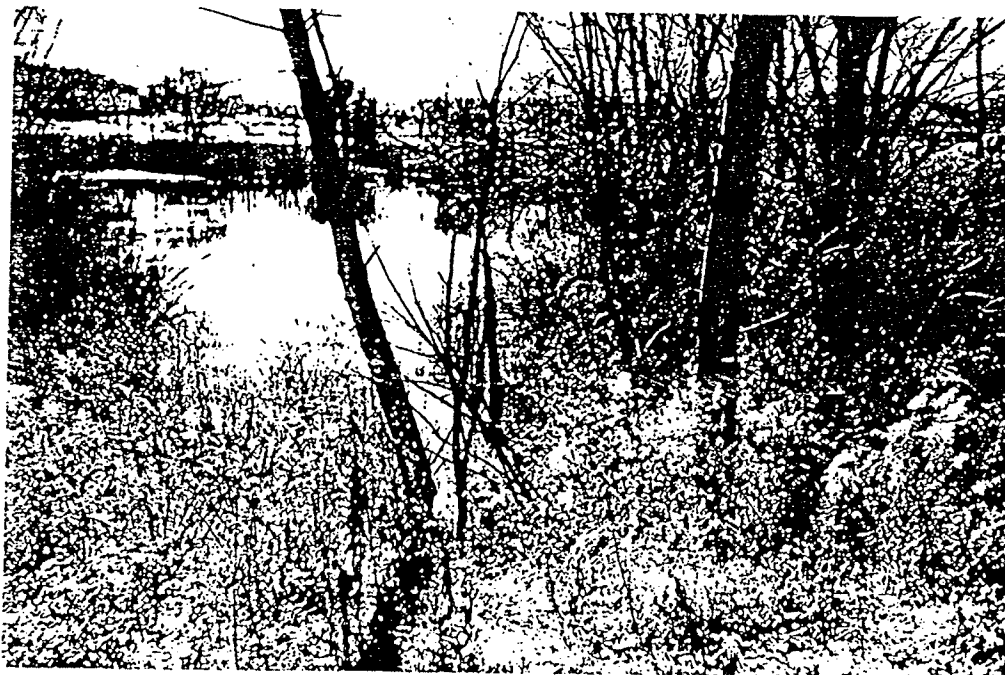
FIGURE 3-SITE PHOTOGRAPHS  
Van De Water Property

Ponded area of Casper Creek looking south from behind Mayflower building. Parking for Caldor's is in the upper right corner of photograph.

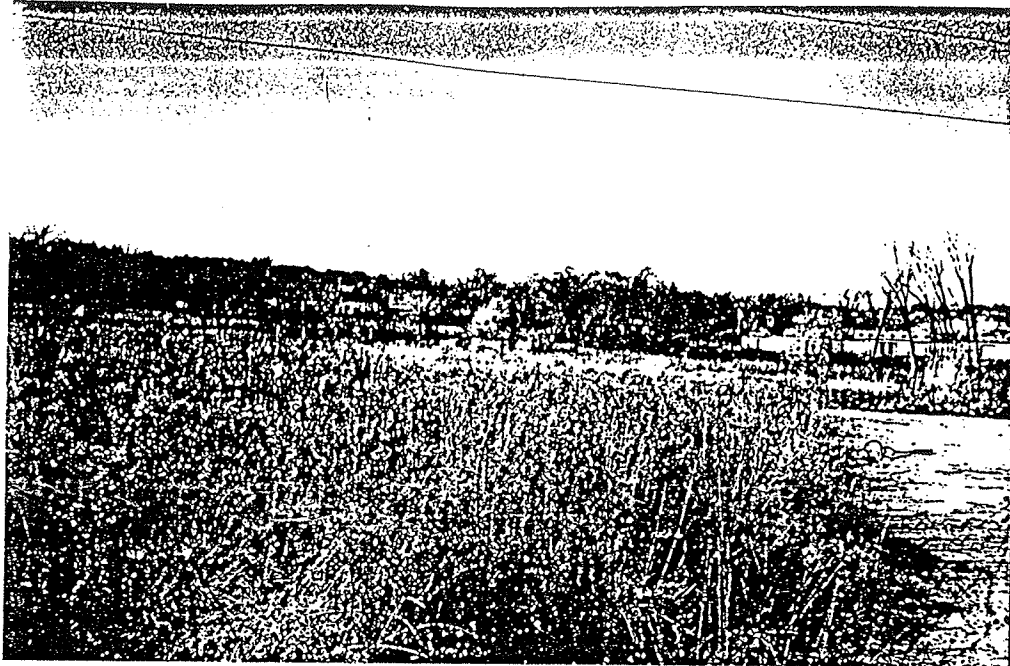
Looking north at northern portion of site where spring clean-up material from the Town of Poughkeepsie was deposited in trenches. Scraps of metal, wood, and plastic are visible on the ground surface.
