**Report of Findings  
Building 310 VOC Source Investigation and  
Implemented Measures  
IBM East Fishkill Facility  
Hopewell Junction, New York**

File 2999.00  
April 2010

Re: Report of Findings  
Building 310 VOC Source Investigation and Implemented Measures  
RFI Work Plan Implementation  
IBM East Fishkill Facility, Hopewell Junction, New York  
EPA ID No. NYD000707901

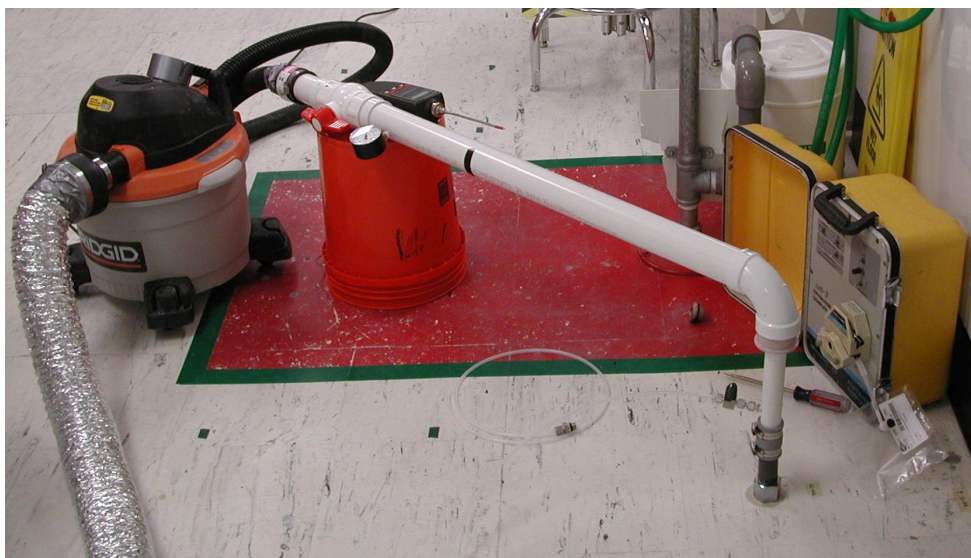
**Exhibit 2 - Subslab Extraction Testing Set-Up**

Subslab vapor extraction testing was performed at extraction ports SS-01 through SS-10 on May 6 through May 8, 2009. This testing was conducted to assess the method as a potential source reduction/remediation measure to remove VOC mass from beneath the floor slab. A shop-vacuum and temporary piping/hose, as shown in Exhibit 2, was used to extract vapor from below the slab at each location for test durations ranging from 30 to 65 minutes. Extraction rates ranged from 11 to 60 cubic feet per minute (cfm) at applied vacuums ranging from 20 to 52 in. wc.

Extraction testing conditions and pressure response results are shown on Figure 11. During the tests, samples of the extracted vapor were periodically collected into Tedlar bags and screened using a PID. Samples were also collected into Summa canisters near the conclusion of each extraction test. The screening and sampling data for each test are presented in Exhibit 3 below, and the complete analytical results for the extraction test vapor samples are provided in Table 3

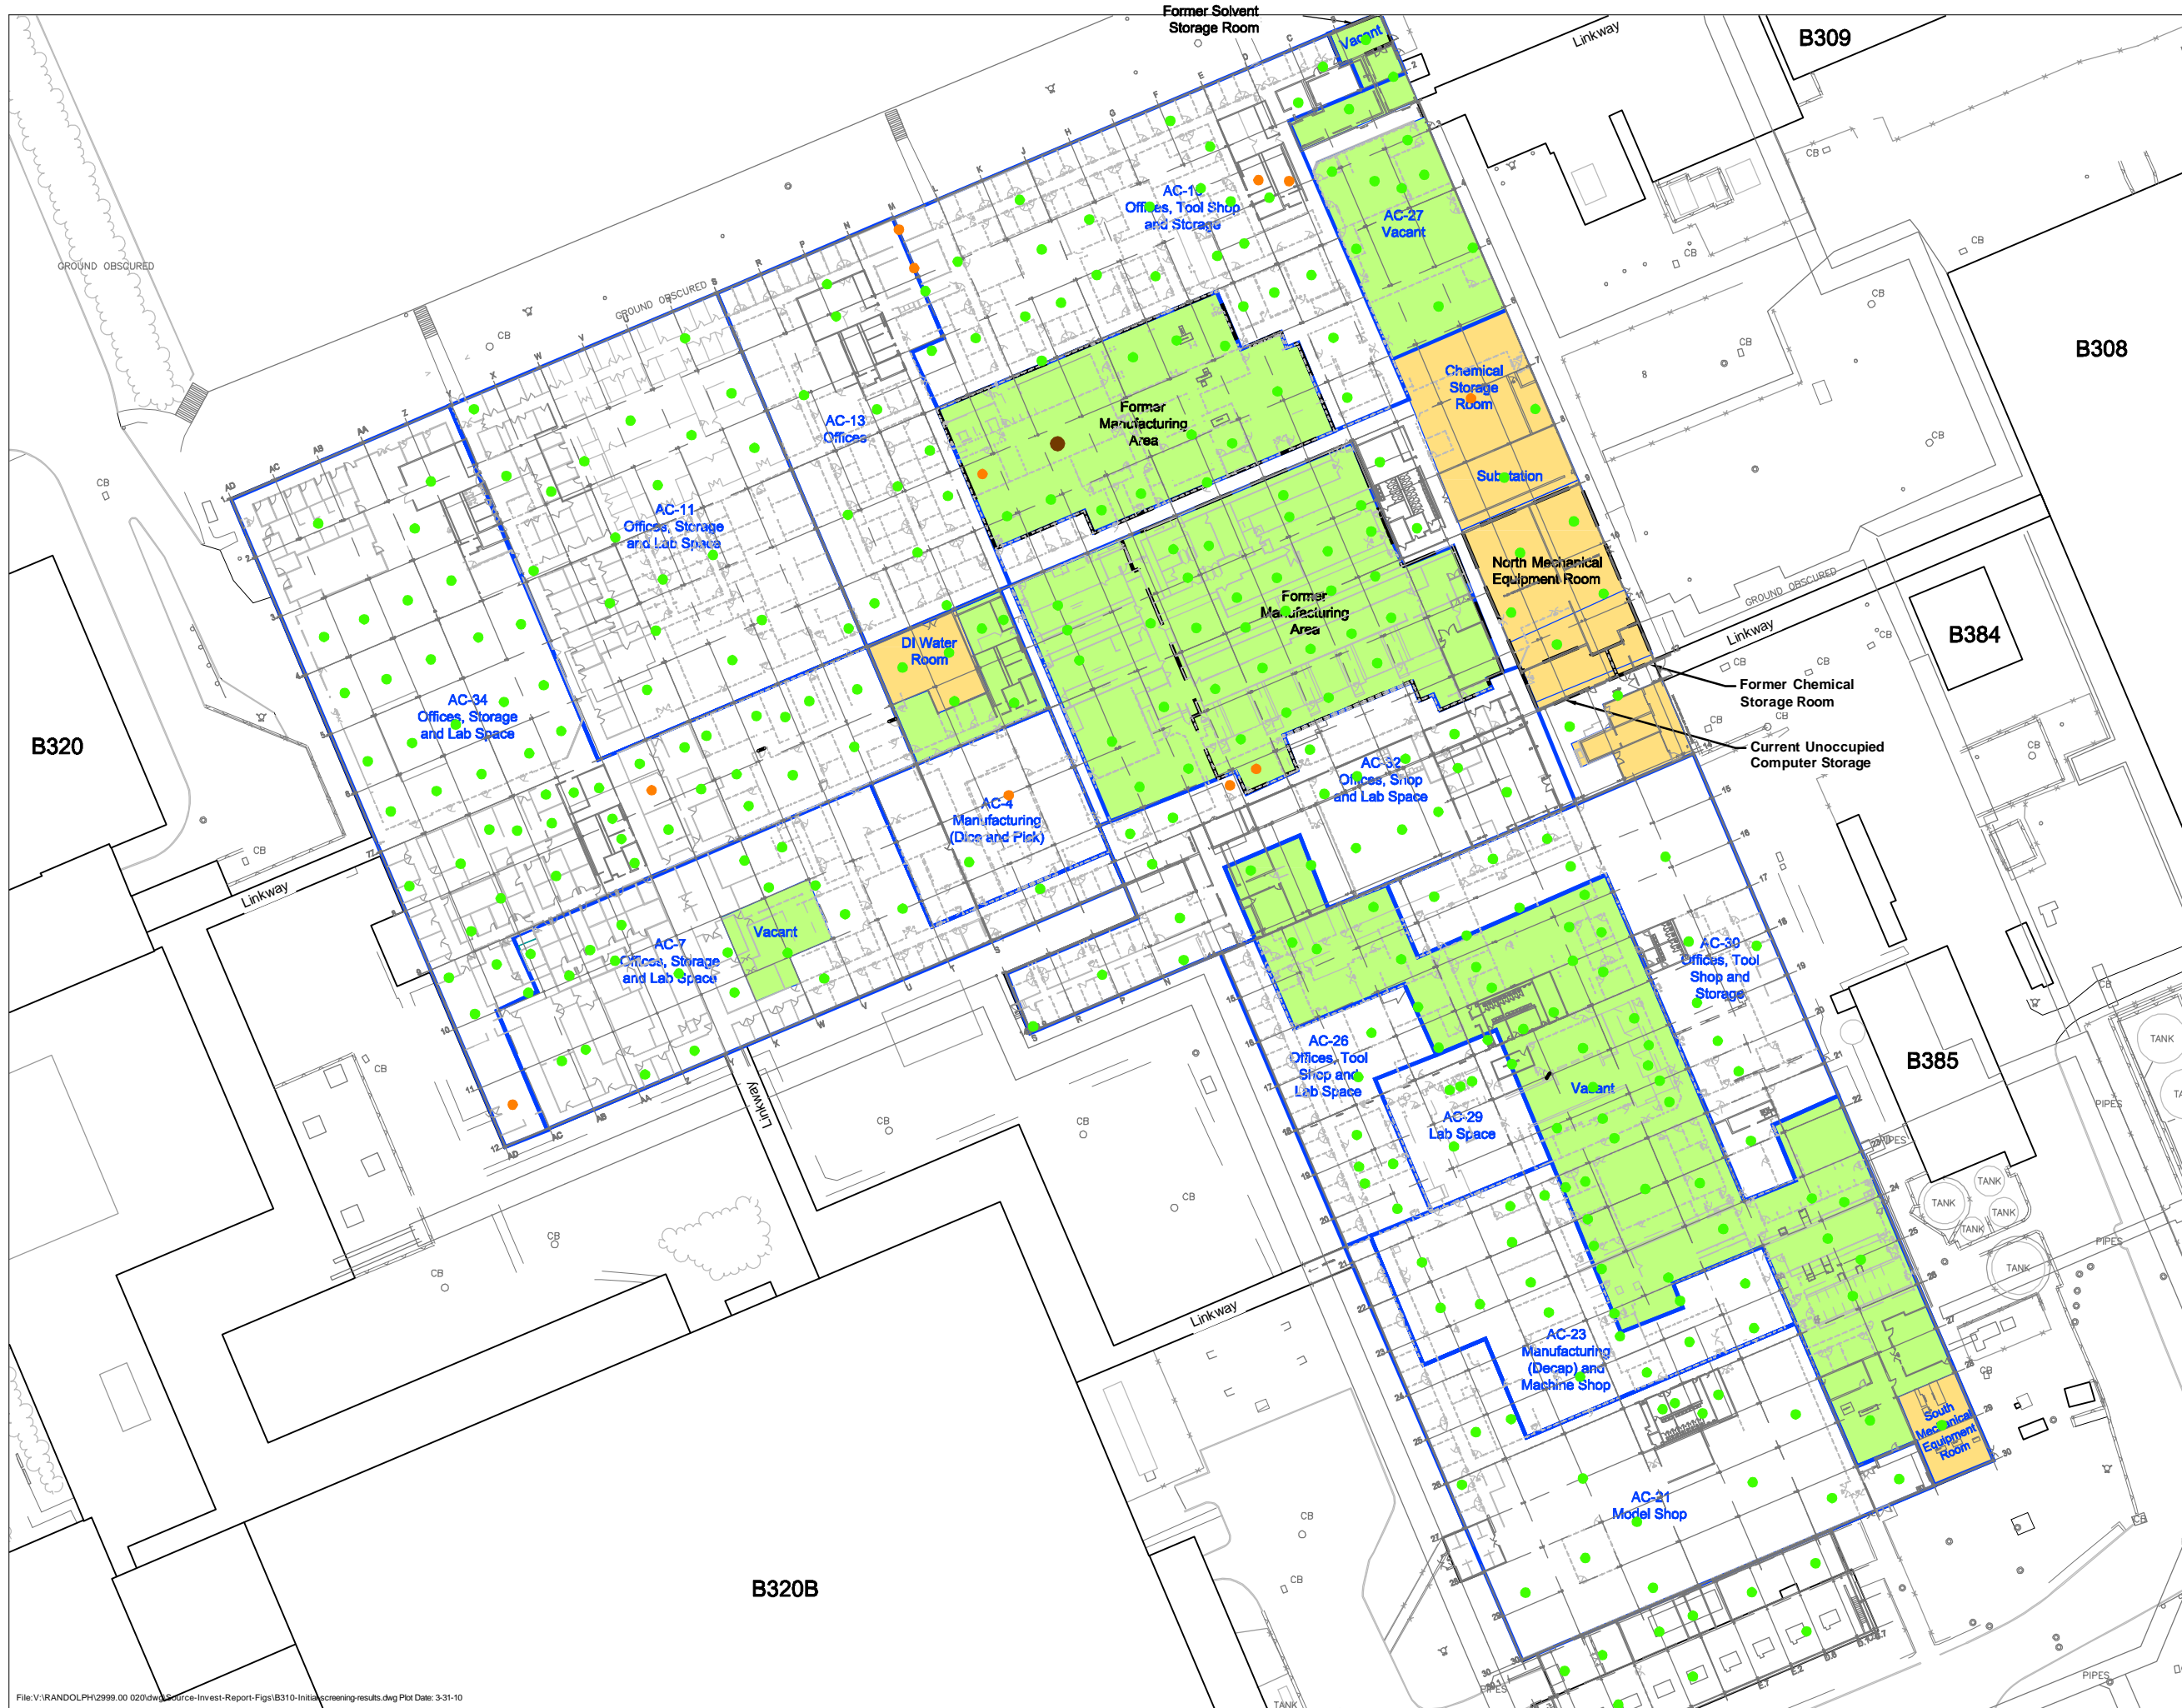
Figure 4  
**Initial VOC Screening Results**  
Report of Findings - Building 310 VOC Source Investigation  
IBM East Fishkill Facility  
Hopewell Junction, New York  
Drawn By: E. Wright  
Designed By: C. Lund  
Reviewed By: D. Shea  
Date: April 2010

**Figure Narrative**  
This figure shows the layout of the ground floor level of Building 310 and the results of indoor air screening performed in October and November 2008. Total volatile organic compound (VOC) screening was conducted using a hand-held photoionization detector (PID) with parts per billion by volume (ppbv) detection limit.

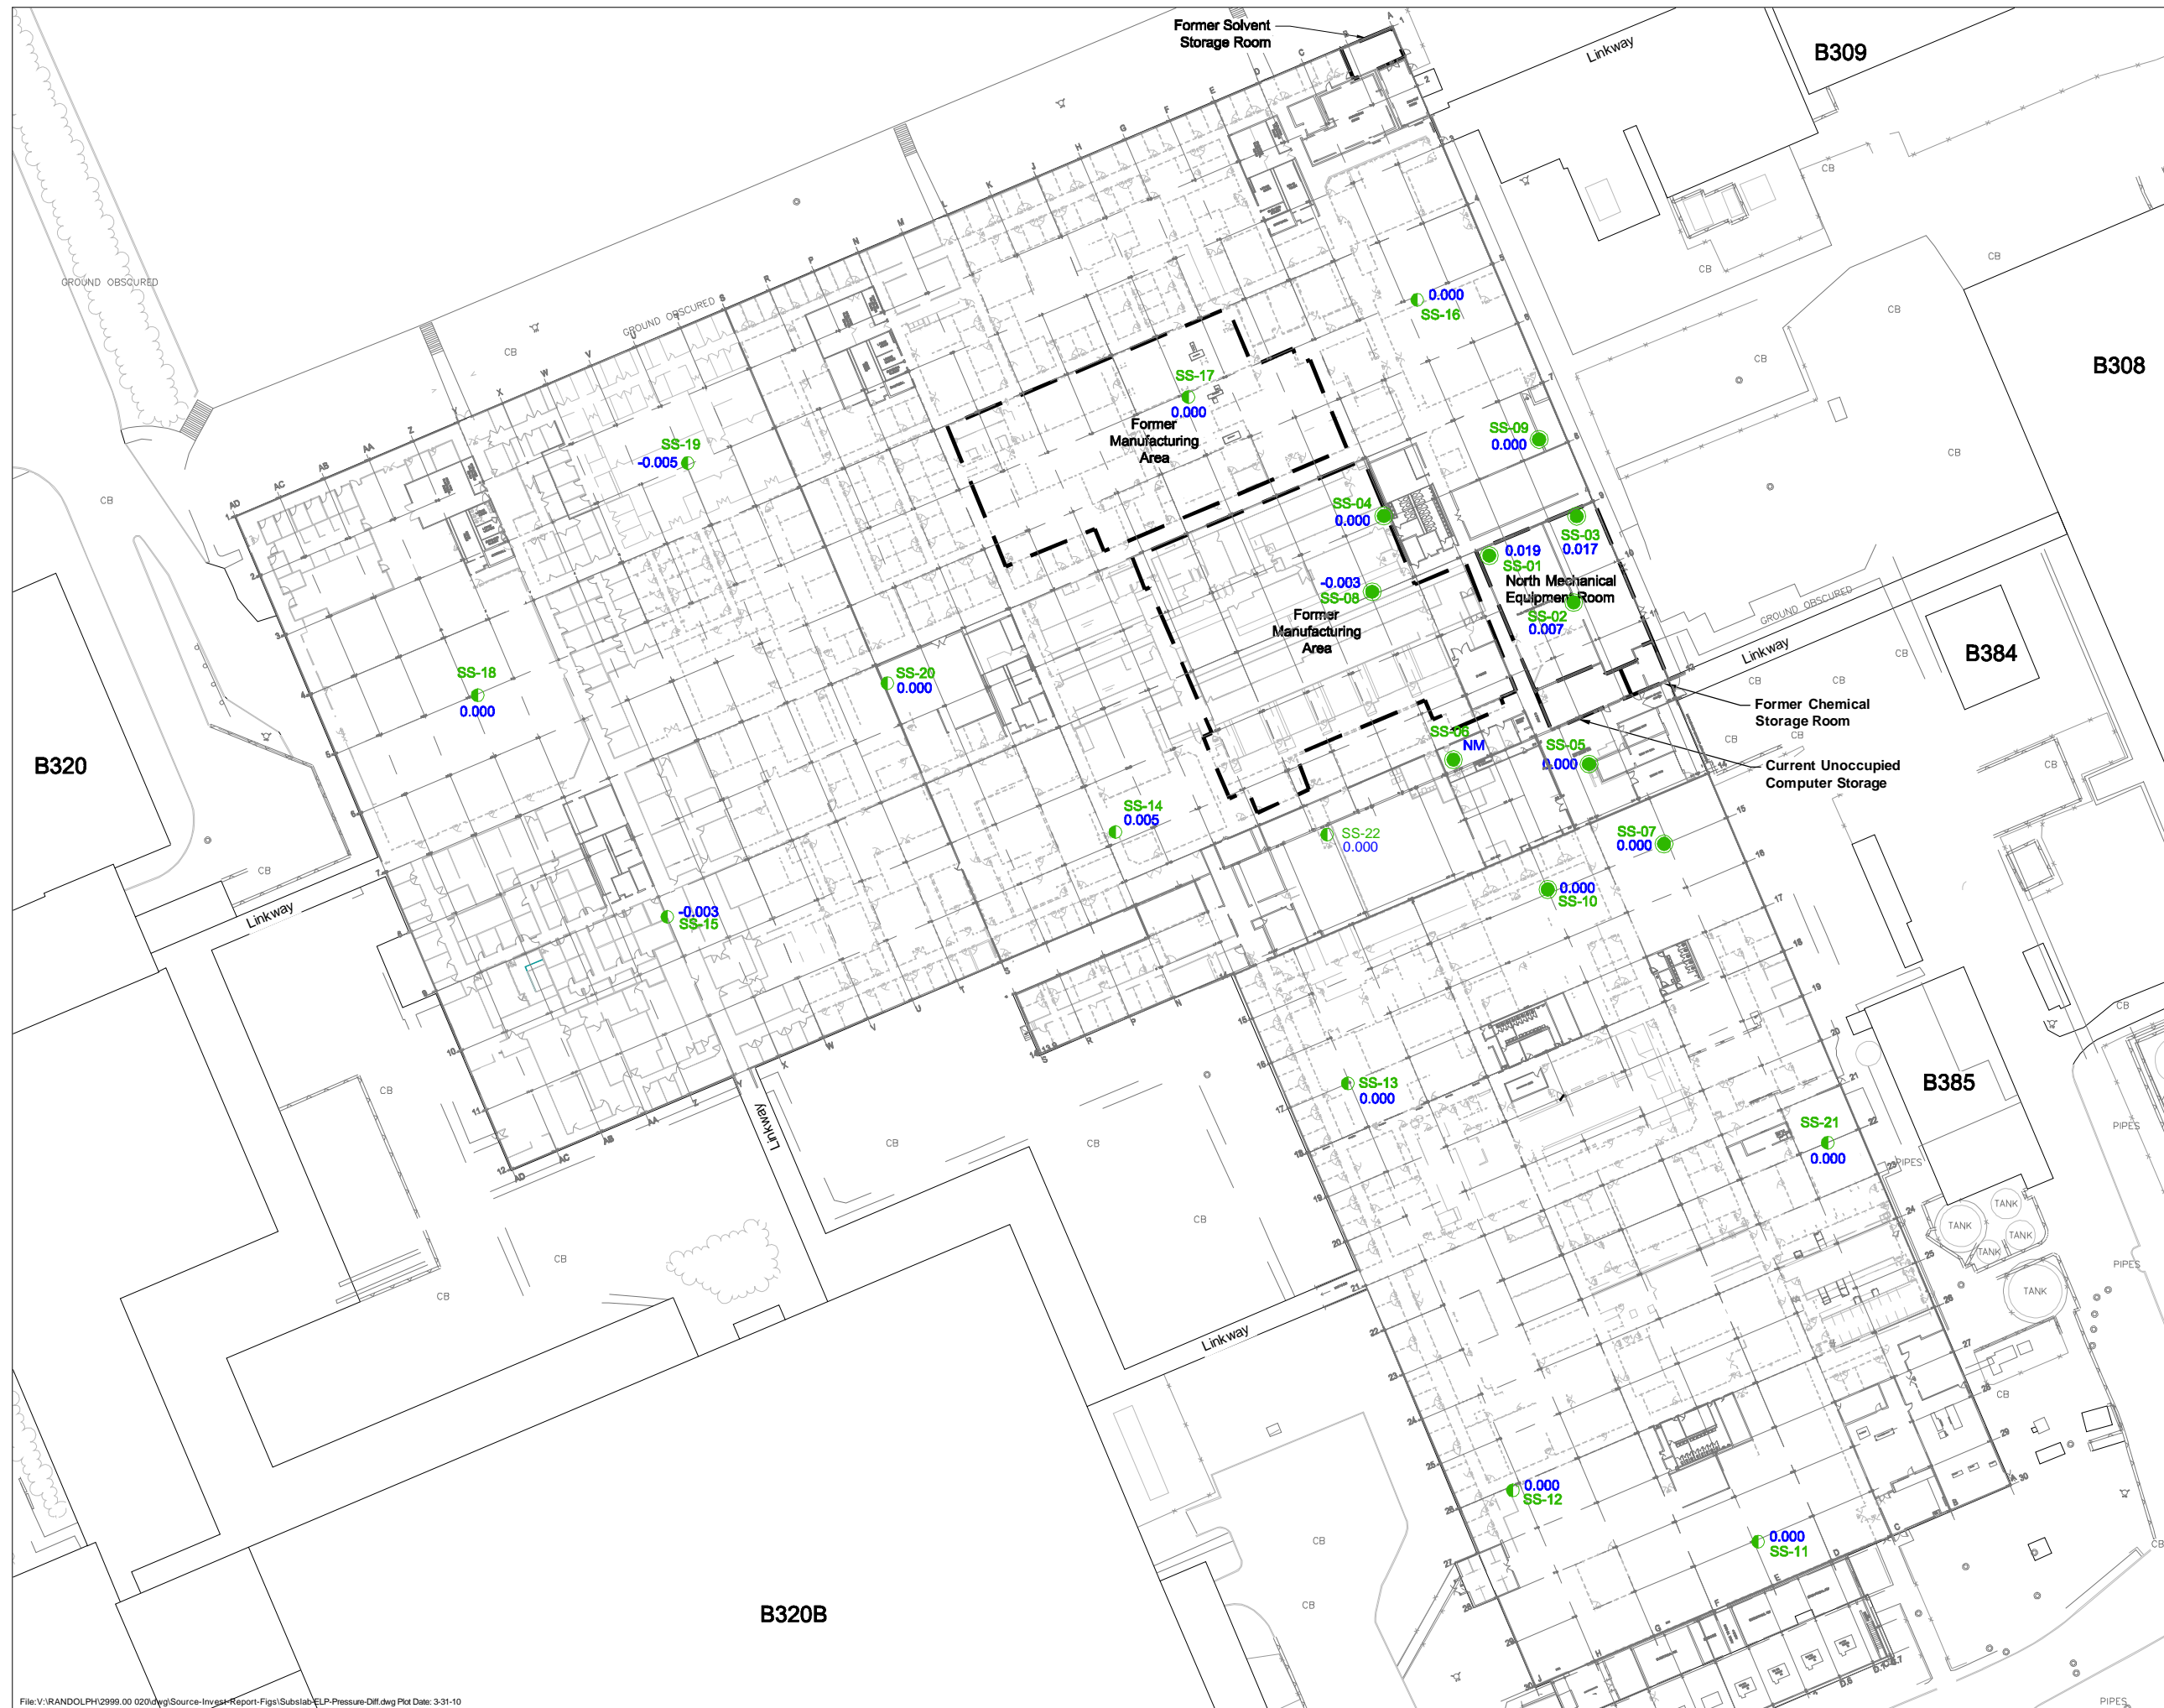
Figure 9

As shown on Figures 9 and 10, the subslab vapor presence of PCE and Freon 113 is centered within a region beneath the former manufacturing area in the eastern central portion of the building. The highest PCE concentrations are on the order of 1 million  $\mu\text{g}/\text{m}^3$  as detected in samples from ports SS-06 and SS-08. The subslab concentrations decrease with increasing distance from the region around SS-06 and SS-08, with the exception of an area in the southeastern part of Building 310 centered on port SS-21, where relatively higher PCE and Freon 113 were detected as compared to the sampling ports nearest this location.

Figures 9 and 10 also show the historically inferred patterns of VOCs in overburden groundwater along the east side of Building 310 currently being managed by the Area A groundwater recovery and treatment system housed in Building 384. The highest observed subslab PCE vapor concentration of 1,000,000  $\mu\text{g}/\text{m}^3$  is consistent with what would be expected from equilibrium partitioning of aqueous-phase PCE at about 1,700  $\mu\text{g}/\text{L}$ <sup>4</sup>.

The HVAC zone served by AC-30 along the southeastern side of the building overlies a localized area of relatively greater subslab VOC concentrations (see subslab port SS-21 on Figure 9). Field reconnaissance of a tool shop and abutting storage room near column B-22 identified six return air chases constructed such that the floor functions as part of the air duct system, which provides a potential pathway for subslab vapor to enter the HVAC system. The ACH for the tool shop and the storage room based on outdoor air flow was calculated to be relatively low at  $0.9 \text{ hr}^{-1}$  and  $0.3 \text{ hr}^{-1}$ , respectively.

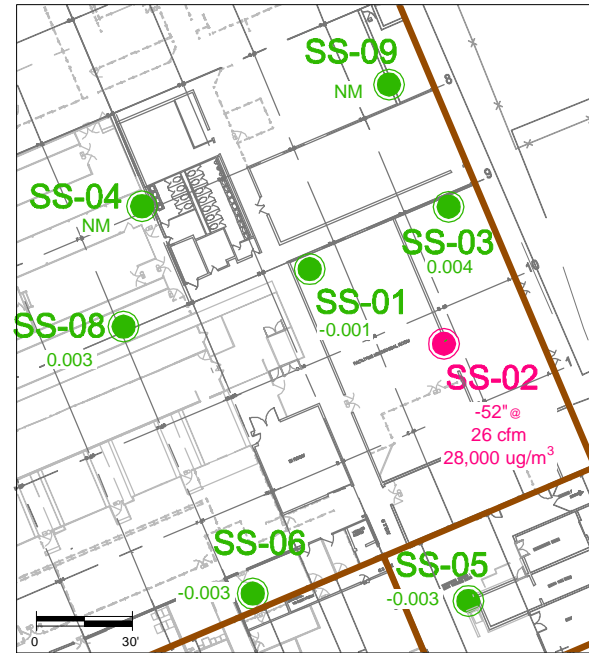
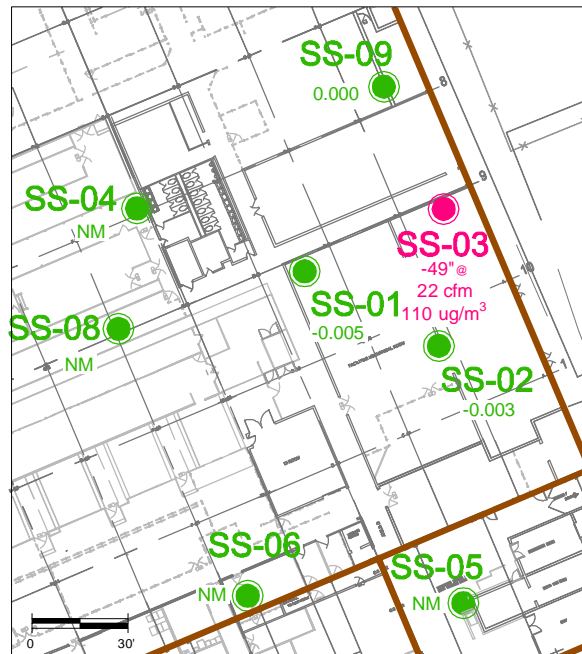
# Figure 11

Figure 11 shows the subslab pressure response observed near the end of each test when pressure readings had generally stabilized. These data indicate generally limited subslab vacuum response to extraction conditions. The generally limited extent of measurable vacuum is consistent with the modest rate of extraction and may also reflect the presence of building foundation elements (grade beams), floor trenches, and sumps that likely act as barriers to flow or boundary conditions limiting expansion of the vacuum field.

Each of the nine inserts show the extraction rates, vacuums, and observed changes in subslab pressure for a single test. The extraction port where the test was being performed is highlighted in red. No results are shown for the extraction test performed at SS-04 due to water in the extraction port.

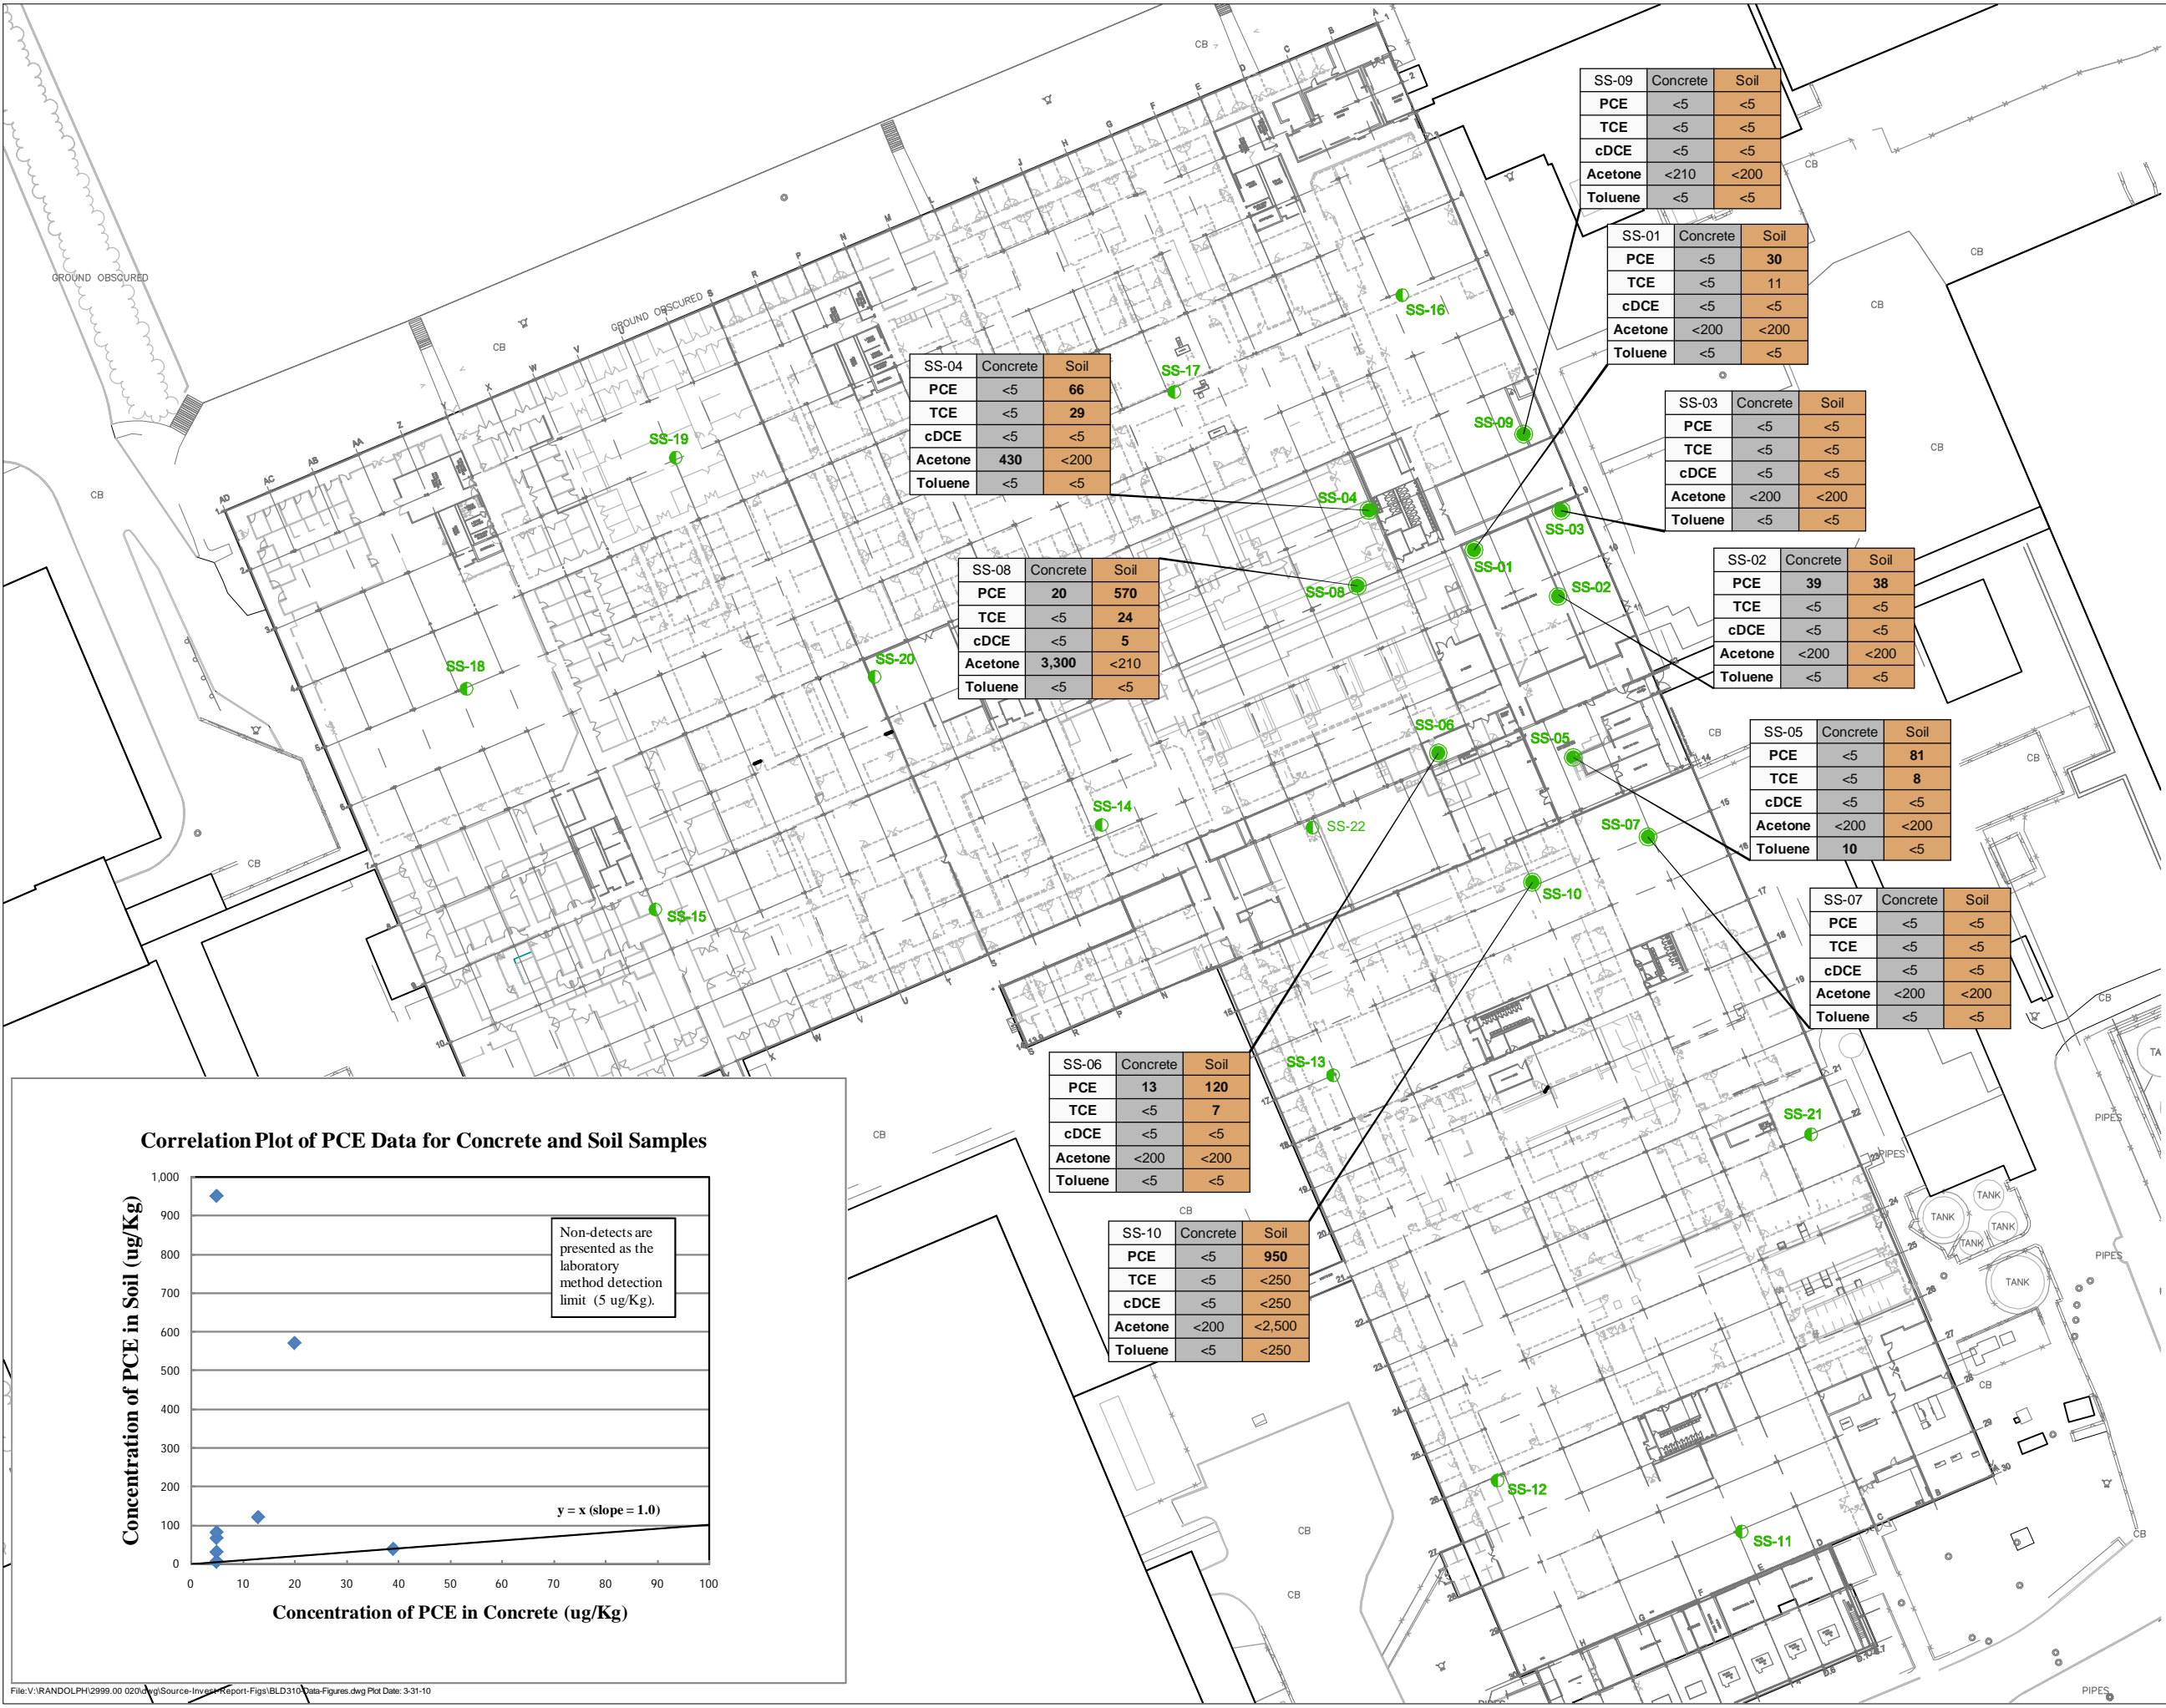
The locations of the concrete core and soil samples, and associated laboratory analytical results, are shown on Figure 12 and provided in Table 4. For the concrete samples, laboratory analysis indicated PCE at concentrations ranging from less than 5 micrograms per kilogram ( $\mu\text{g/Kg}$ ) to 20  $\mu\text{g/Kg}$ . SHPC believes that these concentrations are not sufficient to support off-gassing of PCE from the concrete alone as a principal source for the PCE presence observed in indoor air.

Concrete and Soil  
Sampling Results

- Although lab testing of floor slab concrete confirmed the presence of PCE in the concrete, the results do not indicate PCE concentrations that would solely account for the observed concentrations in indoor air. Soil samples collected from beneath the slab indicated the presence of PCE at concentrations consistent with the subslab PCE vapor concentrations.
