# **SUBSLAB DEPRESSURIZATION SYSTEM COMPLETION AND STARTUP REPORT (PHASE I)**

**BUILDING 330C**

*Former IBM East Fishkill Facility  
Hopewell Junction, New York*

*Prepared for IBM Corporate Environmental Affairs  
File No. 2999.04  
October 2019*

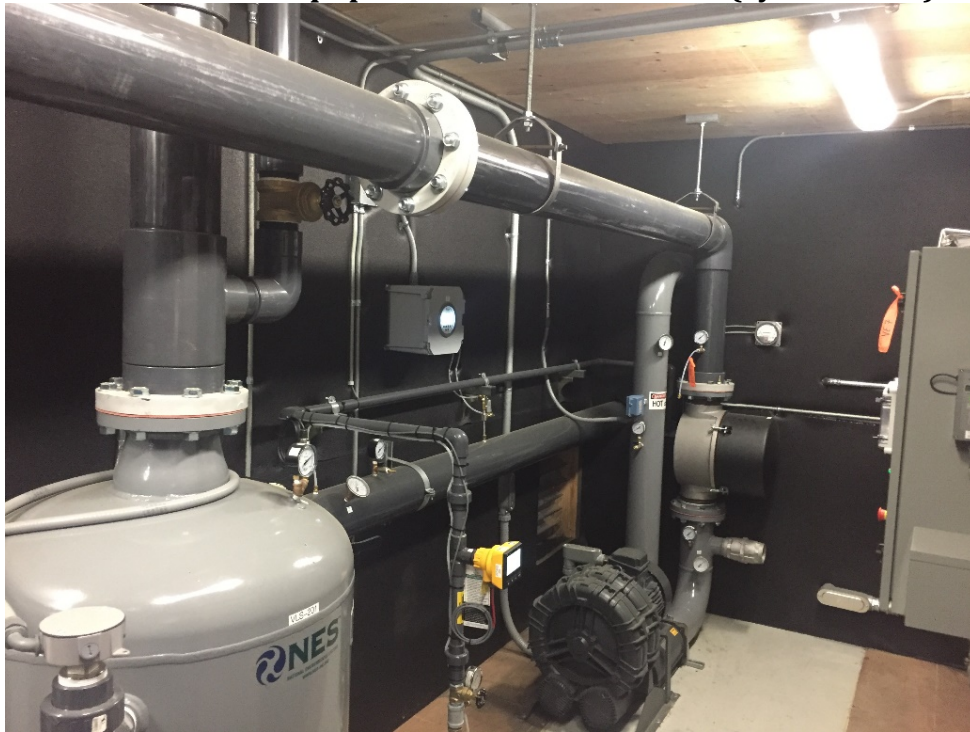
**Exhibit 3.1: SSD Equipment Enclosure Interior (System VE-7)**

Subslab vapor is withdrawn from extraction ports EP3007, EP3018, and EP3019 as shown on Figure 3. Vapor is withdrawn from beneath the slab using a 25-horsepower, regenerative-type vacuum blower installed inside one of two equipment enclosures (System VE-7) located on the south side of B330C. Subslab vapor is pulled through a vapor-liquid separator and treated via three 700-lb granular activated carbon (GAC) adsorber units plumbed in a lead-lag-polish series configuration. The treated vapor then enters the vacuum blower and is discharged above the B330C roofline and away from any outside air intakes. The system is equipped with instruments, controls, and alarms so that the appropriate personnel are notified automatically in the event of a malfunction. The system in the second SSD enclosure (System VE-8) will cover other areas of B330C, including the area currently covered by System VE-4, once the SSD system piping has been installed in those areas. Photographs of System VE-7 enclosure are provided in Exhibits 3.1 and 3.2 below.

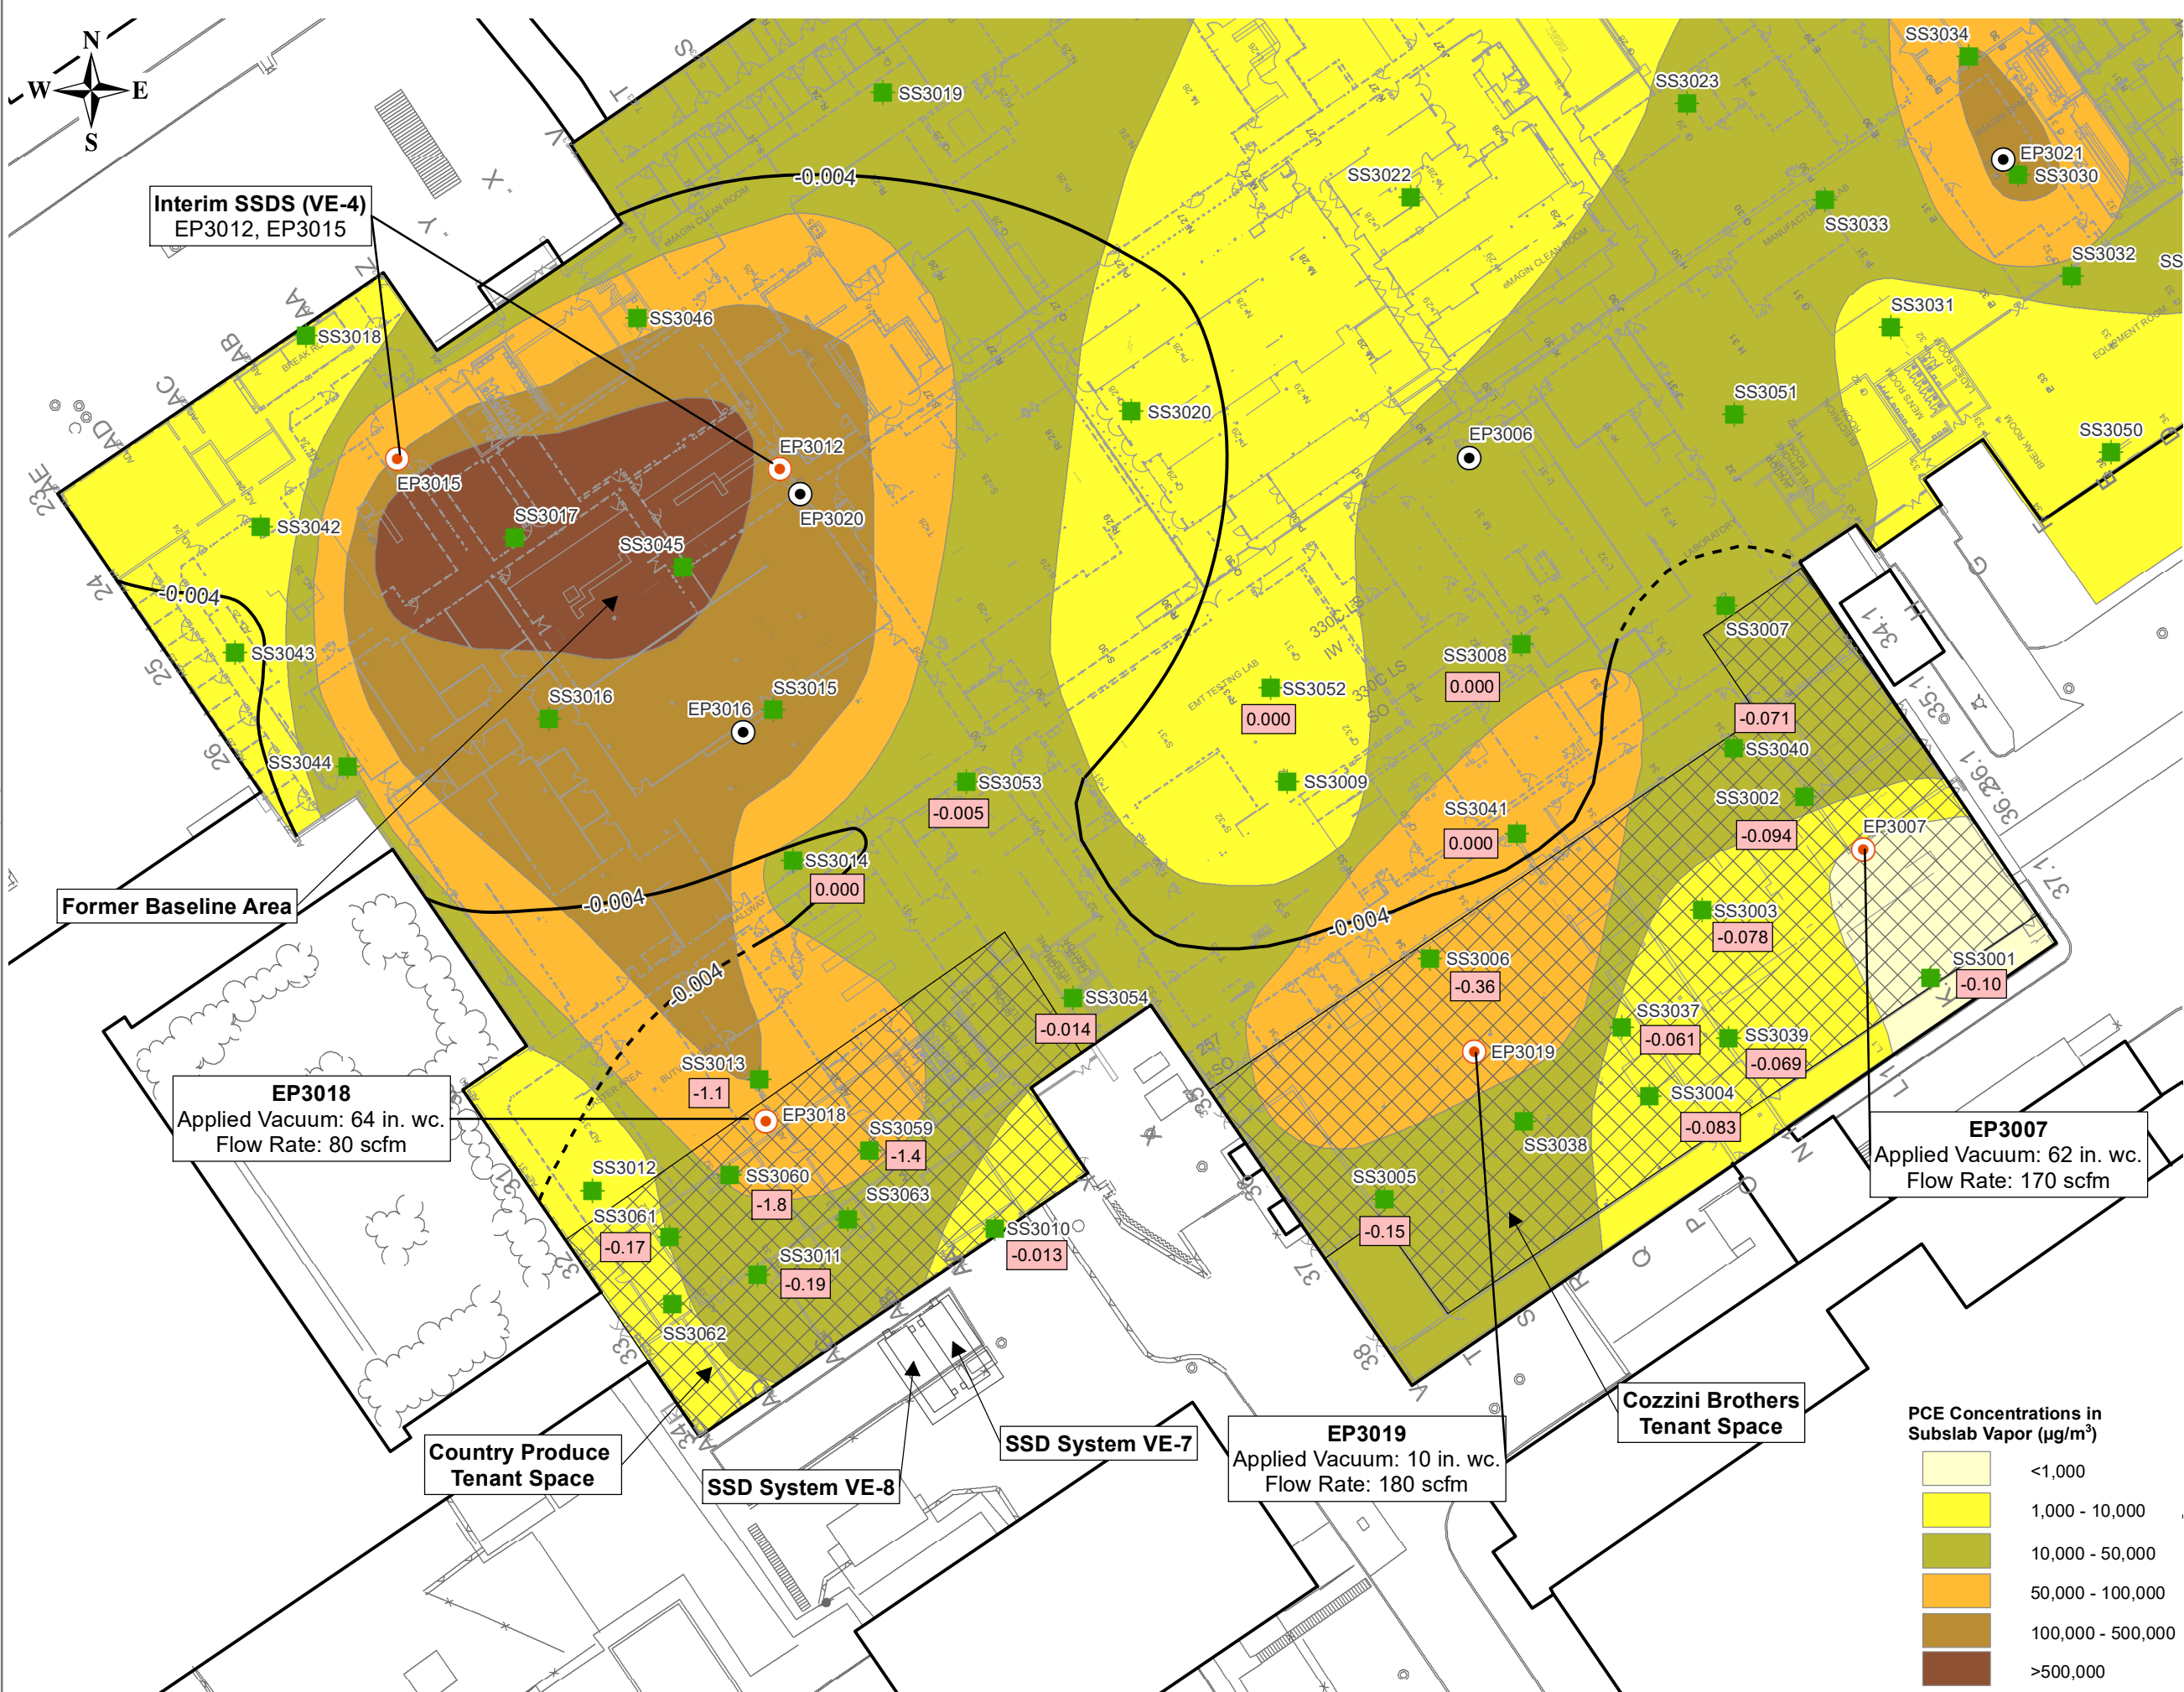
The applied vacuums and flow rates measured at the operating extraction ports during startup are shown on Figure 4. A combined total of 430 standard cubic feet per minute (scfm)

of subslab vapor is being extracted by System VE-7. The resulting cross-slab differential pressure measurements collected at these conditions are also shown on Figure 4, along with the inferred extent of the subslab pressure response depicted by the differential pressure isopleth. The applied vacuums, extracted vapor flow rates, and subslab differential pressure response are generally consistent with observations made during pilot testing activities and indicate subslab depressurization of the occupied Country Produce and Cozzini Brothers tenant space footprints.

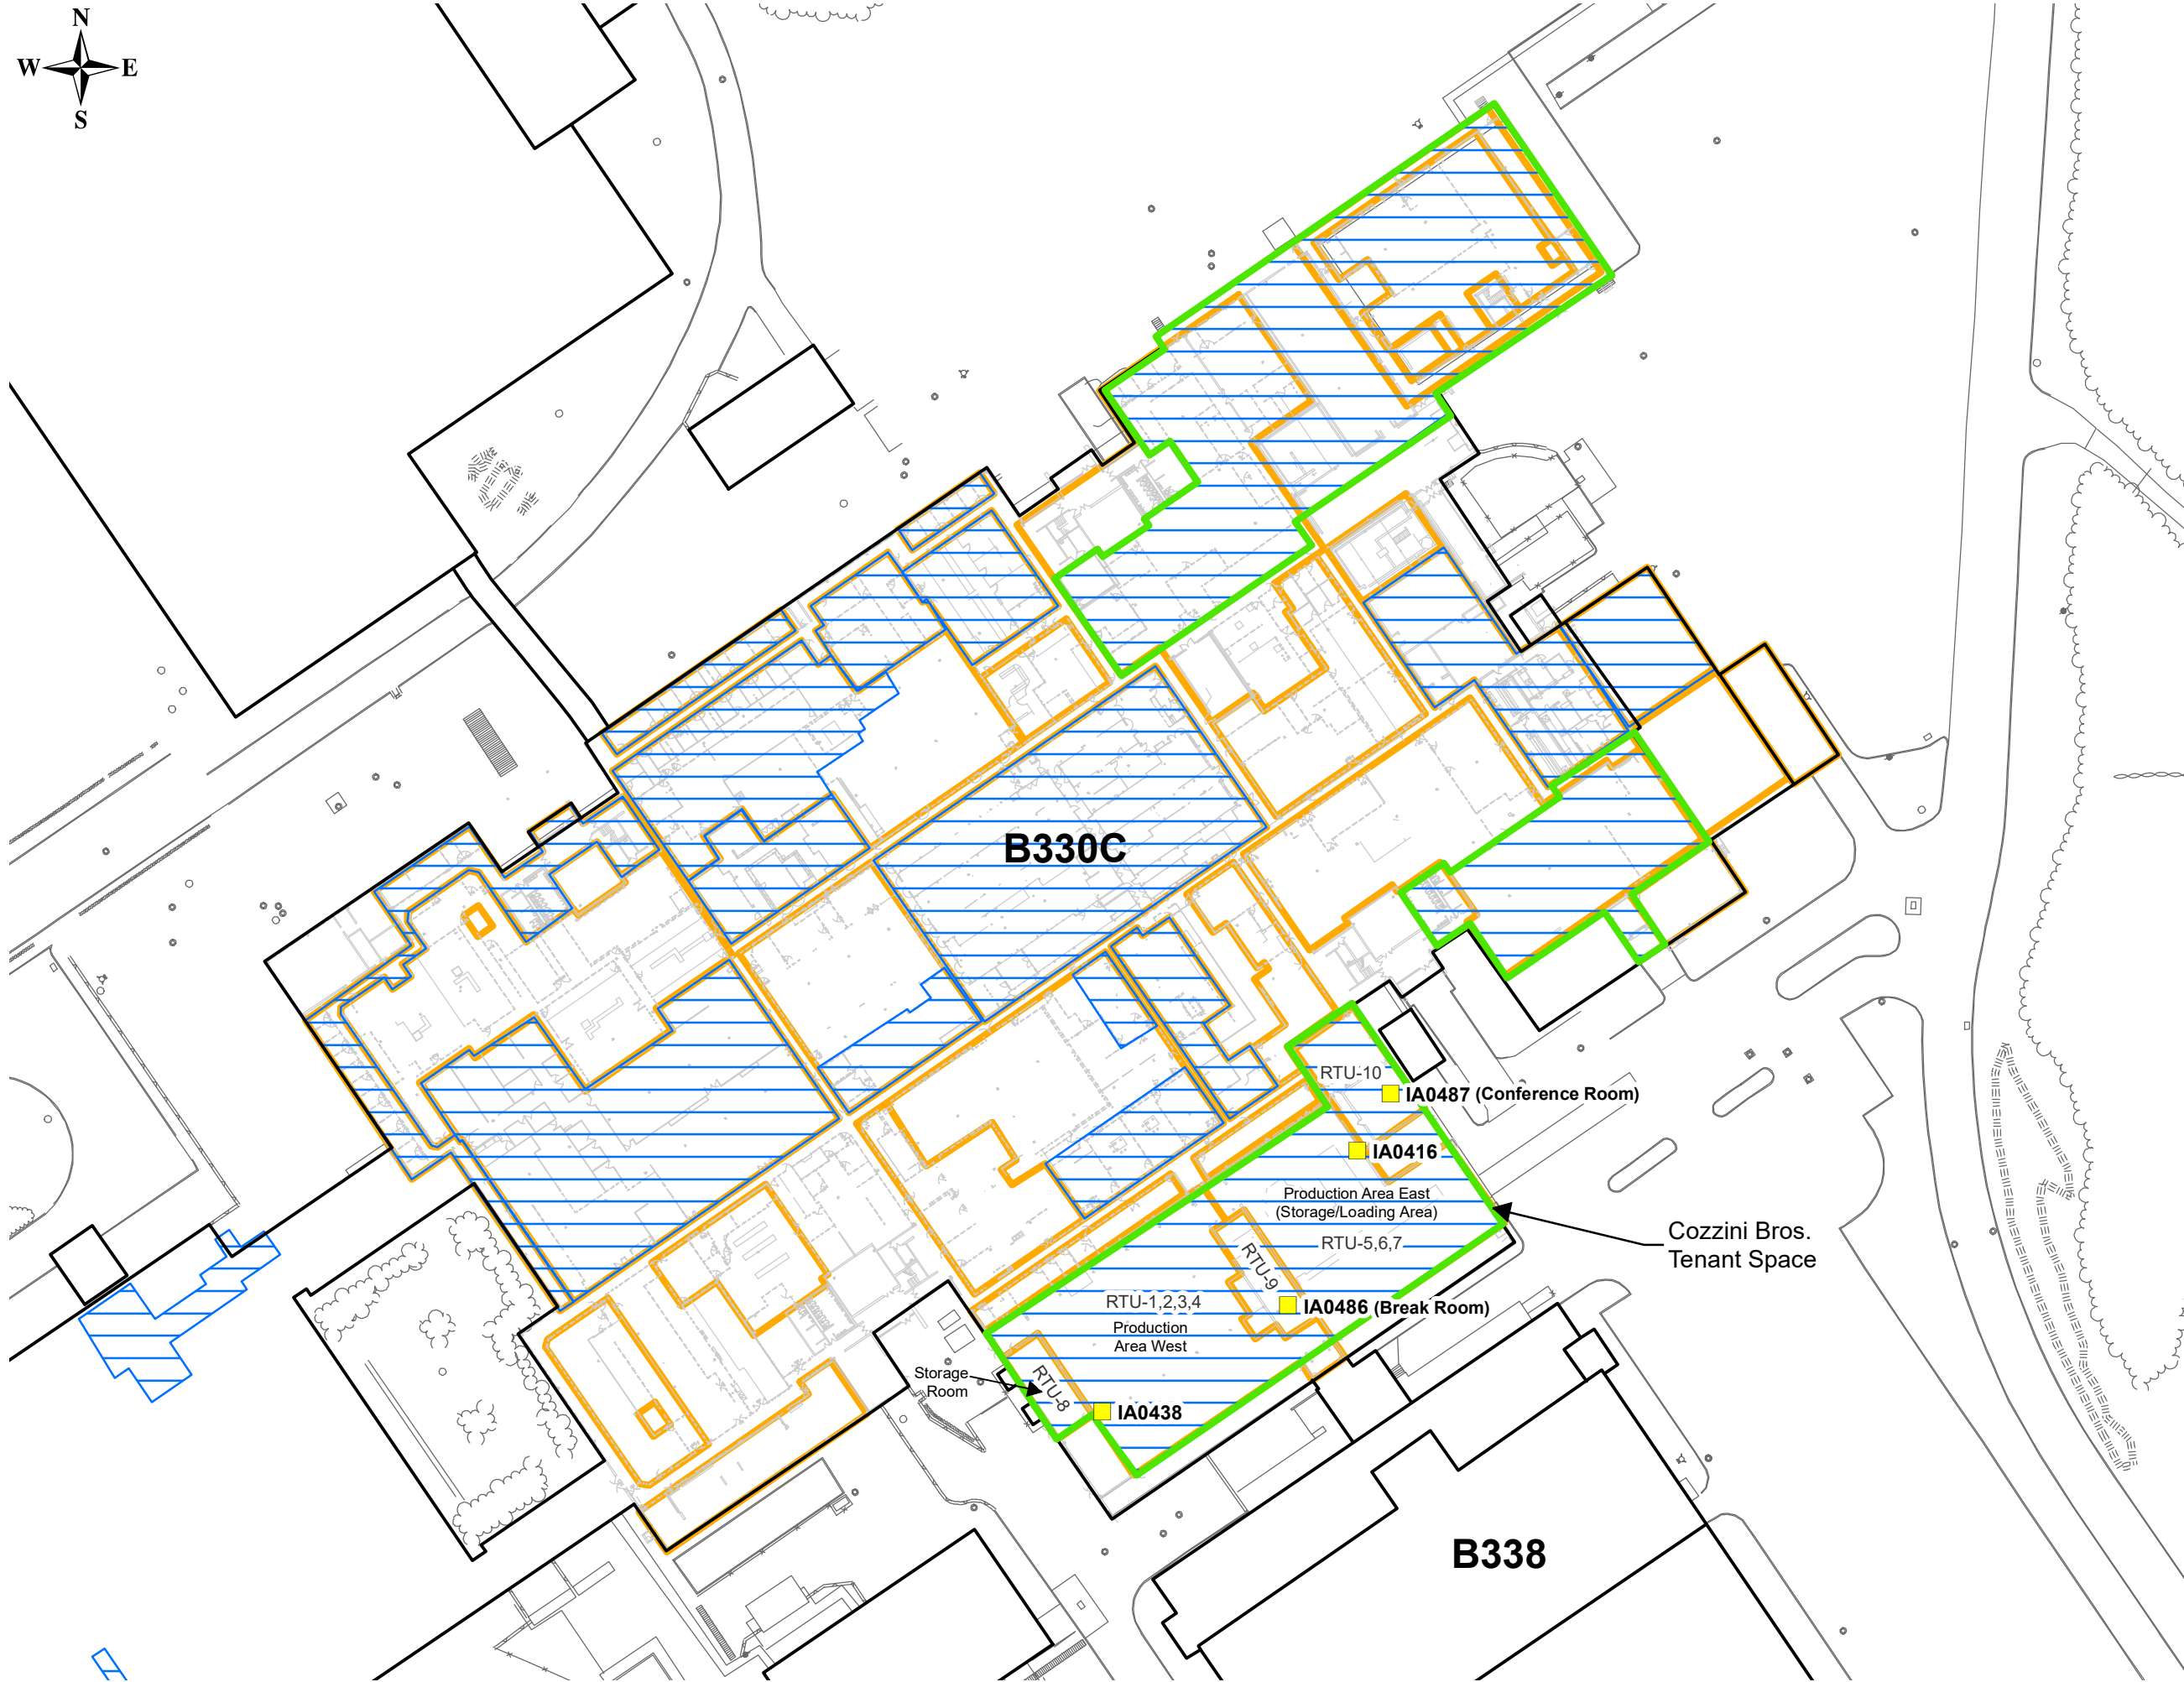
| Parameter | ppbv<br>Result | ppbv<br>RL | ug/m3<br>Result | ug/m3<br>RL | Date/Time | By | Dilution |
|---|---|---|---|---|---|---|---|
| Trichloroethene | 0.051 | 0.037 | 0.27 | 0.20 | 07/29/19 | KCA | 1 |

# Indoor Air Sample Locations of September 5, 2018

IAQ testing was conducted in conformance with the procedures described in IBM's RCRA Facility Investigation (RFI) Work Plan, which was approved by the New York State Department of Environmental Conservation and Department of Health. IAQ samples were collected using 6-liter, pre-evacuated, stainless-steel canisters (Summa® canisters) equipped with flow controllers to obtain 8-hour time-averaged samples. Indoor air samples were collected from breathing zone height of 3 to 5 feet above the floor at the four locations shown on attached Figure 1. These locations are identified as follows:
