Re: Subslab Depressurization System Completion and Startup Report–  
Building 330D North System  
Former IBM East Fishkill Facility  
NYSDEC Site No. 314054, EPA ID No. NYD000707901,

**SUBSLAB DEPRESSURIZATION SYSTEM  
COMPLETION AND STARTUP REPORT  
BUILDING 330D NORTH SYSTEM**

*Former IBM East Fishkill Facility  
Hopewell Junction, New York*

*Prepared for IBM Corporate Environmental Affairs  
File No. 2999.05  
December 2019*

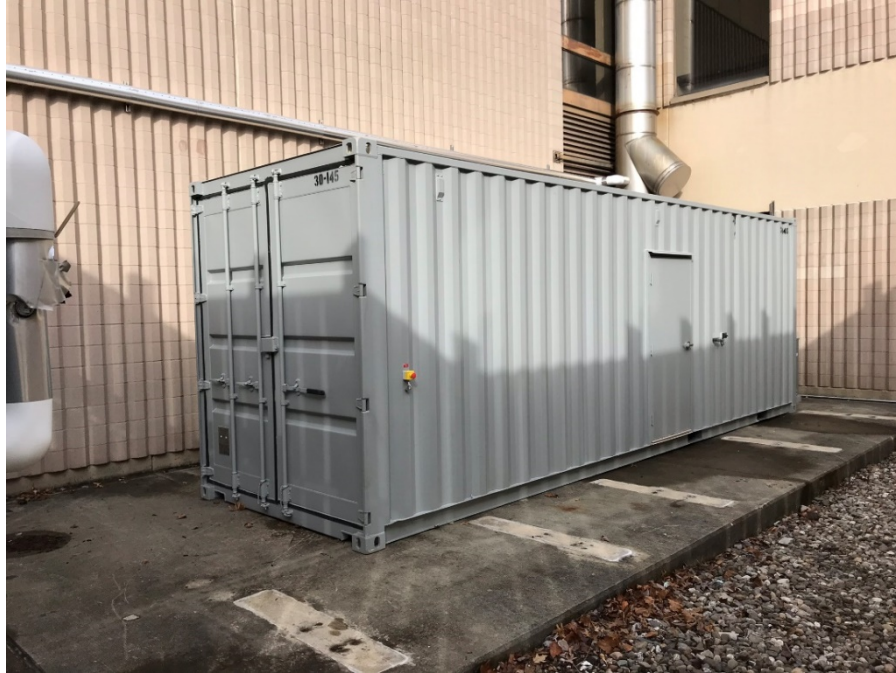
**Exhibit 3.1: System VE-1 Equipment Enclosure Exterior**

Subslab vapor is withdrawn from extraction ports EP4017 and EP4023, and suction pit SP4001, as shown on Figure 3. Vapor is withdrawn from beneath the slab using a 25-horsepower, regenerative-type vacuum blower installed in an equipment enclosure (System VE-1) located on the northwest side of B330D. Subslab vapor is pulled through a vapor-liquid separator and treated via three 700-lb granular activated carbon (GAC) adsorber units plumbed in a lead-lag-polish series configuration. The treated vapor then enters the vacuum blower and is discharged above the B330D roofline and away from any outside air intakes. The system is equipped with instruments, controls, and alarms so that the appropriate personnel are notified automatically in the event of a malfunction. Photographs of System VE-1 enclosure are provided in Exhibits 3.1 and 3.2 below.

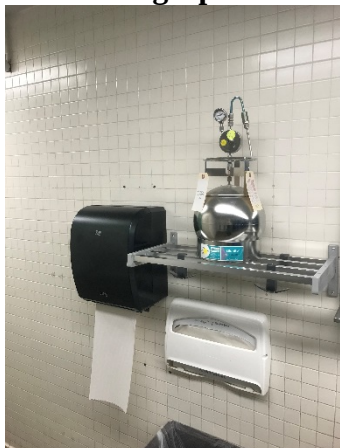
**Photograph #1**

Sample Location IA-1, located in Men's Restroom

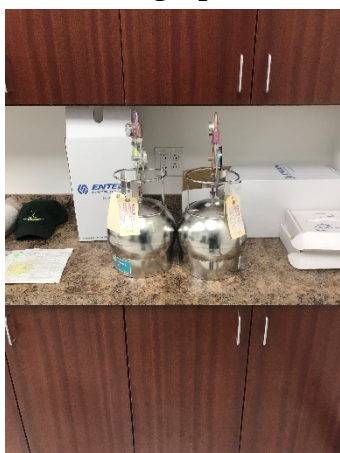
**Photograph #3**

Sample Location IA-3/Duplicate, located in Lunch Room

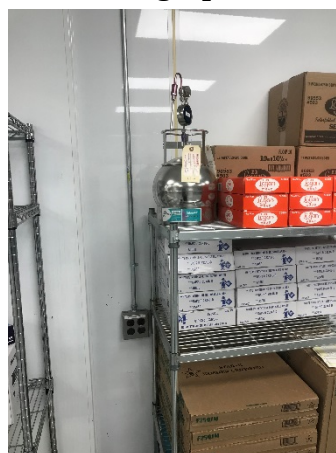
**Photograph #4**

Sample Location IA-4, located in Open Area

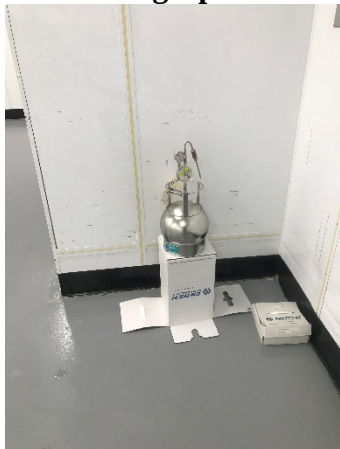
**Photograph #5**

Sample Location IA-5, located in Production Room

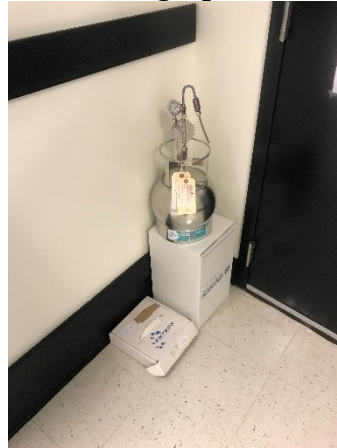
**Photograph #8**

Sample Location IA-8, located in Entrance

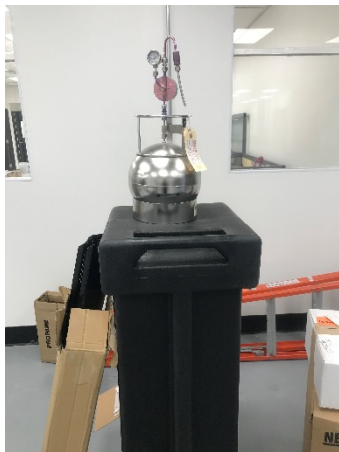
**Photograph #9**

Sample Location IA-9, located in Loading/Distribution Room

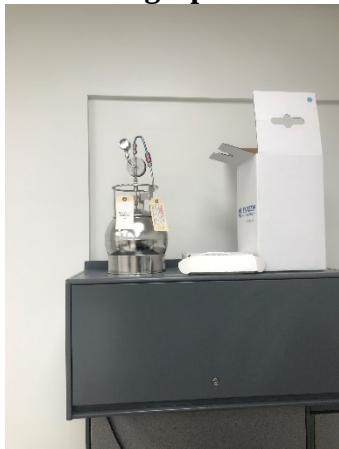
**Photograph #11**

Sample Location IA-11, located in Corporate Office
