**REMEDIAL ACTION PROJECT**  
**Building 906**  
**Final Report**  
**Poughkeepsie, N.Y.**

**March, 1984**  
**Ref. No. 1315**

**CONESTOGA-ROVERS & ASSOCIATES LIMITED**

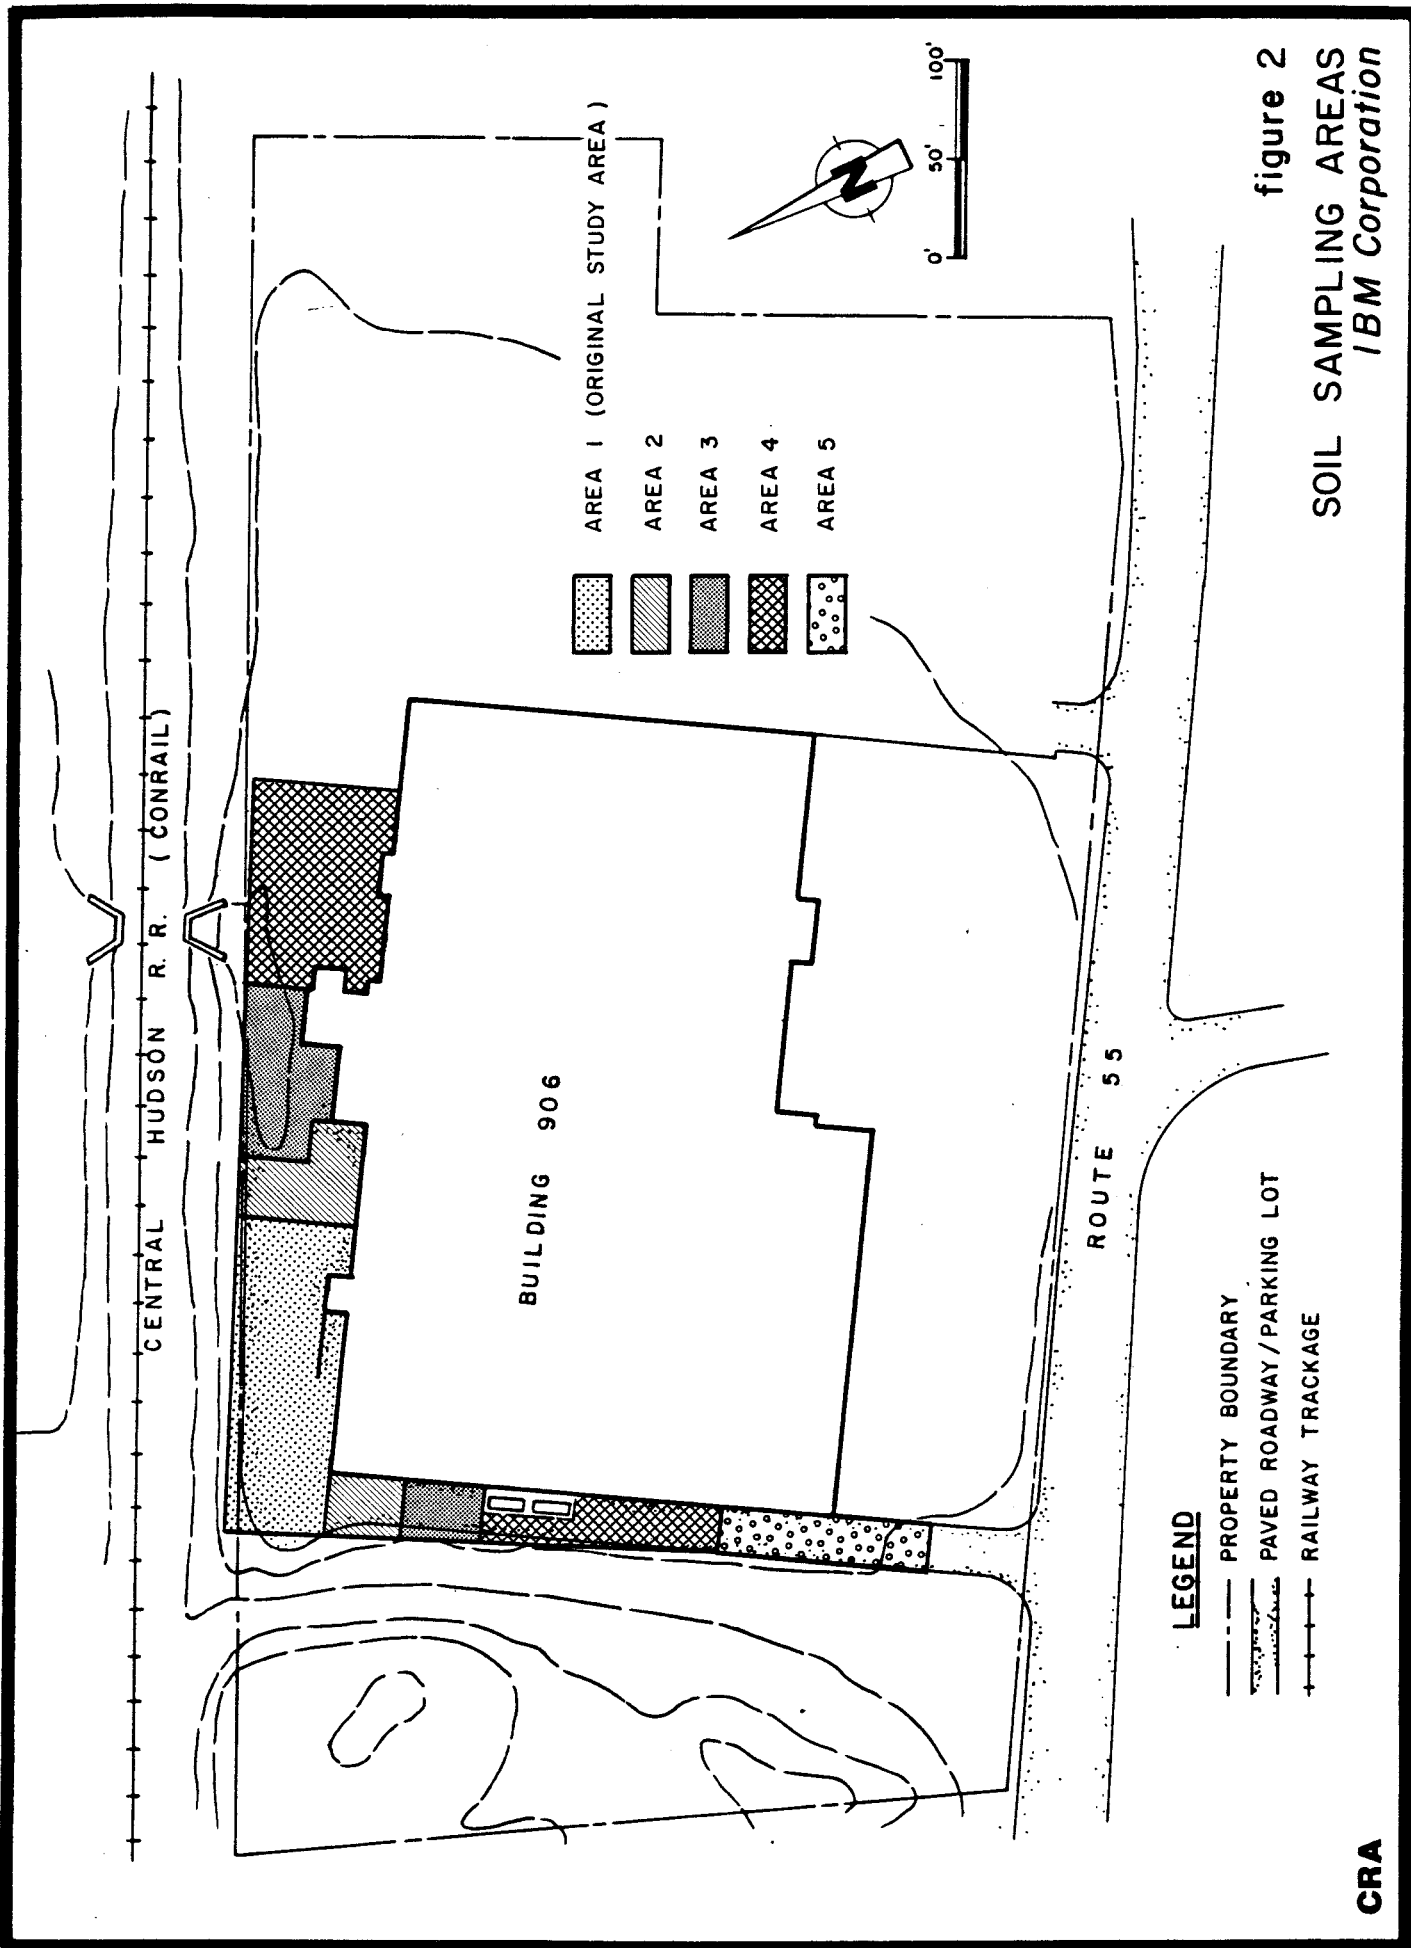
figure 2  
SOIL SAMPLING AREAS  
IBM Corporation

Area 1 was the original study area for the proposed remedial action program. Within this area it was estimated that 42 boreholes averaging 12.5 feet in depth would be required to obtain the specified 264 samples. During the initial borehole installation program it was discovered that the average depth to bedrock throughout Area 1 was significantly less than the estimated 12.5 feet. At IBM's direction the sampling grid was expanded to include Area 2 where an additional 4 and 11 boreholes were installed west and north respectively of Building 906. A total of 262 samples were collected from Areas 1 and 2 during the period August 4 to August 18, 1983.

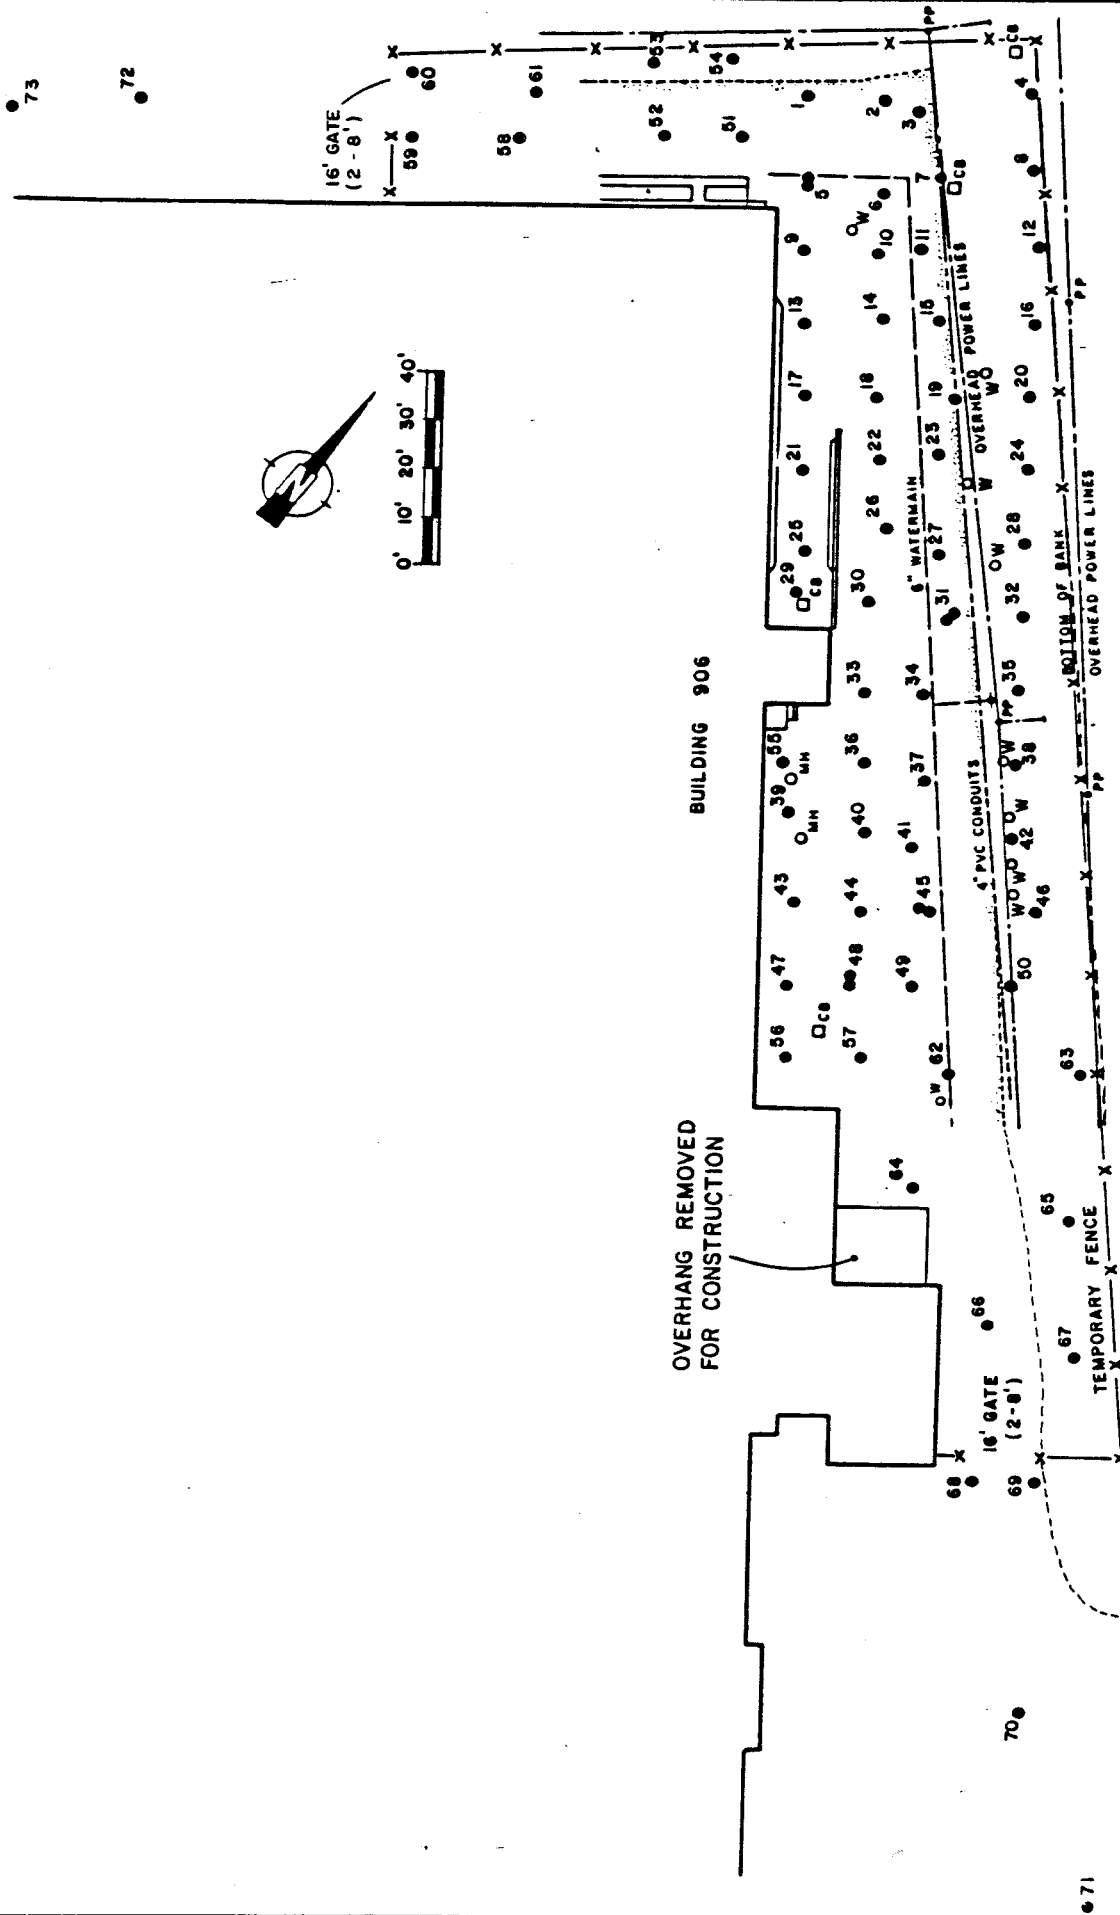
figure 3  
BOREHOLE LOCATIONS  
IBM Corporation

Continuous split spoon sampling was conducted at locations as detailed in Figure 3. Boreholes were installed by drill rigs equipped with rotary heads and 8-inch diameter hollow stem augers.

Three-inch diameter, 24-inch long stainless steel split spoon sampling tools, driven at the desired depths with a 140-pound hammer having a vertical drop of 30 inches, were used to recover the soil samples. Samples were handled with stainless steel spatulas, knives and large spoons. For collection of samples for chemical analysis, a "clean" sampling protocol designed to minimize the potential for cross contamination, was adhered to. Details of the sample preparation and handling protocol are contained in Appendix A-1.

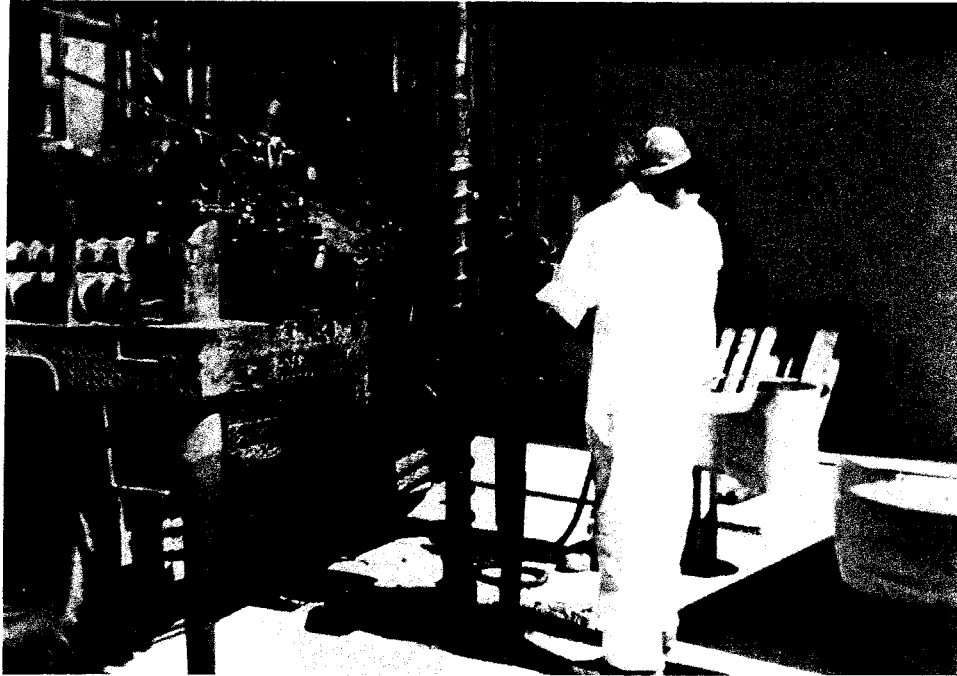
PHOTO 1  
DRILLING CREW ADVANCING A BOREHOLE

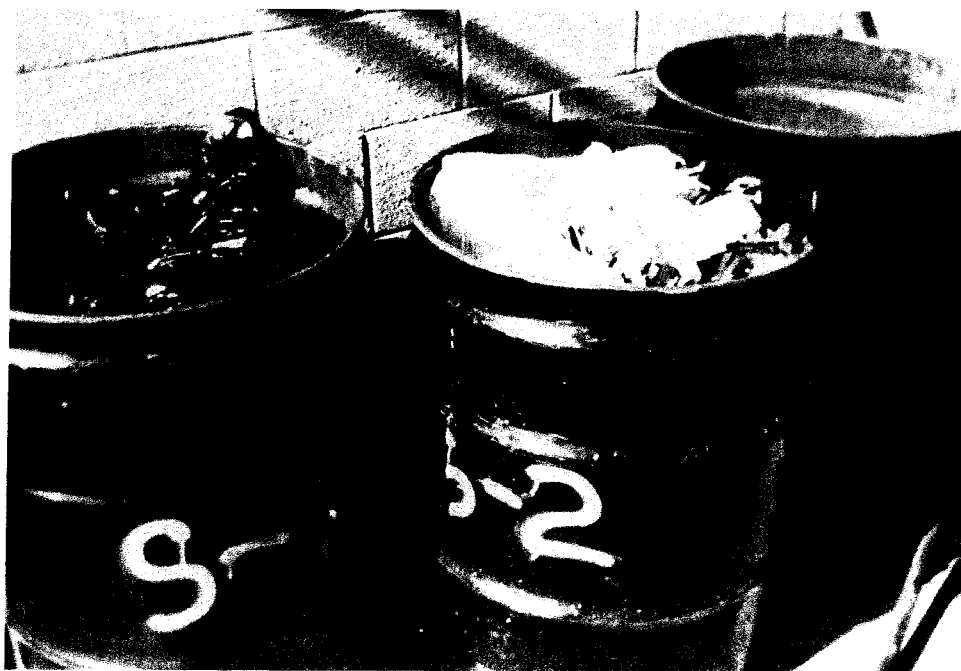
PHOTO 6

DRUMS CONTAINING SAMPLING DEBRIS SUCH AS RINSE WATER, SAMPLING  
CONSUMABLES, REMAINING SOIL FROM THE SPLIT SPOONS AND  
SOILS FROM THE AUGERING

A TYPICAL BOREHOLE. THE SOILS IN THE UPPER PART OF THE PICTURE BROUGHT UP BY THE AUGERING OPERATION WERE DISPOSED IN DRUMS SIMILAR TO THOSE SHOWN IN PHOTO 6. THIS WAS TO REDUCE THE POSSIBILITY OF CROSS-CONTAMINATION IN THE DIFFERENT LAYERS OF EACH BOREHOLE.

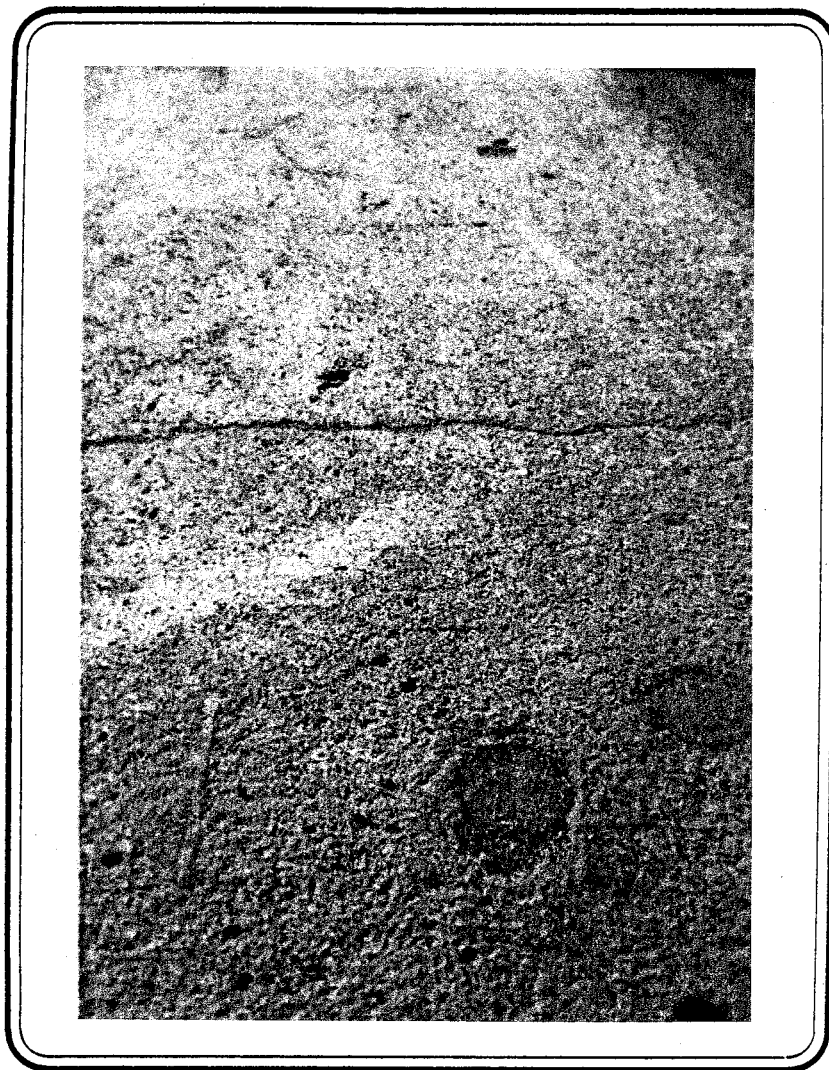
PHOTO 8  
BOREHOLE FILLED TO ORIGINAL LEVEL  
WITH CLEAN OFF-SITE FILL AND TAMPED

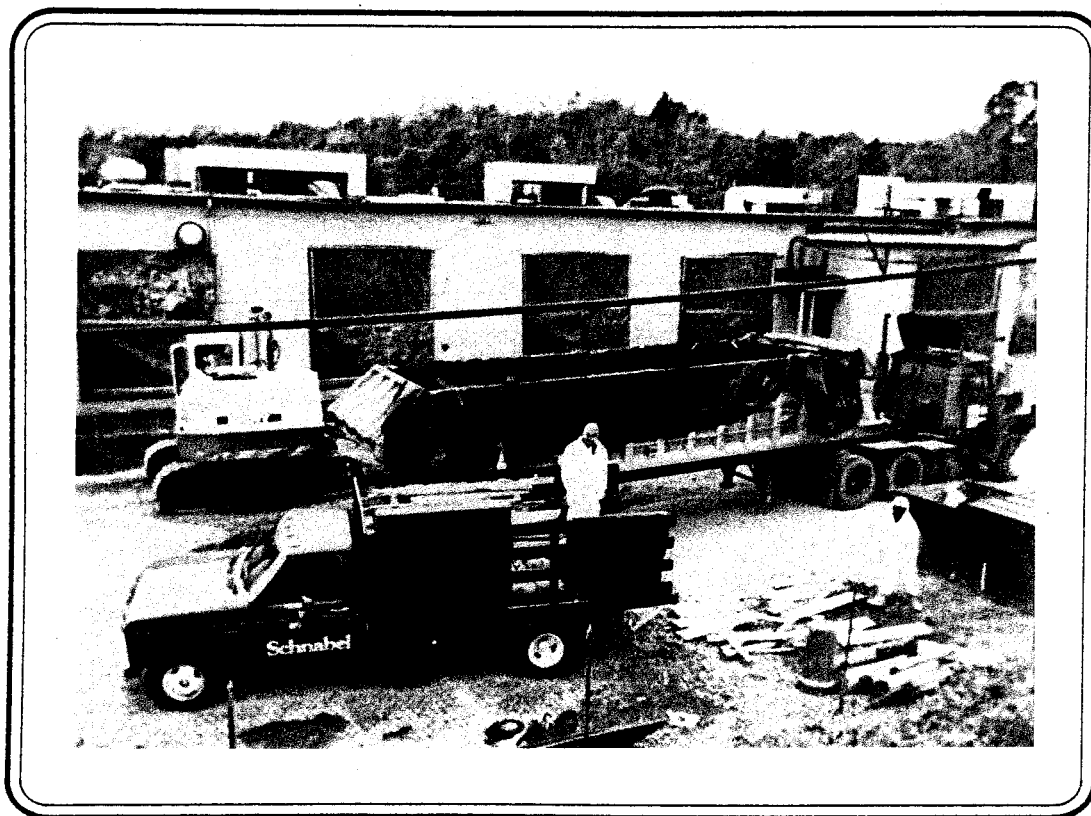
PHOTO 13  
WINDOWS ADJACENT TO THE ACTIVE WORK AREAS COVERED  
WITH PLYWOOD SHEETING AND BLUE INSULATING BLANKETS

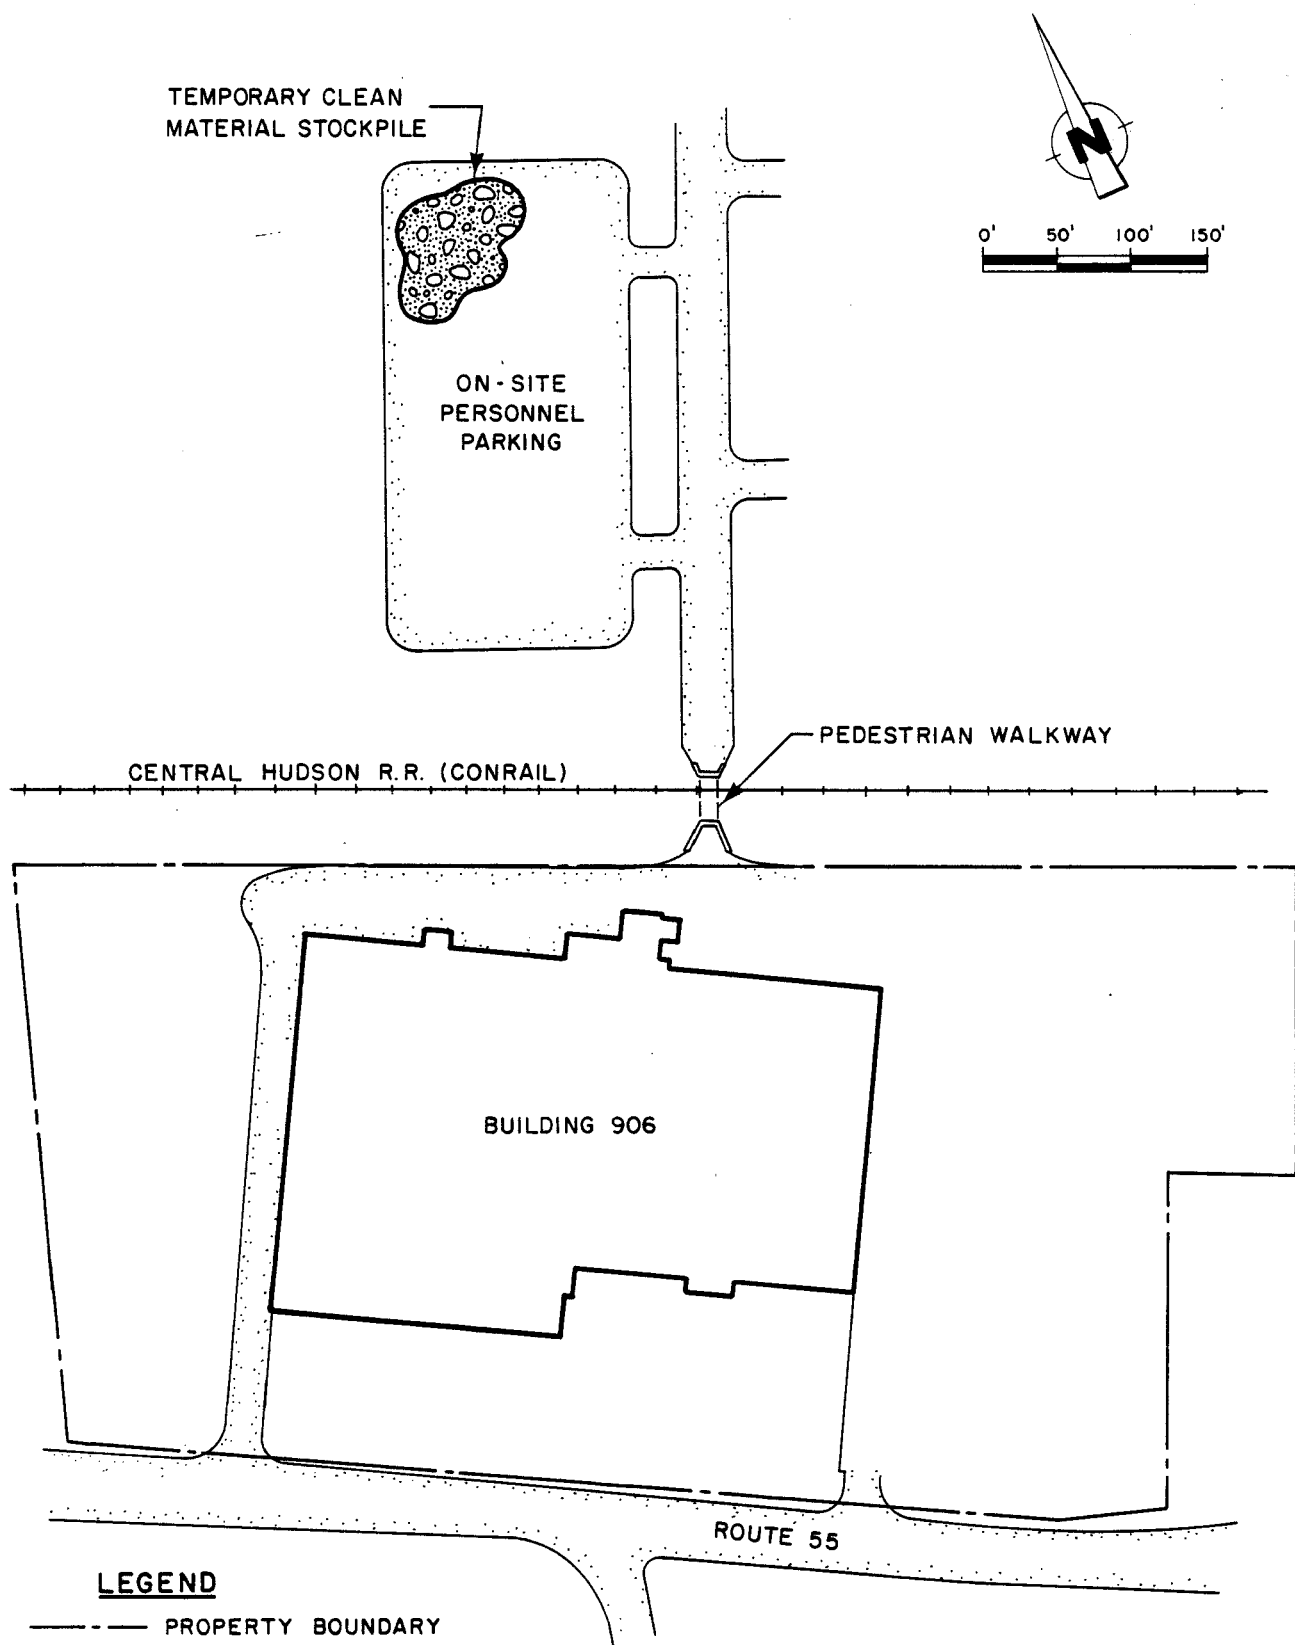
figure 4  
PARKING AND  
MATERIAL STOCKPILE AREA  
*IBM Corporation*

- i) Off-site clean fill, bank run gravel and #4 stone was stockpiled in the parking area for replacement of material excavated in the remedial action zone. The location of this stockpile is shown on Figure 4 and Photograph 14.

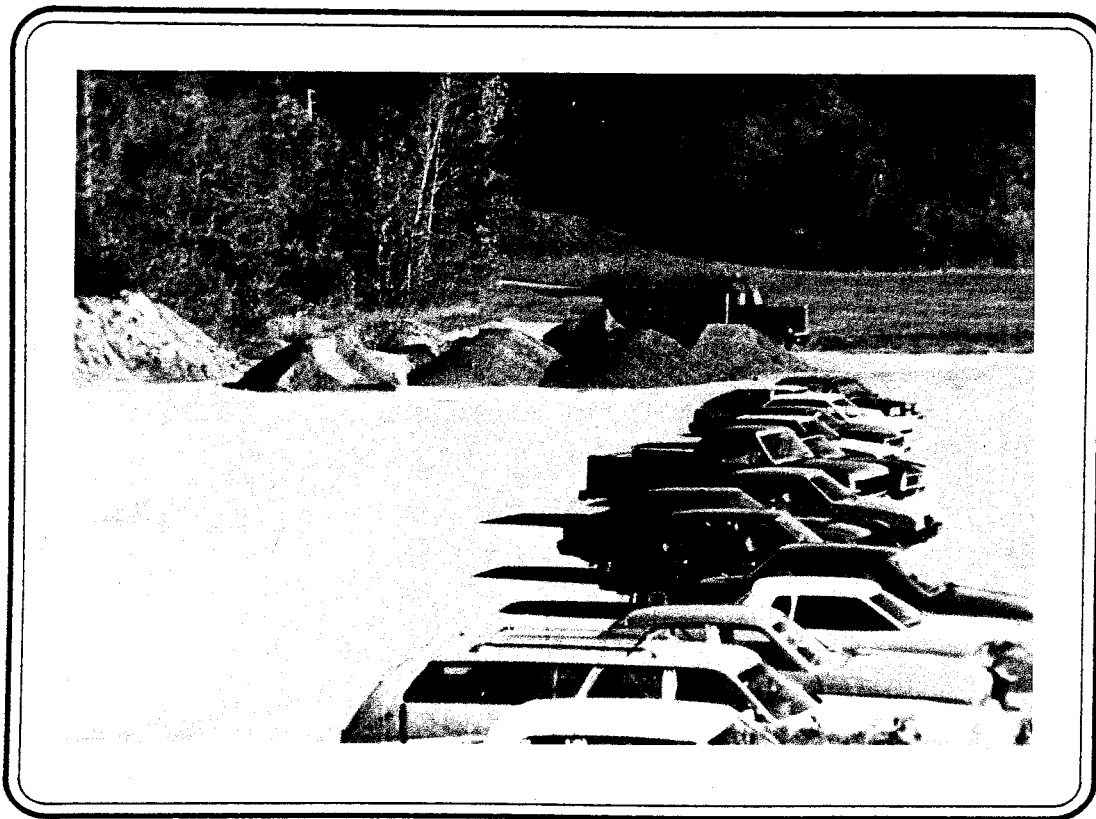
PHOTO 14  
STOCKPILE OF OFF-SITE CLEAN MATERIAL FOR BACKFILLING  
OF THE REMEDIAL ACTION AREA

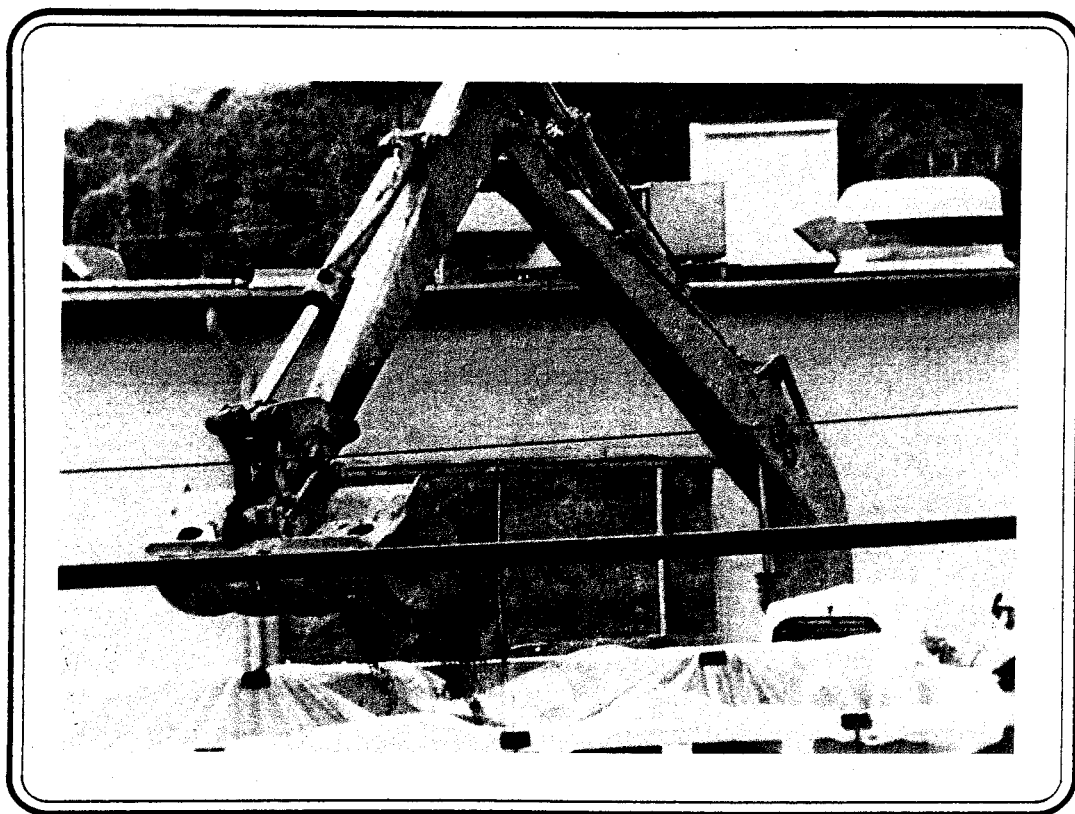
PHOTO 19  
HIGH VOLTAGE TRANSFORMERS, POWER LINES AND OVERHEAD UTILITIES  
IN THE AREA OF EXCAVATION. THESE UTILITIES WERE ALSO VERY LOW.

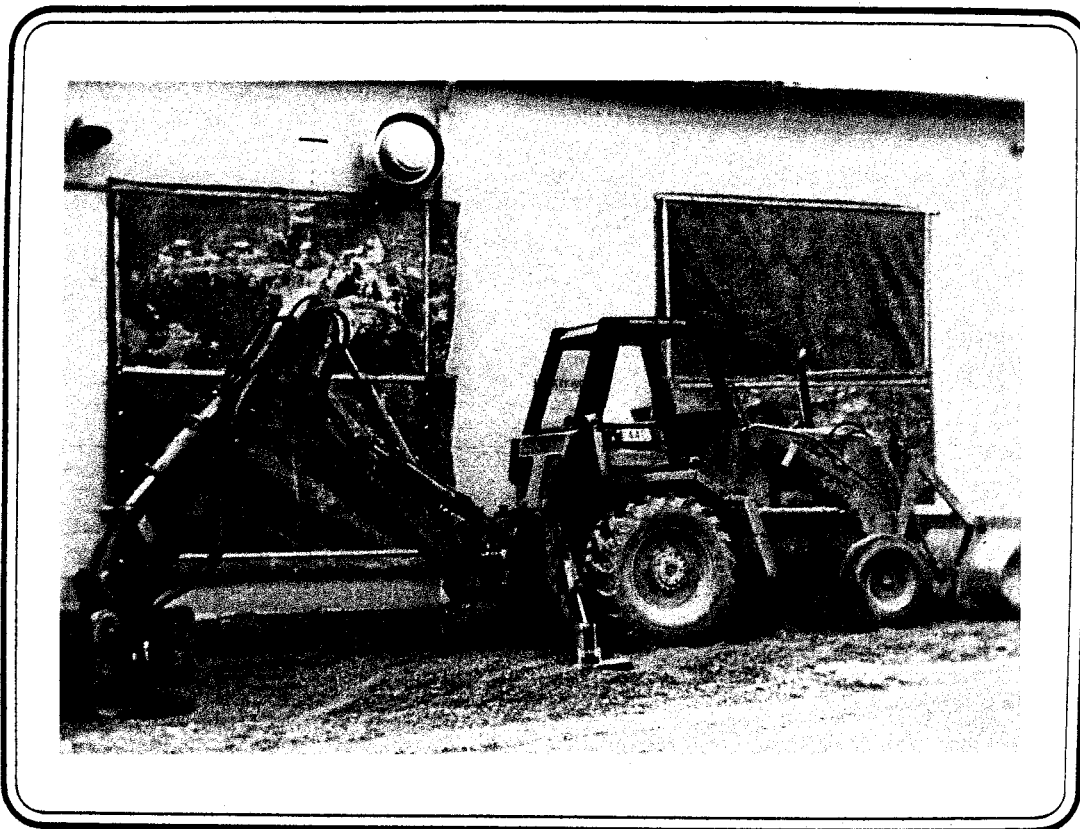
PHOTO 22  
CASE 680E RUBBER TIRE COMBINATION FRONT END LOADER  
AND BACKHOE EQUIPPED WITH VIBRATORY COMPACTOR

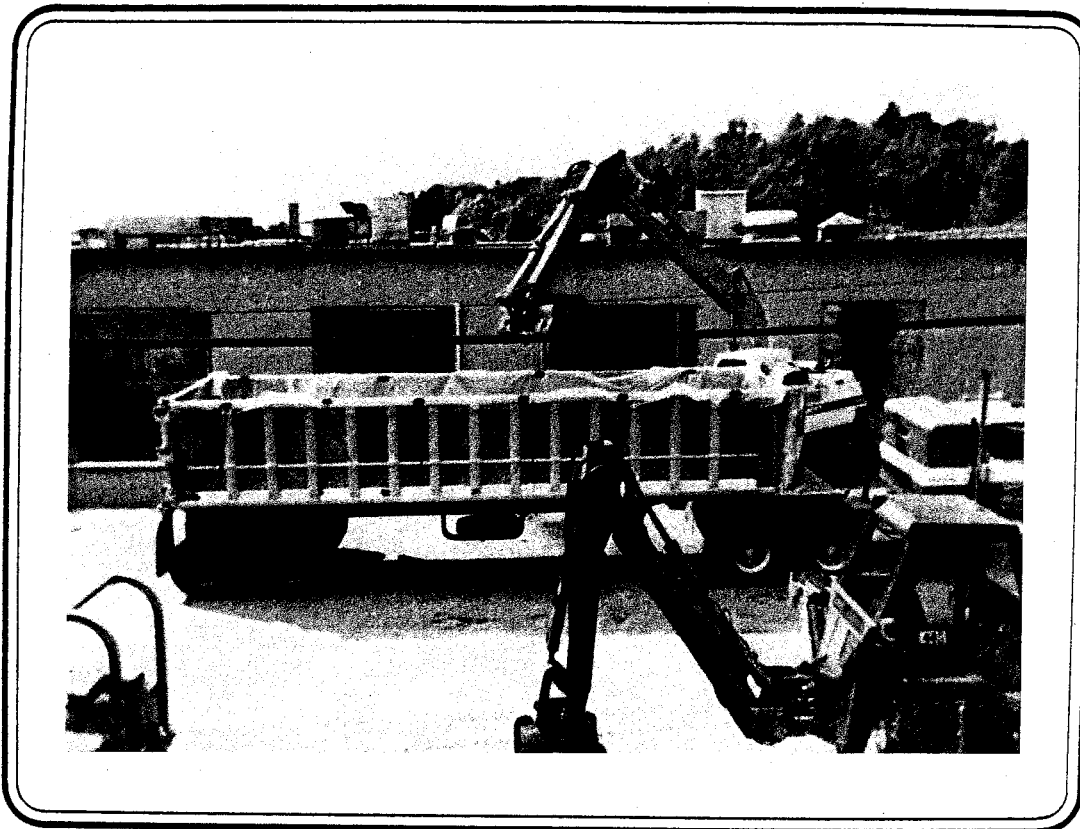
PHOTO 24  
TYPICAL EXCAVATING OPERATION

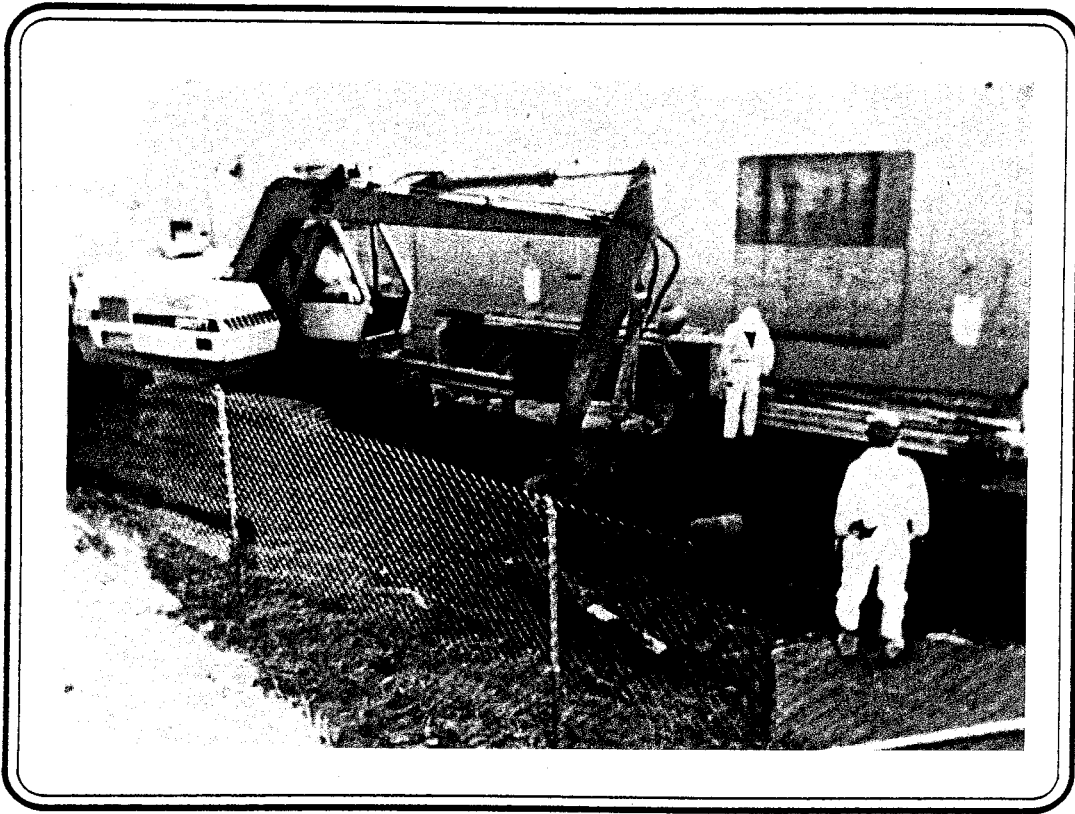
PHOTO 26  
EXCAVATING AT THE WESTERLY SIDE OF BUILDING 906.  
NOTICE THE RESTRICTED AREA OF OPERATION.

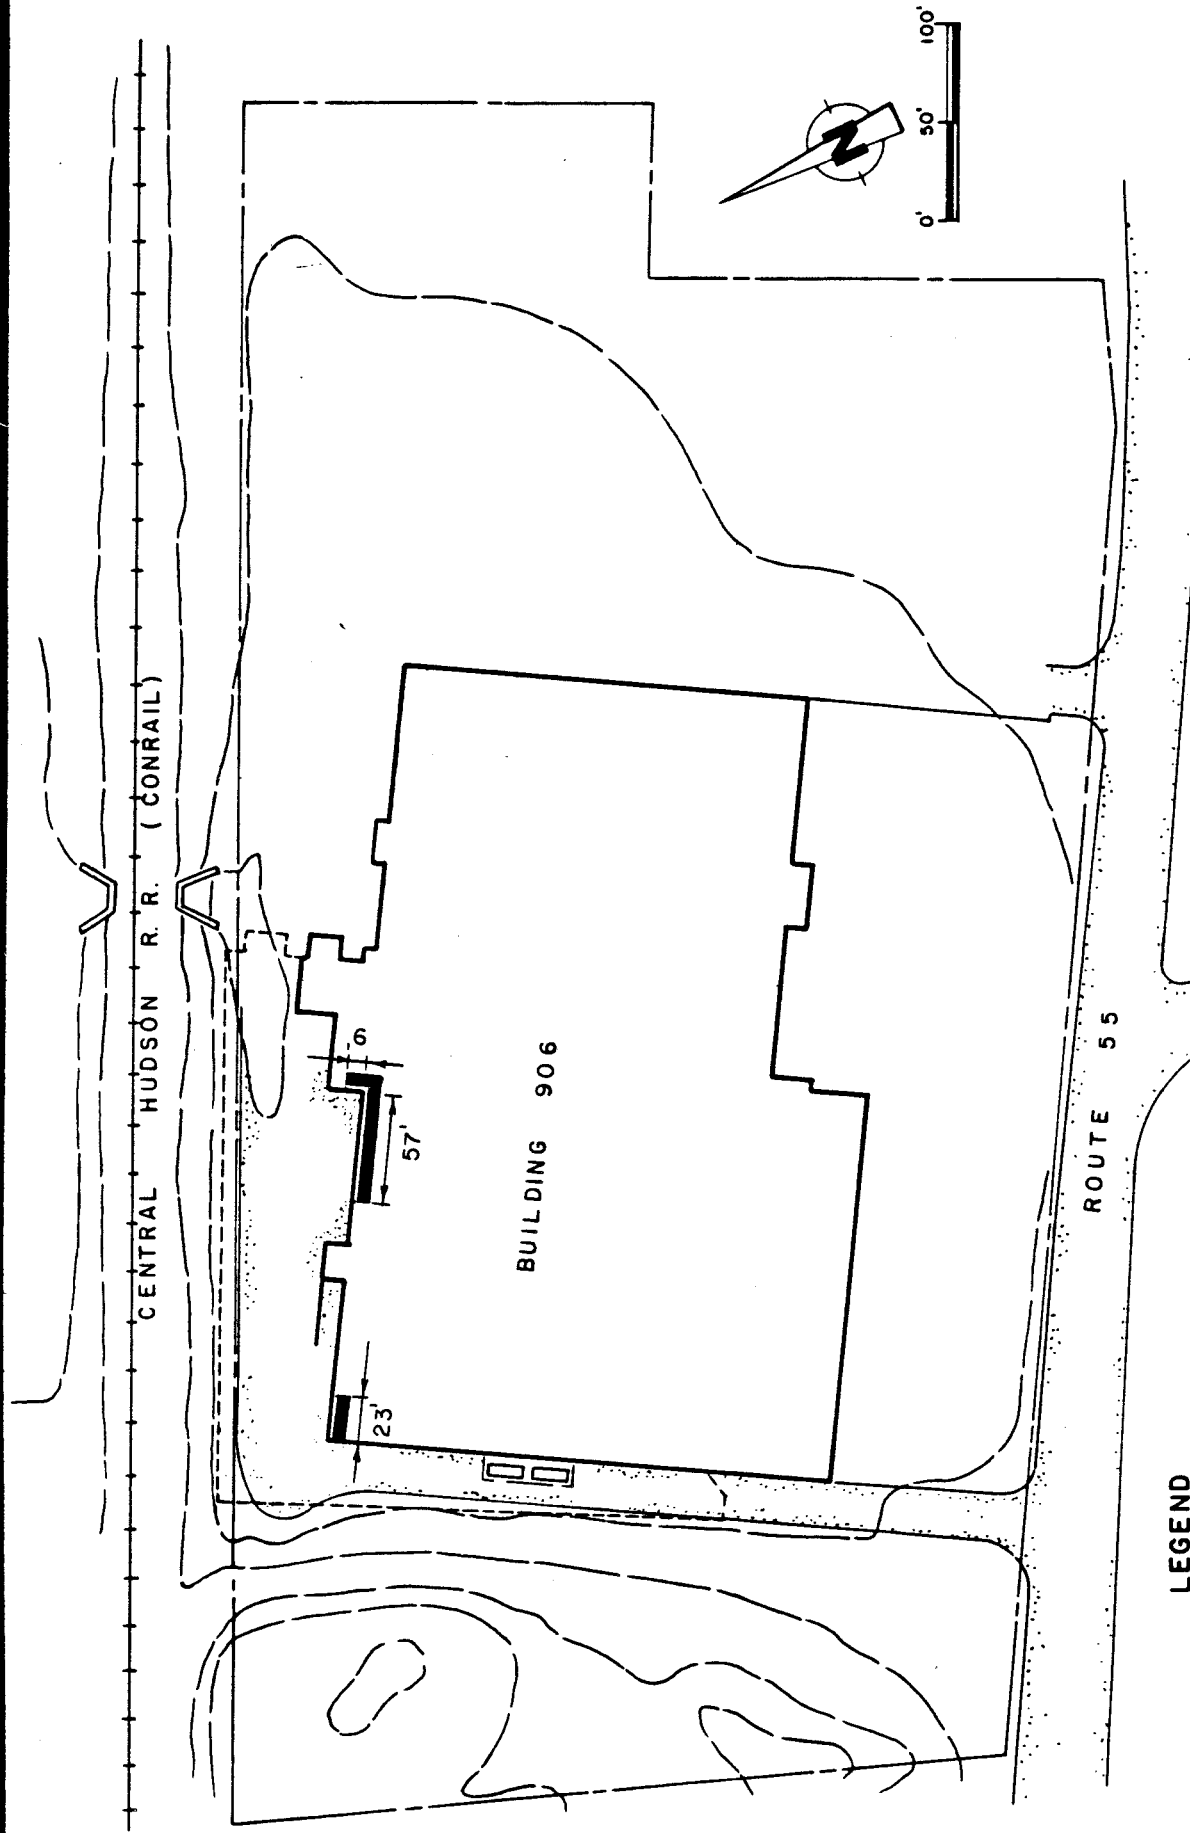
figure 53  
AS CONSTRUCTED FOUNDATION SUPPORT  
IBM Corporation

During the period October 11 to October 15, 1983, Schnabel Foundation Company, a sub-contractor to SCC, installed a total of 80 lineal feet of foundation wall support at locations detailed on Figure 53.

Initially, at each pier location the backhoe excavated soil from existing ground to the level of the bottom of the building footing. The soil under the footing was hand excavated and slip forms measuring 3-feet by 4-feet in section and constructed of construction grade 2-inch by 12-inch lumber were

Following a one day curing period, dry cement was packed between the bottom of the footing and the top of the poured concrete pier by means of a wooden dowel and hammer. Once the concrete had cured for a period of 7 days, the soils between and adjacent to the piers were excavated and replaced by clean compacted off-site fill.

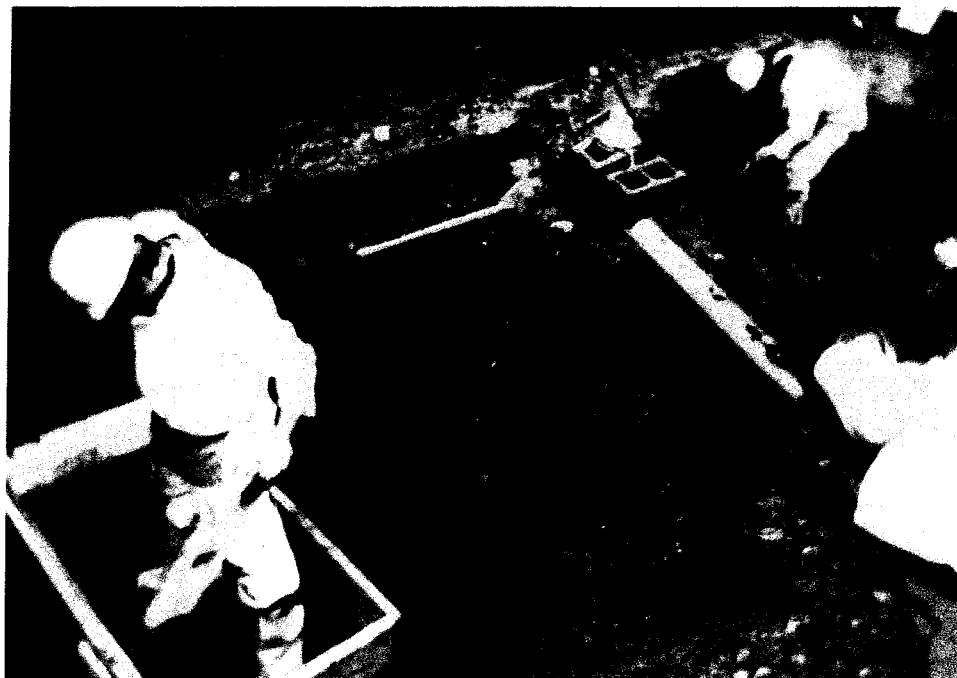
Photographs 27, 28, 29 30 and 31 illustrate portions of the technique employed. During pier construction, particular care was given to monitoring air quality within the excavated areas.

PHOTO 27  
FOOTING SUPPORT CONSTRUCTION UTILIZING  
HAND DUG WOOD FRAME SLIP FORMS

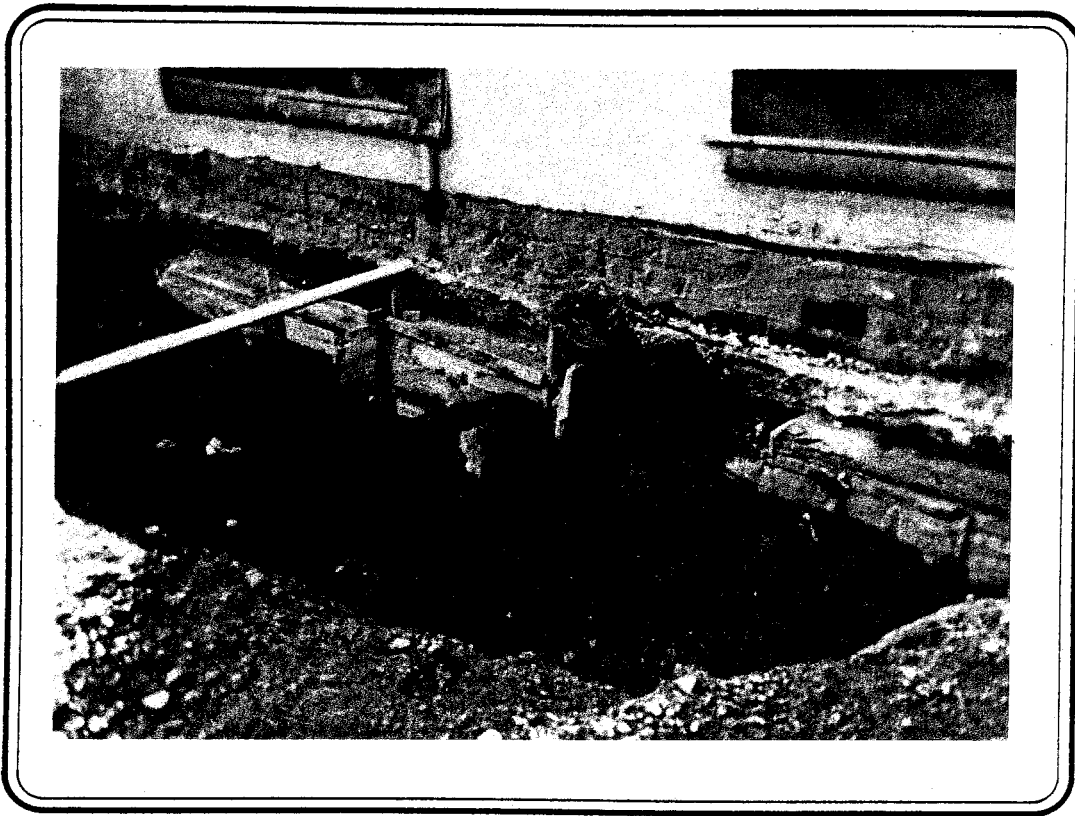
PHOTO 31  
FOUNDATION SUPPORT PIERS COMPLETE

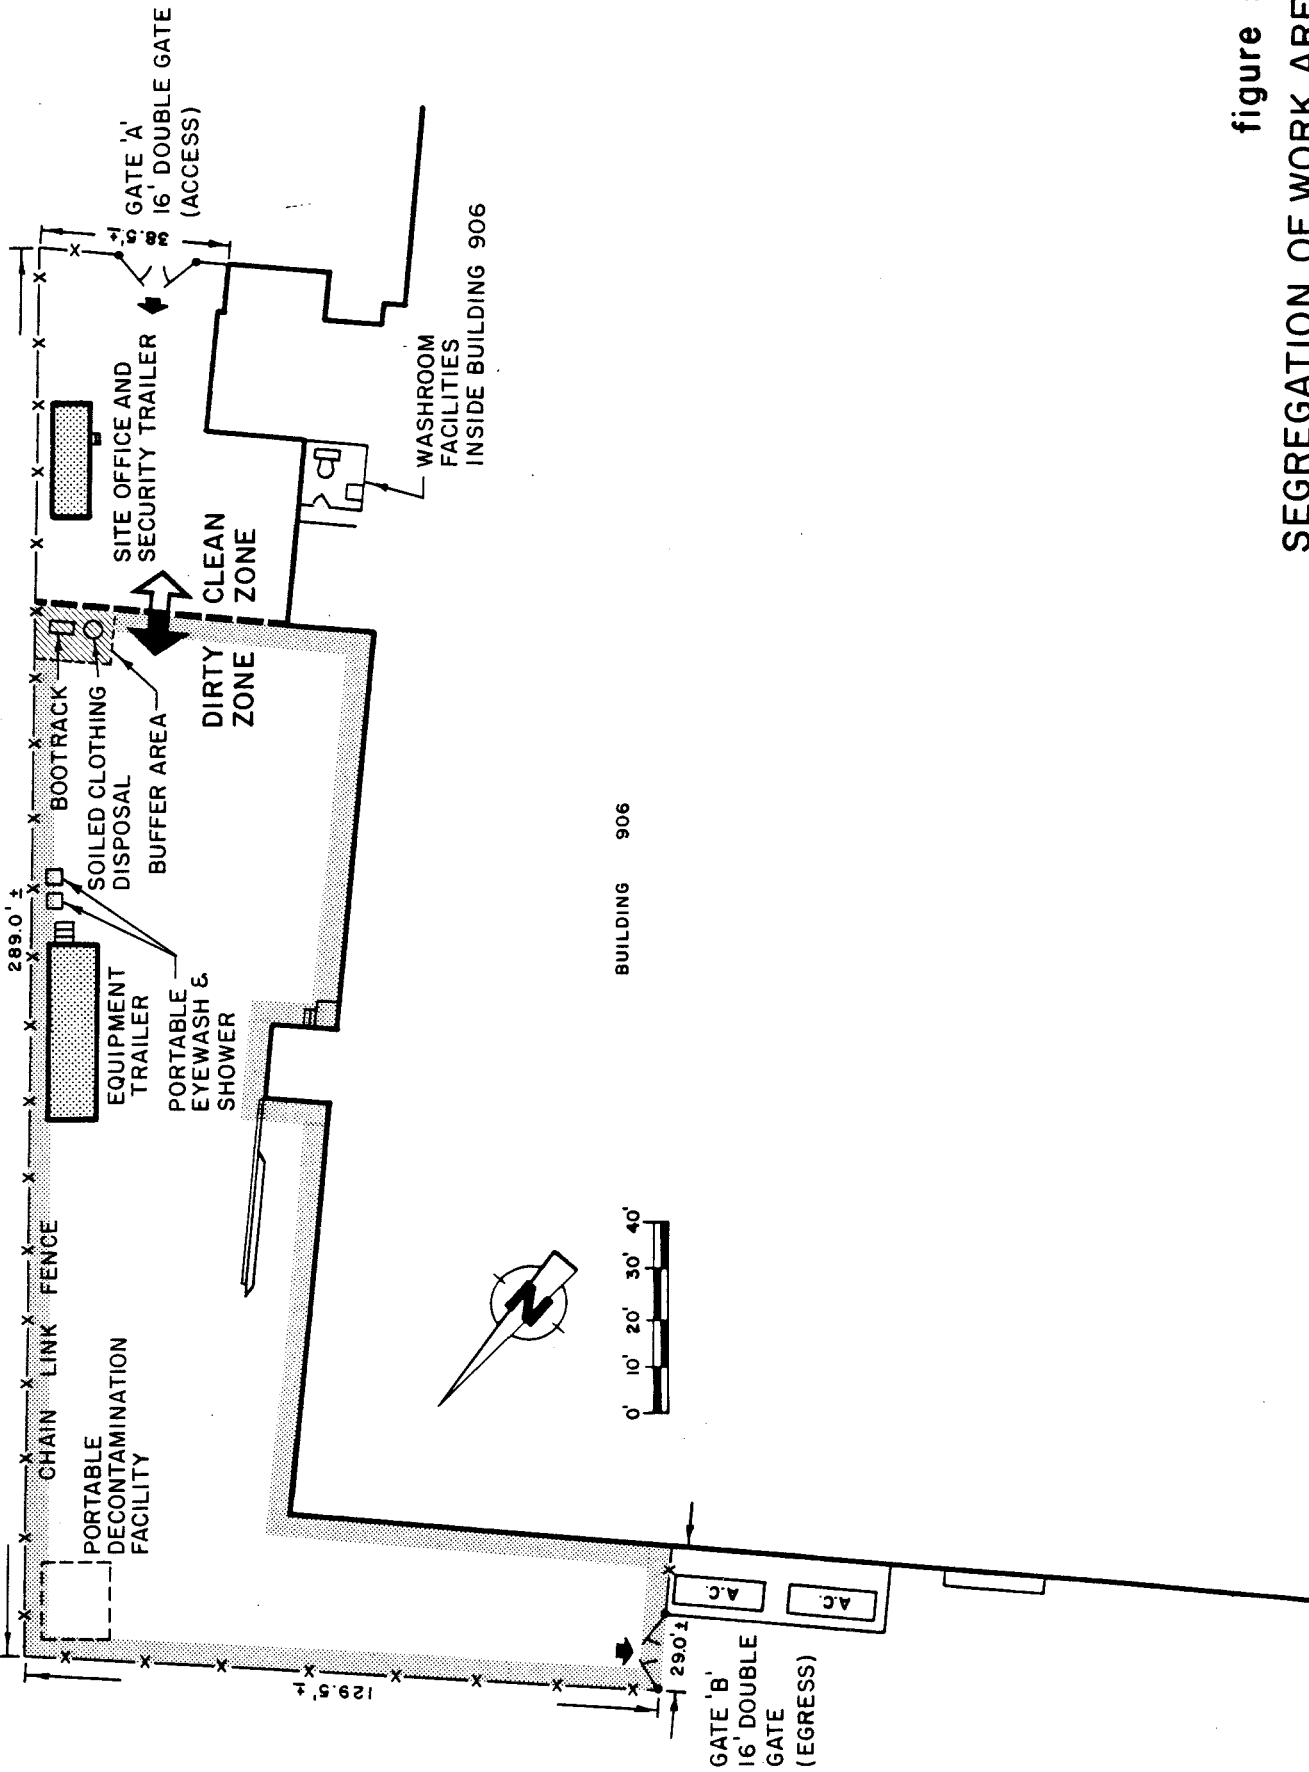
figure 54  
SEGREGATION OF WORK AREAS  
IBM Corporation

The site was segregated into a "dirty", "buffer", and "clean" work zone as detailed on Figure 54. All personnel leaving the Dirty Zone were required to remove soiled clothing and rubber overboots in the Buffer Zone prior to entering the Clean Zone.
