**REMEDIAL ACTION PROJECT**  
**Building 906**  
**Final Report**  
**Poughkeepsie, N.Y.**

**March, 1984**  
**Ref. No. 1315**

**CONESTOGA-ROVERS & ASSOCIATES LIMITED**

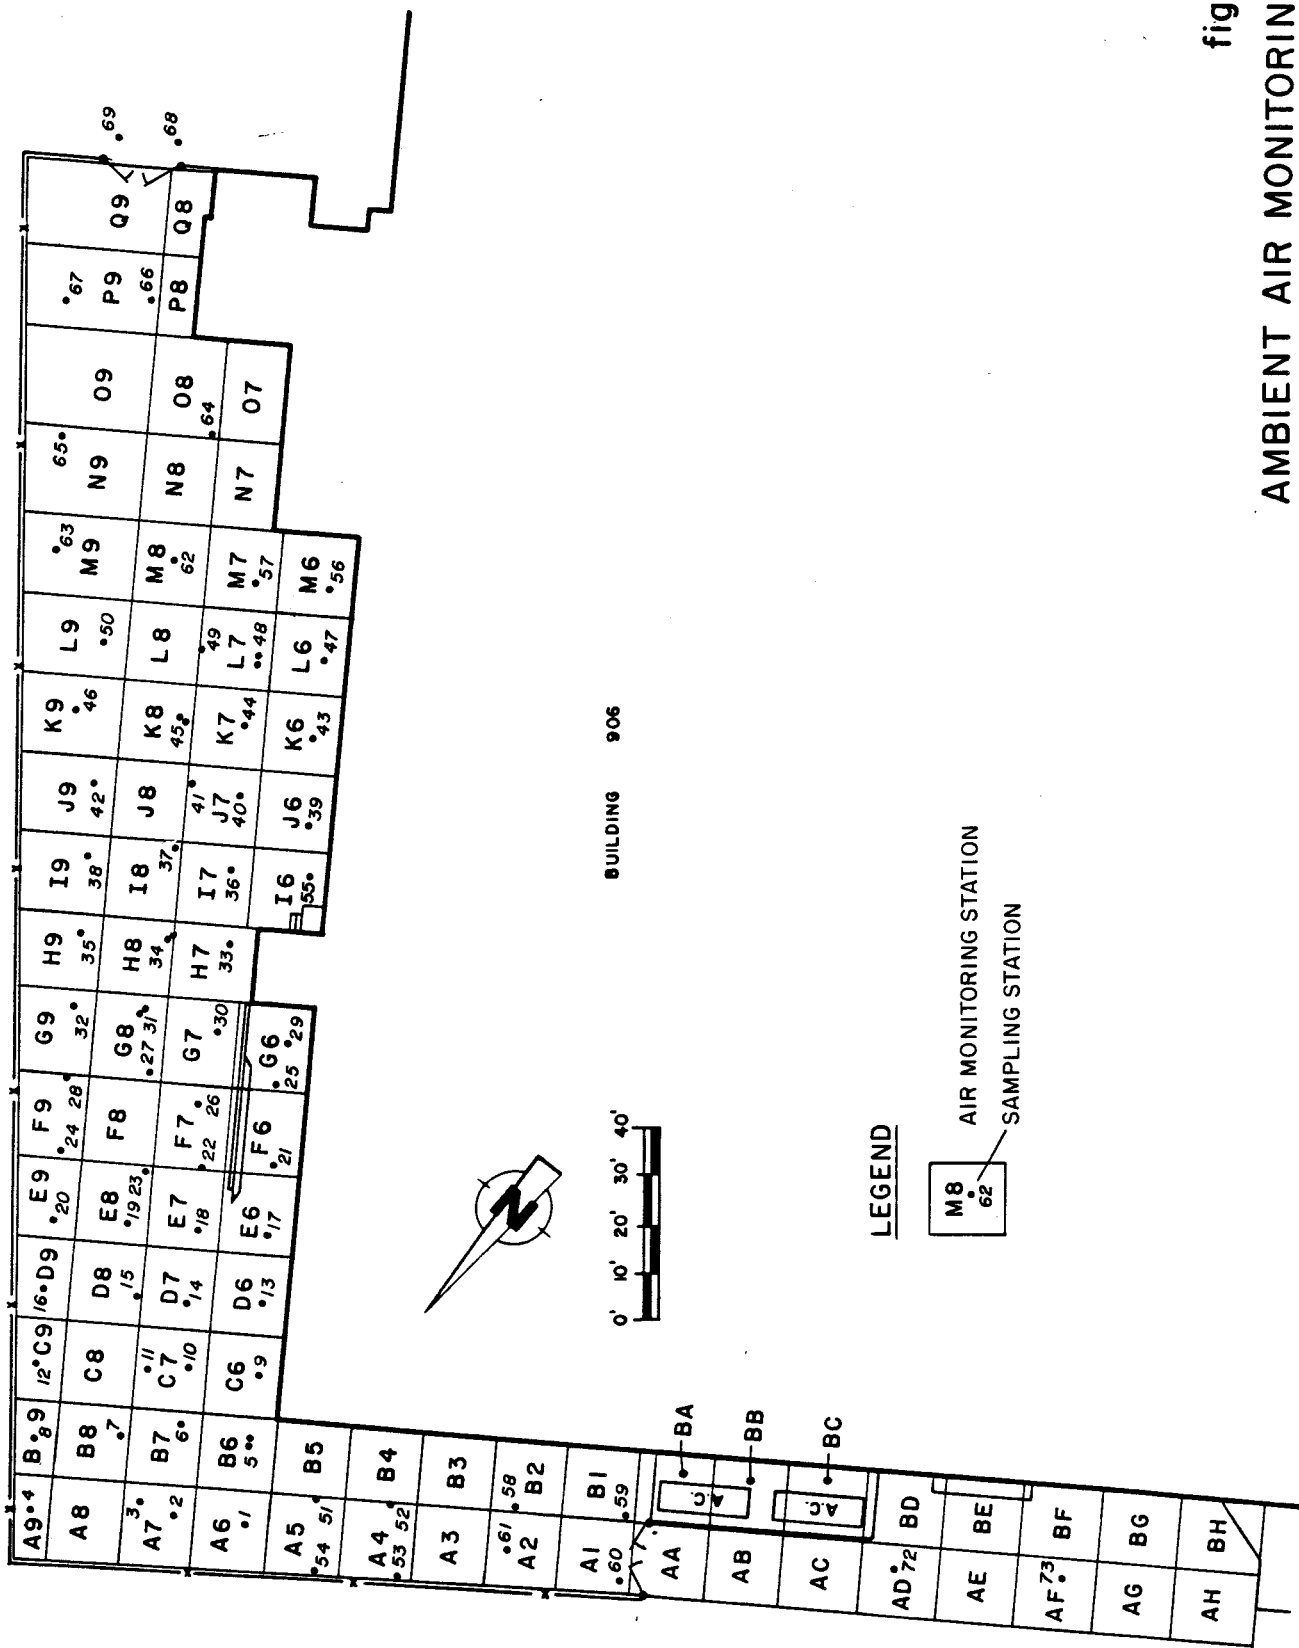
figure 55  
 AMBIENT AIR MONITORING GRID  
 IBM Corporation

Explosivity and organic vapor concentration were monitored throughout the excavation phase of the remedial construction. The air monitoring sampling grid is illustrated on Figure 55.

The majority of organic vapor concentration readings ranged between non-detected to 5 ppm. The highest recorded reading was 17 ppm monitored at Station 67 in the vicinity of borehole 30 on September 24. Positive explosivity readings were not detected over the course of the Project. Monitoring data as recorded on the Daily Air Monitoring Logs are presented in Appendix H.

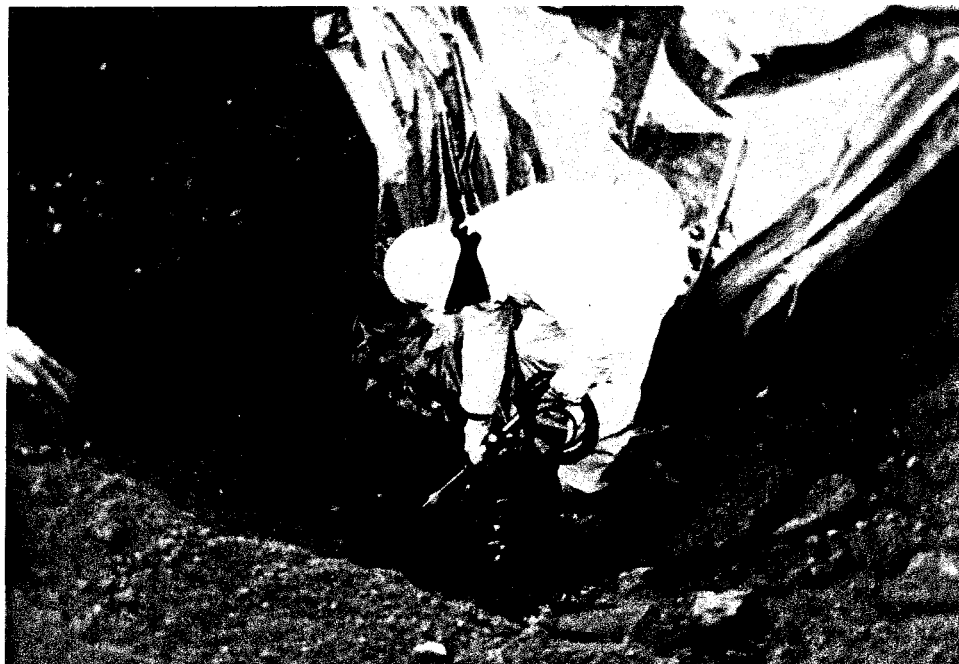
PHOTO 35

AIR MONITORING IN EXCAVATION

Photographs 34, 35 and 36 illustrate the field ambient air monitoring activity.

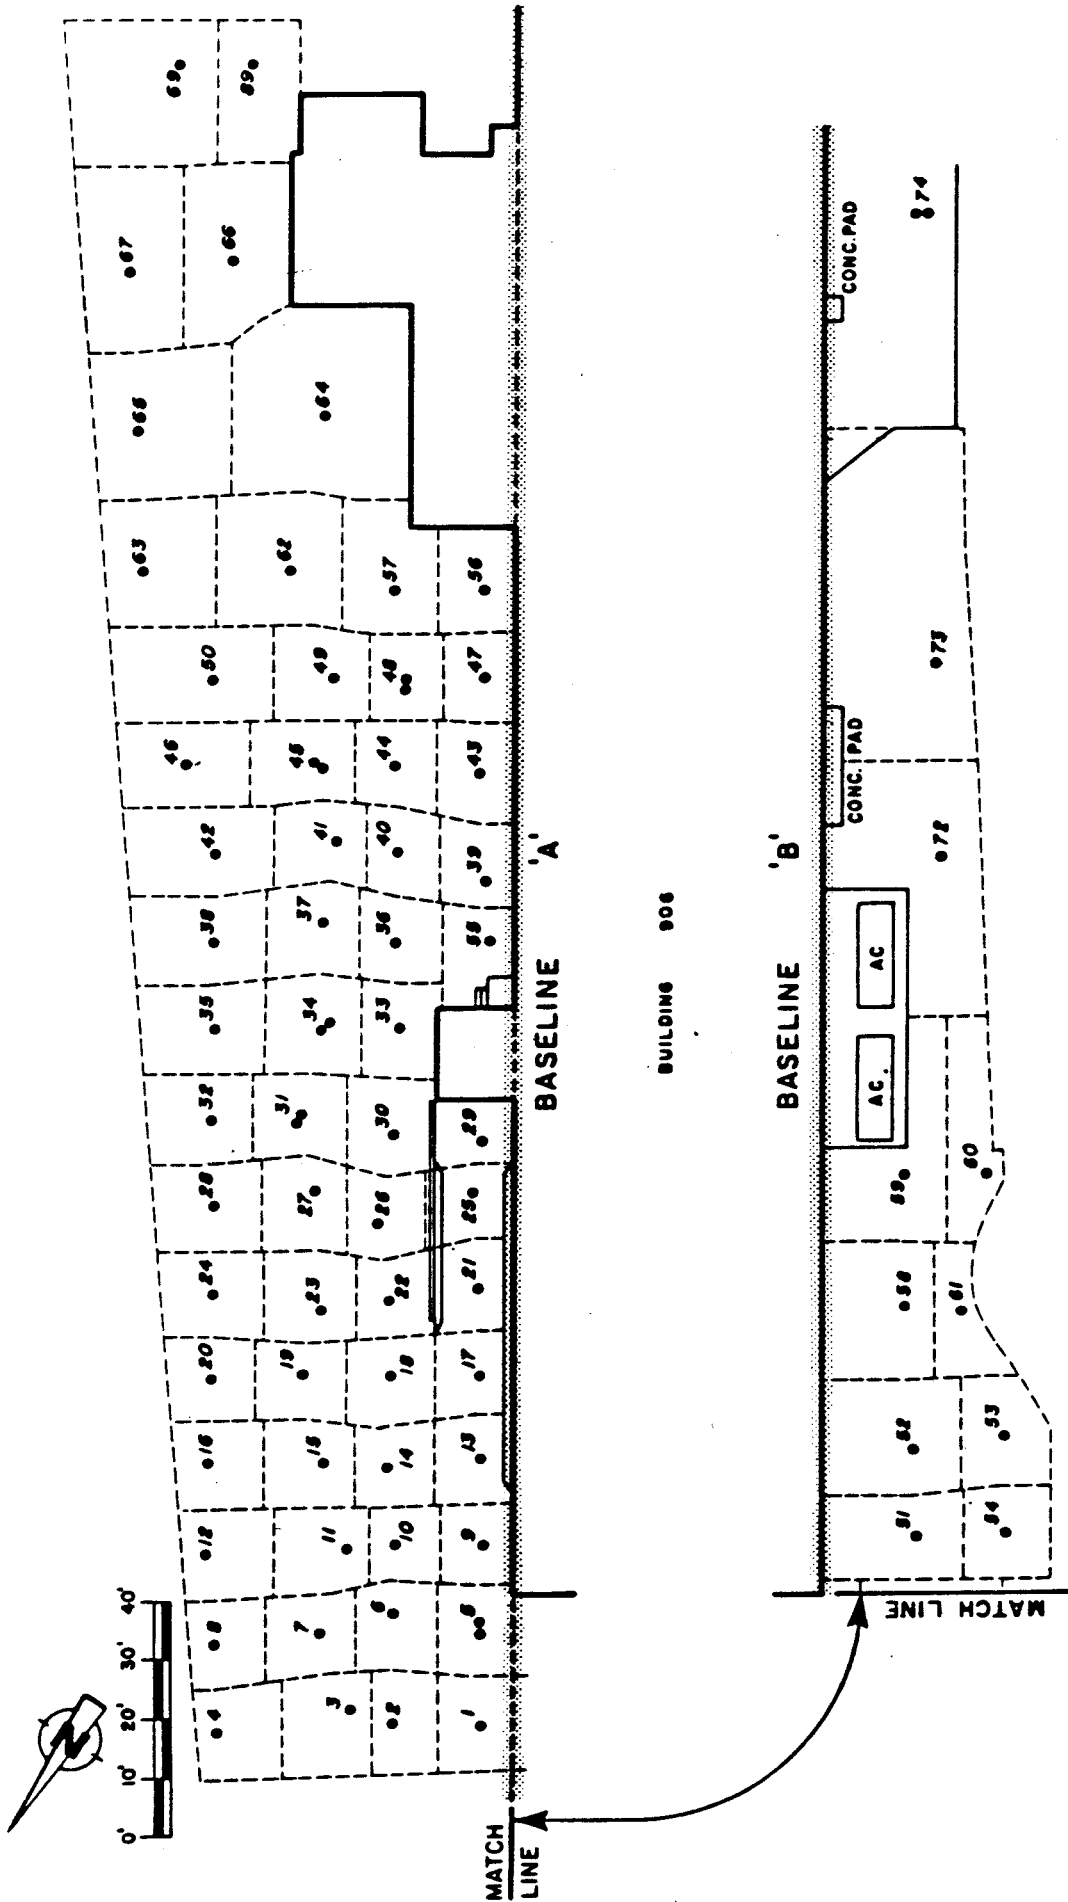
**figure 57**  
**AREAL LIMITS OF EXCAVATION**  
**ELEMENTS FOR TOTAL VOLATILE**  
**ORGANIC MASS CALCULATION**  
*IBM Corporation*

On the basis of analytical data developed from the soil sampling program, the mass of priority pollutant volatile organics contained in the 2893.24 cubic yards of soil specified for disposal is 19.48 pounds. This calculation is based on the assumption that the TVO concentration in each borehole sampling interval is the average TVO concentration for that interval over the areal extent of the excavation element. The areal configuration of excavation elements used in the TVO mass calculations is detailed on Figure 57. Appendix K presents the calculations for the derivation of the mass of TVO contained in the soils specified for excavation and off-site disposal.
