**PRE-DESIGN INVESTIGATION REPORT  
Apple Valley Shopping Center – RD  
(NYSDEC Site Number 314084)**

**NYSDEC STANDBY ENGINEERING CONTRACT  
Work Assignment #D007625-15**

**PREPARED FOR  
NEW YORK STATE DEPARTMENT OF ENVIRONMENTAL CONSERVATION  
625 BROADWAY  
ALBANY, NEW YORK 12233**

January 2019

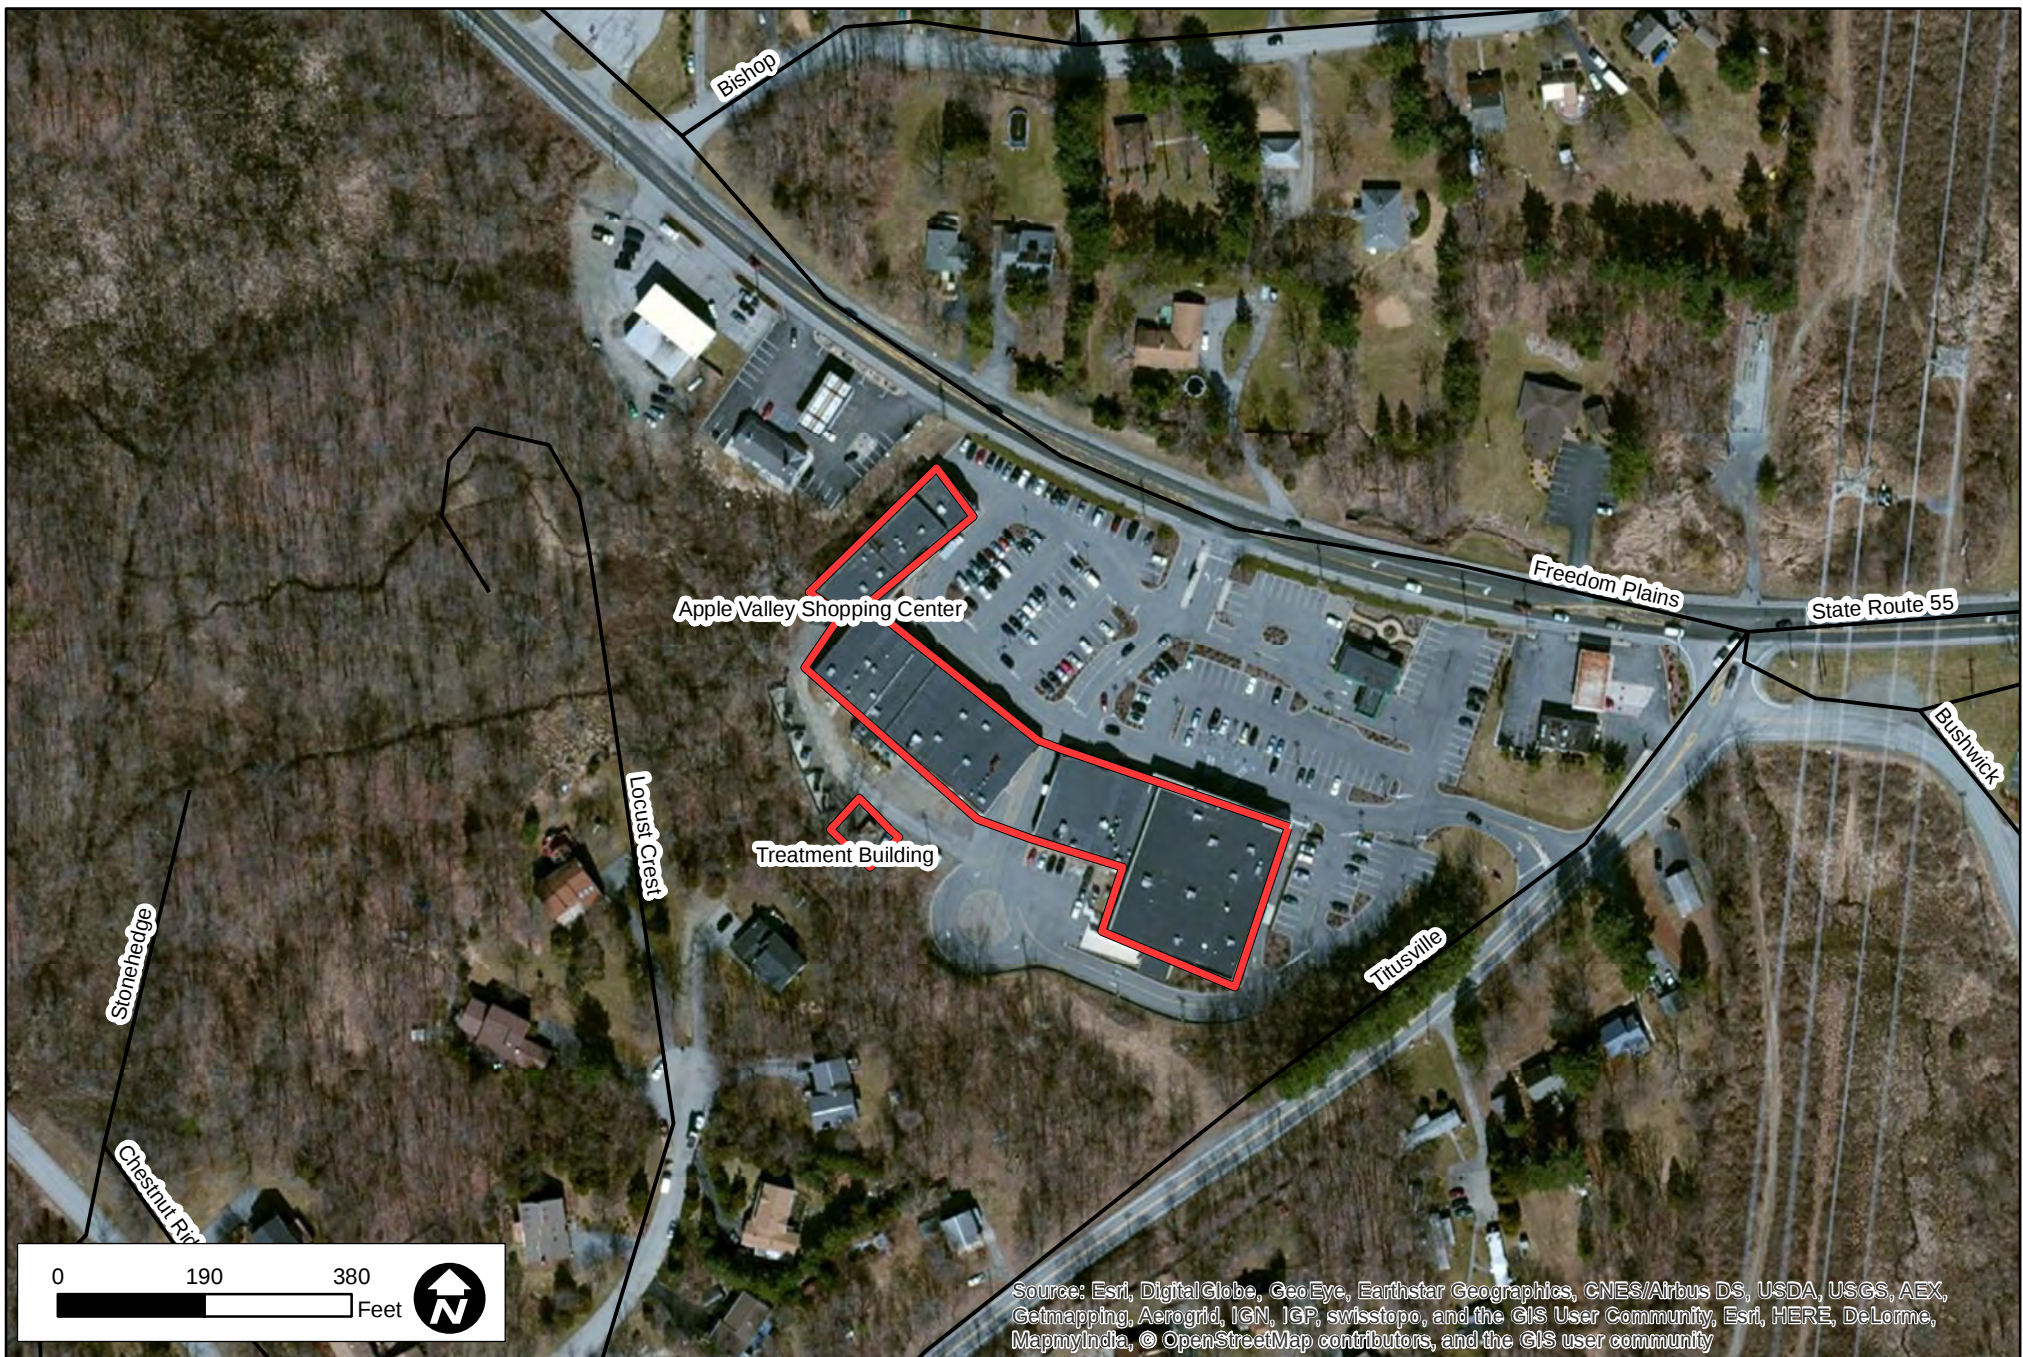
## Site Plan

Apple Valley Shopping Center NYSDEC Site # 314084  
Town of LaGrange, Dutchess County, New York

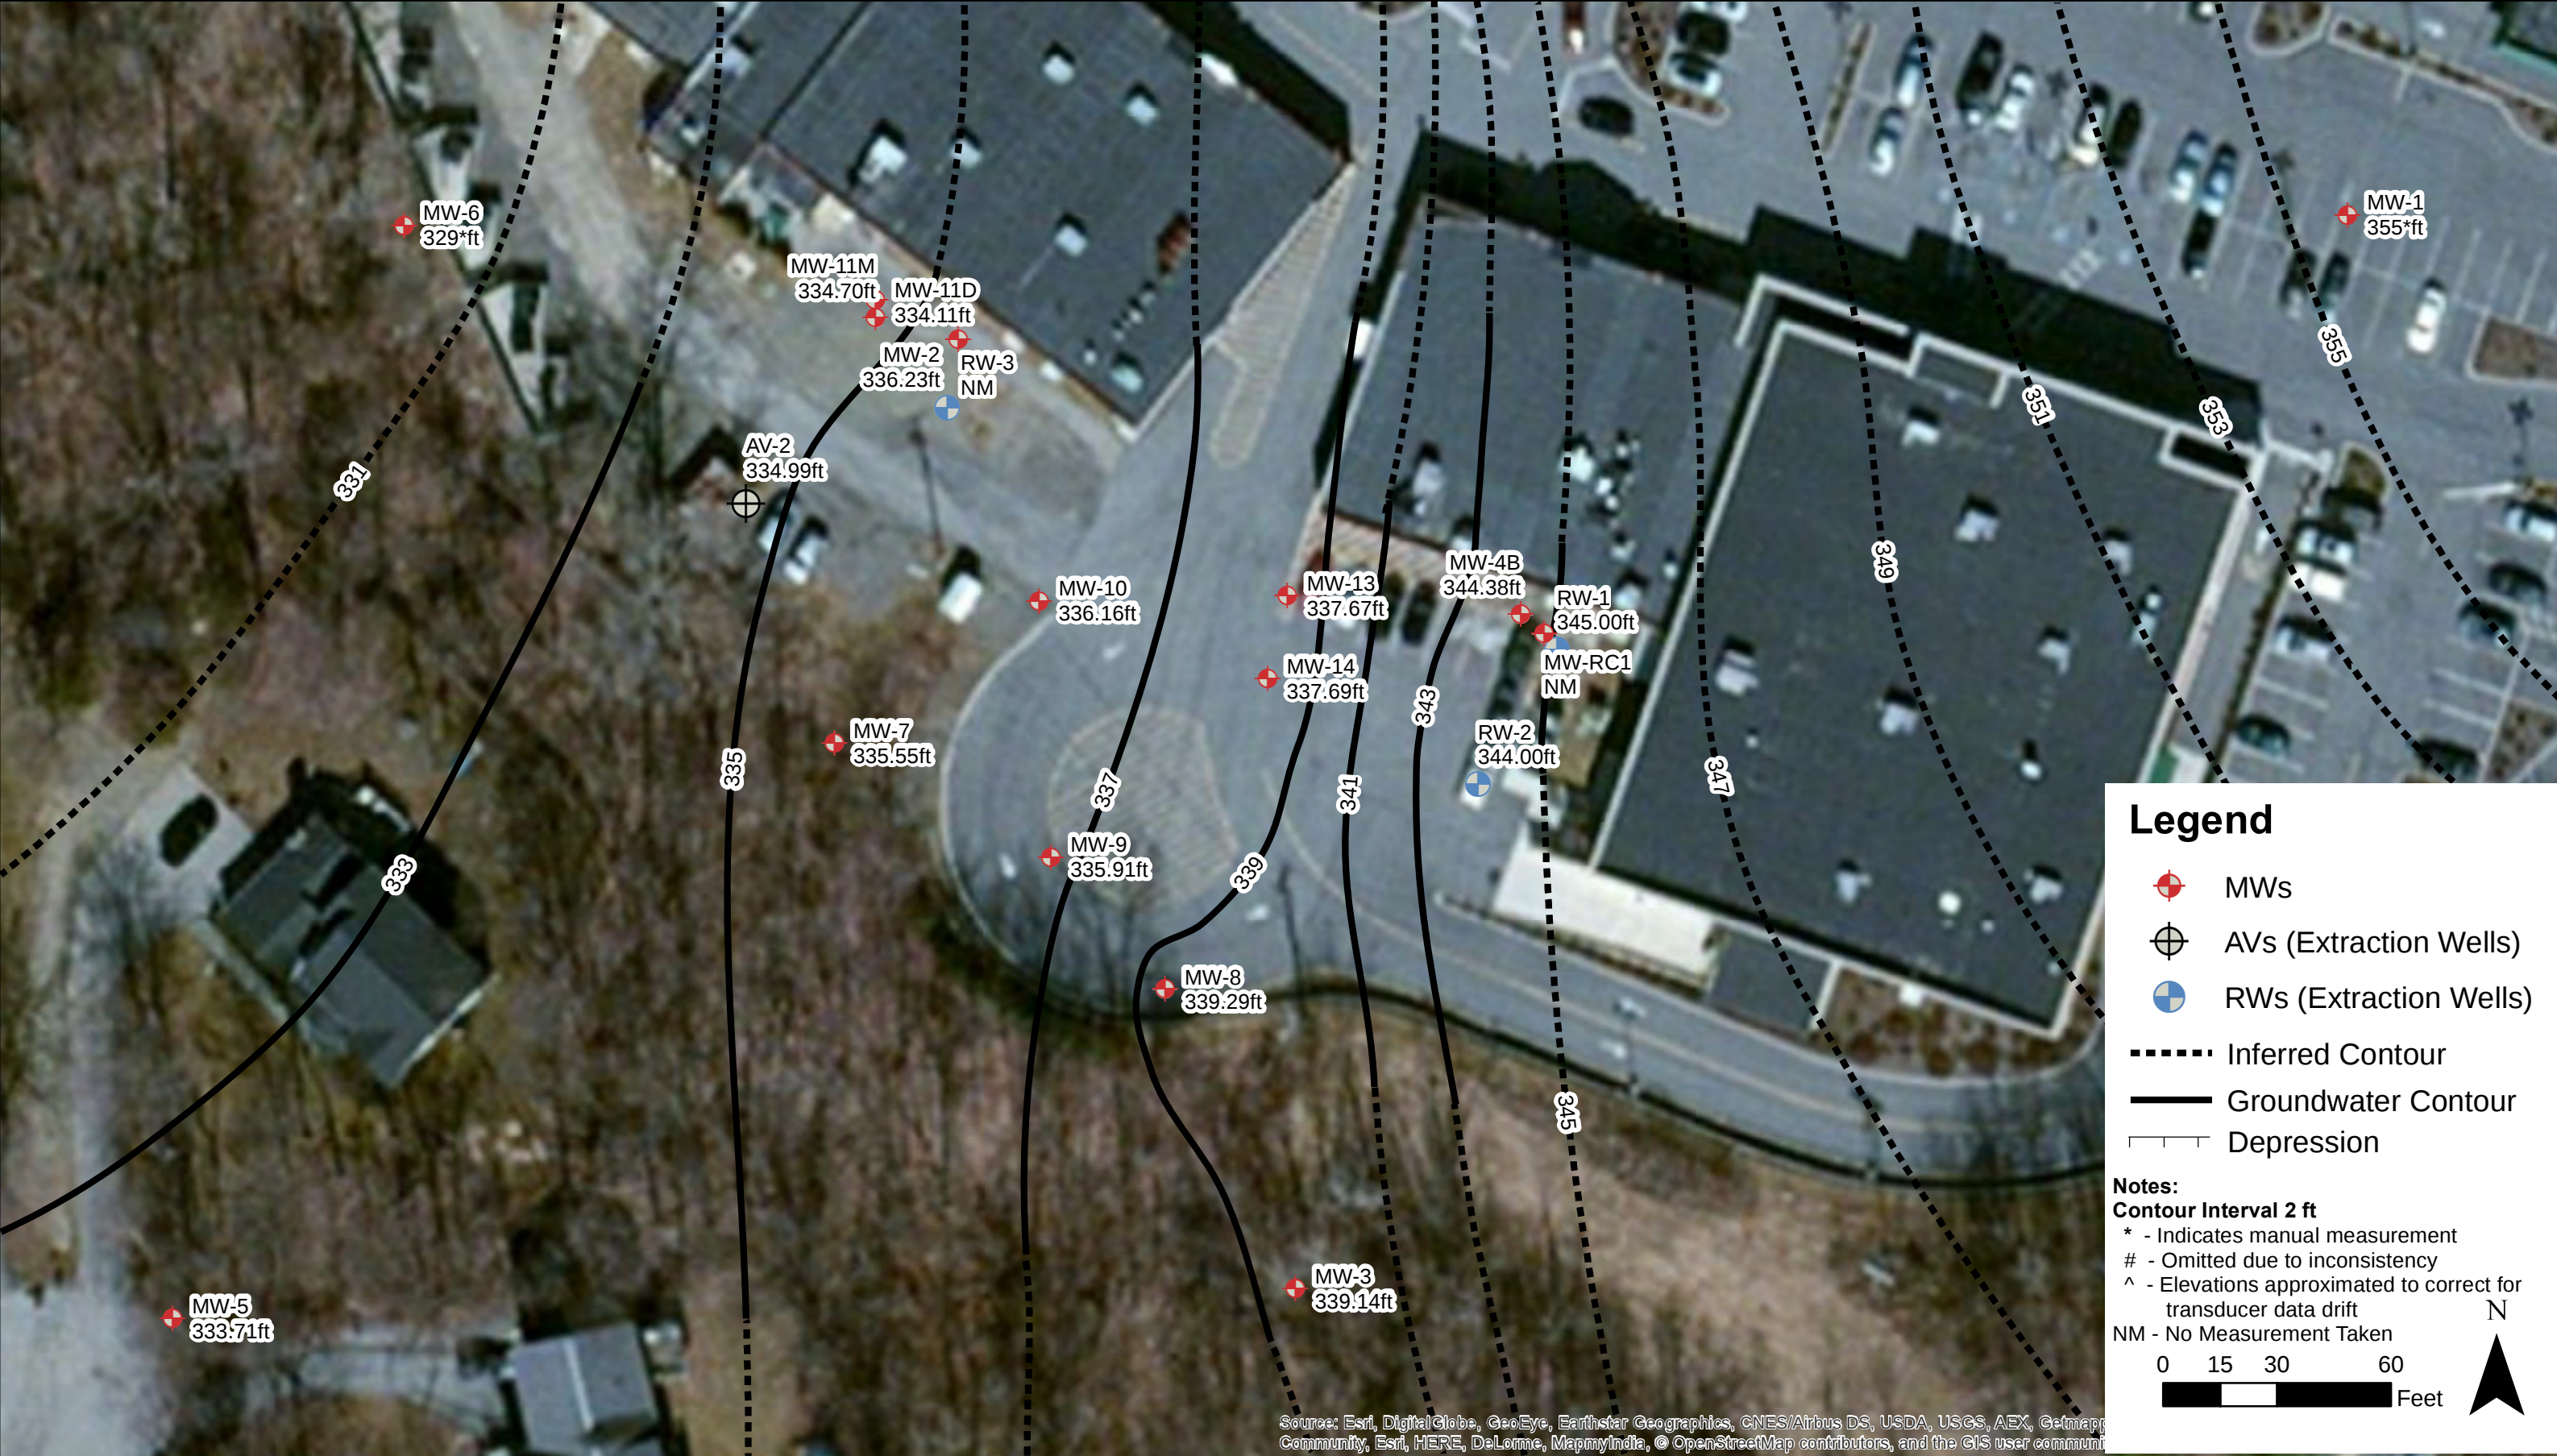
**Groundwater Contours – Non-Pumping Condition (12/7/2015)**

Apple Valley Shopping Center New York State Department of Environmental Conservation Site # 314084  
Town of LaGrange, Dutchess County, New York

To determine the influence of both extraction wells on groundwater elevation and flow, water level elevations were contoured based on the data recorded on December 7 (Figure 9). This allows for the conservative establishment of static, non-pumping conditions from which to determine aquifer drawdowns/responses when either well is shutdown (or operating). When the water level responses from the individual shutdowns of RW-1 and AV-2 are compared to this static non-pumping condition, it is evident that AV-2 is more effective in hydraulically containing a wider area than RW-1. Elaboration of the response of each well is in its respective section below.

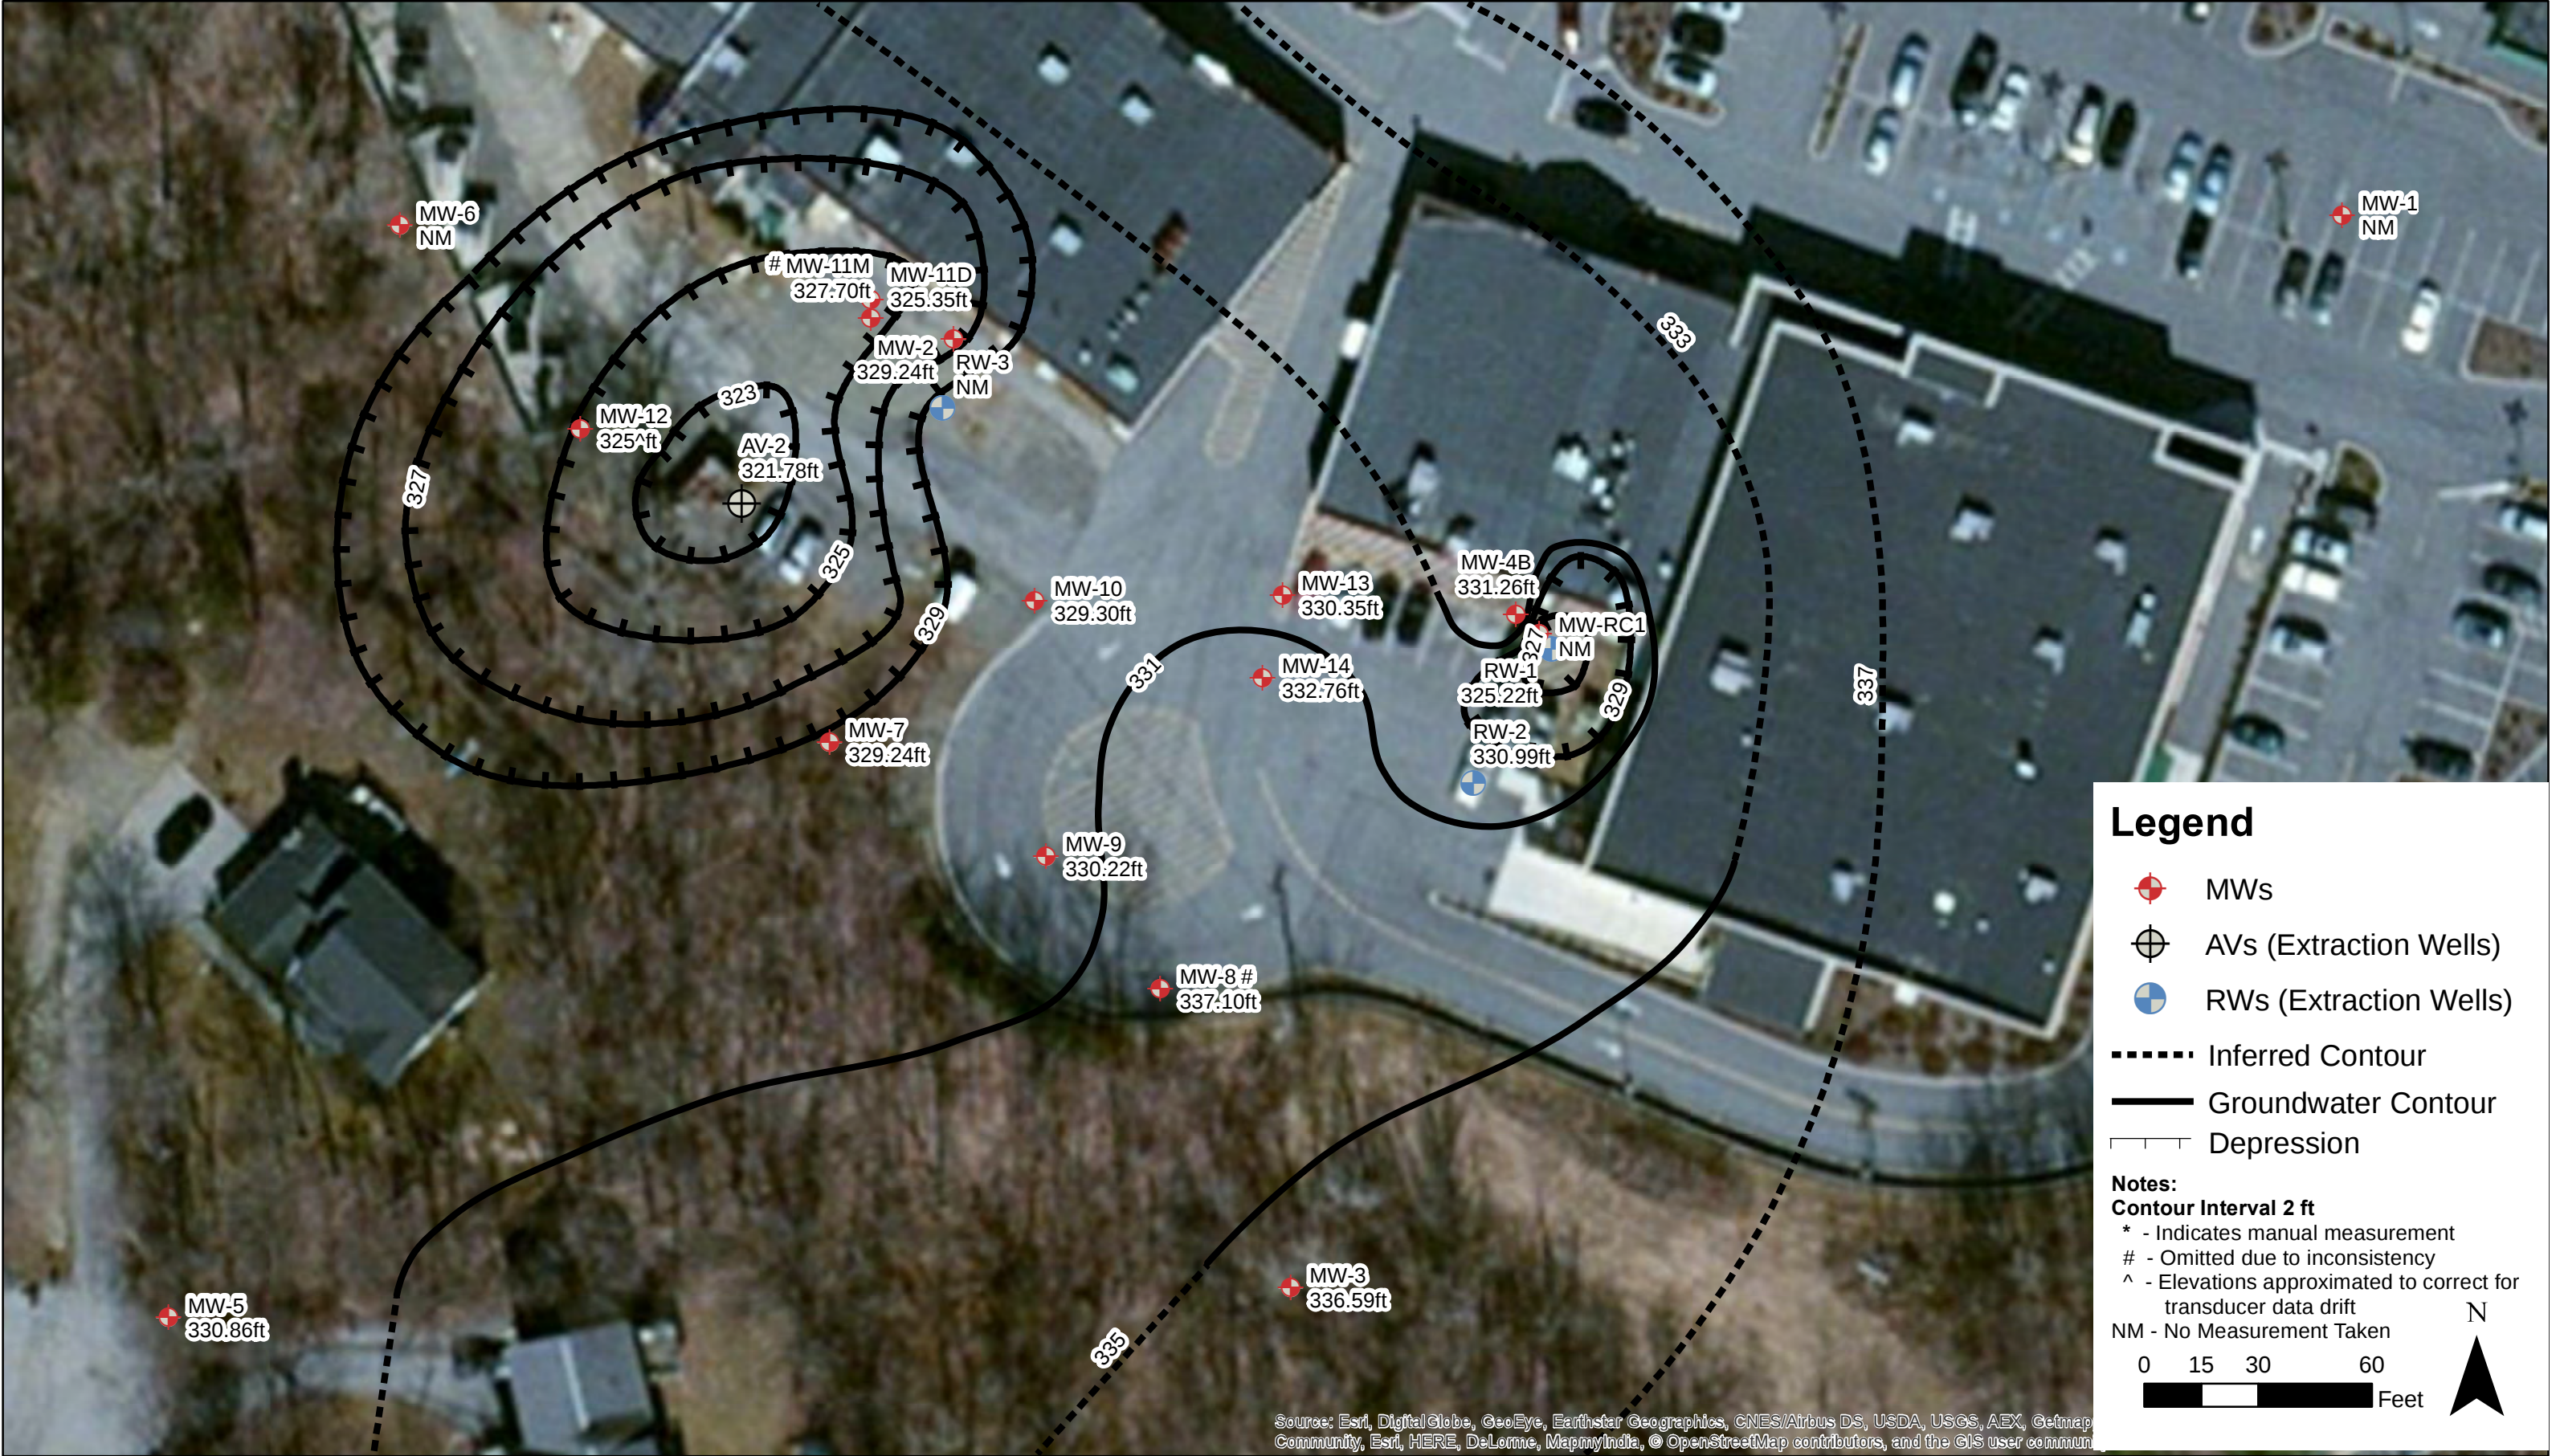
## Groundwater Contours – RW-1 and AV-2 Pumping

Apple Valley Shopping Center New York State Department of Environmental Conservation Site # 314084  
Town of LaGrange, Dutchess County, New York

With both AV-2 and RW-1 pumping, the cone of depression from both extraction wells merges and forms a single combined capture zone. The capture zone from AV-2 is the larger portion of the combined zone and acts to hydraulically contain the known groundwater contamination (Figure 12). When compared to the static, non-pumping condition, maximum drawdowns site-wide range from 2.56 ft. at MW-3 to 19.78 ft. at RW-1. Each observation well has an apparent hydraulic connection to the extraction wells as each observation well shows positive values of drawdown. When AV-2 is operating individually, the extent of its capture zone extends to around MW-10. When RW-1 is operating individually, the extent of its capture zone extends to just west of MW-13/14. This indicates a small zone of overlap in-between both wells that bridge both capture zones.
