**Site Name: C&D Power Systems Tributary D-1-7  
and Lagoon Remediation**

**Site Number: 336001**

**Location: Town of Deerpark, Orange County,  
New York**

## **Limited Size Data Package**

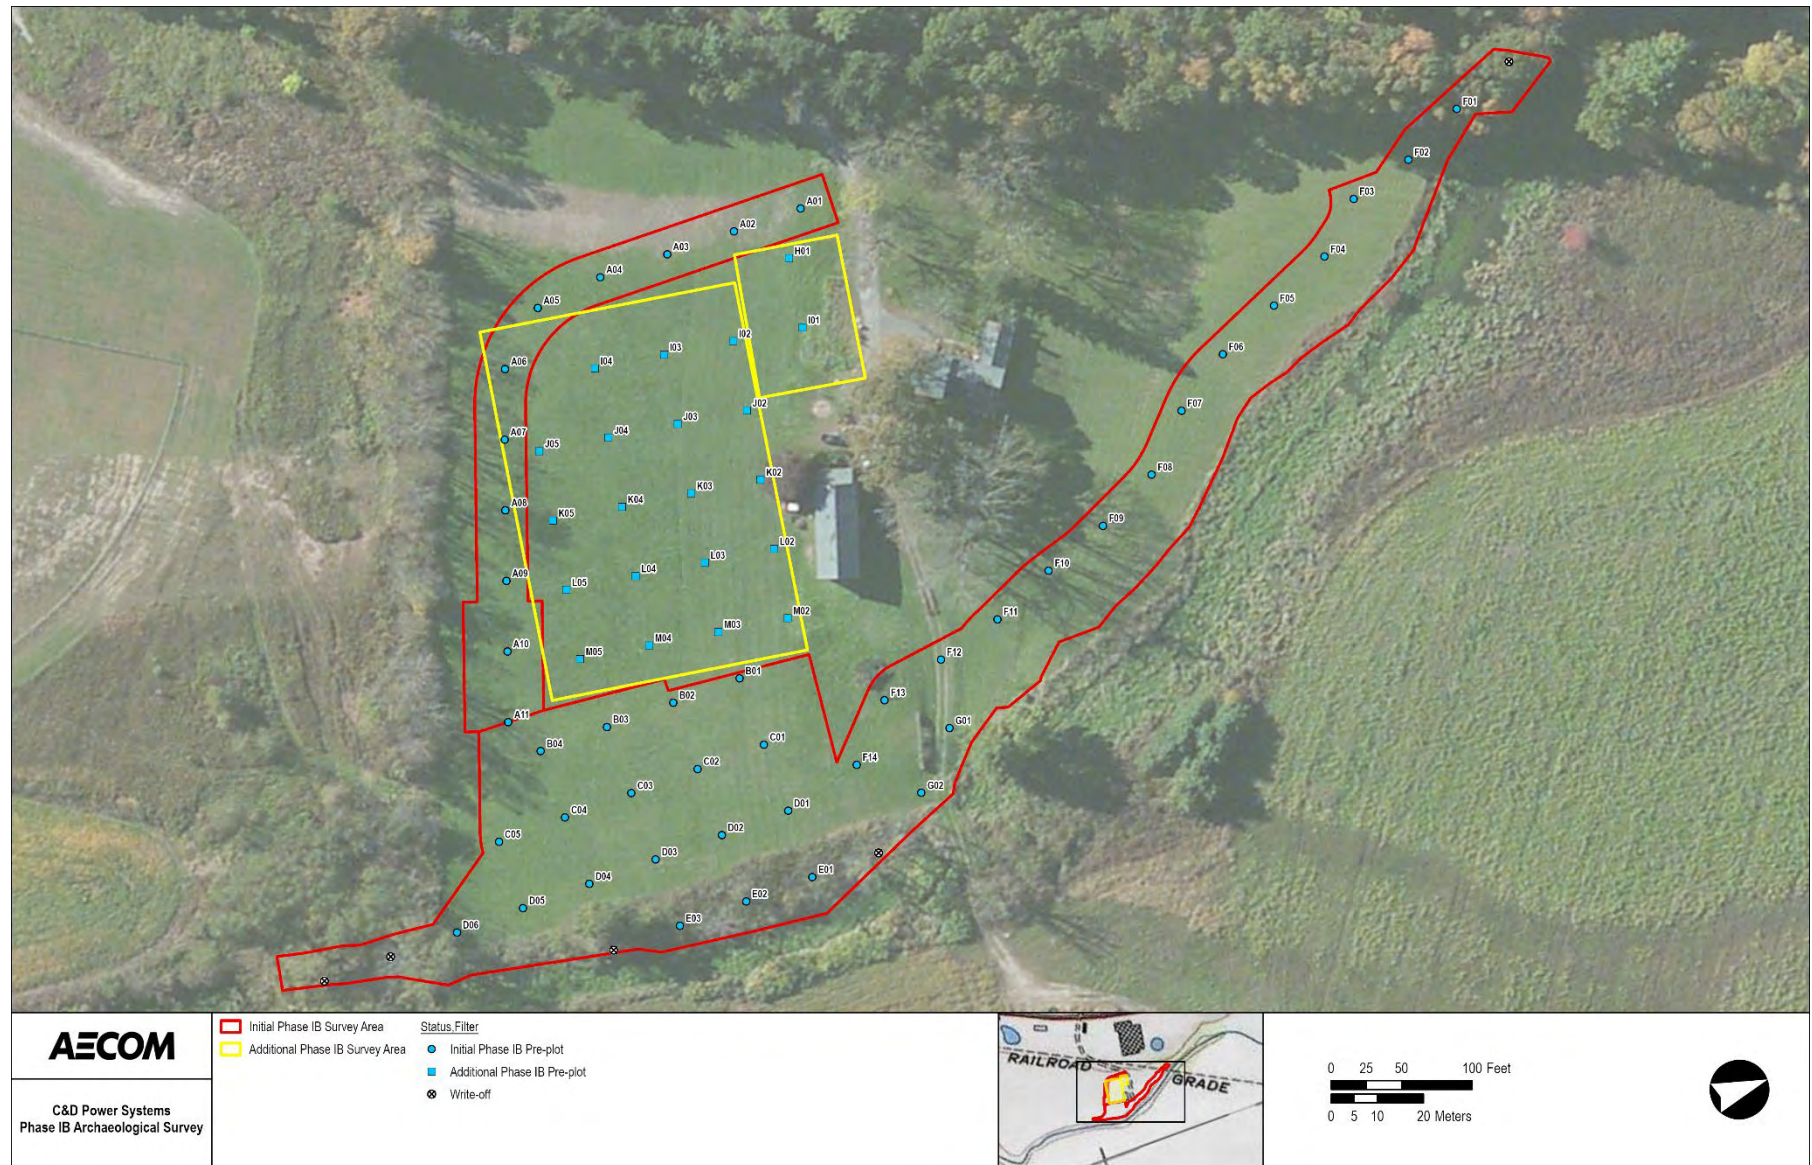
Figure 2-1: Pre-Plotted STPs in Phase IB Survey Areas

Subsurface testing was conducted through two systematic STP surveys during July 2021 and October 2021. The STPs were excavated along linear transects at an interval of 50 feet, where feasible. The transects and STP locations were pre-plotted prior to the initiation of each fieldwork effort to facilitate location in the field. Transect lengths varied, and the number of STPs along each transect varied as well (Figure 2-1). Not all the pre-plotted STPs were excavated due to existing field conditions at the time of the survey.

Testing was not conducted in areas of documented prior subsurface disturbance, standing water, or slopes greater than 20 percent. The STPs measured approximately 1 foot in diameter, and were excavated to sterile soils when possible.

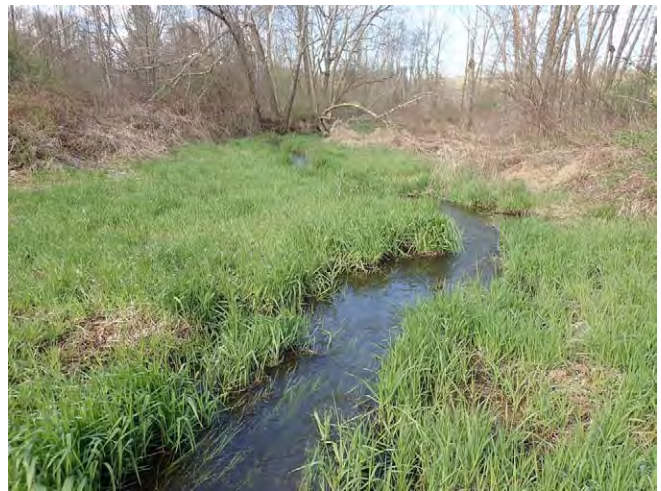
Narrow wetland-dominated channel near downstream end of the survey area.

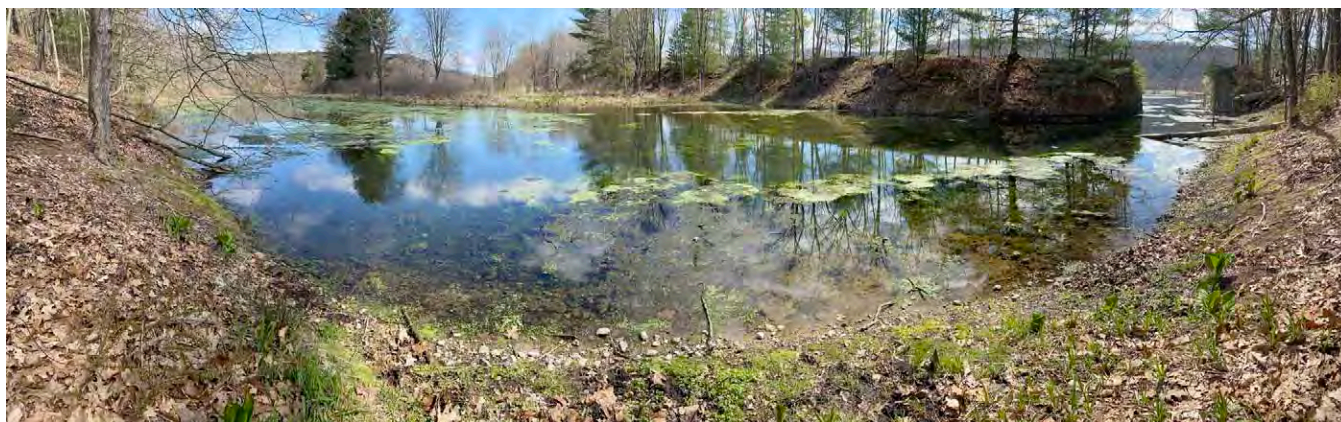
Small pond/swamp (impoundment) at the upper end of the study area.

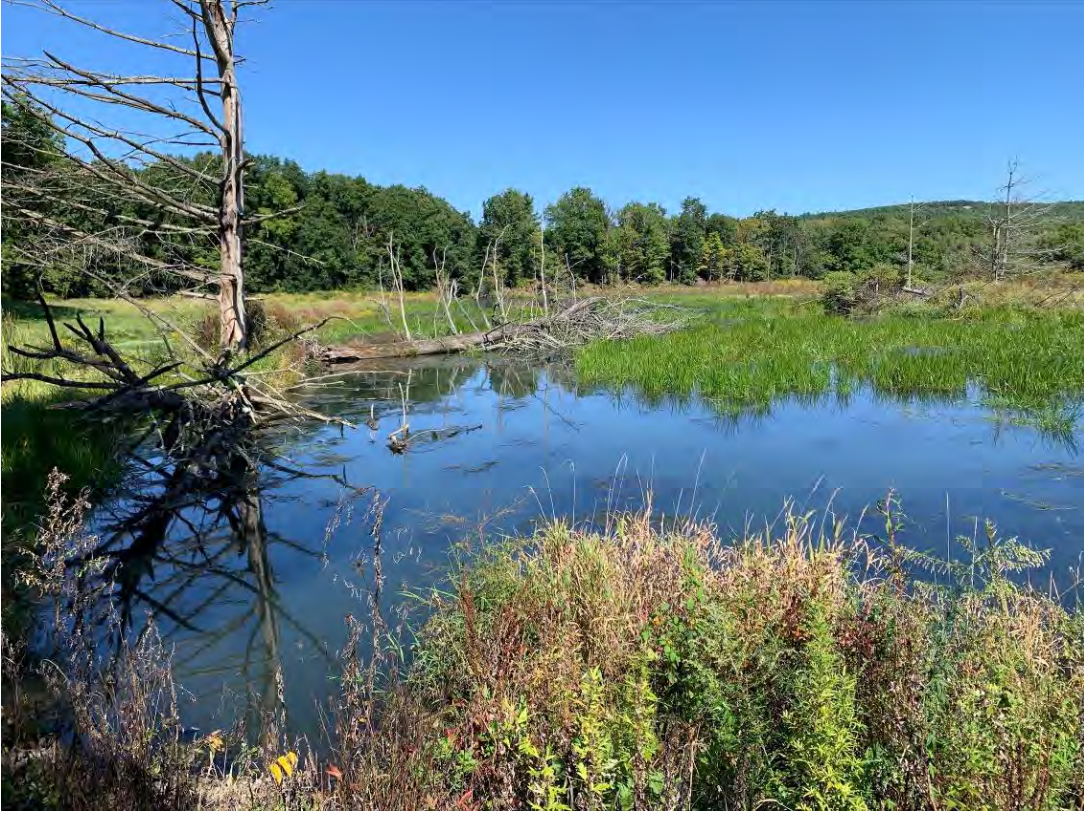
**View of field upstream of culvert. [view north from culvert mouth] Over a foot of standing water covers an area similar to that observed in field visits in August 2020.**

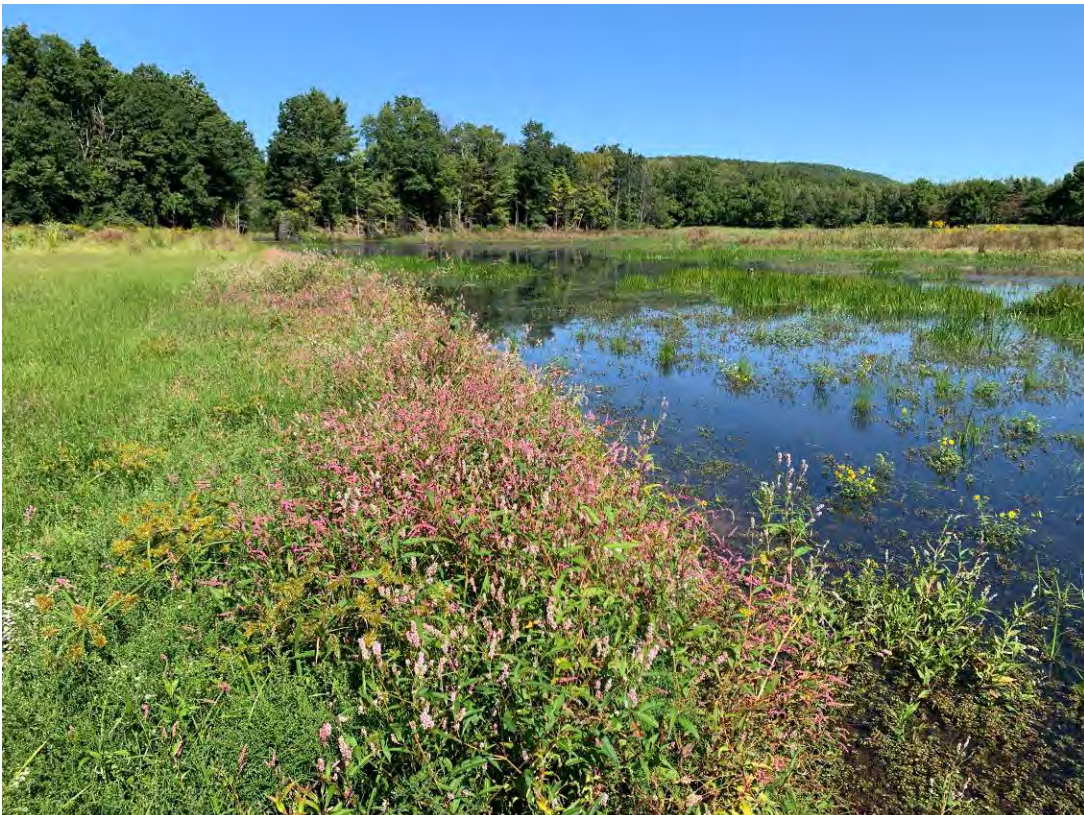
**Water level approximately 100 ft upstream of culvert. [view looking north]**

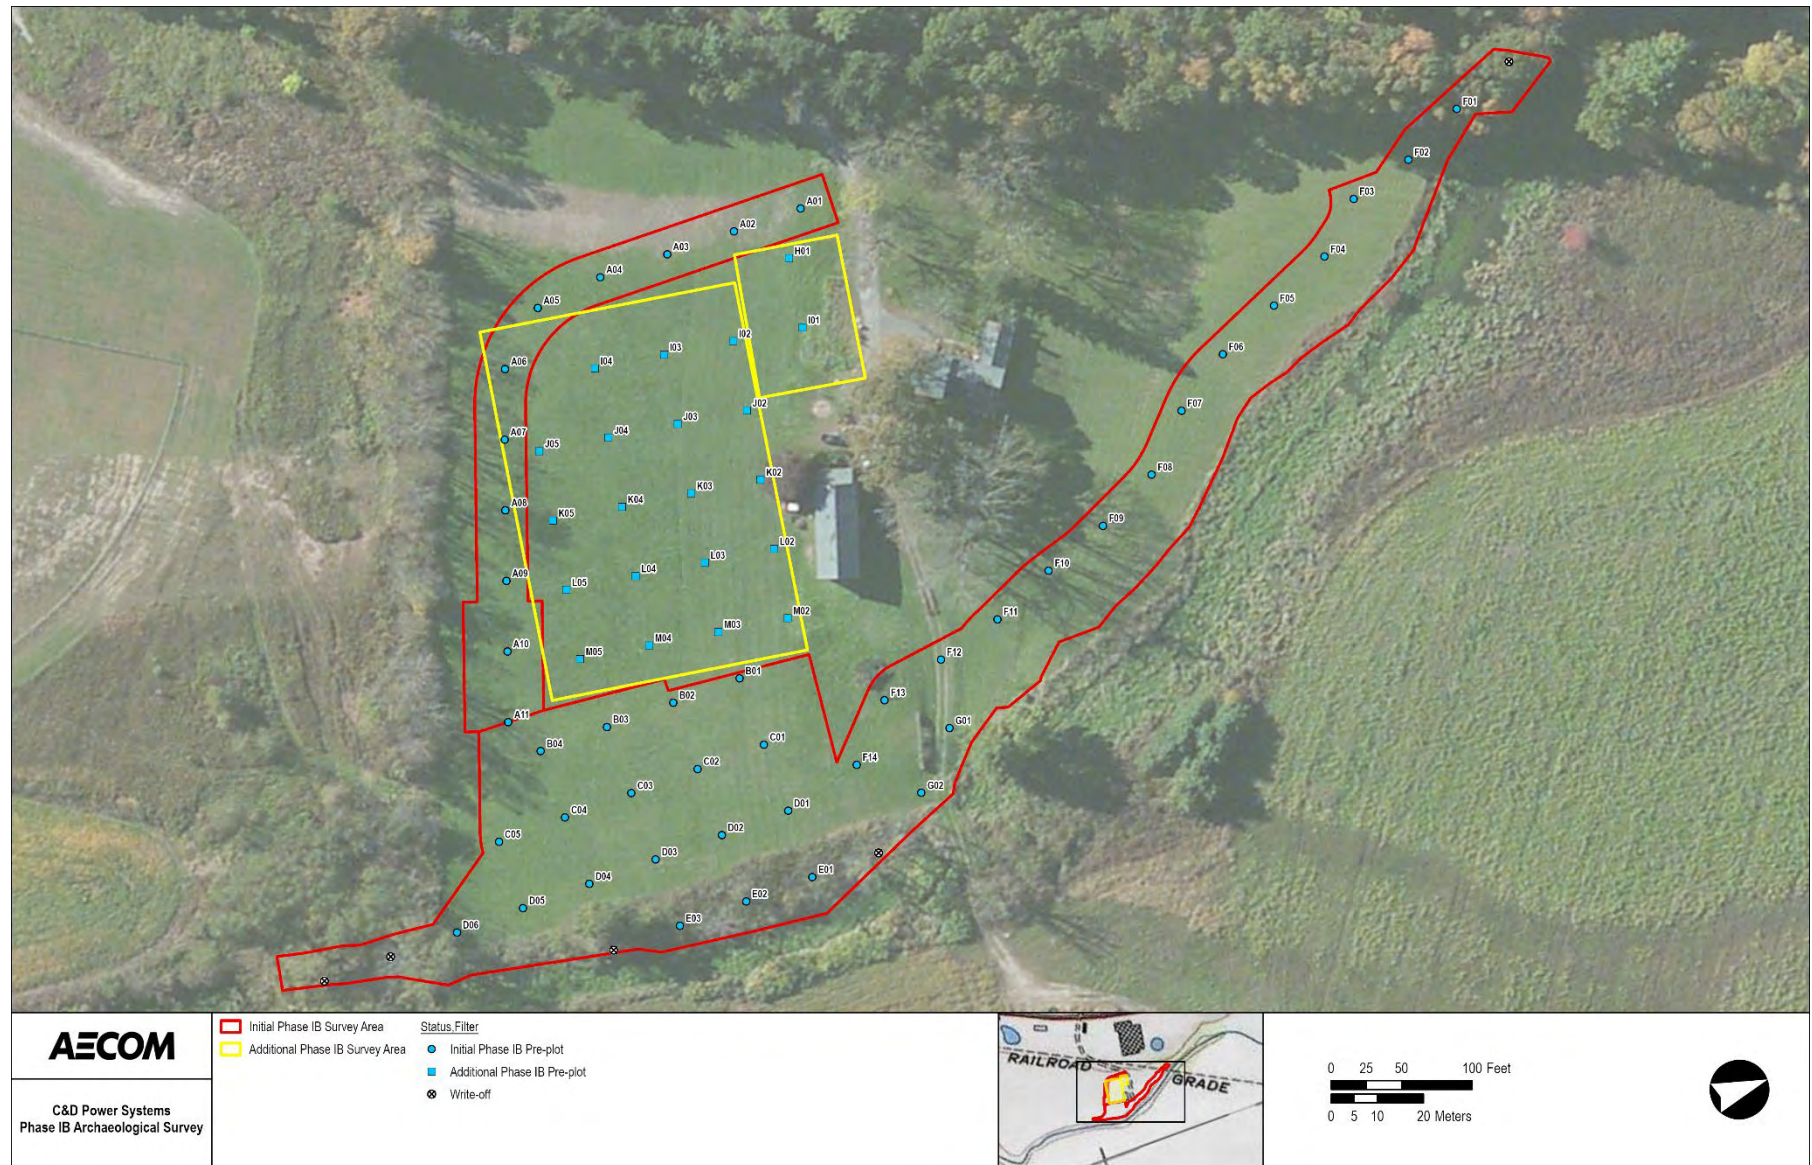
Figure 2-1: Pre-Plotted STPs in Phase IB Survey Areas

Subsurface testing was conducted through two systematic STP surveys during July 2021 and October 2021. The STPs were excavated along linear transects at an interval of 50 feet, where feasible. The transects and STP locations were pre-plotted prior to the initiation of each fieldwork effort to facilitate location in the field. Transect lengths varied, and the number of STPs along each transect varied as well (Figure 2-1). Not all the pre-plotted STPs were excavated due to existing field conditions at the time of the survey.
