**PERIODIC REVIEW REPORT
(February 1, 2017 - May 31, 2018)**

**ORANGE COUNTY LANDFILL
NYSDEC SITE NO. 336007
ROUTE 17M, GOSHEN, NEW YORK**

Sterling Environmental Engineering, P.C.
24 Wade Road
Latham, New York 12110

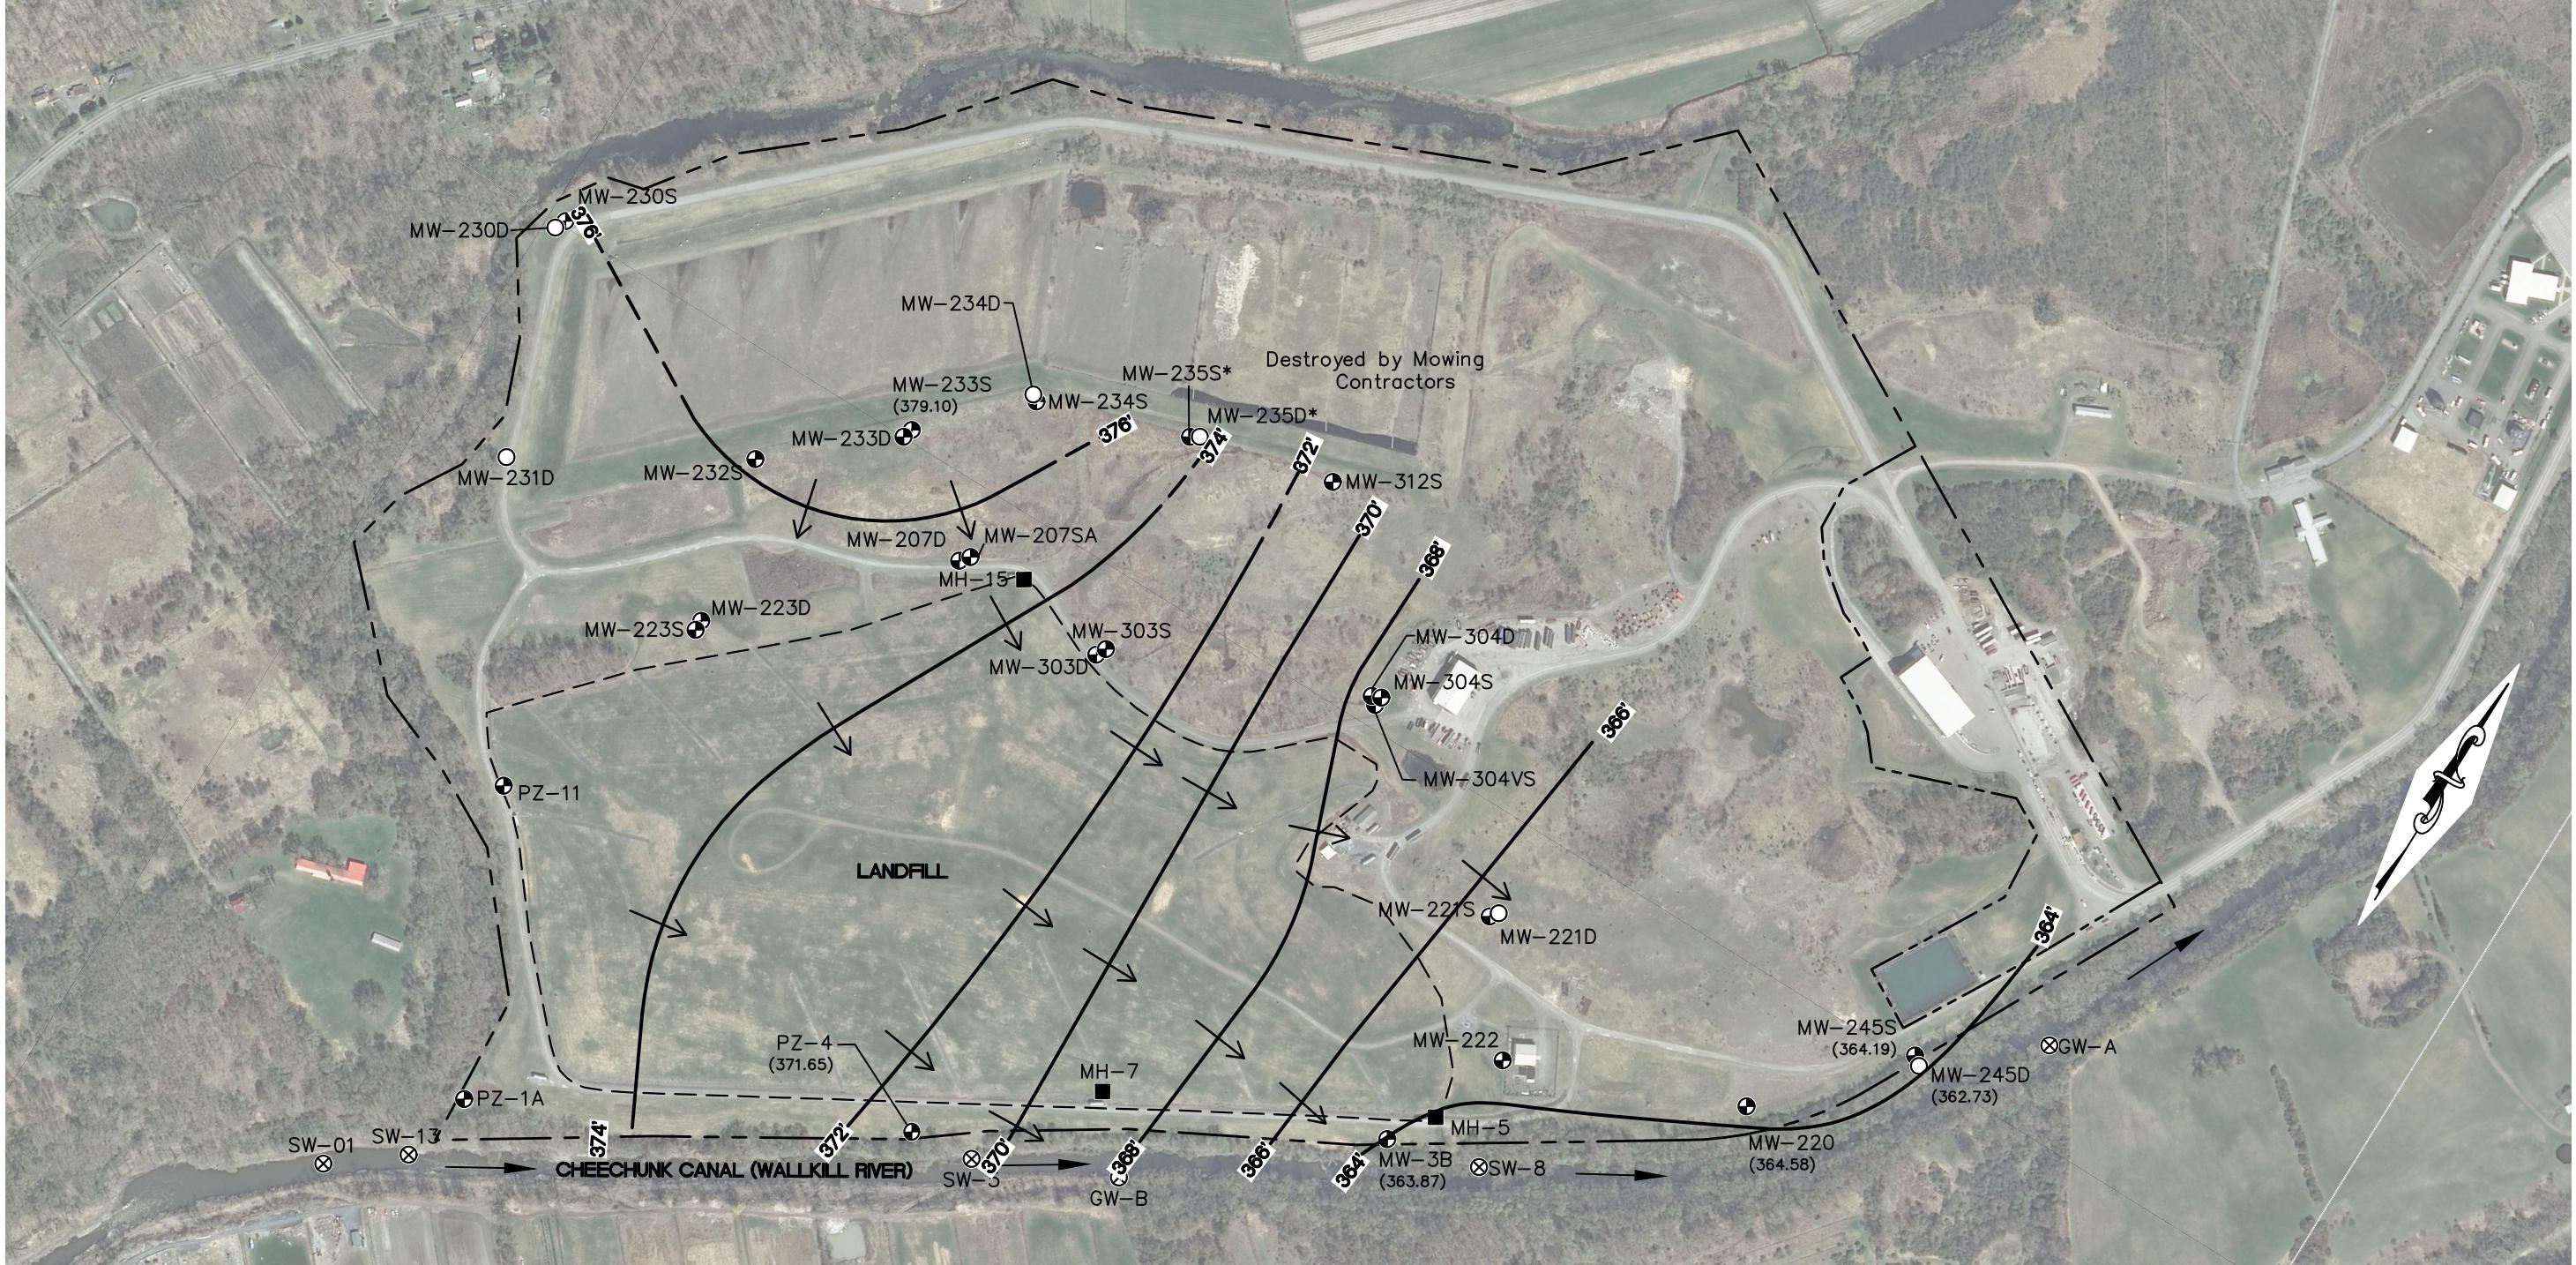
Depth to water measurements were obtained at or near the Landfill perimeter to determine groundwater elevations in the overburden and upper bedrock aquifer systems. Groundwater flow direction in the overburden aquifer is to the east-southeast towards the Cheechunk Canal (see Figure 3). Groundwater flow direction in the bedrock aquifer is similar, which is consistent with historical reports. Groundwater gradients are similar in both aquifer systems and upward vertical gradients are noted throughout the Landfill perimeter. These vertical gradients are consistent with historical trends.

- 370' GROUNDWATER ELEVATION CONTOUR
- INFERRED GROUNDWATER FLOW DIRECTION
- MW-245S (364.19) OVERBURDEN MONITORING WELL AND PIEZOMETER LOCATION WITH APRIL 20, 2018 GROUNDWATER ELEVATION (FEET ABOVE MEAN SEA LEVEL (AMSL))
- MW-245D(362.73) BEDROCK MONITORING WELL LOCATION WITH APRIL 20, 2018 GROUNDWATER ELEVATION (FEET AMSL)
- MH-7 LEACHATE SAMPLING LOCATION
- ⊗ SW-5 SURFACE WATER SAMPLE LOCATION
- LIMIT OF WASTE
- PROPERTY BOUNDARY

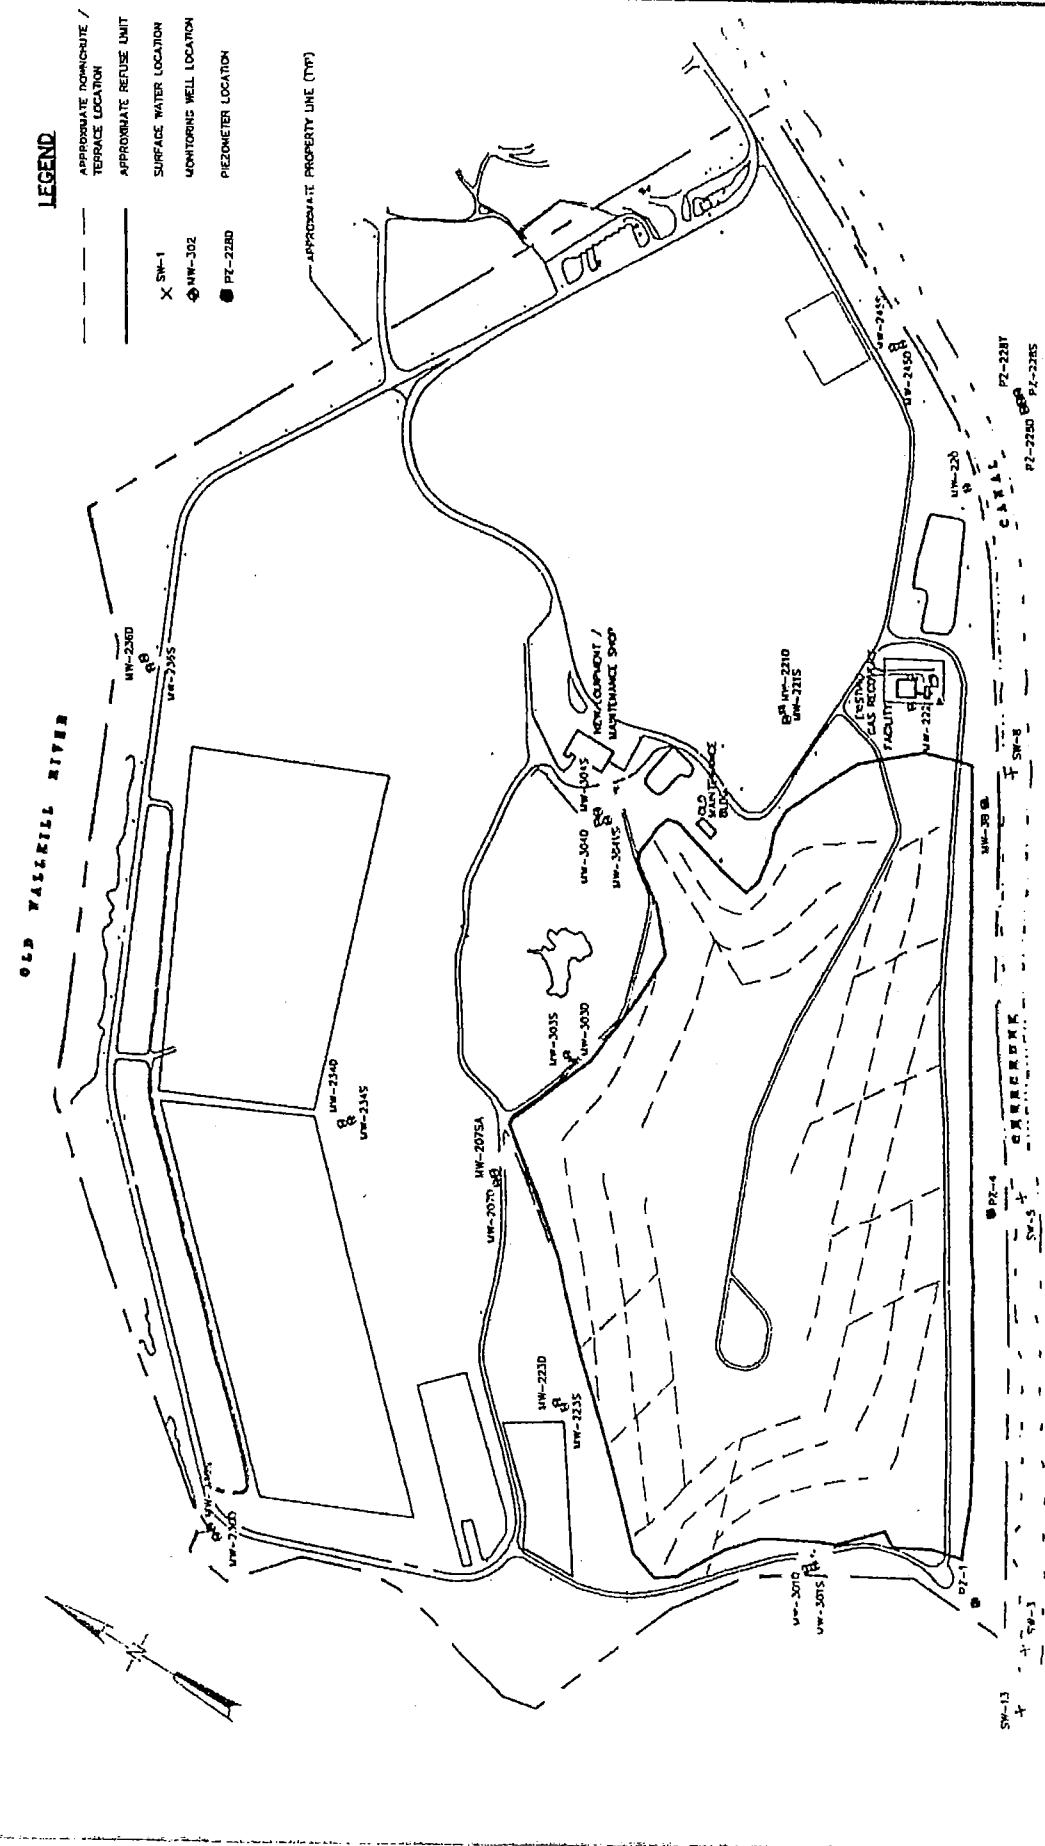
FIGURE 2A DIRECTION SITES AND ENVIRONMENTAL ENGINEERS & SCIENTISTS

COMMENTS: L-4 tank is not working. Pipe has a crack by elbow going into tank and manhole pipe is disconnected. Cook has been notified.

L-5 tank has a crack in the pipe

- The Orange County inspector noted in the February 1, 2017 Monthly Inspection Report (Appendix A) that leachate collection tanks L-4 and L-5 were not functioning properly. The manhole pipe at L-4 was disconnected by the Orange County inspector as the pipe into the tank had a crack near the elbow. Cook, Orange County's contractor, was notified of the condition. A similar crack was observed in the pipe at L-5. The pipes were replaced by Cook on March 15, 2017.

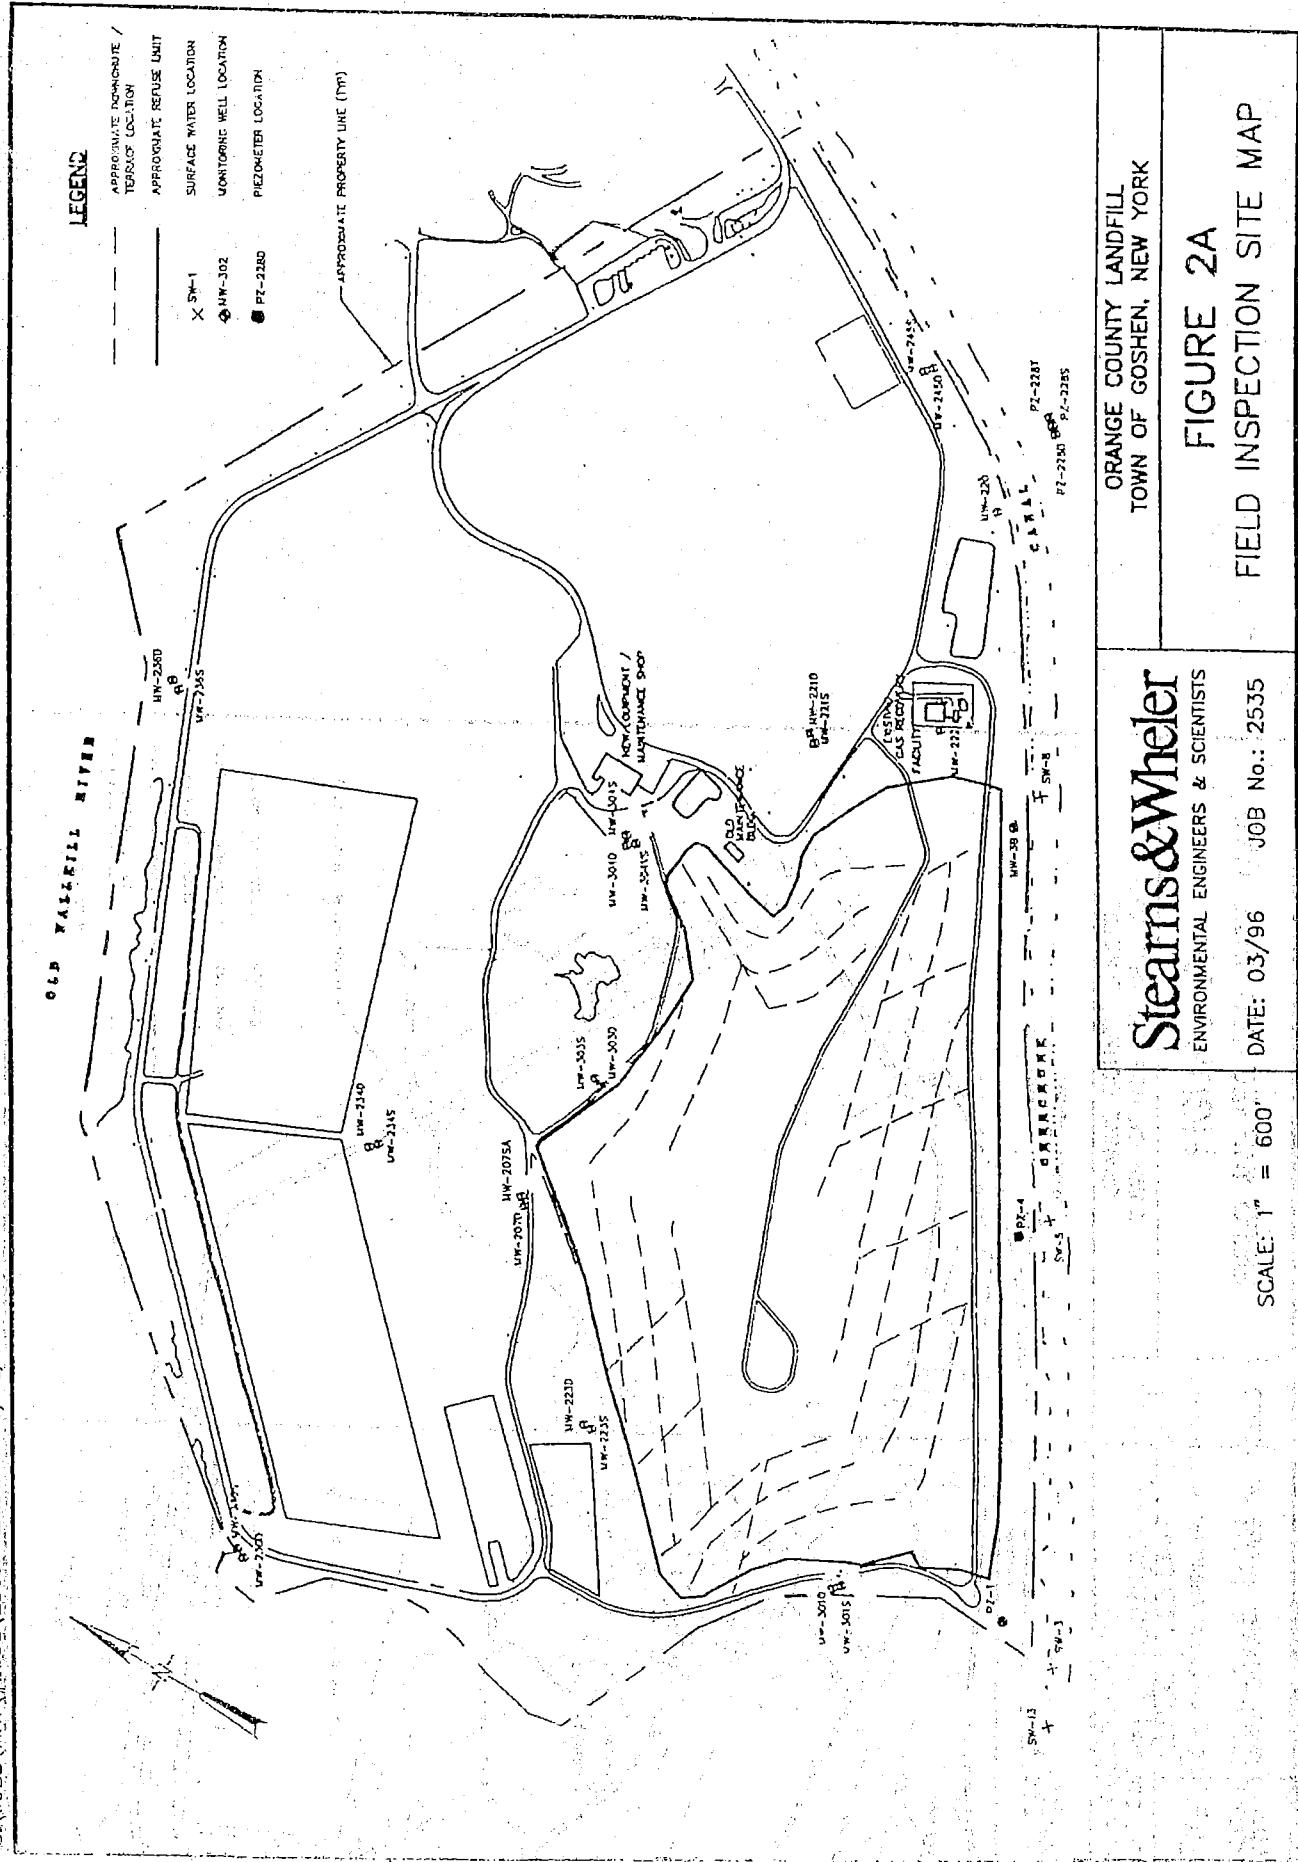
COMMENTS: L-4 is still not working. Pipe has a crack by the elbow going into the tank and the manhole pipe is disconnected. Cook has been notified twice now.

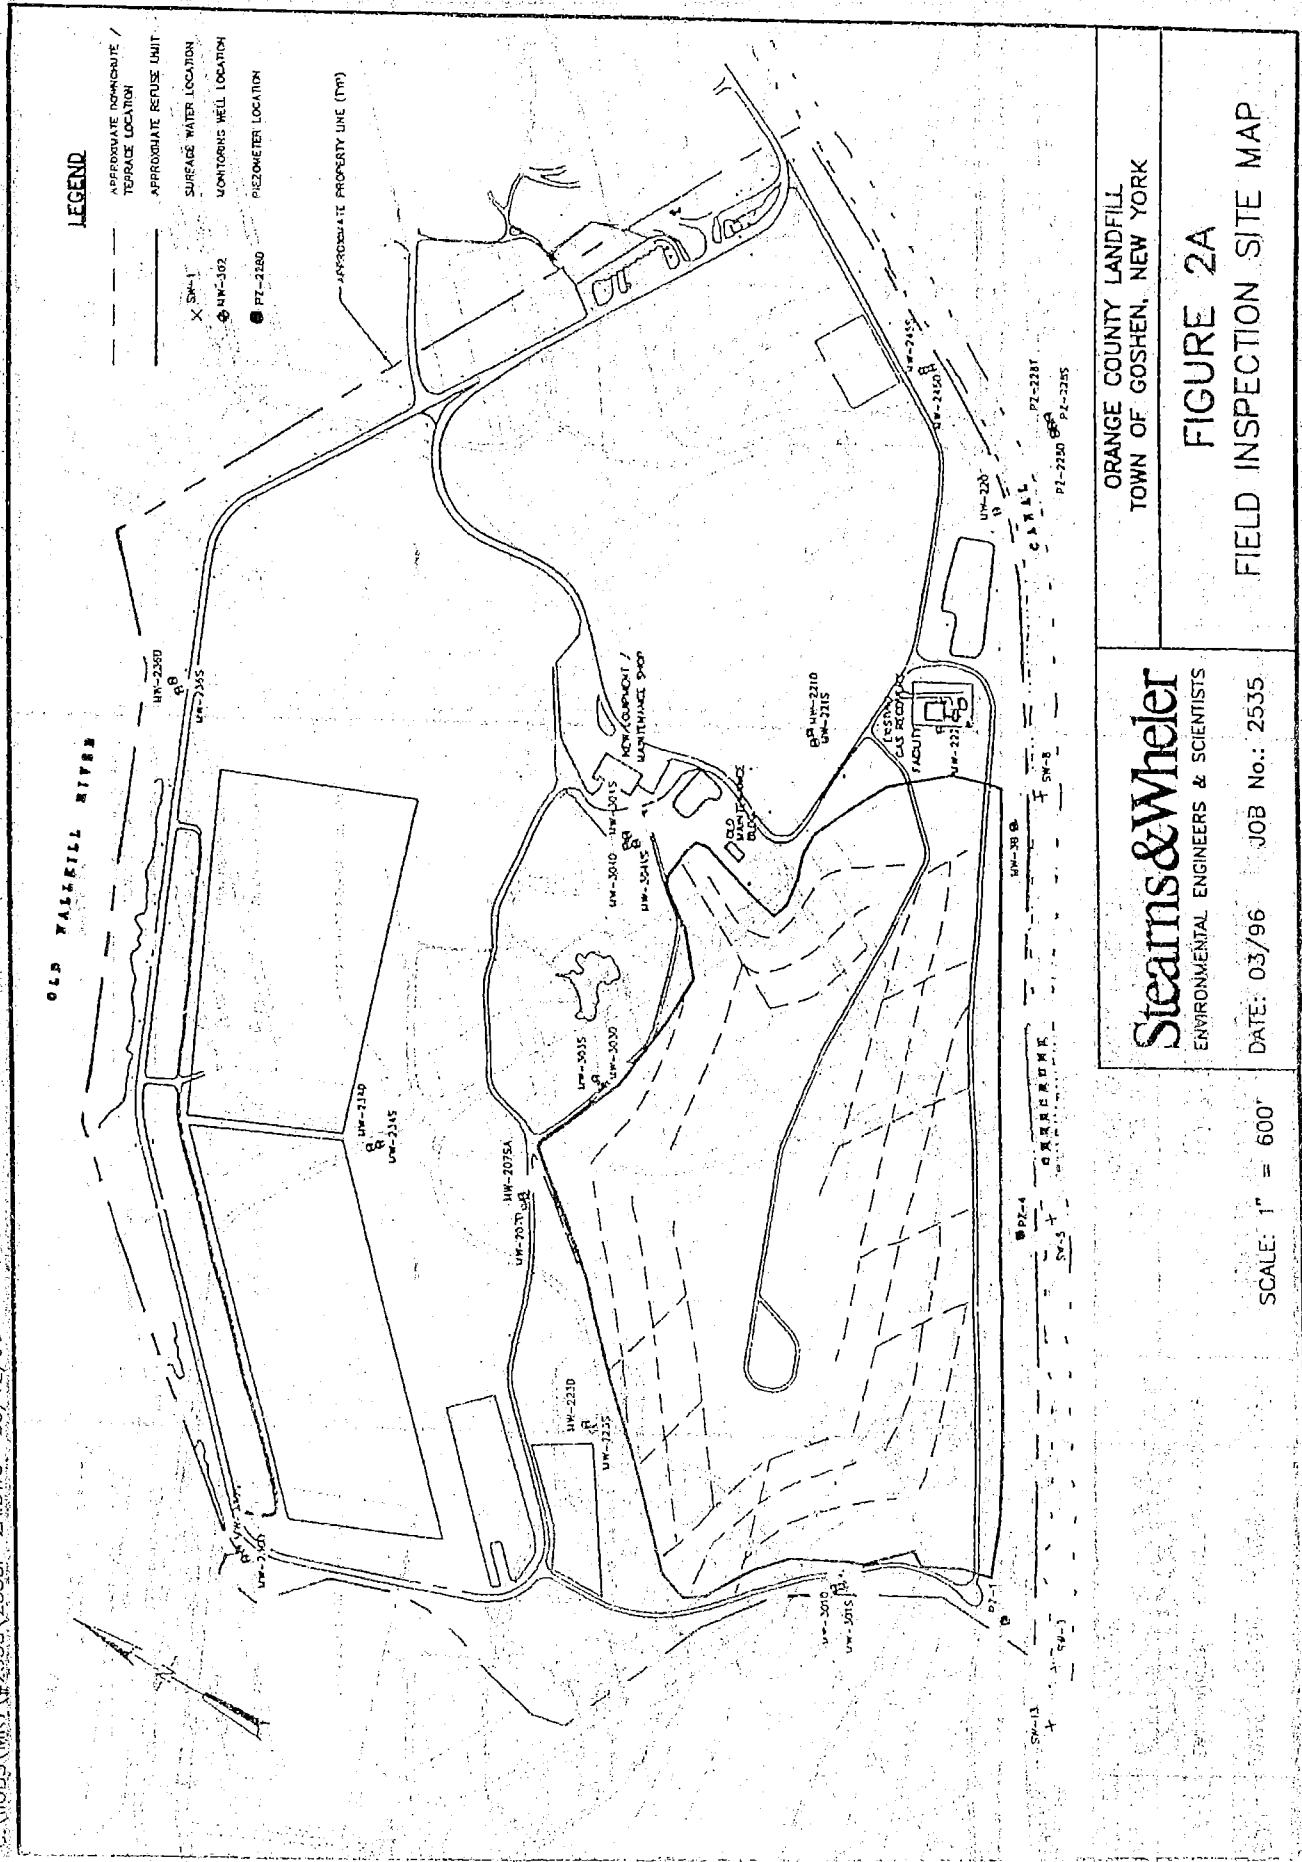
FIGURE 2A
FIELD INSPECTION SITE MAP

L-4 Red light is on. I noticed that the tank was empty. When I checked the float in the man hole the plastic pipe had been moved. When I moved it back the pump started and water was pumping into tank. Red light still would not go out.

CORRECTIVE ACTION TAKEN: Called Cook and they told me that the driver would check when he pumps tanks out.
