Subject: Well Abandonment Letter Report Site 2 Former Pesticide Pit Burial Area, Stewart Air National Guard Base Site #: 3-36-022

On behalf of National Guard Bureau (NGB), AECOM has prepared this letter to describe the abandonment of wells associated with the closure of Site 2 Former Pesticide Pit Burial Area (Site). The Site number is 3-36-022. The Site is located on the Stewart Air National Guard Base (ANGB), Newburgh, Orange County, New York (Figure 1). The Stewart ANGB occupies approximately 268 acres and is located in both the Town of Newburgh and the Town of New Windsor. Stewart ANGB is located southeast of the airport complex at the Stewart International Airport (IAP) as shown in Figure 1.

ATTACHMENT B Photograph Log

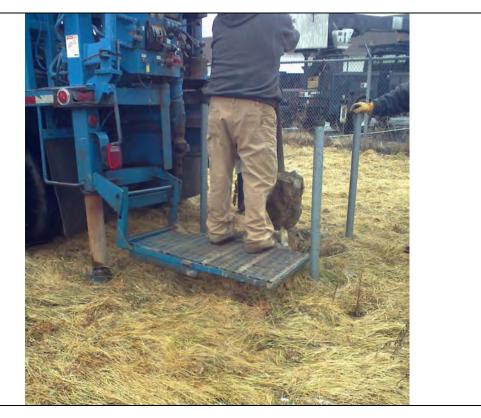
Photo No. 2	Date: 1/17/12
Direction Ph	oto Taken:
View northwes	st.
Decerintien	
Description:	
Pulling MW-17 of the ground v rig.

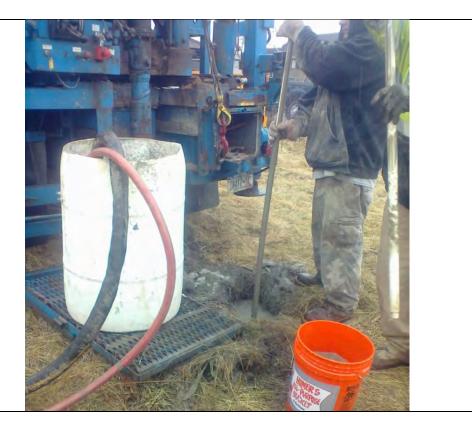
Photo No. Date: 4 1/17/12 Direction Photo Taken: View northwest. Description: Retracting the tremie pipe used to place the grout.
