Construction Completion Report for Source Area Excavation and NAPL
Recovery Well Installation
Orange and Rockland Utilities, Inc.
Port Jervis Former Manufactured Gas Plant Site
City of Port Jervis, Orange County, New York
Site No. 336049

CONSTRUCTION COMPLETION REPORT FOR SOURCE AREA EXCAVATION AND NAPL RECOVERY WELL INSTALLATION

Port Jervis Former Manufactured Gas Plant Site
City of Port Jervis, Orange County, New York
Site No. 3-36-049

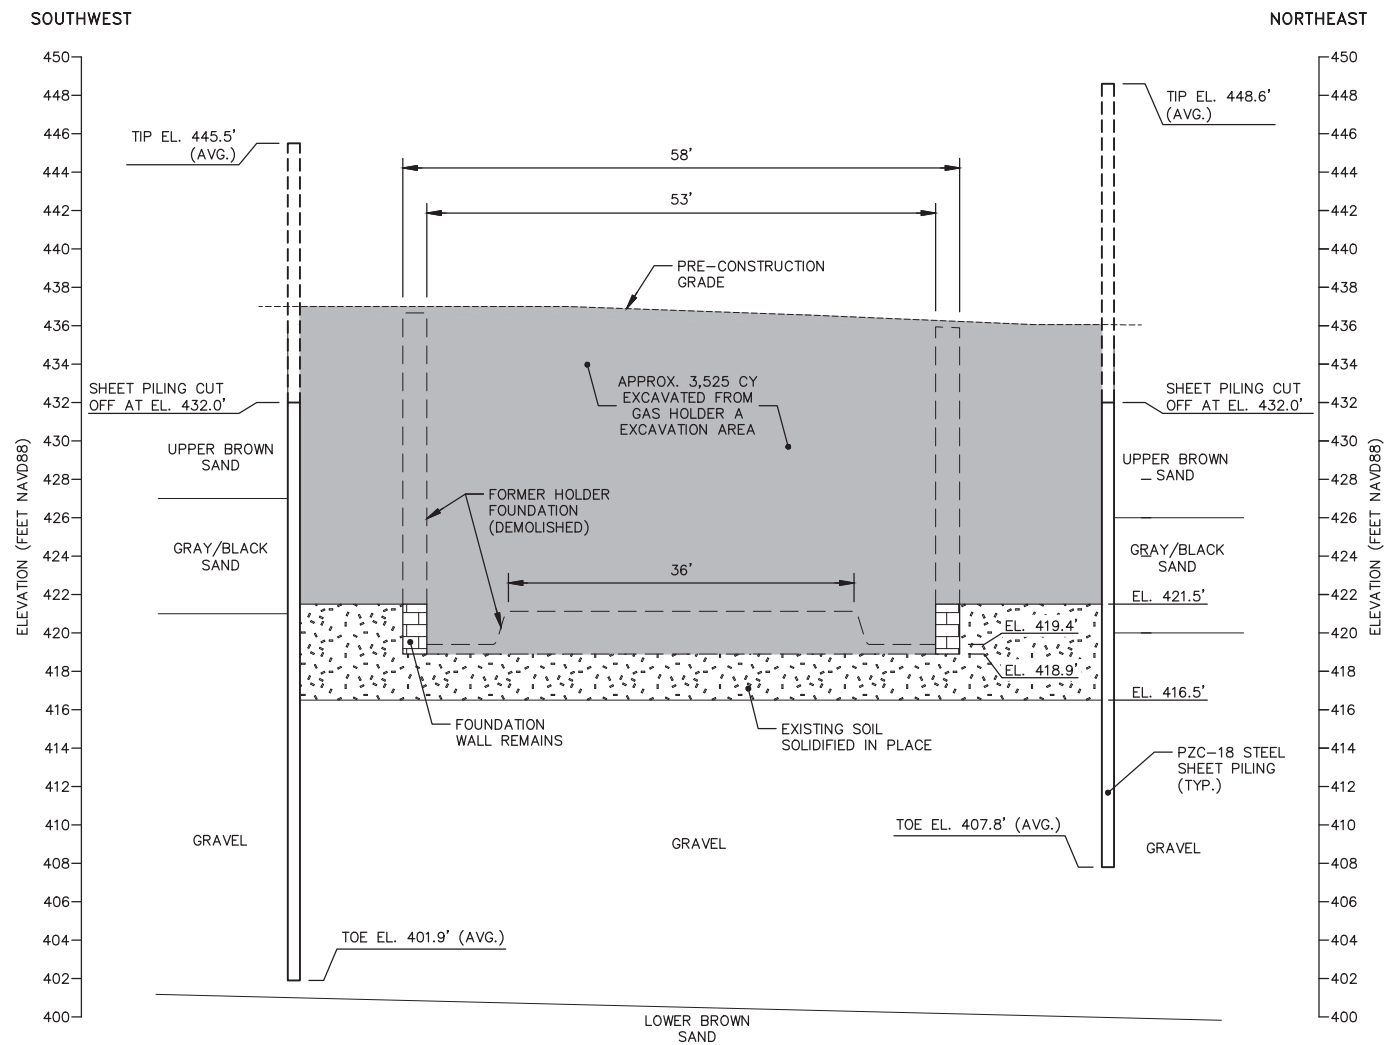
SECTION 1

PHASE 2 EXCAVATION AND IN-SITU SOIL SOLIDIFICATION SECTIONS

Soil and debris in Cells 1 and 2 were initially excavated to an interim elevation of approximately 423.0 feet NAVD88 to facilitate the ISS activities described in Section 6.5 below. An additional 1.5 feet of soil was subsequently excavated from Cell 2 in conjunction with the ISS activities in that cell. Within Cell 1, soils surrounding the former holder foundation were ultimately excavated to an elevation of 421.5 feet NAVD88. Soil and debris located within the footprint of the foundation were excavated, and the floor of the foundation was removed to an elevation of approximately 418.9 feet NAVD88. The perimeter ring wall of the former holder foundation was left in place below an elevation of approximately 421.5 feet NAVD88 (Record Drawings 3 and 4 in Appendix F).

Within Cell 1, ISS activities were initiated in the soil mixing cells surrounding the former holder foundation, which were each mixed and solidified in-place between elevations 421.5 feet NAVD88 and 416.5 feet NAVD88. Soil and debris located within the footprint of the foundation itself were excavated and transported off-site for disposal, and the floor of the foundation was completely exposed to assess its condition and construction. Once exposed, the foundation floor was broken up with a hoe ram and loaded out for off-site disposal. Existing soils underlying the foundation were then mixed and solidified in-place between elevations 418.9 feet NAVD88 and 416.5 feet NAVD88. The perimeter ring wall of the former holder foundation was left in place below elevation 421.5 feet NAVD88 (Record Drawings 3 and 4 in Appendix F).
