Wetland Restoration Plan  
Glenmere Lake Property  
Town Of Chester, Orange County, NY  
(Site Registry No. 336071)

Prepared for  
D&B Engineers & Architects, P.C.

Prepared by  
EcoLogic LLC  
Cazenovia, NY

*November 2013*

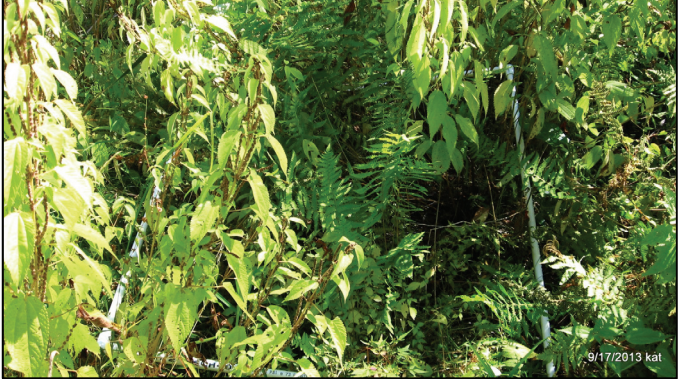
<p><b>Photograph 2</b> - Herbaceous layer of Zone C, with meter-square for scale reference.</p>

- Zone C – extending from the edge of Zone D lakeward approximately 20 ft. In this zone, the recommended herbaceous plants are false nettle (*Boehmeria cylindrica*), swamp loosestrife (*Decodon verticillatus*), marsh fern (*Thelypteris palustris*), arrow arum (*Peltandra virginica*), and marsh St. John's wort

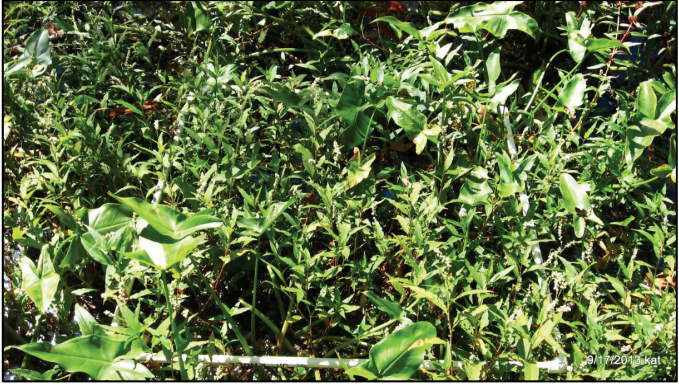
<p><b>Photograph 3</b> - Herbaceous layer of Zone B, with meter-square for reference.</p>

- Zone B – extending from the edge of Zone C approximately 15 ft lakeward. In this zone, herbaceous plants that would do well are swamp smartweed (*Persicaria hydropiperoides*), swamp loosestrife (*Decodon verticillatus*), arrow arum (*Peltandra virginica*), and nodding burr marigold (*Bidens cernua*).

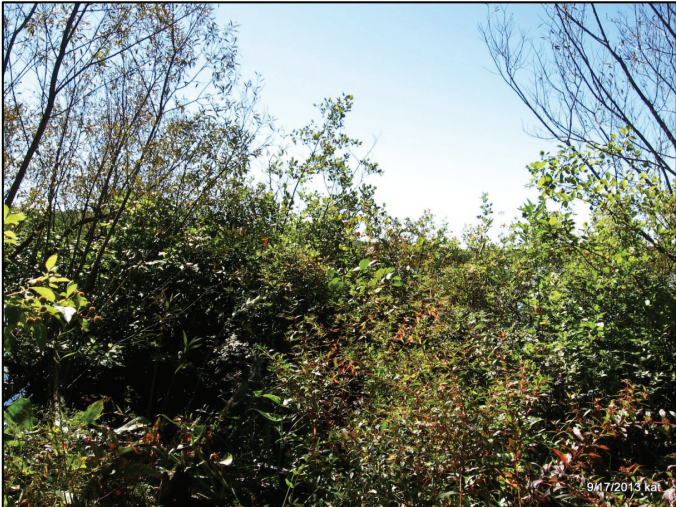
<p><b>Photograph 4</b> – Shrub layer of Zone A.</p>

- Zone A – extending from the edge of Zone B lakeward, consisting of a small low island of assorted shrubs and small trees. This area is not expected to be excavated, therefore no planting will be required. However, if in the course of remediation it becomes clear that this area will require replanting, acceptable replacement shrubs include buttonbush (*Cephalanthus occidentalis*), hazel alder (*Alnus serrulata*), sweet pepperbush (*Clethra alnifolia*), highbush blueberry (*Vaccinium corymbosum*), and silky dogwood (*Cornus amomum*). These shrubs were identified in the Watershed Management Plan as commonly occurring on Glenmere Lake (Milone & MacBroom, Inc., 12/2011, revised 02/2012).

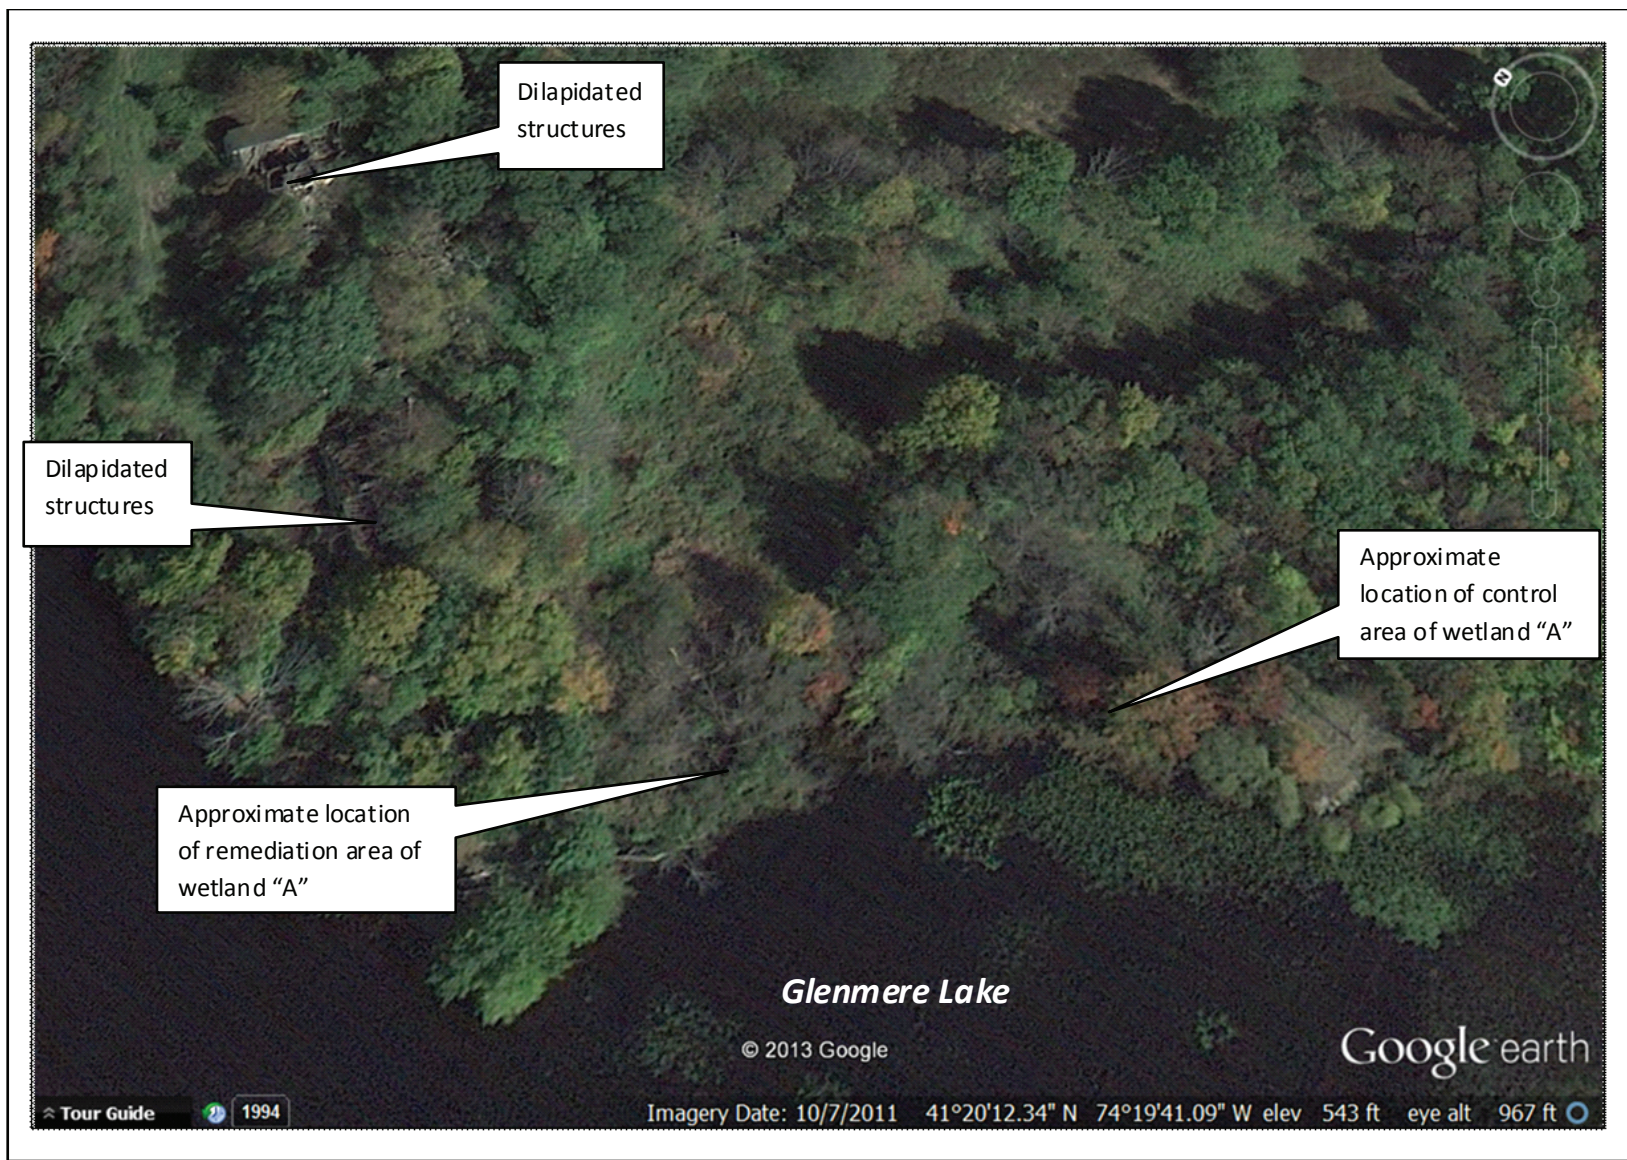
Figure 3. Aerial image, circa 2011, of the vegetation survey area (EcoLogic, LLC, September 2013).

During the vegetation survey of September 2013, EcoLogic staff observed that The Property was fenced and vacant. There were remnants of seven buildings on The Property, in various states of deterioration. In addition to the dilapidated structures, there were wooded areas, open meadow, and wetlands fringing along the shoreline of Glenmere Lake (Figure 3).
