Glenmere Lake Property
Site No. 336071

Final Engineering Report

GLENMERE LAKE PROPERTY PINE HILL ROAD CHESTER, ORANGE COUNTY, NEW YORK NYSDEC SITE NUMBER: 336071

D&B ENGINEERS AND ARCHITECTS, P.C. 330 CROSSWAYS PARK DRIVE WOODBURY, NEW YORK (516) 364-9890

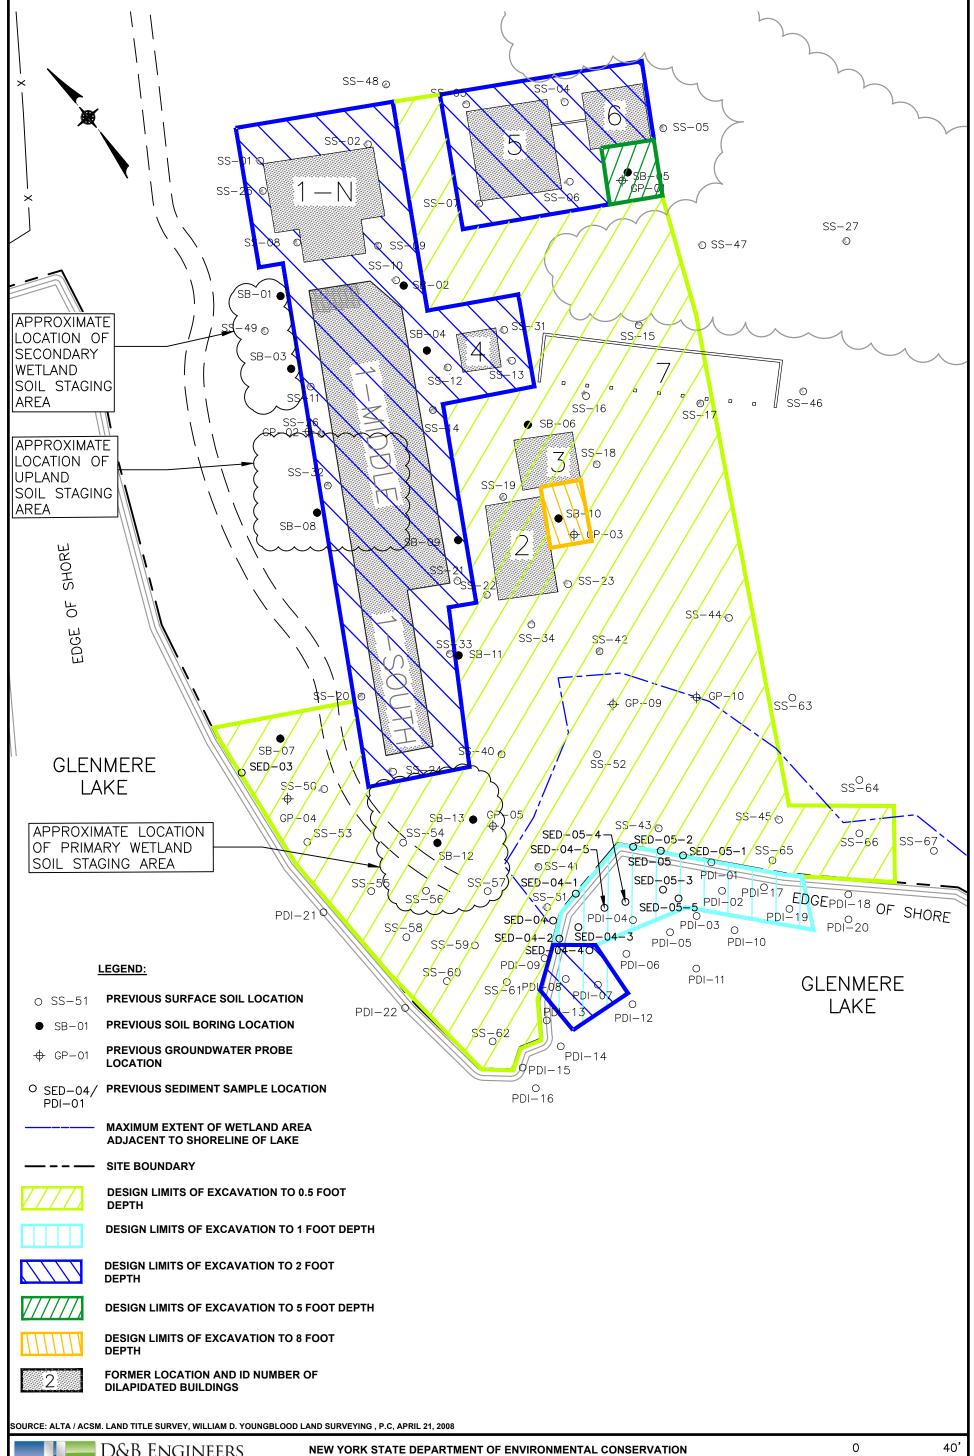
EXCAVATION PLAN

As depicted on *Figure 4-1*, the scope of work included the demolition and off-site disposal of dilapidated Buildings 1 through 7, including their concrete foundations. Buildings 1-North, 1-Middle, 1-South, 5 and 6 were previously determined to contain asbestos-containing material (ACM). These same buildings as well as Building 4 were also previously determined to contain lead-based paint. Neither ACM nor lead-based paint were identified in Buildings 2, 3 and 7.
