**SITE CHARACTERIZATION REPORT
FOR THE
WALSH ROAD SITE (NYSDEC SITE # 336077)
NEW WINDSOR, ORANGE COUNTY, NEW YORK**

DECEMBER 2014

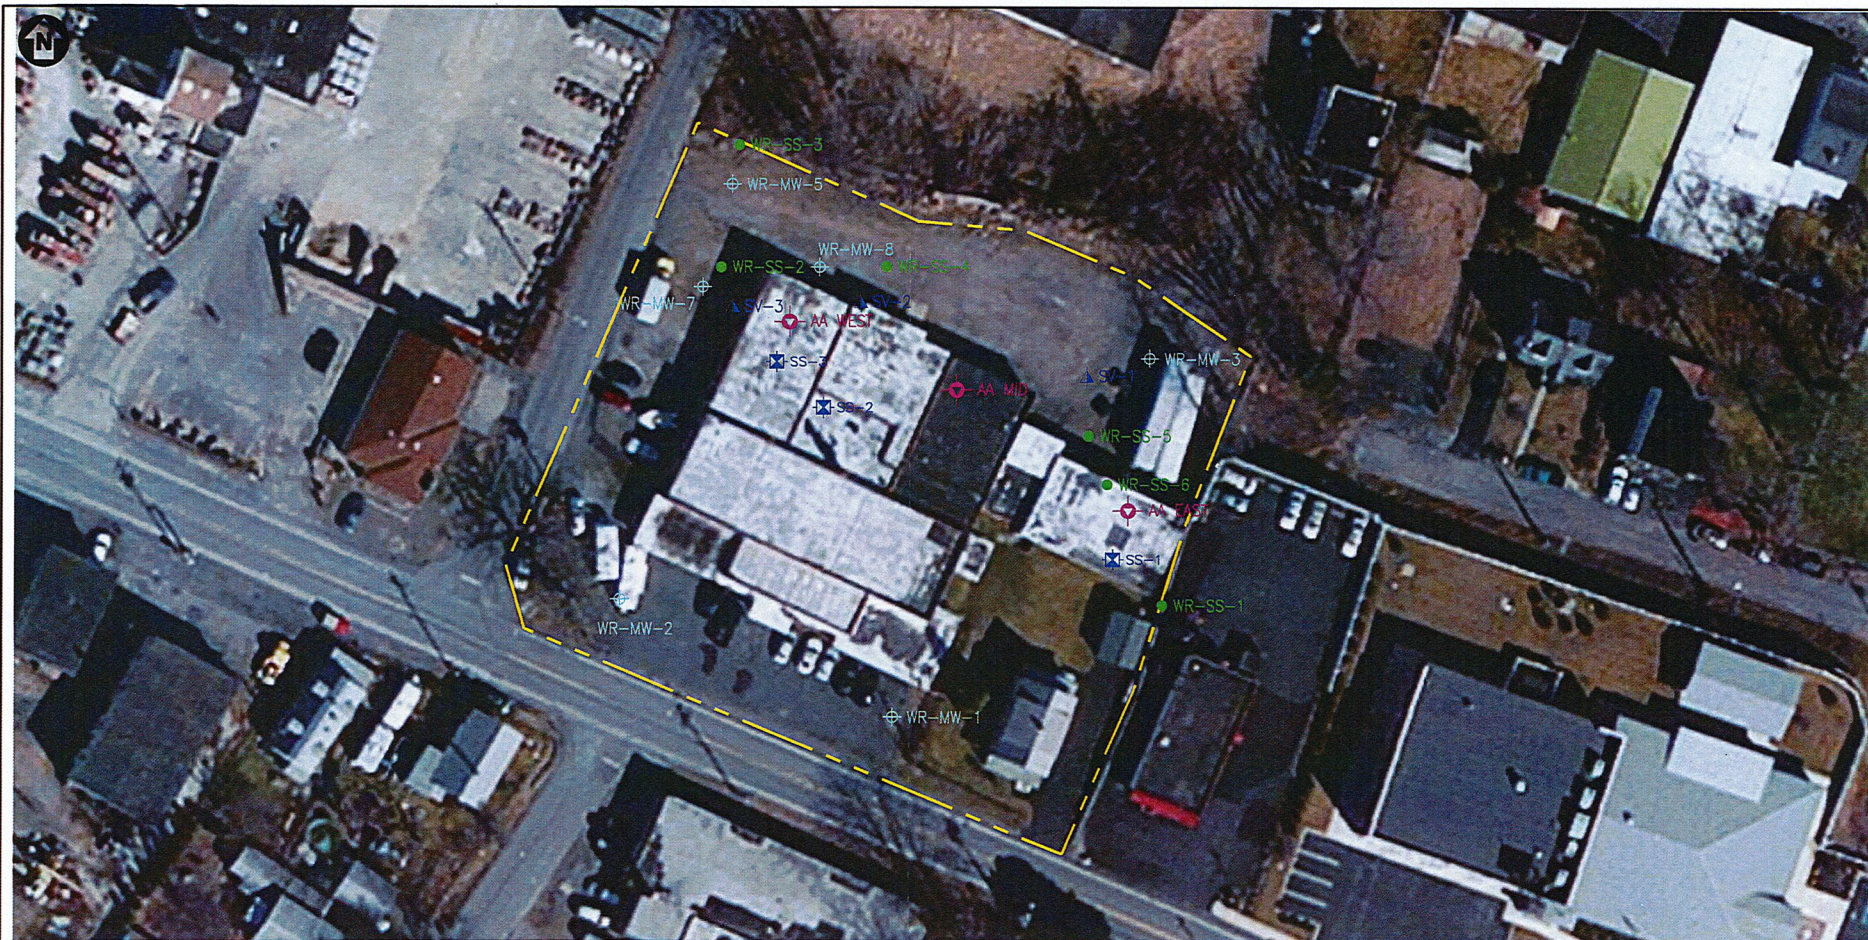
Field activities were conducted in accordance with the Quality Assurance Project Plan (Parsons and OBG, 2011a) and the Health and Safety Plan (Parsons and OBG, 2011b) prepared and approved for Parsons' standby engineering services contract with NYSDEC. Site-specific elements and specific job safety analyses for soil and water sampling, were added to the Health and Safety Plan. A map of sample locations is provided as Figure 2.

Three locations were selected for collection of exterior soil vapor samples (sample locations SV-1, SV-2 and SV-3) as shown on Figure 2. Sample locations were located outside along the northern portion of the on-site building, and were discussed in the field with NYSDEC prior to collection. Soil vapor samples were collected on July 25, 2013 through temporary soil vapor points installed at a depth of 3 to 5 ft. below grade. Soil vapor samples were installed in accordance with the NYSDOH Guidance. Temporary soil vapor points were installed using manual installation techniques. Helium tracer gas was used to verify the integrity of the sample point seals prior to sample collection.

As shown on Figure 2, three sub-slab soil vapor samples were collected within the on-site building (sample locations WR-SS-1, WR-SS-2 and WR-SS-3). Sample locations were discussed in the field with Paul Patel of NYSDEC prior to collection. Locations WR-SS-1 and WR-SS-3 were collected from slab-on-grade portions of the on-site building. WR-SS-2 was collected from

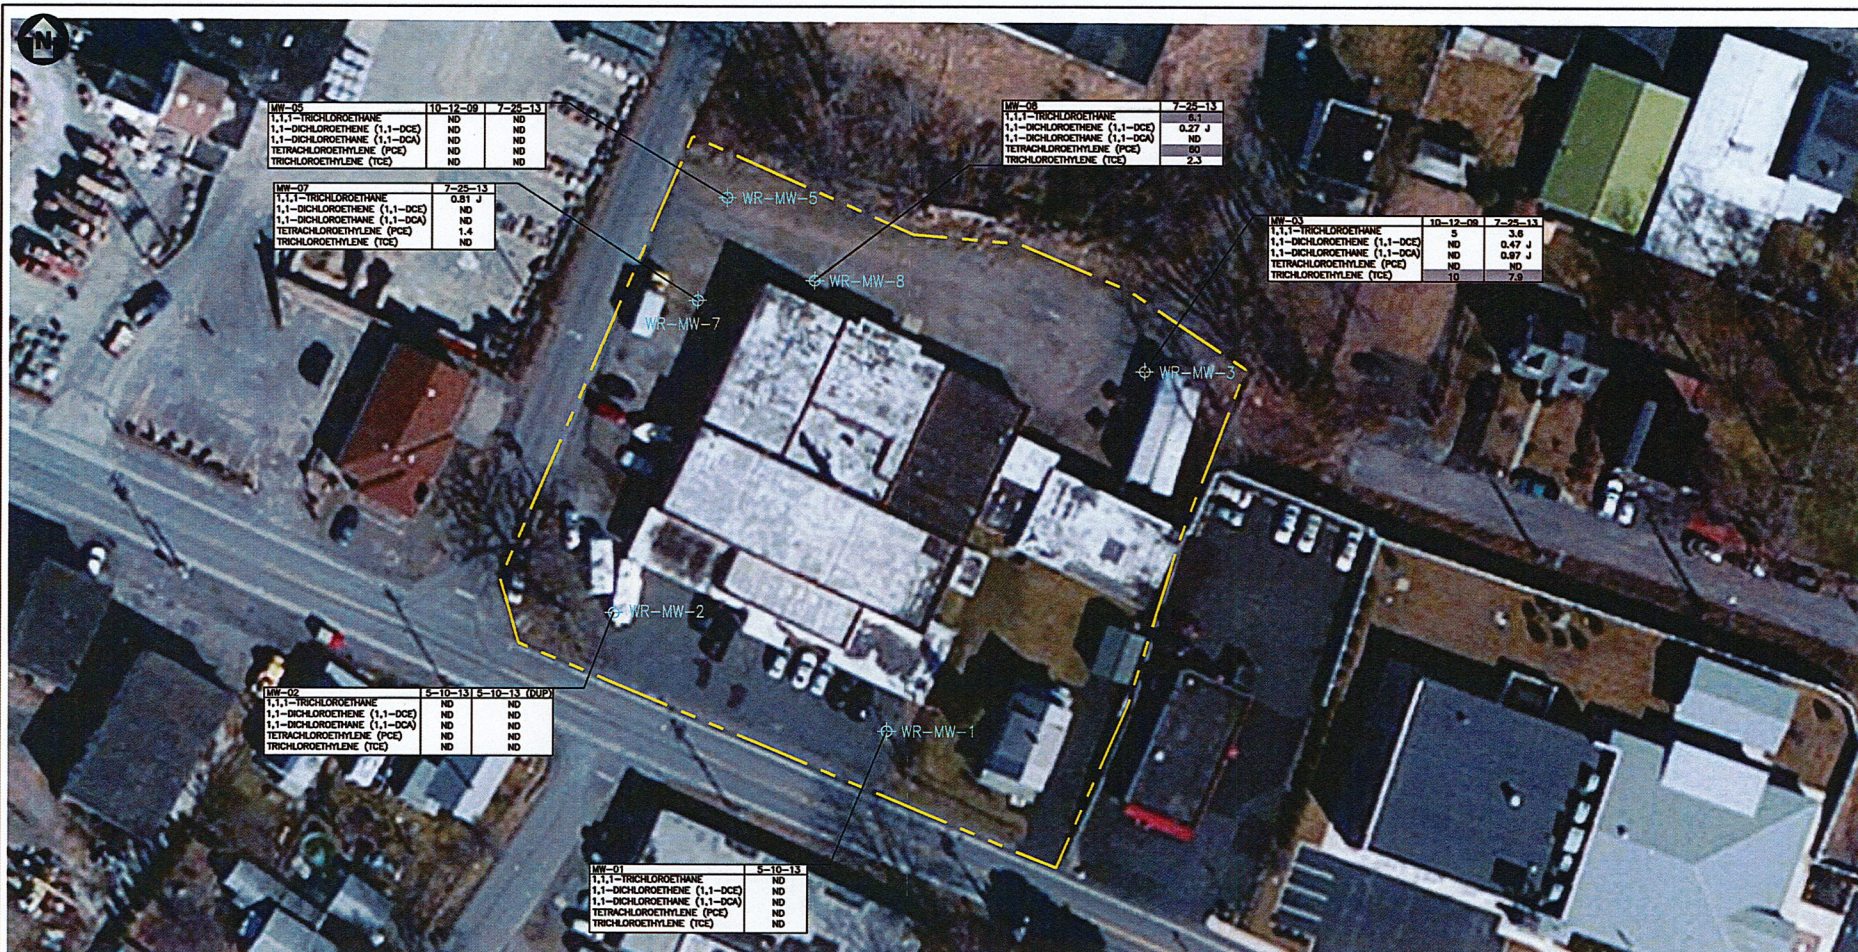
presence of the chlorinated VOCs 1,1,1 trichloroethane (1,1,1 TCA) at 5 parts per billion (ppb) and trichloroethylene (TCE) at 10 ppb at WR-MW-03 (Figure 3). TCE detection results exceed the NYSDEC Ambient Water Quality Class GA Standard/Guidance Criteria of 5 ppb. The summary memo (Enviro Clean Services LLC, 1998) also indicated that the detected groundwater concentrations were similar to concentrations observed during prior investigations. A summary of the data from the 2009 ECS sampling event is provided as Tables 1 and 2.

Compiled 2009 and 2013 sampled well locations, including summarized analytical results for chlorinated VOCs with highlighted NYSDEC standard exceedences, are depicted in Figure 3.

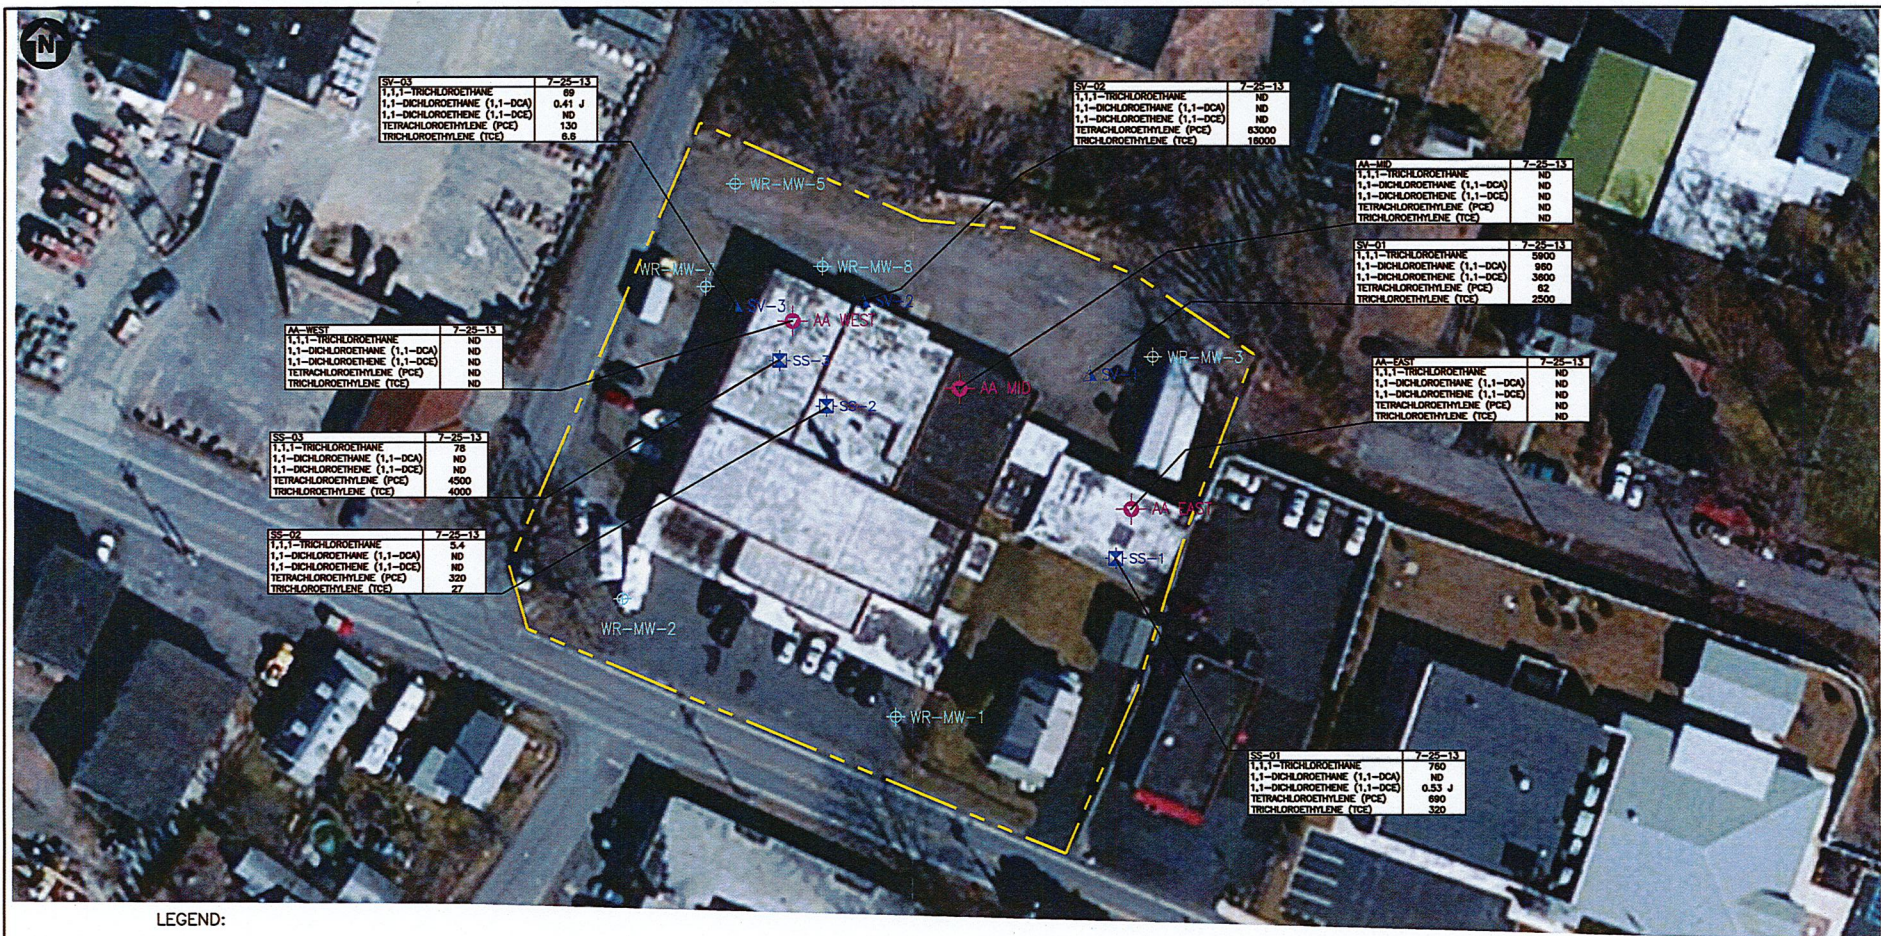
Complete results of the validated data are included in the DUSR report, provided in Appendix A. A summary of chlorinated VOC results for soil vapor is included on Figure 5.

A summary of sub-slab analytical results for chlorinated VOCs are depicted on Figure 5:
