**RE: Draft Remedial Investigation Report, 251 Walsh Road Site  
NYSDEC Site ID #336077  
(HRP #DEC1018.P3)**

# REMEDIAL INVESTIGATION REPORT

## **251 Walsh Road Site- Site #336077**

251 Walsh Avenue  
New Windsor, New York

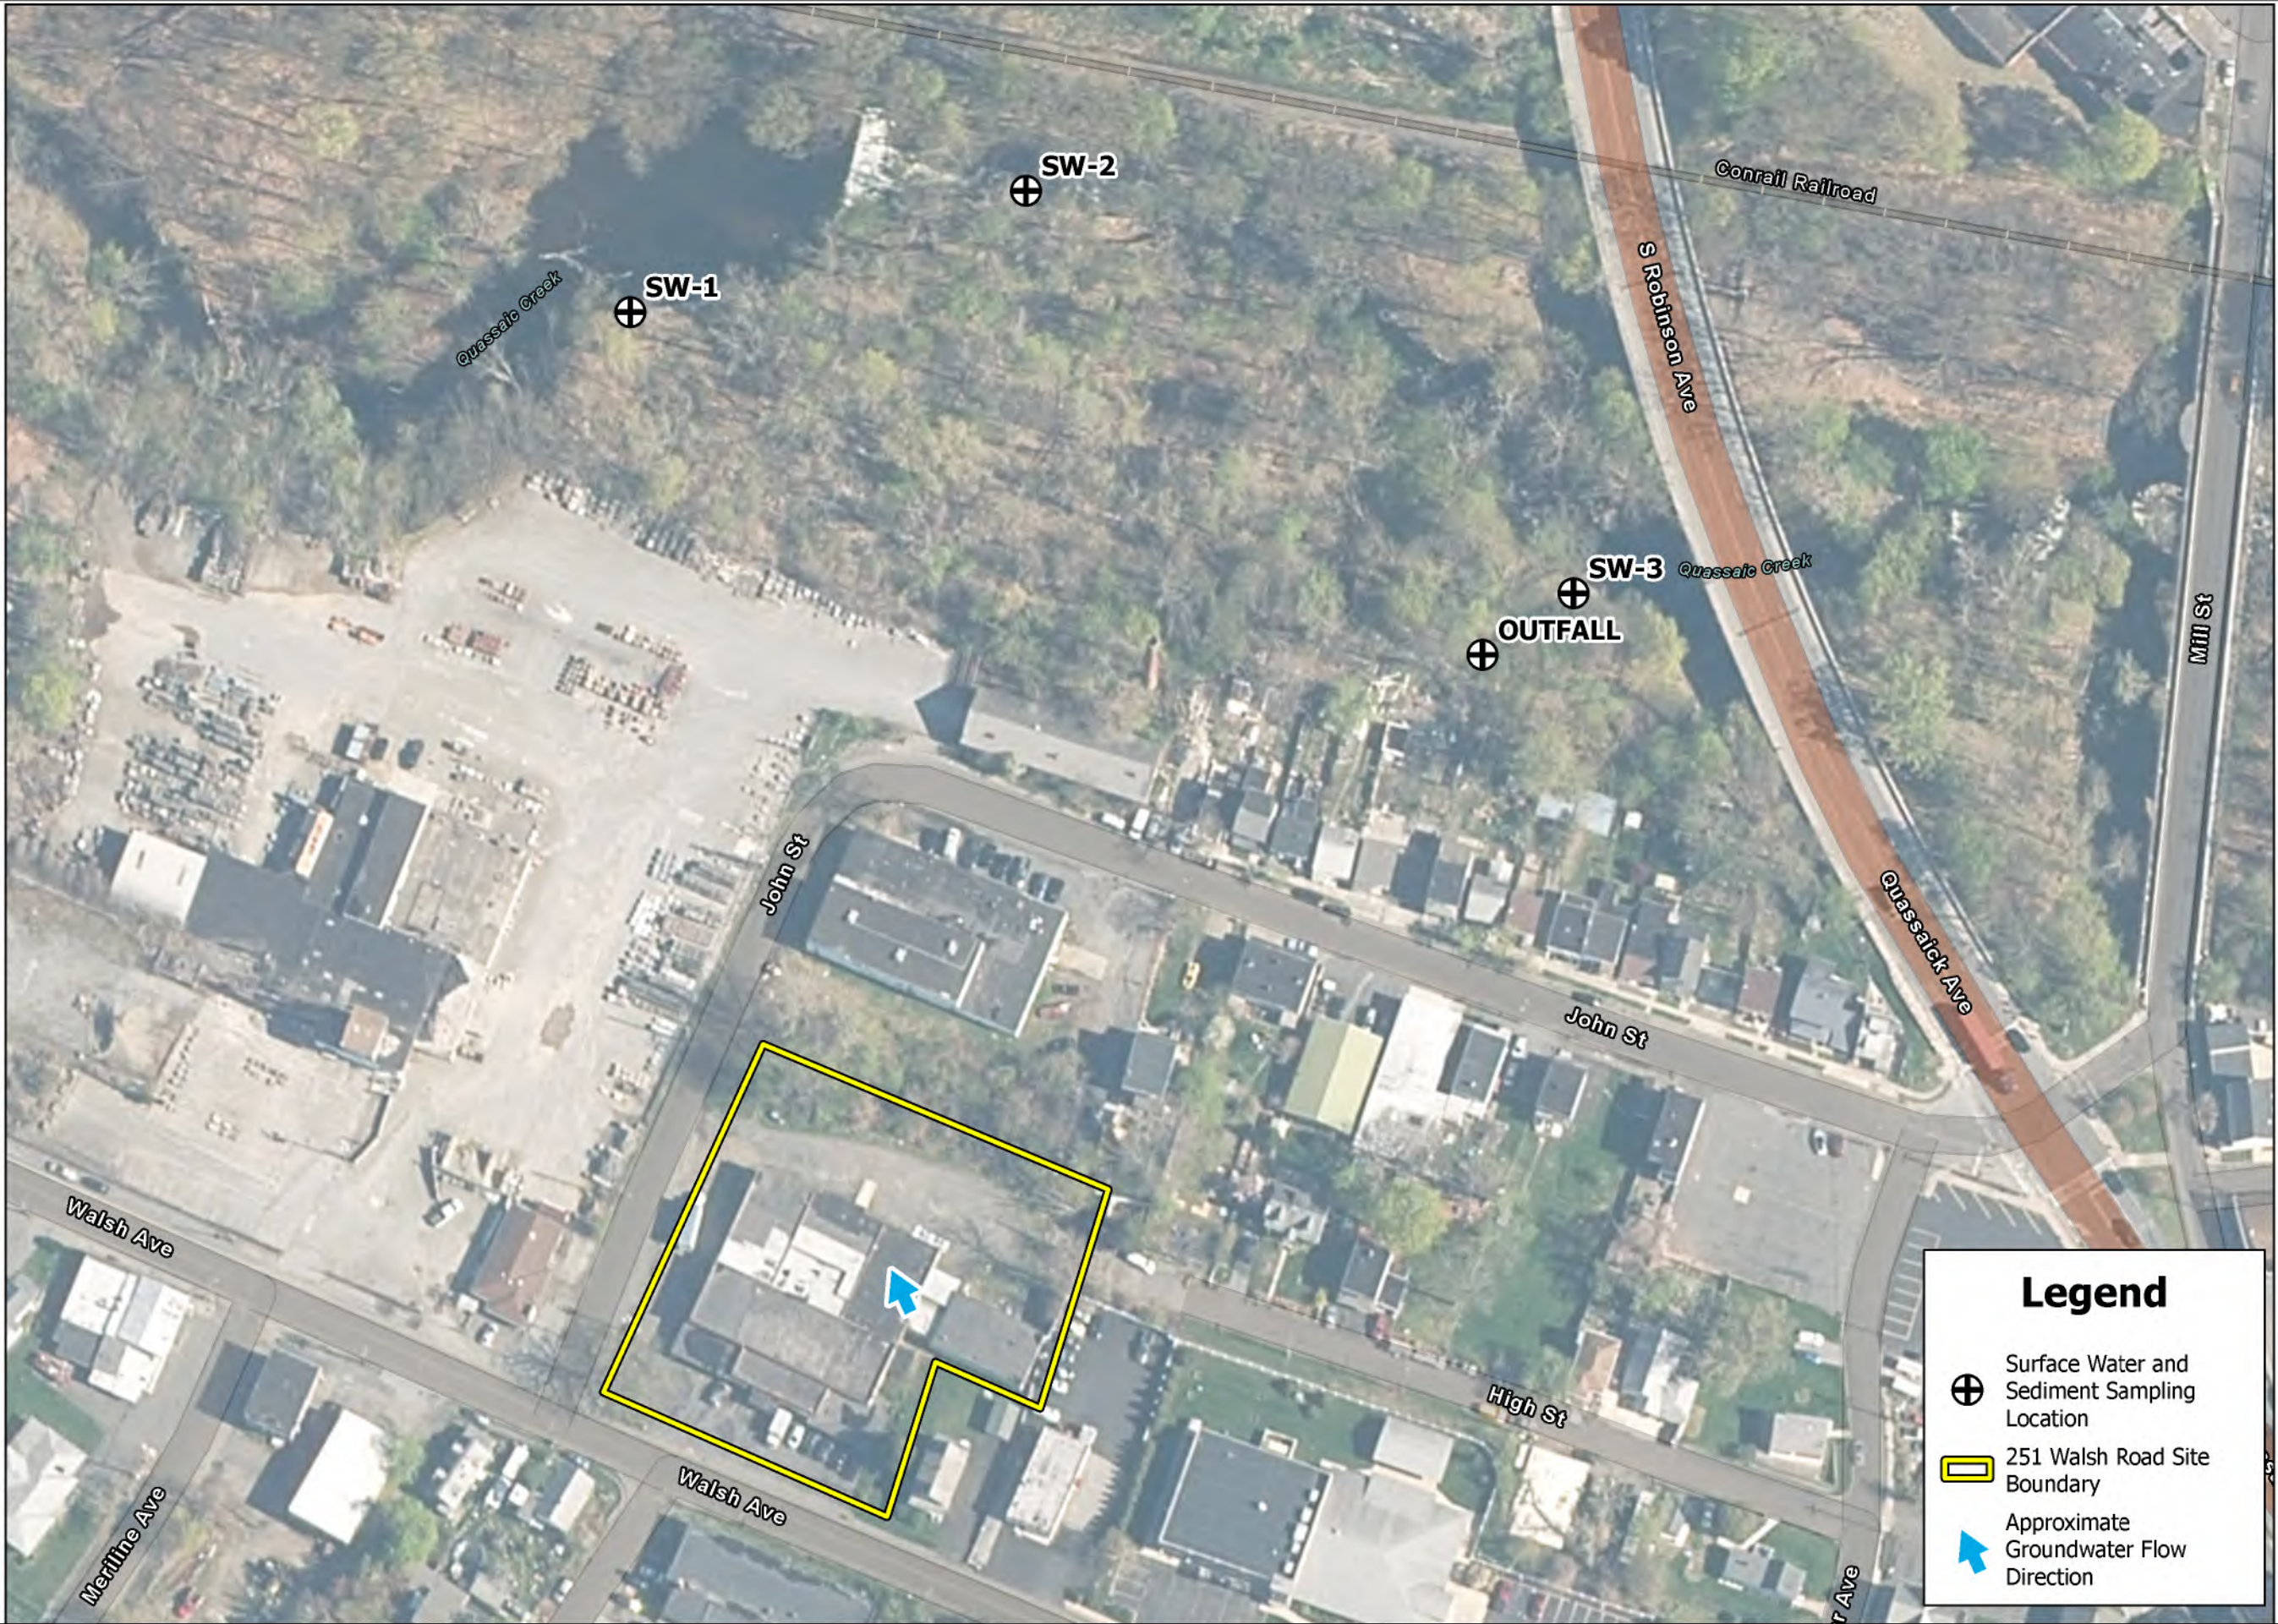
**Site Plan**  
**Soil, Groundwater and**  
**Soil Vapor Locations**

251 Walsh Rd Site  
C#36077  
251 Walsh Avenue,  
New Windsor, New York
