**RE: Draft Remedial Investigation Report, 251 Walsh Road Site  
NYSDEC Site ID #336077  
(HRP #DEC1018.P3)**

## REMEDIAL INVESTIGATION REPORT

### **251 Walsh Road Site- Site #336077**

251 Walsh Avenue  
New Windsor, New York

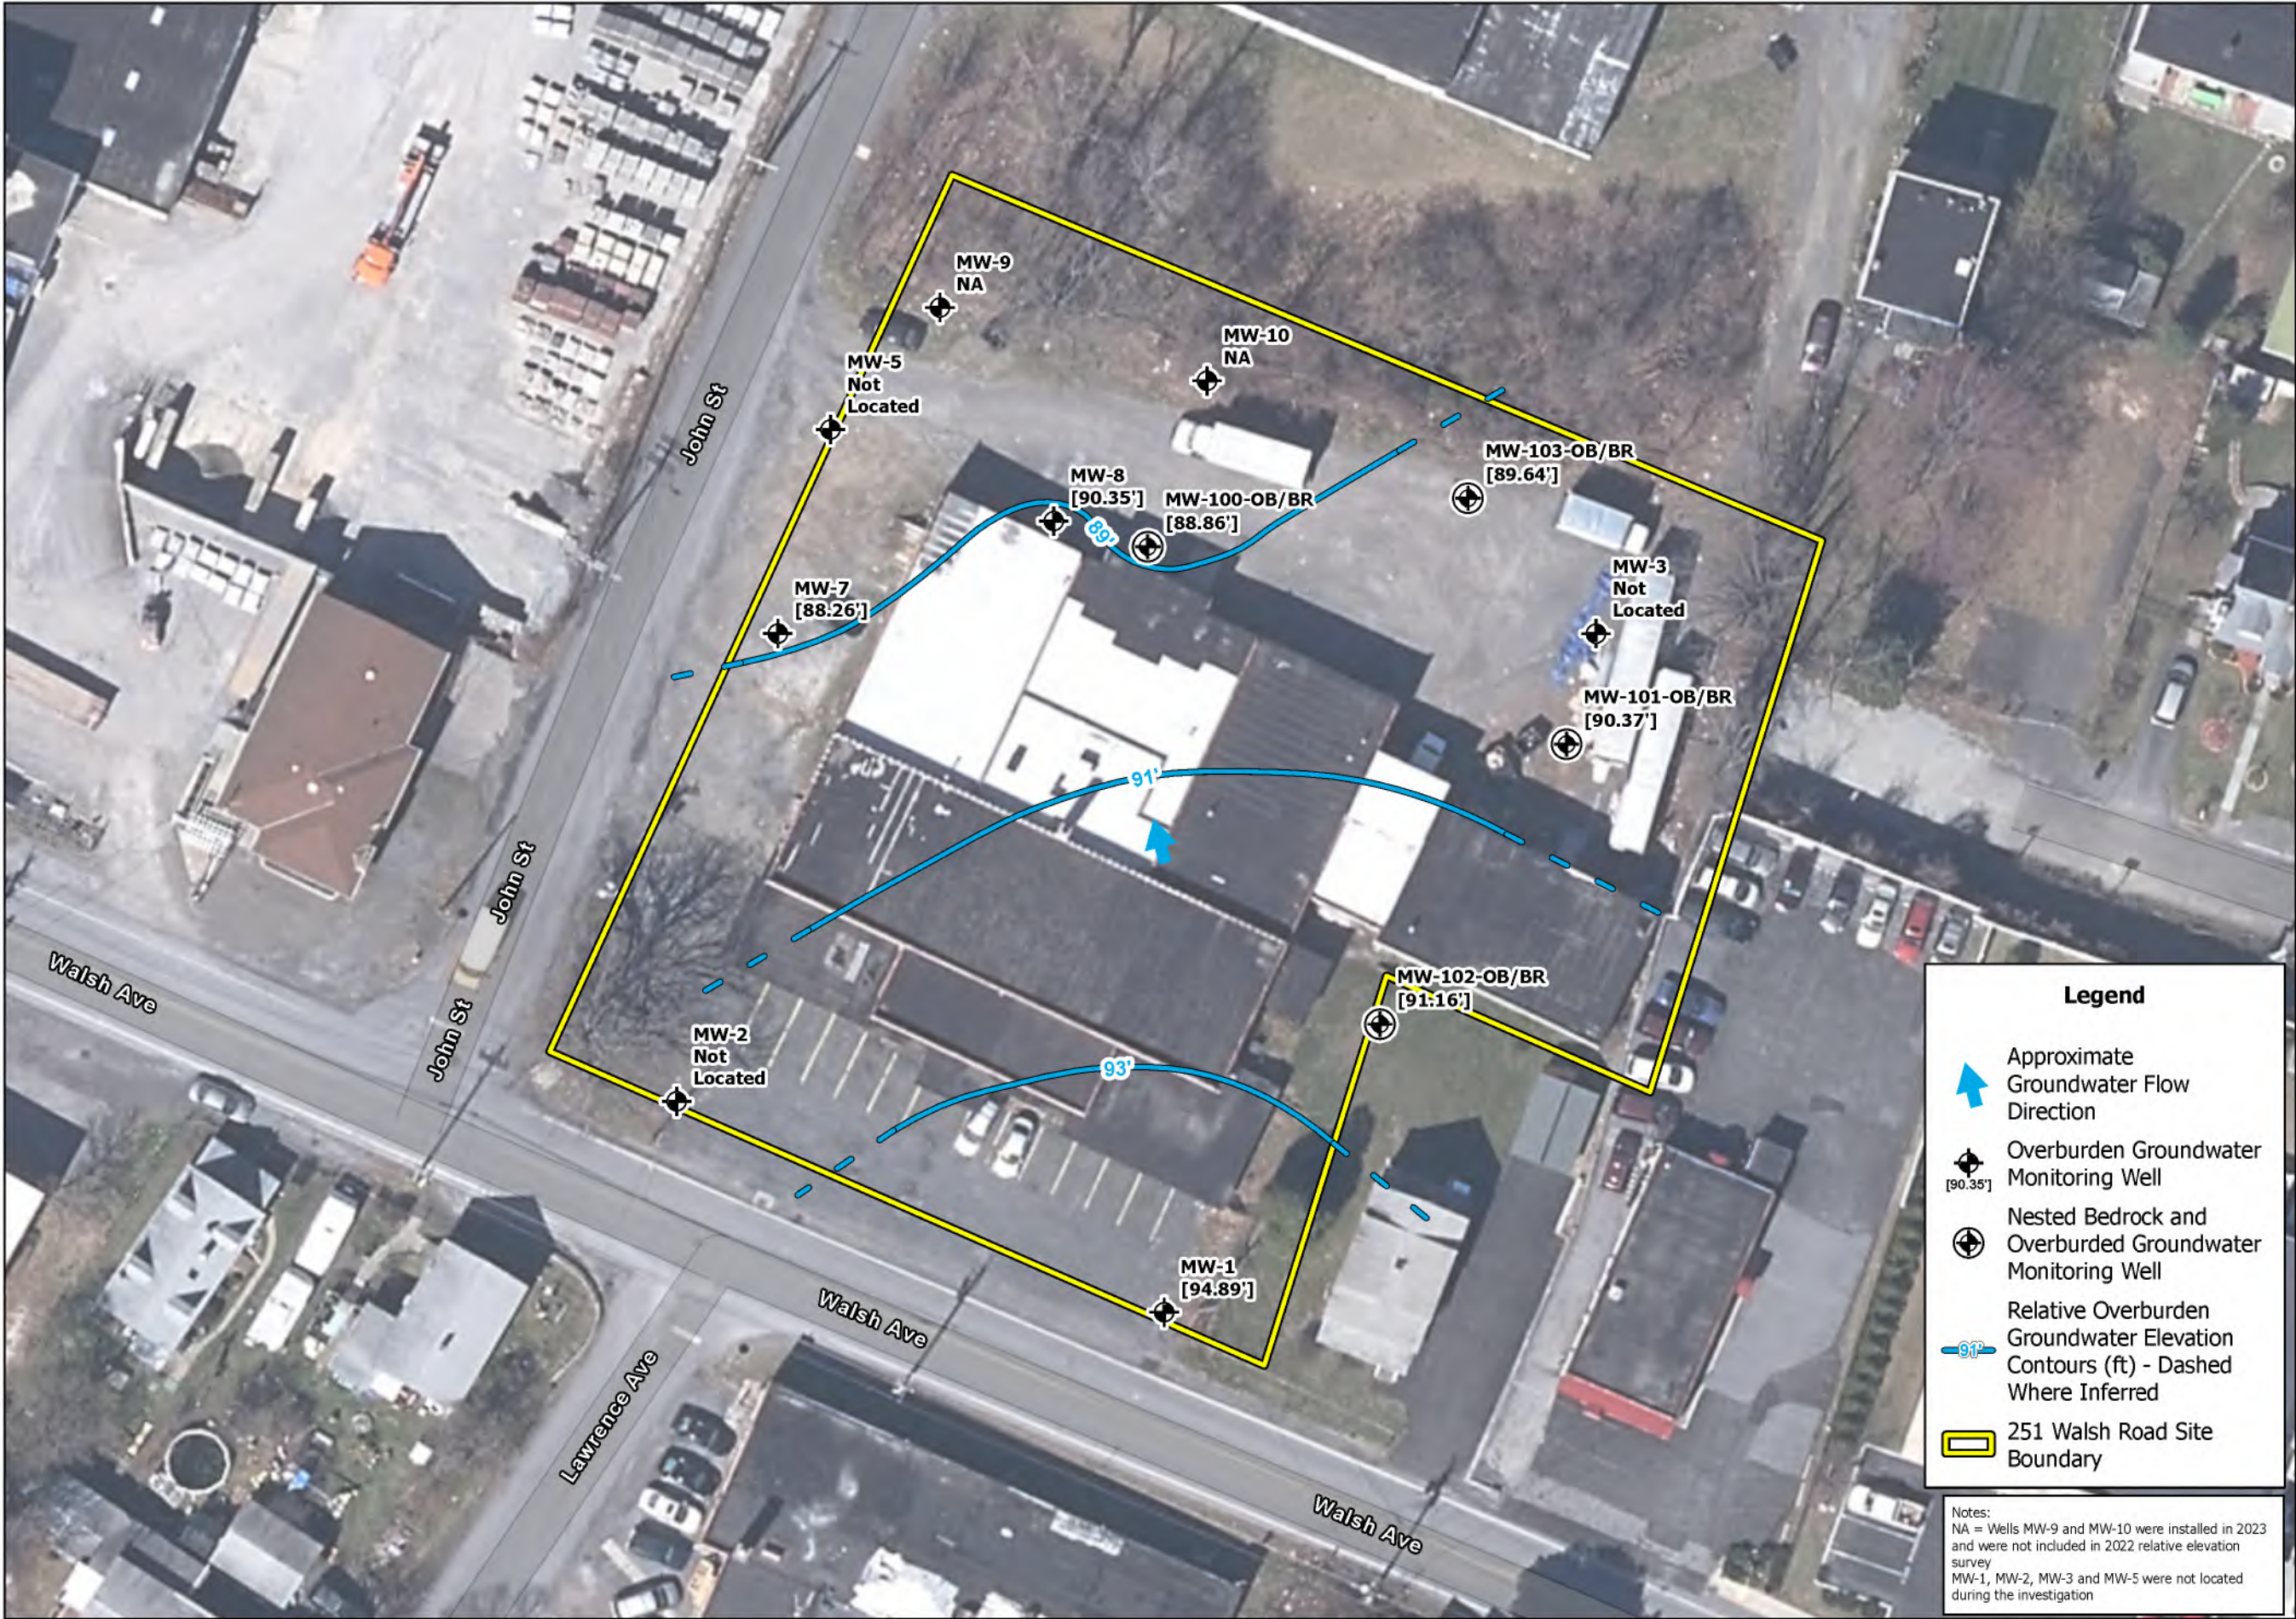
Overburden monitoring wells recorded groundwater depths during the RI sampling event that ranged from 4.75 ft bg (MW-101 OB) to 11.71 ft bg (MW-102 OB). Groundwater well construction logs and low flow logs are included in **Appendix A**. Bedrock monitoring wells recorded groundwater depths during the RI sampling that ranged from 4.14 ft bg (MW-100 BR) to 20.07 ft bg (MW-103 BR). Groundwater within this locale appears to exist under unconfined conditions and flows to the north/northwest (**Figure 4**).

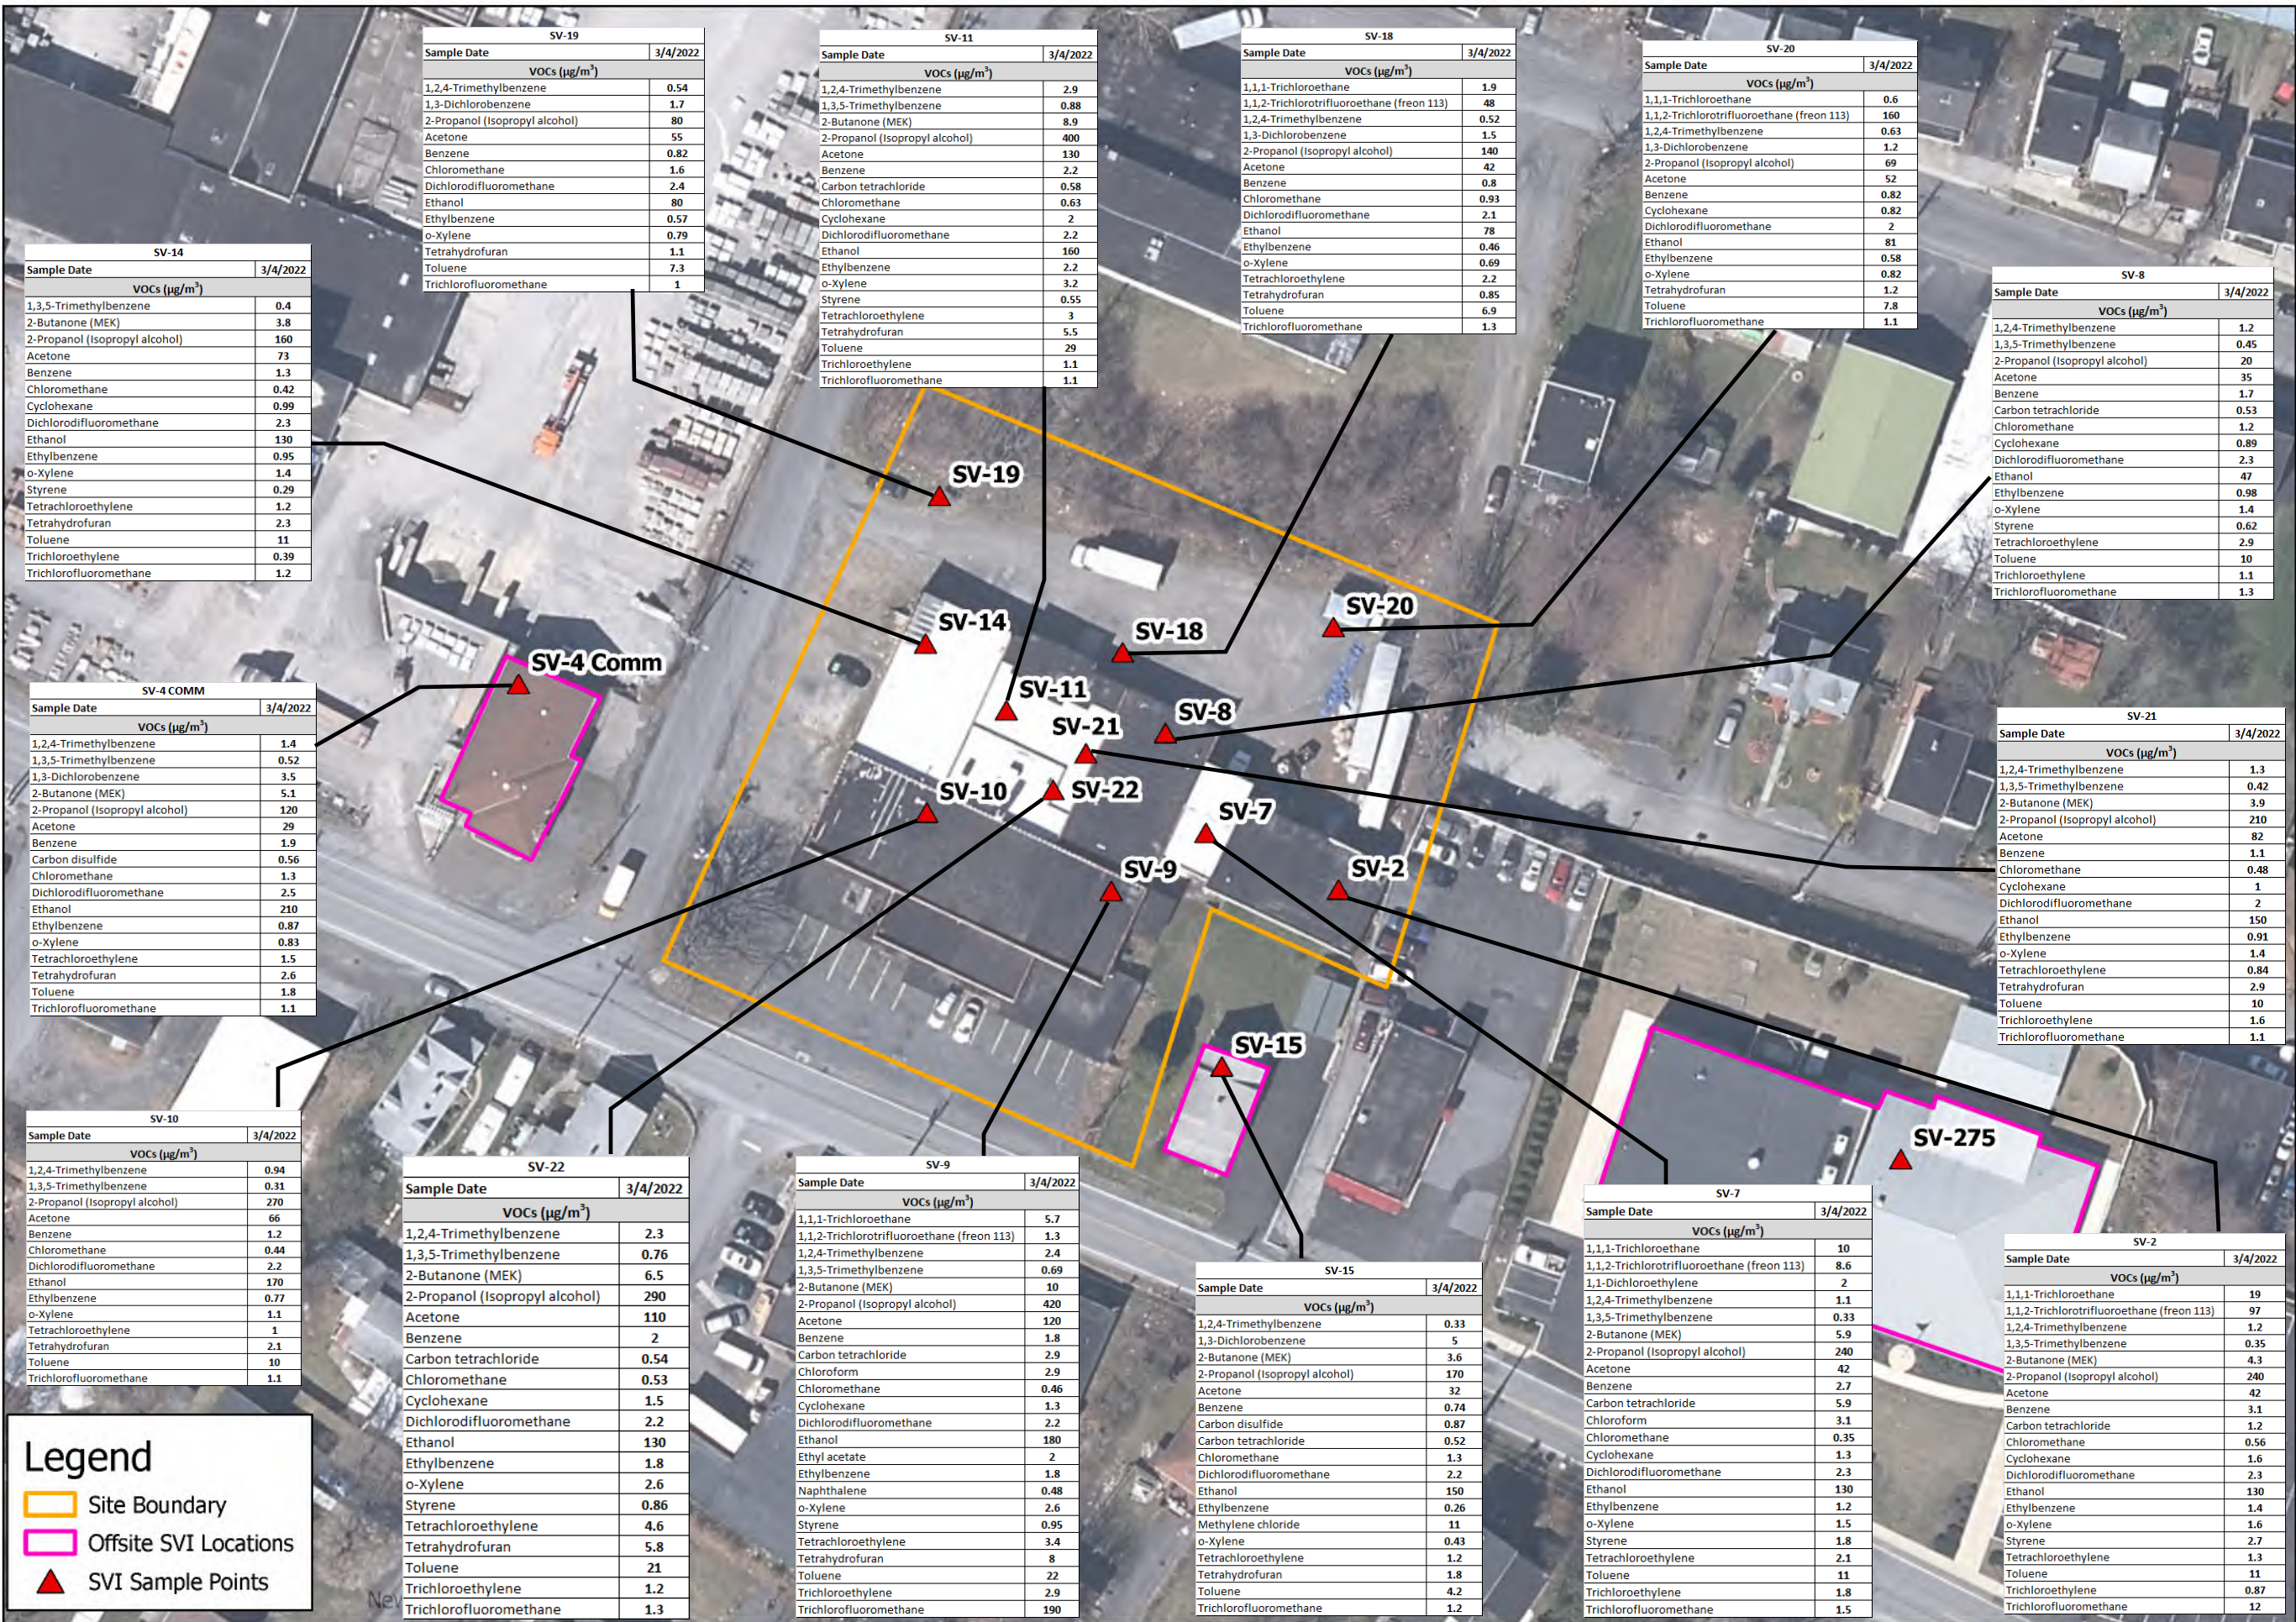
Figure No.  
**8**

Sediment Laboratory  
Analytical Results  
(Detections Only)  
PAHs and Metals  
251 Walsh Rd Site  
C#36077  
251 Walsh Avenue,  
New Windsor, New York

The surface water and sediment samples indicate that the creek has been impacted by SVOCs and metals. As stated in the preceding sections of the RI, the composition and levels of onsite contaminants significantly differ from those found in the creek. The SVOC and metal impacts detected in the creek surface water and sediment samples are likely related to the former paper mill and not from Site.
