# **DUE DILIGENCE RESEARCH FOR SUPPLEMENTAL SOURCES OF PER- AND POLYFLUOROALKYL SUBSTANCES (PFAS)**

**Stewart Air National Guard Base  
Newburgh, New York**

**FINAL REPORT**

**December 2025**

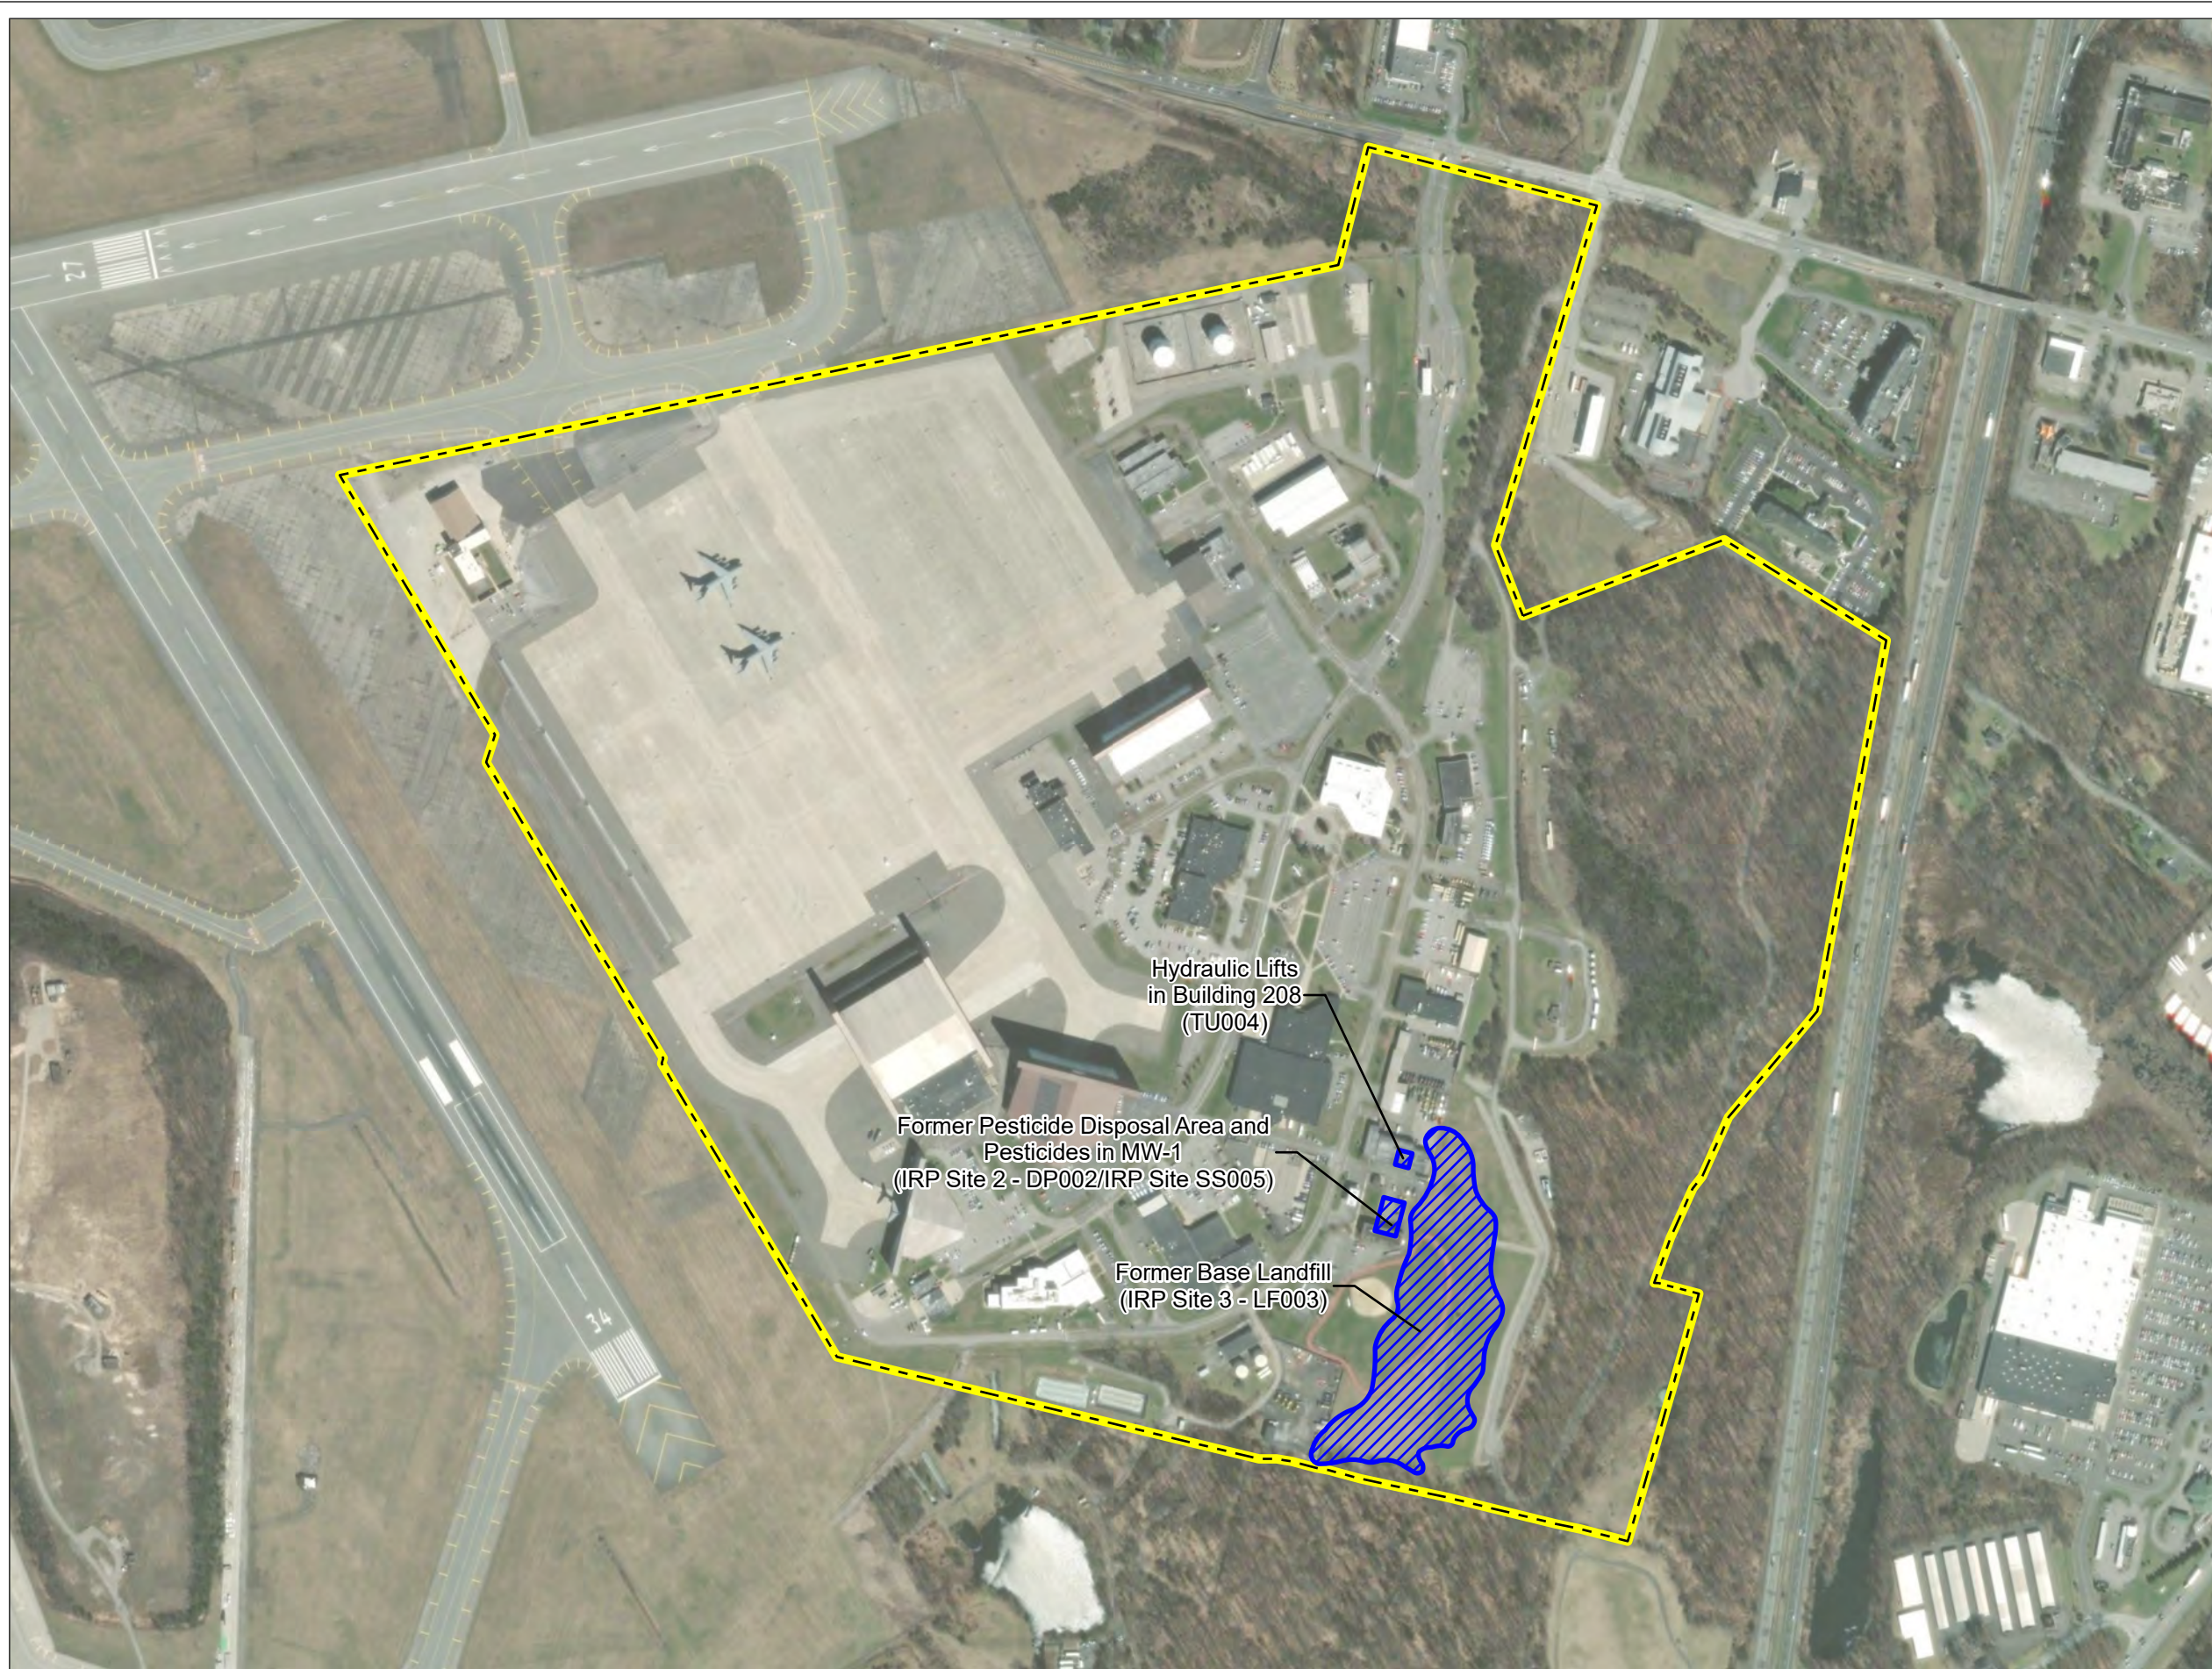
Figure 1-2

AFFF areas (also referred to as Potential Release Locations [PRLs] in previous reports) identified during the PA phase included PRLs 1 through 15. Thirteen of the PRLs (herein referred to as ‘AFFF areas’) proceeded to the SI Phase. AFFF Areas sampled during the SI and expanded SI (AFFF Areas 1-16) (**Figure 1-2**) that exceeded USEPA RSLs were validated as IRP Sites. These sites, as well as IRP Site 3 (LF003) Former Base Landfill, proceeded into the remedial investigation (RI) phase (USACE 2020, NGB 2023). The RI was initiated in December 2020 and is ongoing at the Base. The RI includes the Baseline Risk Assessment for Human Health and Ecological Risk Assessment (USACE 2020). The NGB continues to evaluate PFAS for further investigation based on USEPA RSLs following ASD guidance (ASD 2025).

As part of the assessment for additional investigation, AFFF areas and IRP sites were reviewed and correlated with the locations determined to have potential release of PFAS from sources other than AFFF. The AFFF areas investigated during the AFFF PFAS SI and expanded SI as well as inactive and active IRP sites identified as potential sources of PFAS other than AFFF are shown in **Figures 1-2** and **1-3**, respectively.

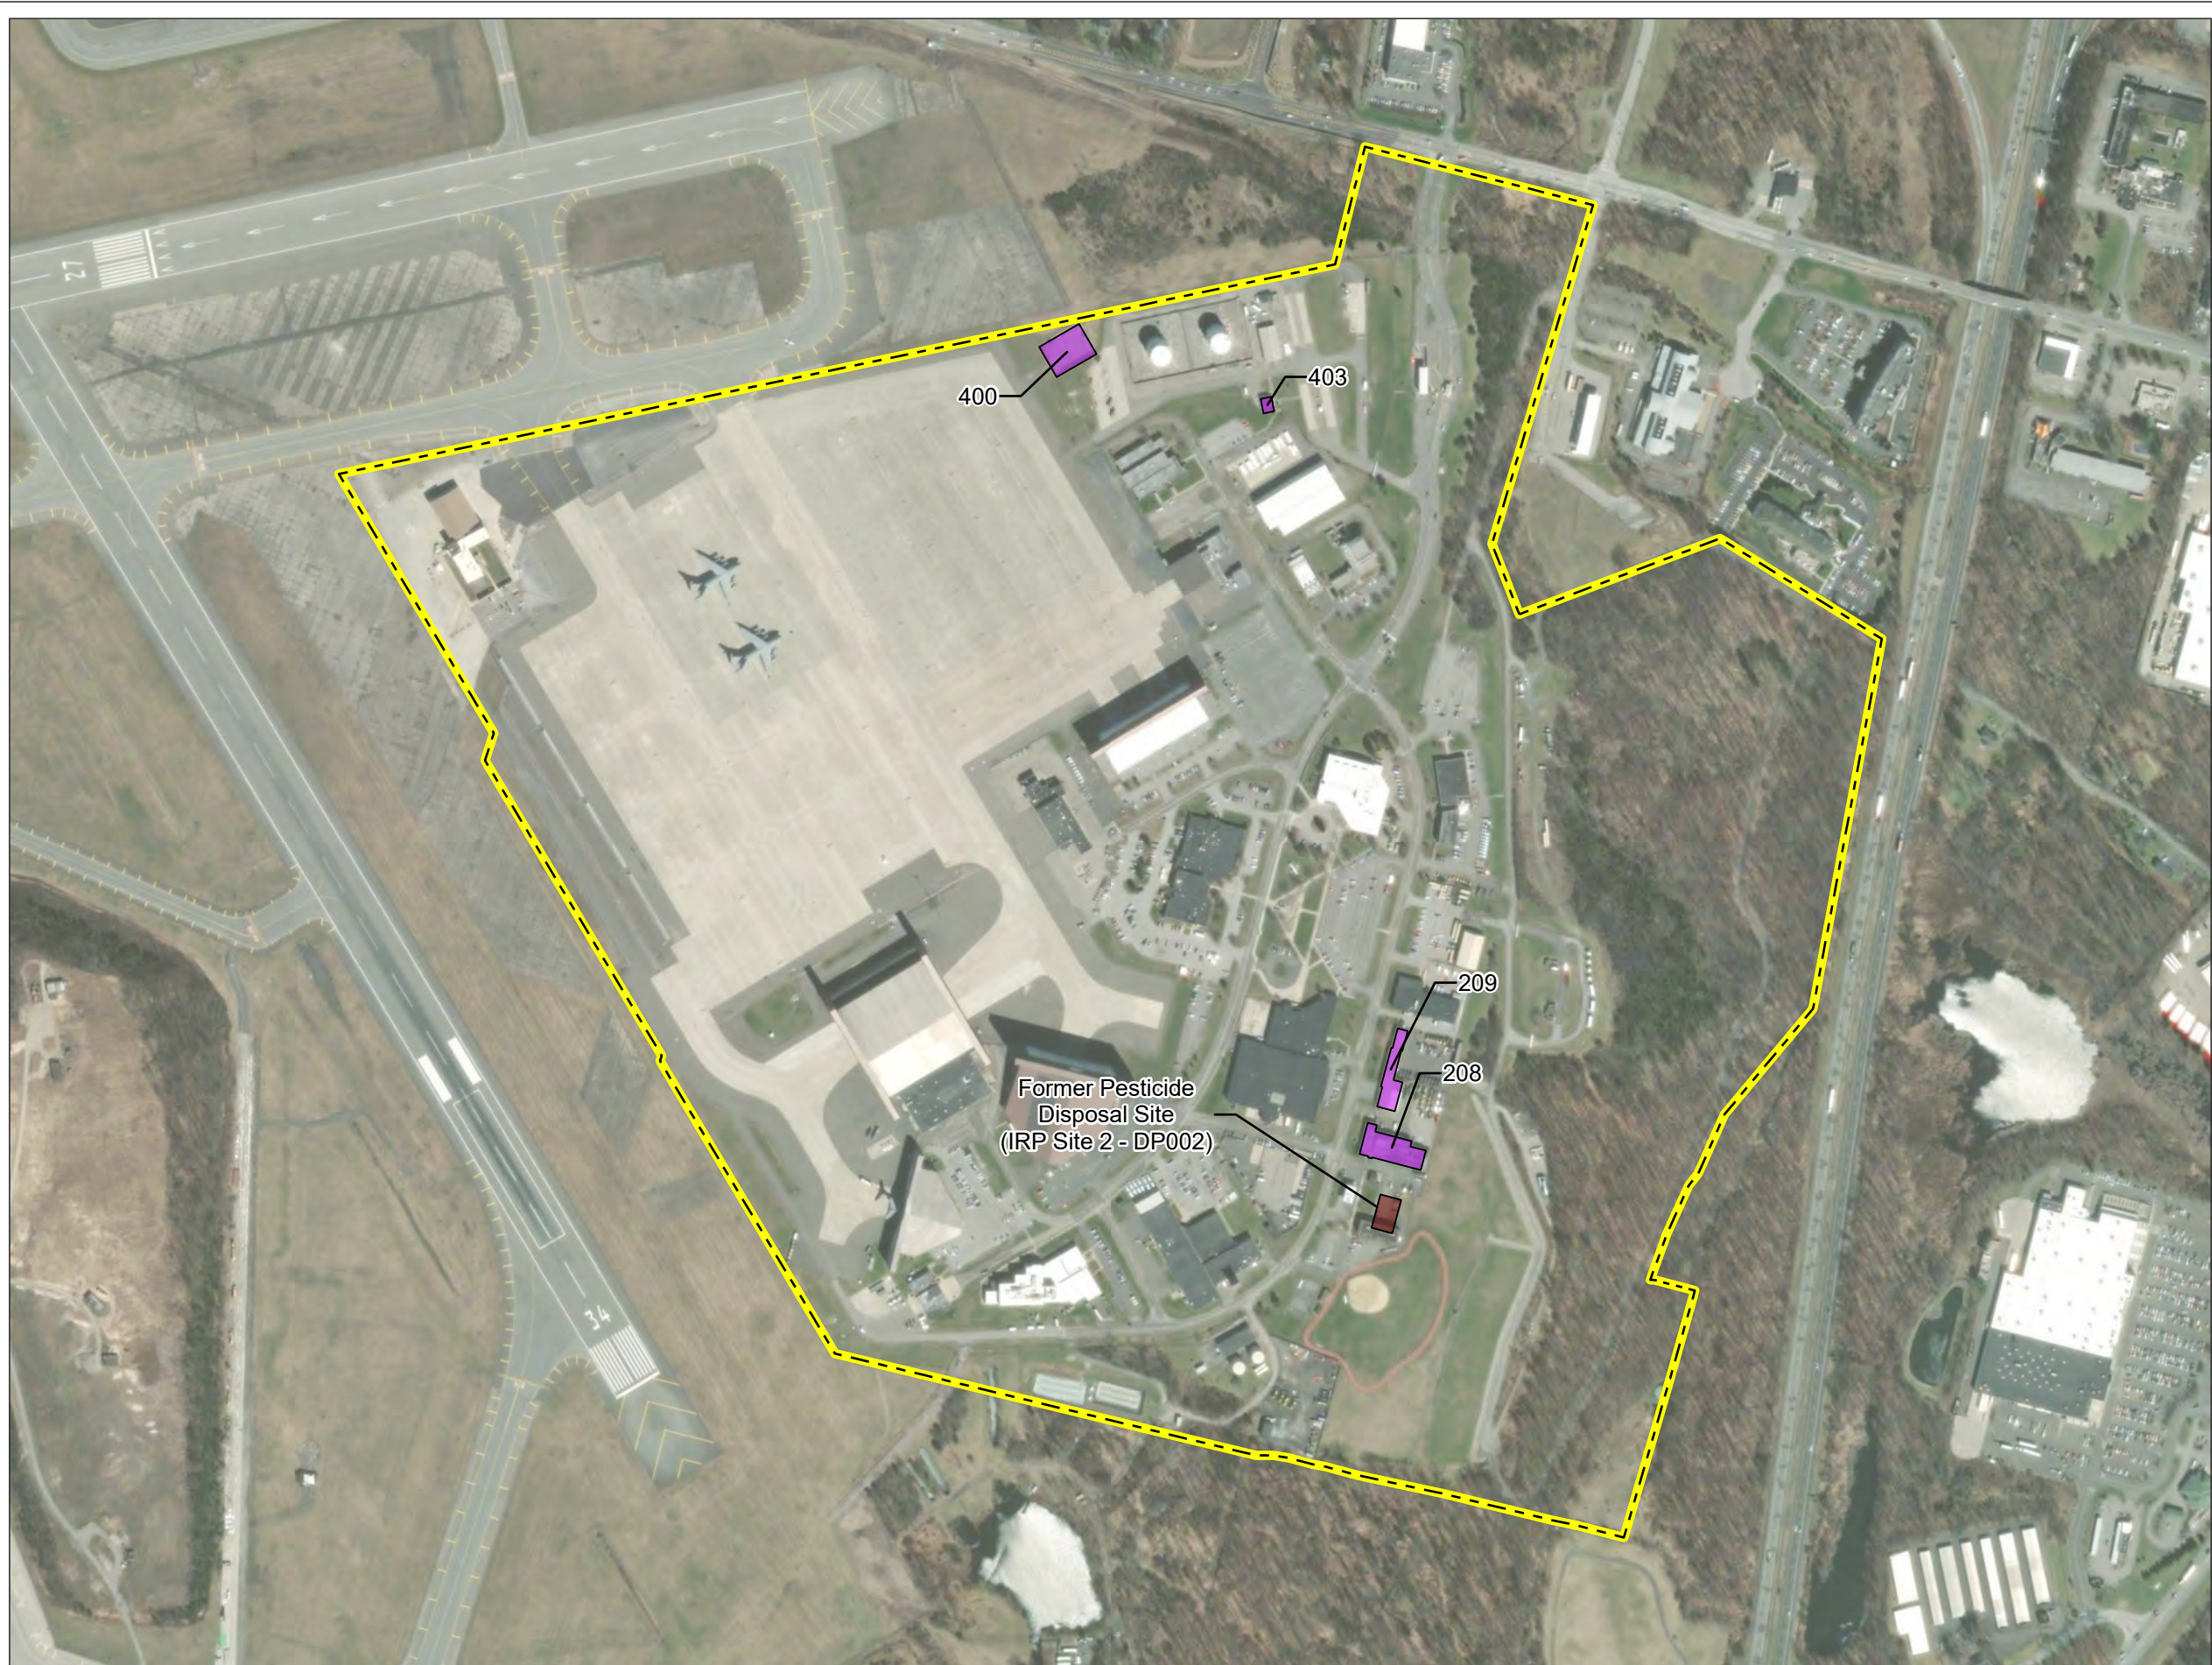
- Legend**
- Building
  - Former Pesticide Disposal Site (IRP Site #2)
  - Installation Boundary

The former pesticide disposal site is documented as having served as a landfill and potentially received materials containing PFAS. Although this disposal site was investigated under IRP Site 2 and the nearby MW-1 was investigated under SS005, no PFAS analysis has been conducted at either location, and there is a probable chance that PFAS migrated into the soil and groundwater at this location. Human and ecological receptors may be exposed to PFAS at the former pesticide disposal site through soil, surface water (sediment), and groundwater pathways. Therefore, further investigation for supplemental sources of PFAS is warranted at the former pesticide disposal site (IRP Site 2).
