NY95-219-04

**SAMPLING EVENT REPORT
YEAR TWENTY-SEVEN – OCTOBER 2022
LONG TERM MONITORING PROGRAM
MARATHON REMEDIATION SITE**

MARATHON REMEDIATION PROJECT**NY95-219-04****EAST FOUNDRY COVE MARSH****October 20, 2022****INSPECTION CONDITIONS**

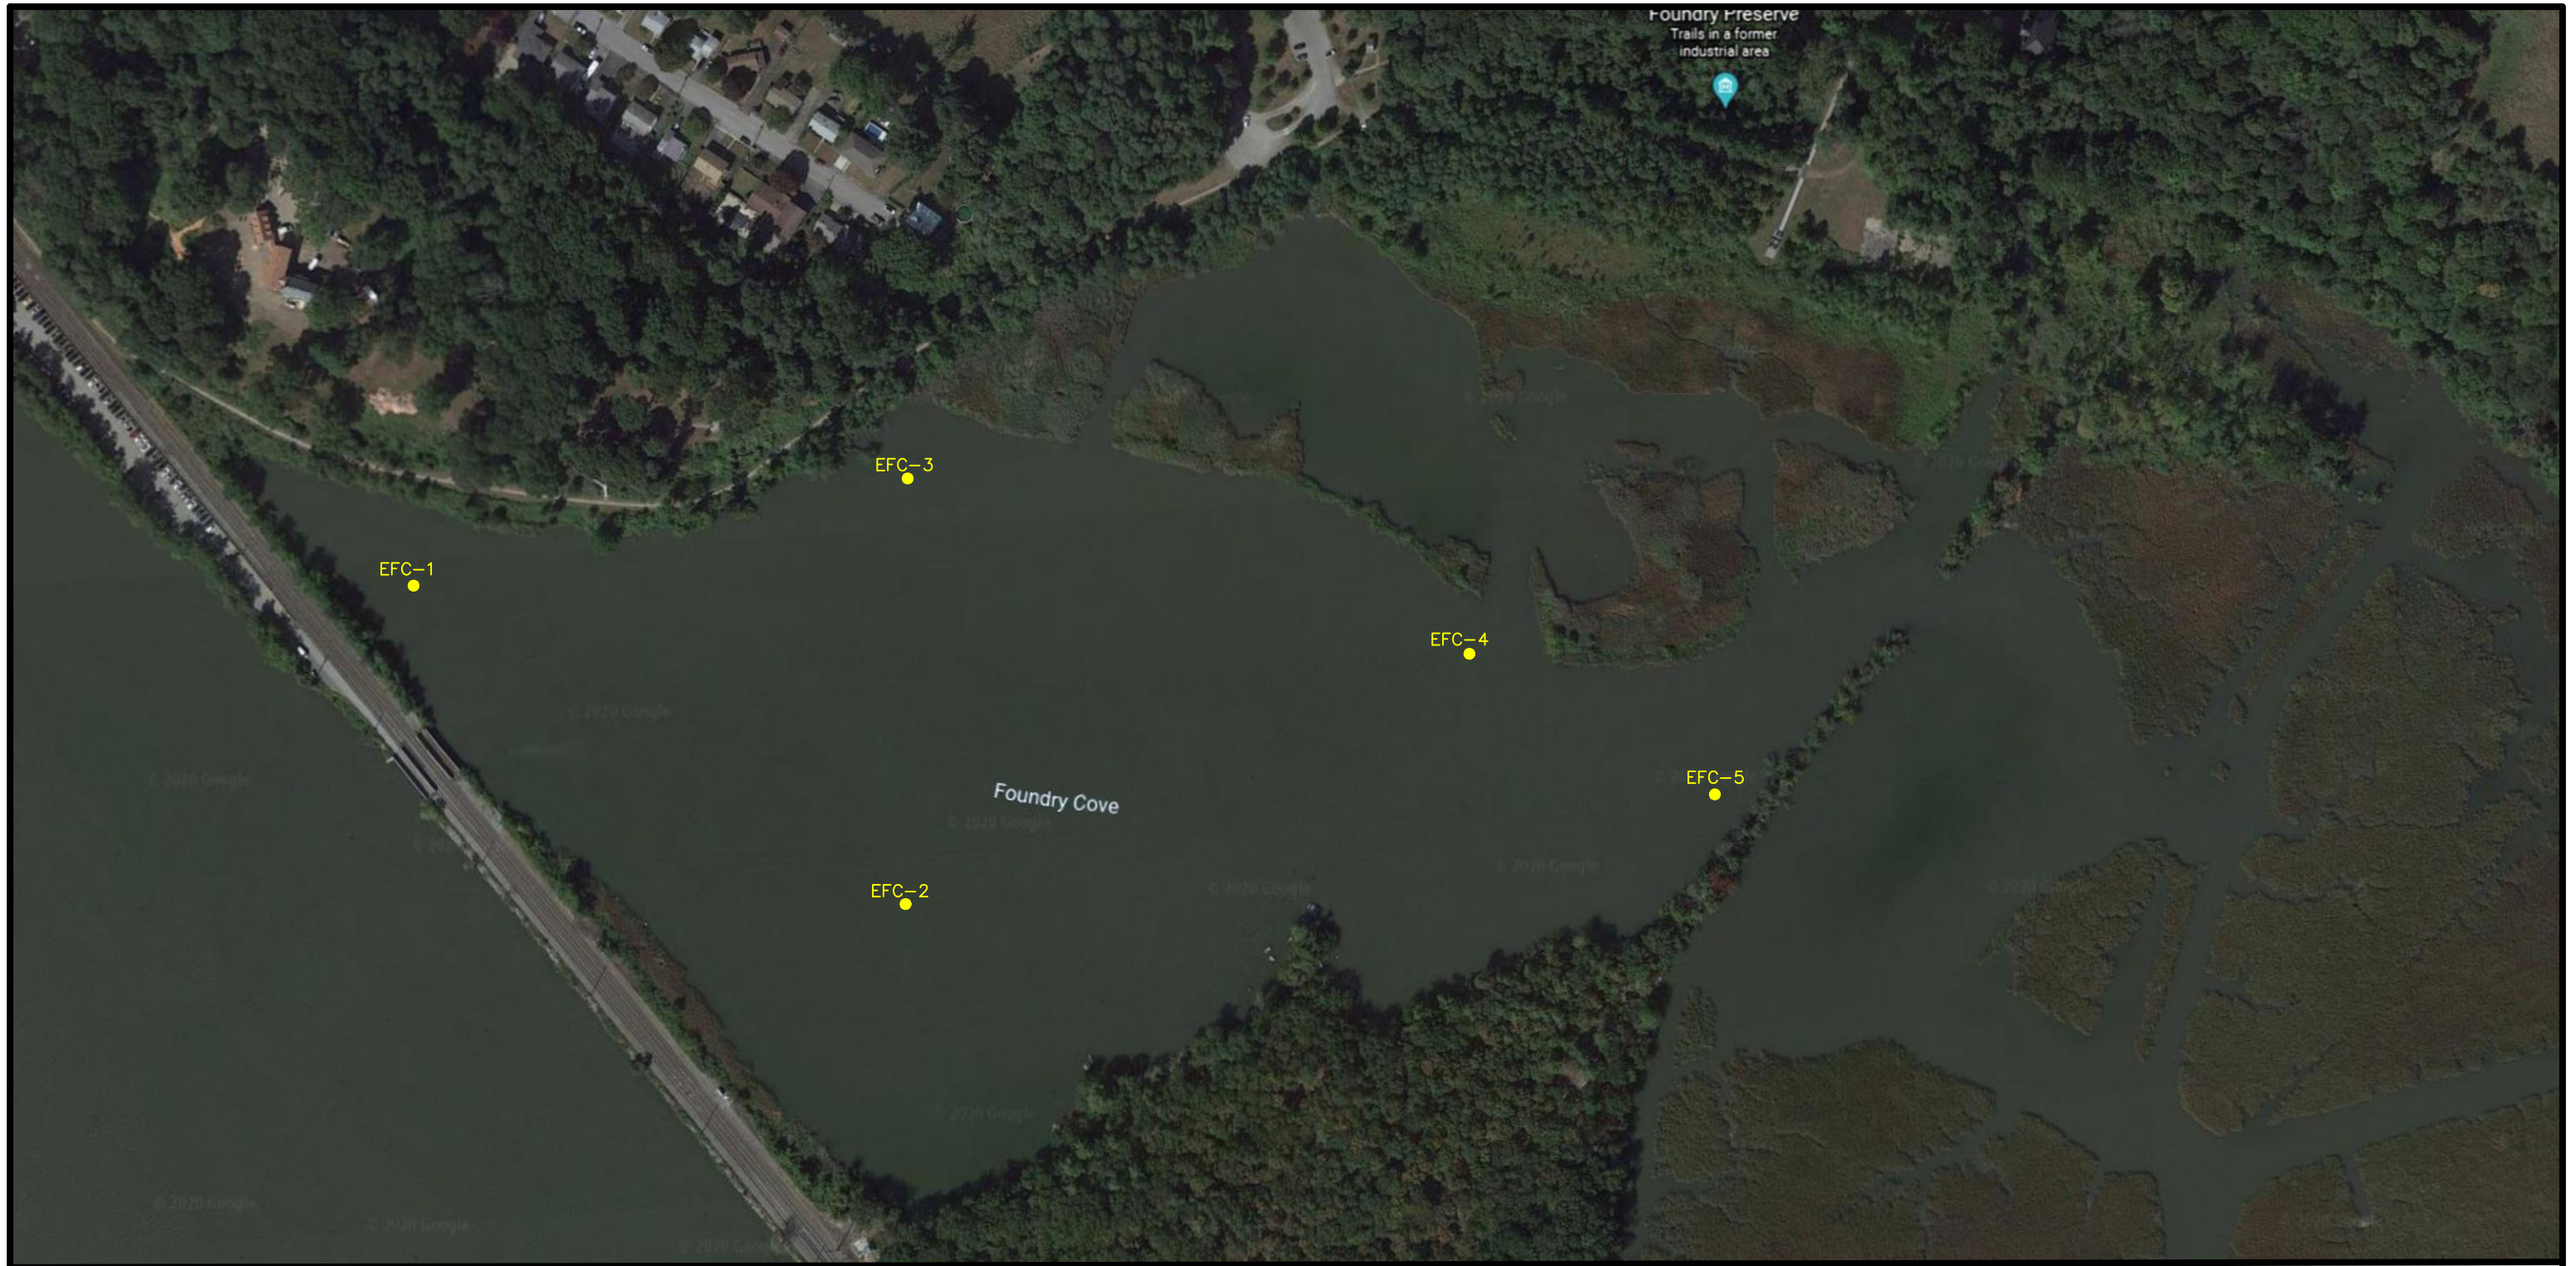
FIGURE 6

APPROXIMATE LOCATION OF
 SEDIMENT SAMPLES
 MARATHON REMEDIATION PROJECT
 COLD SPRING, NEW YORK

The results are presented graphically for each location on Figures 1 through 5. As shown on the graphs, the cadmium concentrations are overall trending downward with the exception of location 3S that is shown in Figure 3. The slight upward trend at that location is attributed to a single, anomalous measurement from 2009; when that measurement is removed, the trend is slightly downward, as shown in Figure 3A. The sample locations are presented on Figure 6.

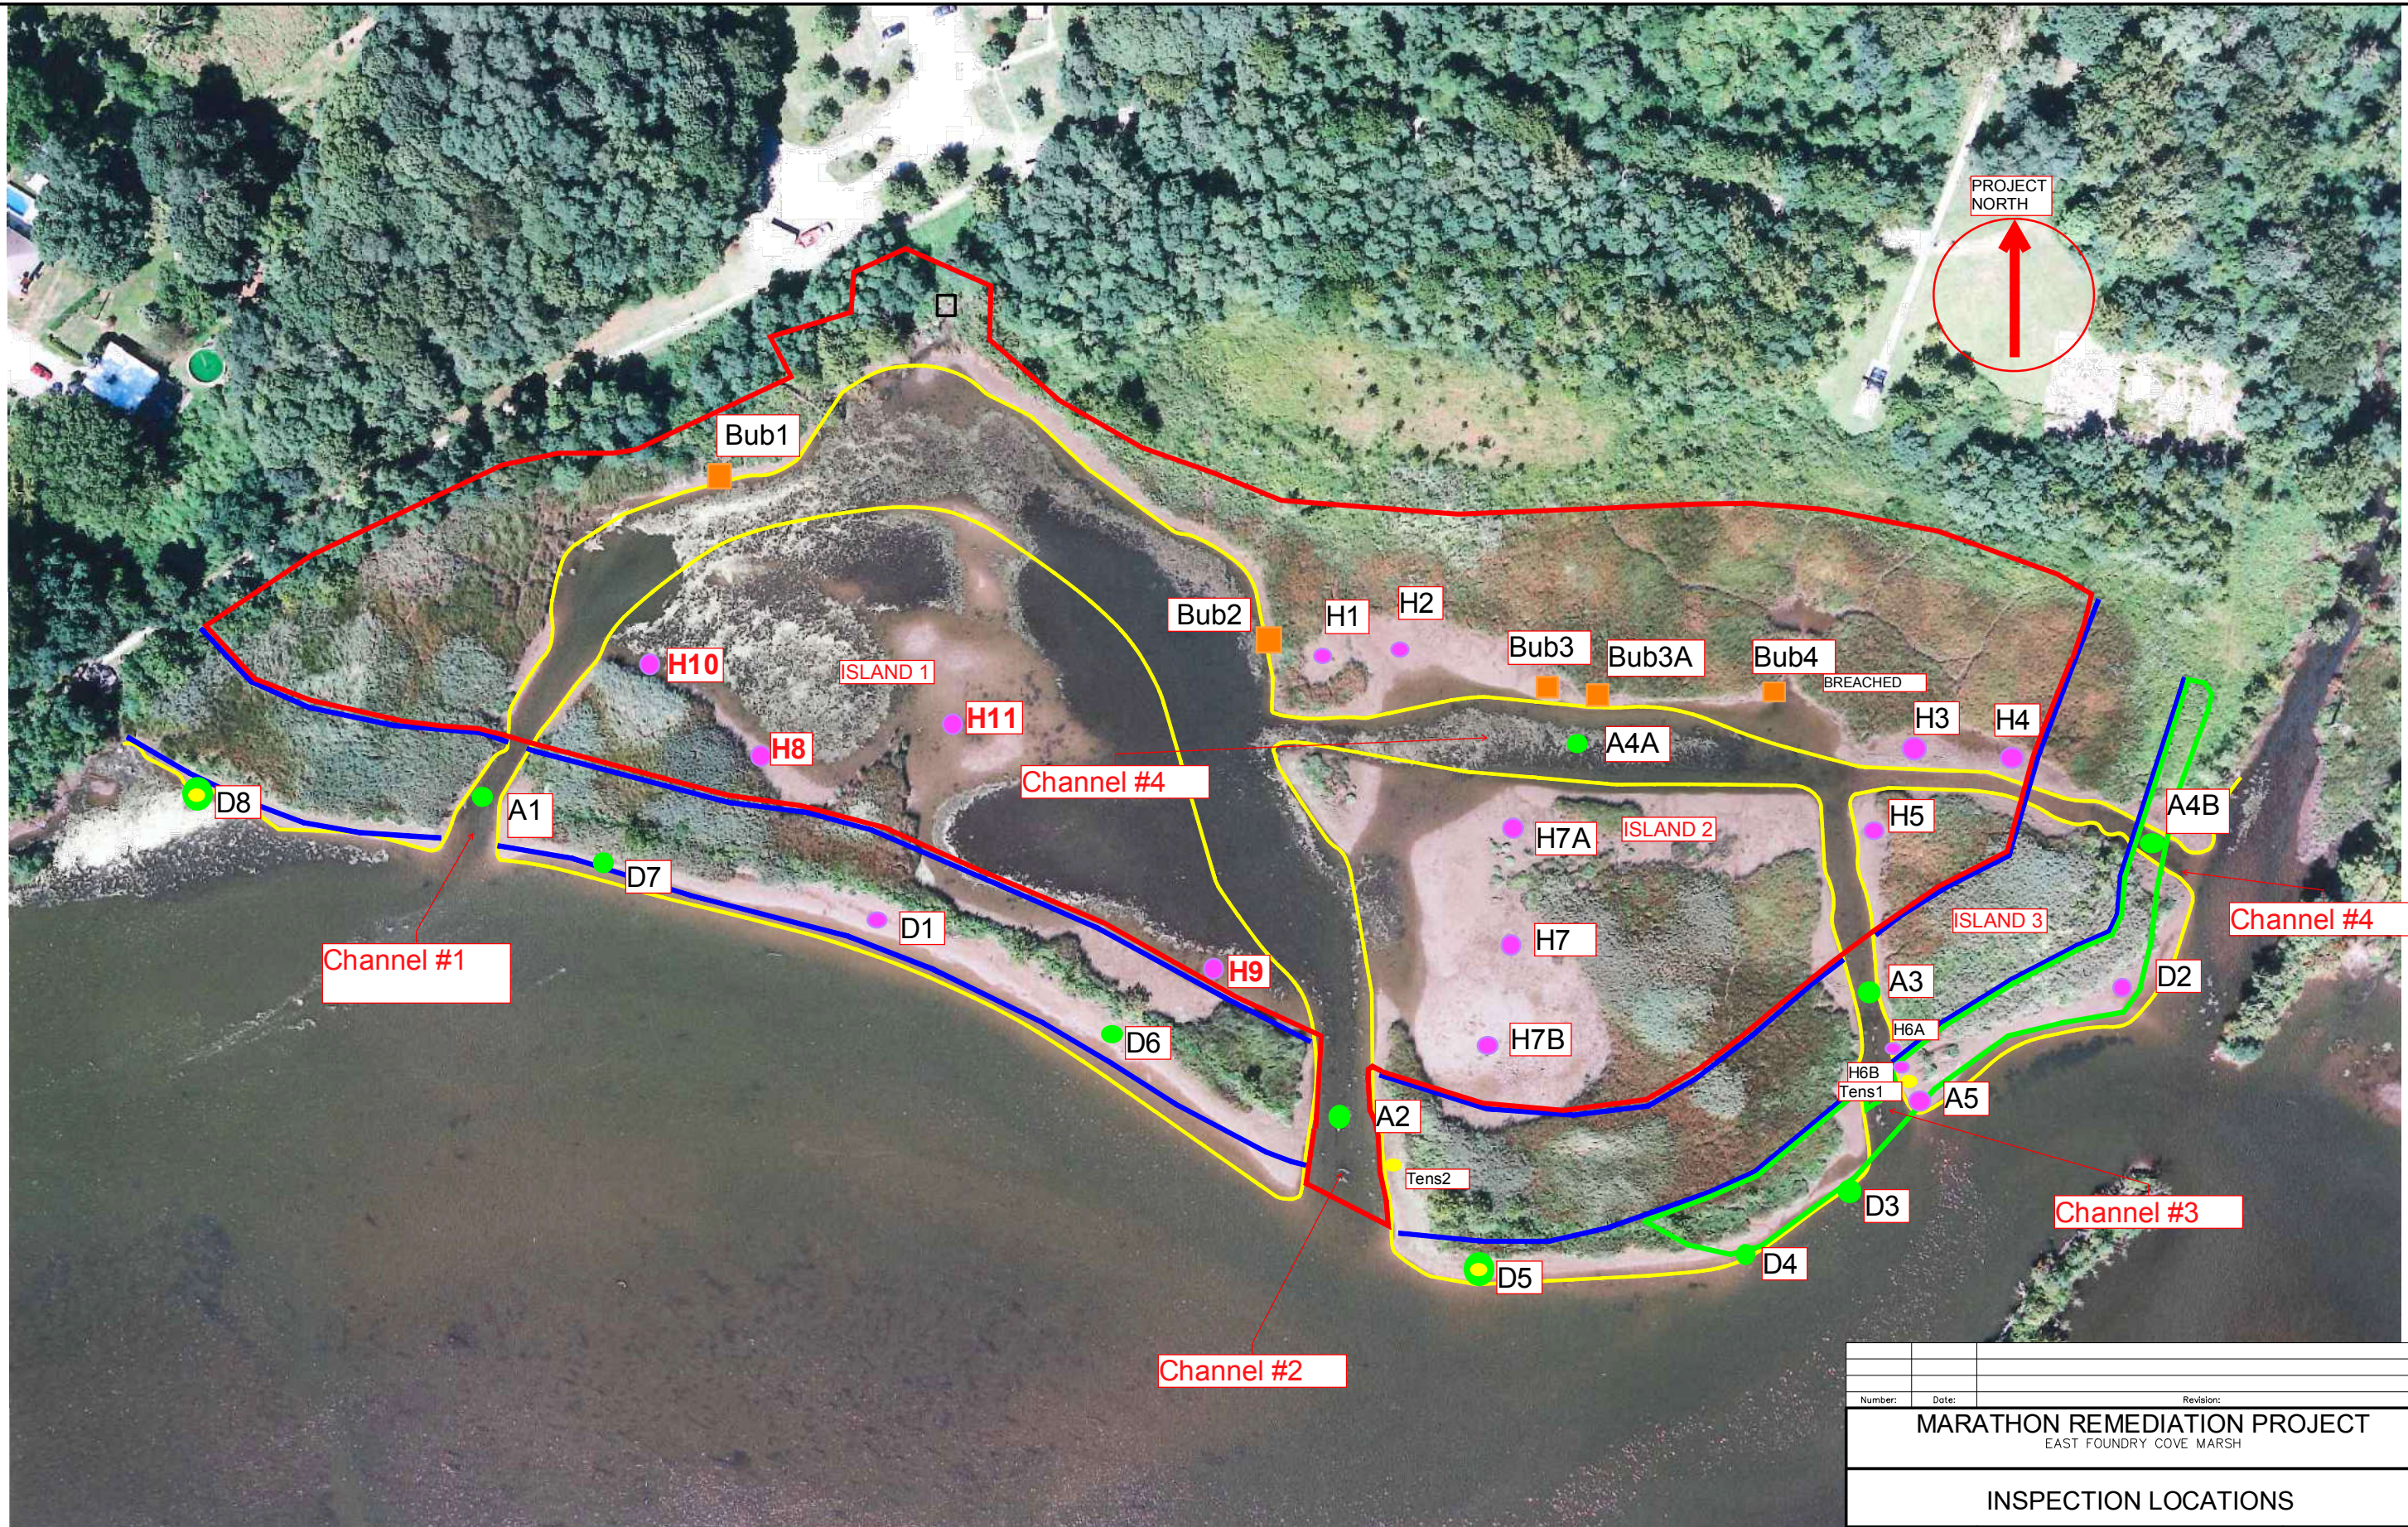
Number:	Date:	Revision:
MARATHON REMEDIATION PROJECT EAST FOUNDRY COVE MARSH		
INSPECTION LOCATIONS		
		Scale: 1" = 50' Drawn By: KHF Checked By: PFM Project Mgr: PFM Originated By: KHF Project No.: NY95219-03 Drawing Date: 12/04/2019 Sheet No.: 1 OF 1 Revision Number: 0

Additional Photographs – Photographs 7 through 20 were taken during 2022 (unless otherwise noted) at the locations shown on Figure 2.

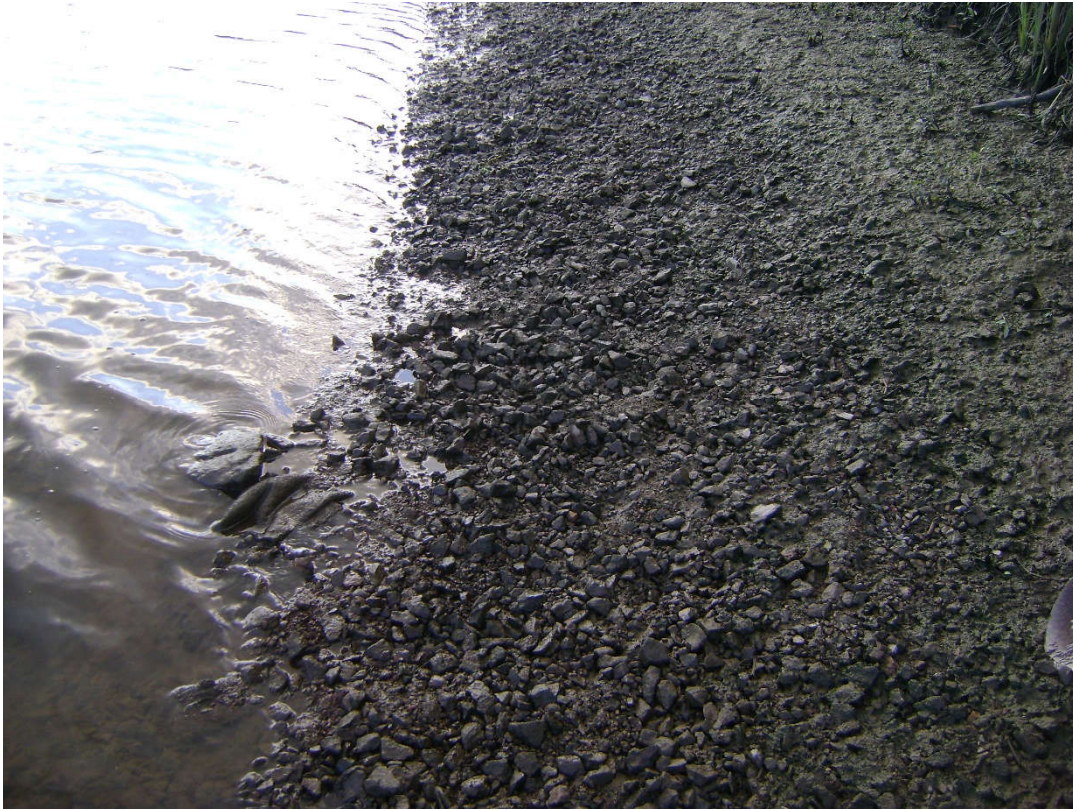
- Bub1 – See Photo 1 (taken September 2021). This location remained unchanged since the previous inspection in September 2021. The tide did not retreat enough to make visible the several small springs which had been observed during previous inspections parallel to shoreline along a 5 to 6-ft stretch of shore. The area where springs had previously been observed coming out from under an edge of the geosynthetic clay layer (GCL) (approx. 3-in deep) was still under several inches of water during the inspection. There was no soft feel to the ground surface along the exposed shoreline. This location is no longer considered to be an active GCL Bubble area.

Photo 1 – Bub 1 – (photo taken September 20, 2021) No change since last visit. Several small springs parallel to shore, still underwater at low tide. Springs coming from edge of GCL close to surface. No soft feel to ground anywhere in this area.

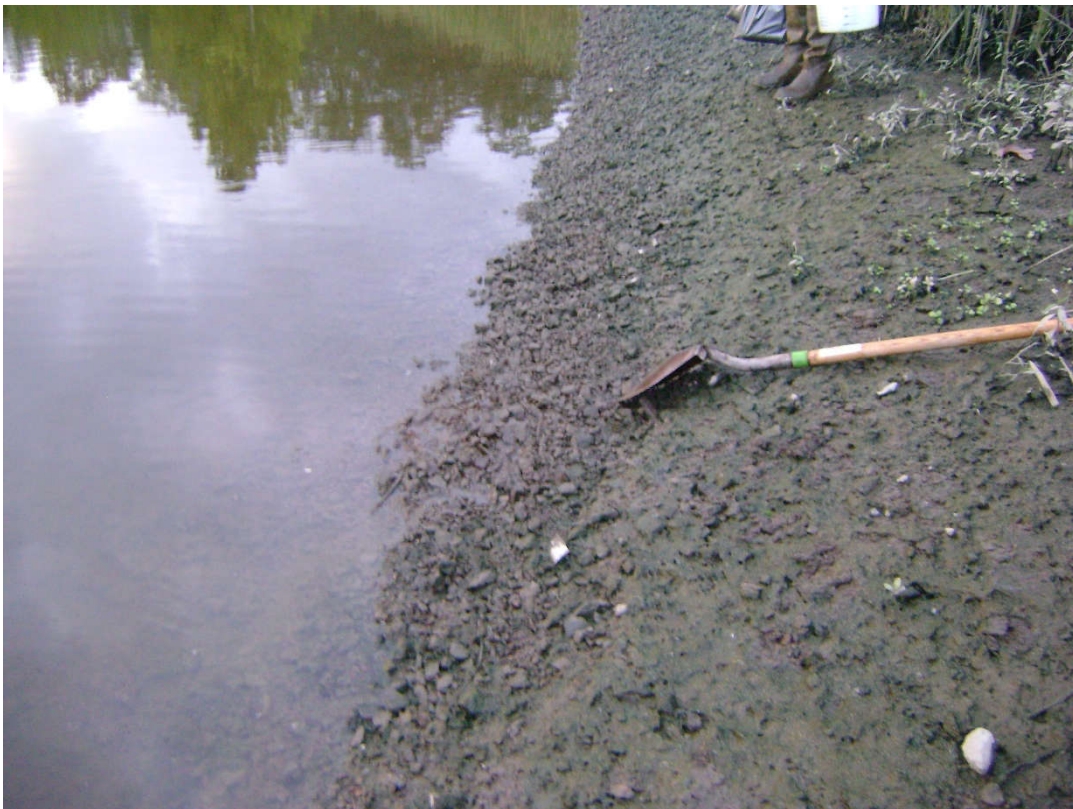
- Bub2 – See Photo 2 (taken September 2021). This location remained unchanged from the previous inspection in September 2022. The tide did not retreat enough to make visible any drainage of water previously observed coming from the stone surface close to edge of shore. There was no soft feel to the ground surface, probably due to cuts having been made (during a previous site visit) through the GCL perpendicular to the shoreline. The cuts through the GCL provide a pathway for a spring to escape and drain from the stone to the surface water. This location is no longer considered to be an active GCL Bubble area.

Photo 2 – Bub 2 – (photo taken September 20, 2021) No change since last visit. Small amount of water draining from stone, indicated by shovel head. No soft feel to ground anywhere in this area.

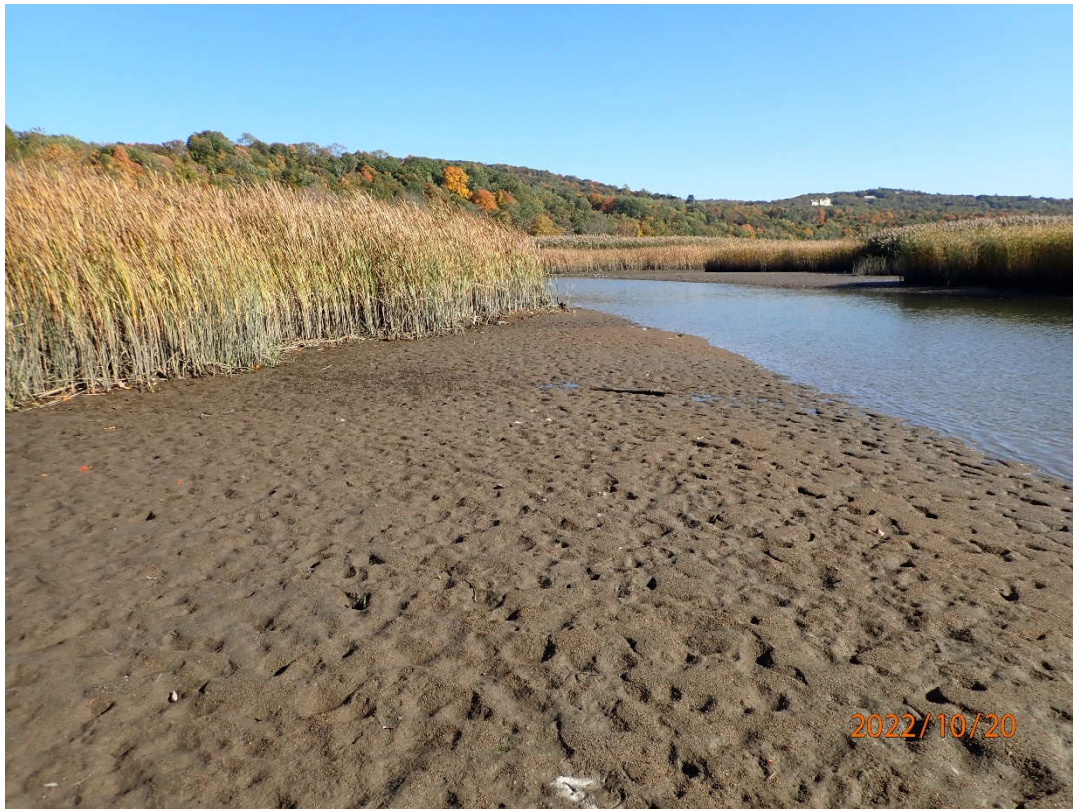
Photo 3 – Bub 3 – Looking south. Historic epicenter of Bub3 area shown in background. Some soft areas around edge of Bub 3, but very small and isolated.

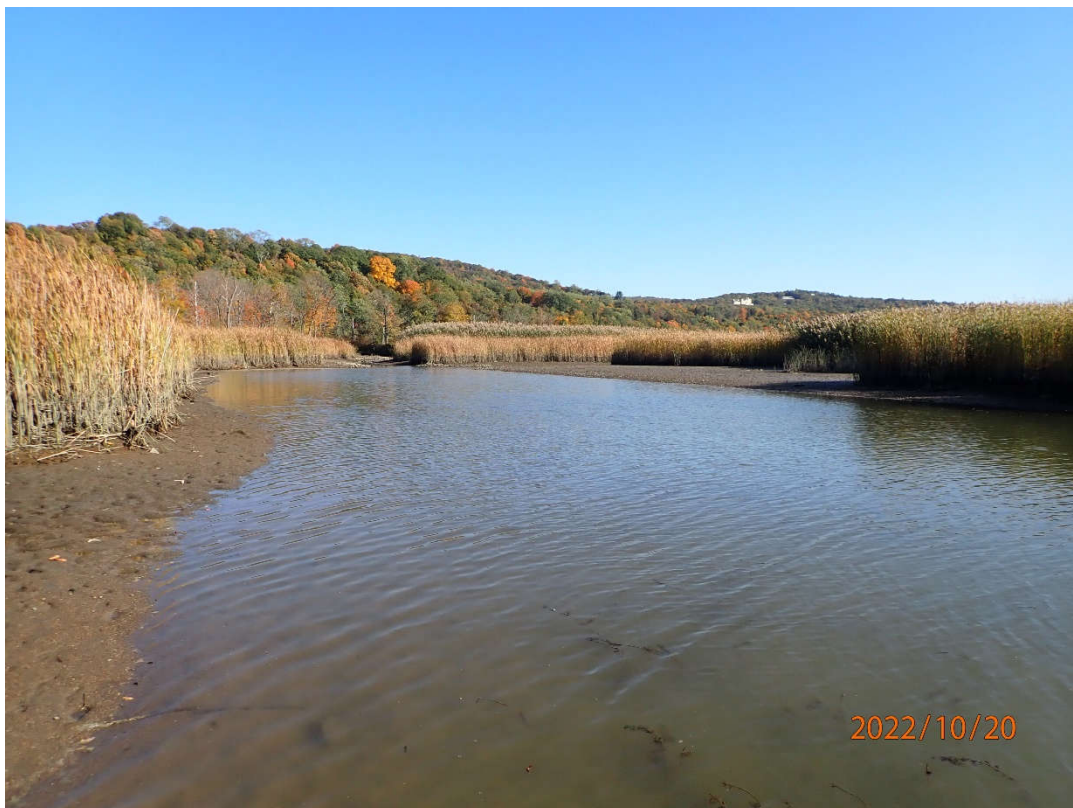
- Bub3A – See Photo 4. This location remained unchanged since the previous inspection in September 2021. Some softness still exists around the central cut through the GCL, but overall, the area and degree of softness was reduced since making the cuts. Figure 2 shows approximately where soft areas were observed during the inspection.

Photo 4 – Bub 3A – Looking southeast. Located on the left side of photo. Small soft area remains at central cut through GCL.

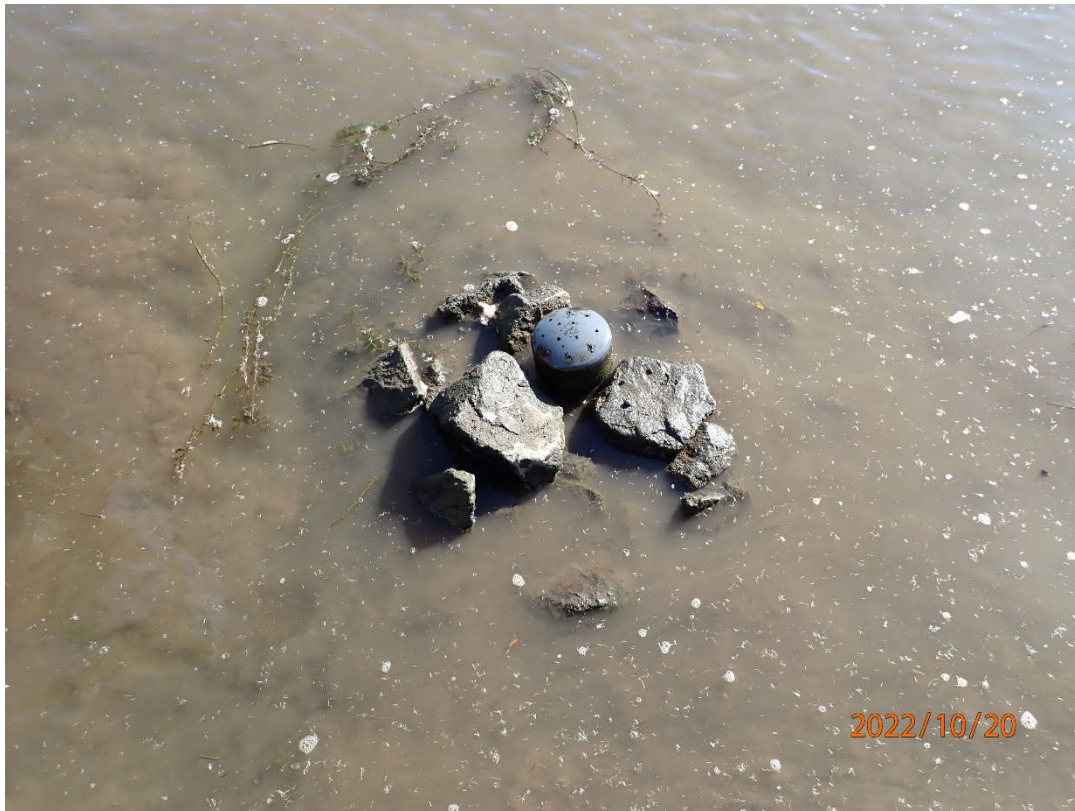
Photo 5 – Bub 4 – 4” diameter perforated pipe just above the water line with stone protection around pipe.

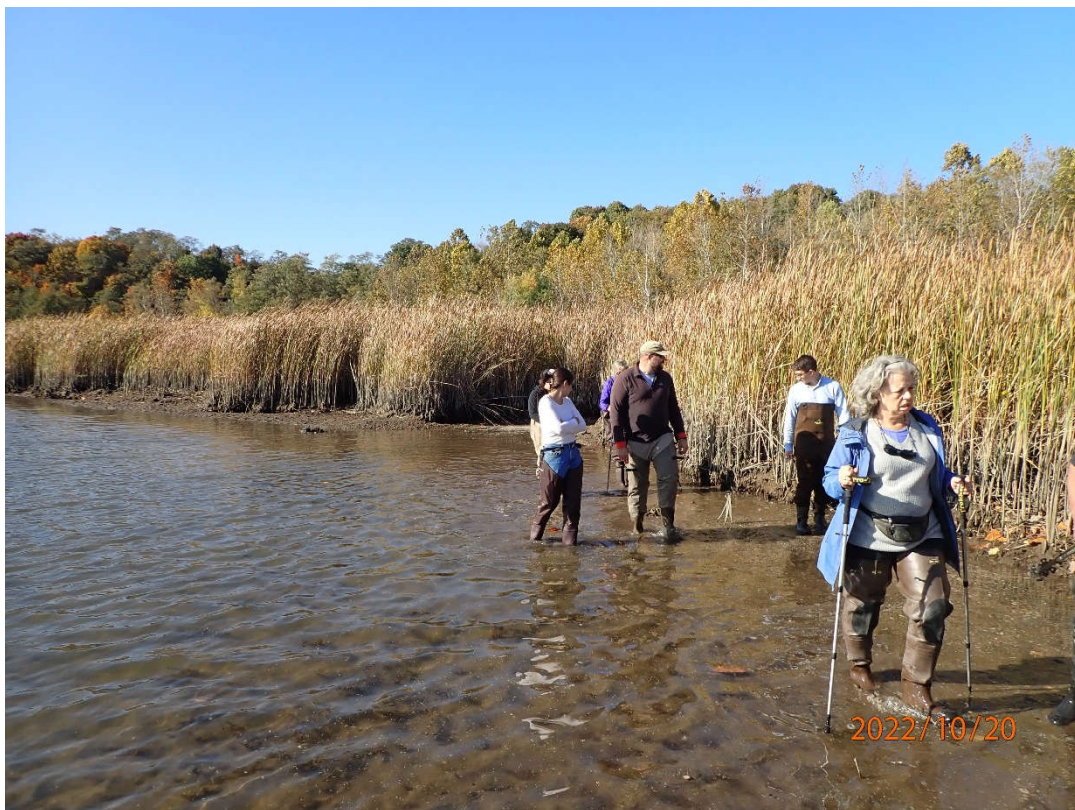
Photo 6 – Bub 4 – Located in background, in front of grass is 4” diameter perforated pipe slightly above water line with stone protection around pipe.
