# **BOG TURTLE HABITAT (PHASE 1) SURVEY REPORT**

**CROSS-COUNTY SANITARY/KESSMAN LANDFILL  
286 CORNWALL HILL ROAD  
PATTERSON, NEW YORK 12563  
PUTNAM COUNTY  
NYSDEC Site No. 340011  
Work Assignment No. D009812-07**

**JULY 2020**

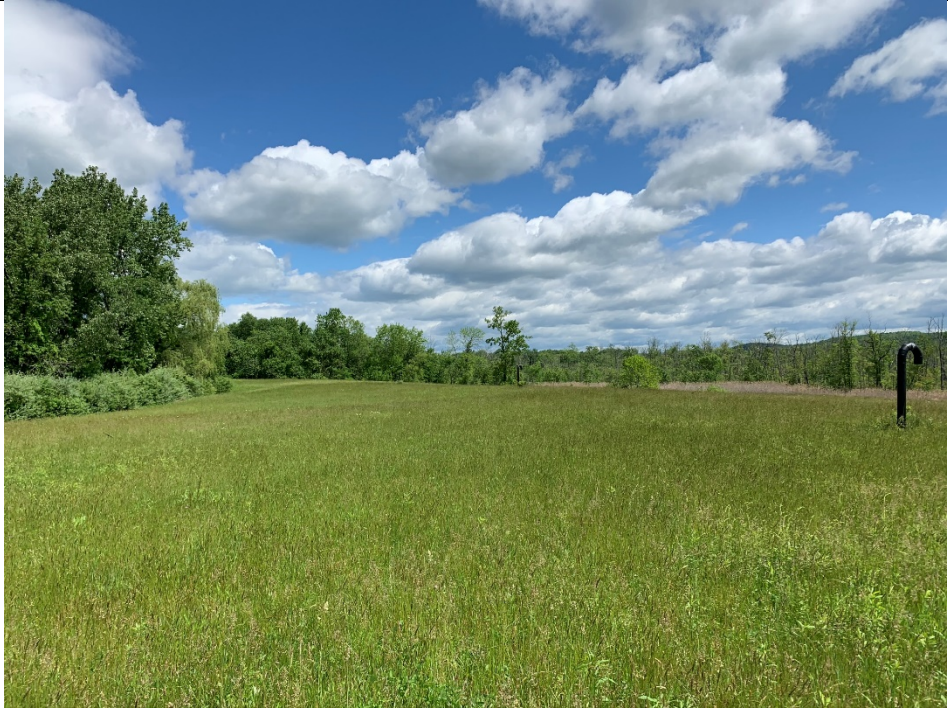
Cross-County Sanitary / Kessman Landfill	
<b>Photo: #1</b> <b>Date:</b> 6/1/2020 <b>ID:</b> N/A <b>Comments:</b> Kessman Landfill, looking north over capped landfill toward wetland W- WH-1

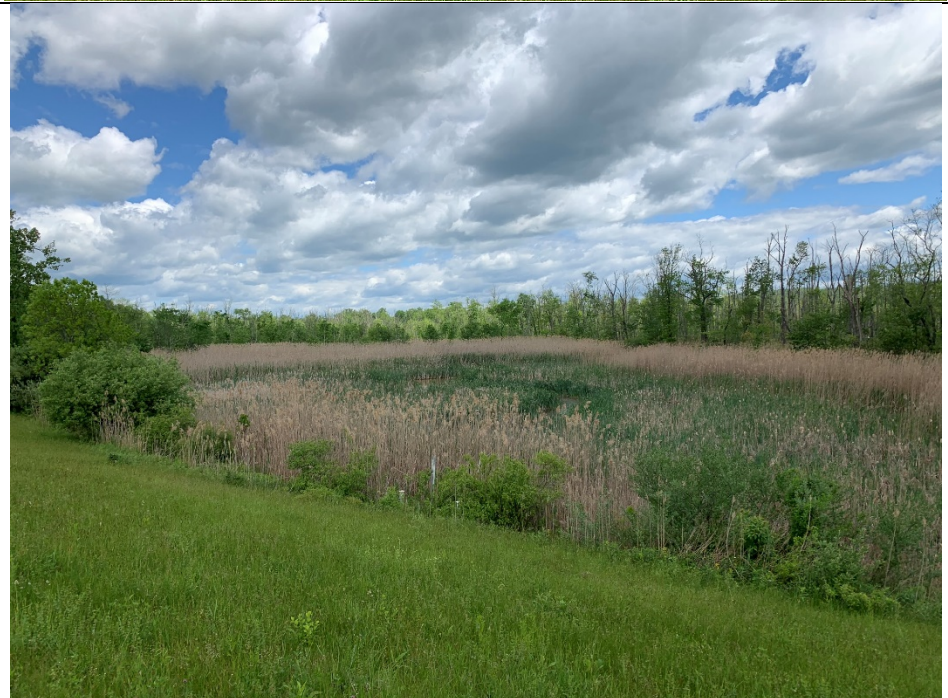
<b>Photo: #2</b> <b>Date:</b> 6/1/2020 <b>ID:</b> W-WH-1 <b>Comments:</b> Photo looking north across wetland W-WH-1

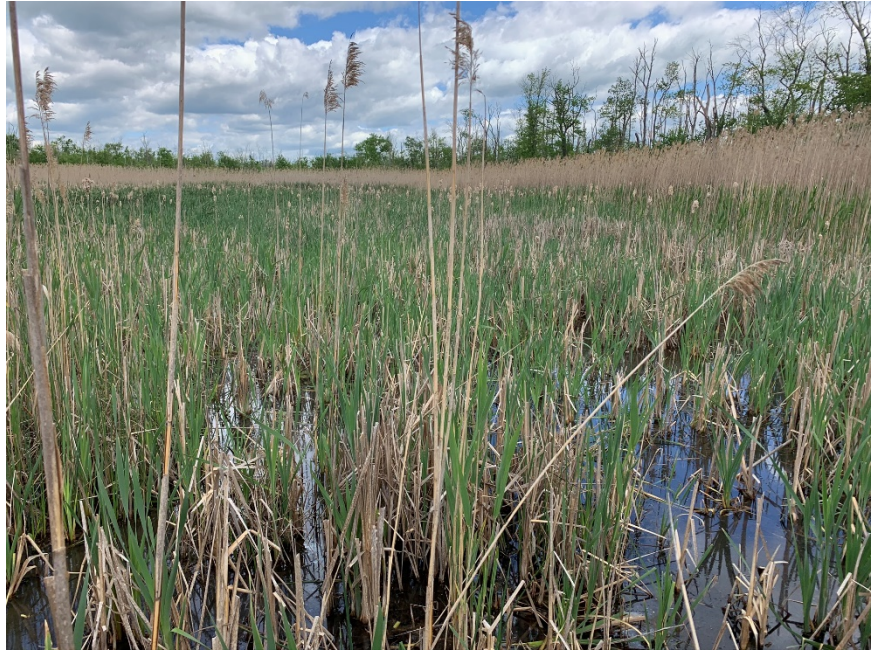
Cross-County Sanitary / Kessman Landfill	
<b>Photo: #3</b> <b>Date: 6/1/2020</b> <b>ID: W-WH-1</b> <b>Comments:</b> Looking North across open marsh in center of wetland W-WH-1

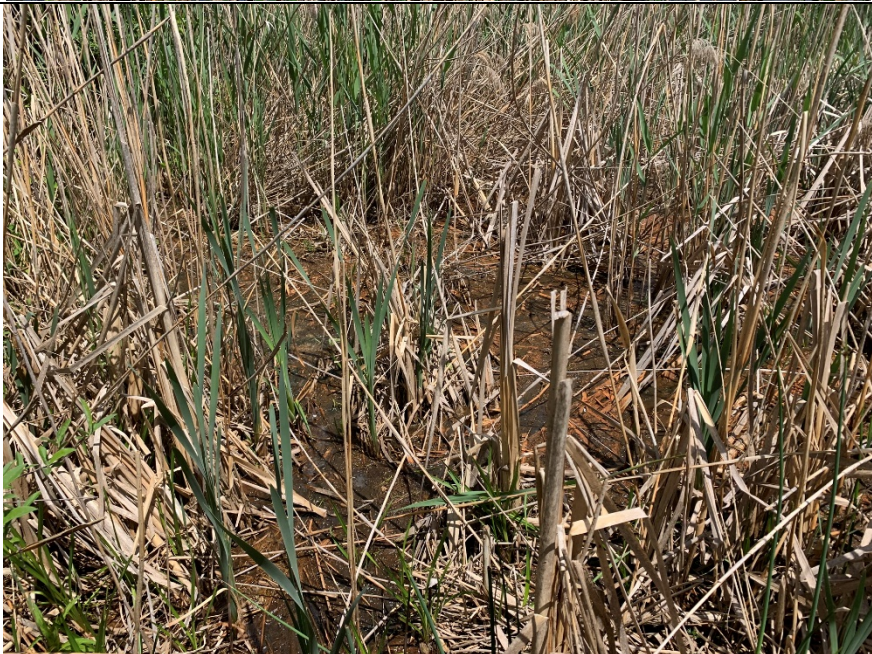
<b>Photo: #4</b> <b>Date: 6/1/2020</b> <b>ID: W-WH-1</b> <b>Comments:</b> Mucky iron rich soils under the phragmites canopy.

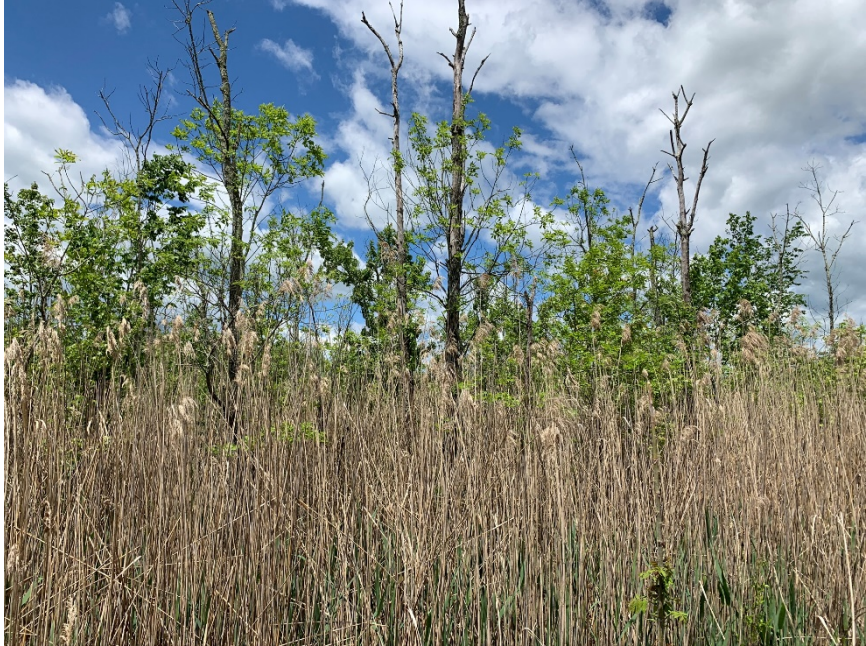
Cross-County Sanitary / Kessman Landfill	
<b>Photo: #5</b> <b>Date: 6/1/2020</b> <b>ID: W-WH-1</b> <b>Comments:</b> Looking west from Rail bed across PSS habitat. Primarily dead green ash, with red maple and green ash saplings surrounded by common reed.

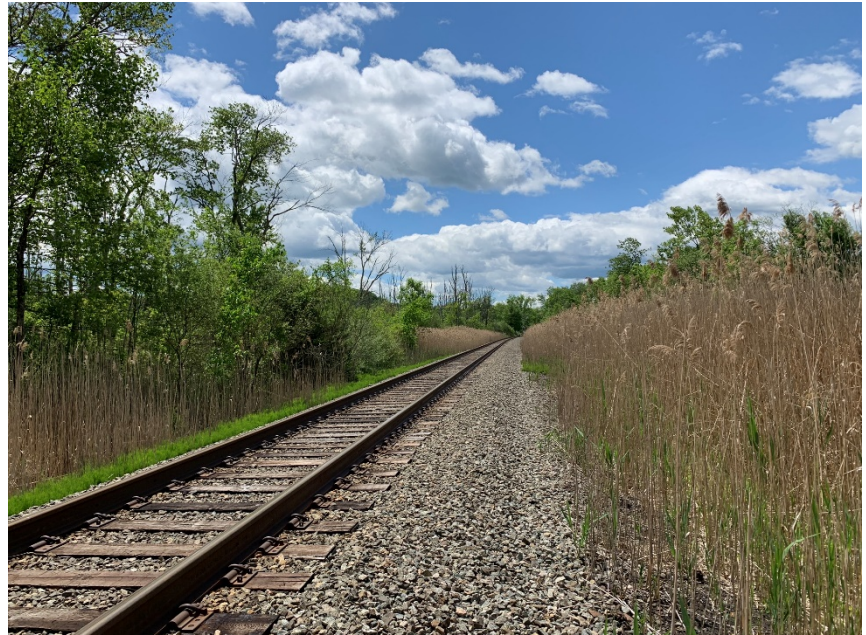
<b>Photo: #6</b> <b>Date: 6/1/2020</b> <b>ID: W-WH-1</b> <b>Comments:</b> Looking south along rail bed. Wetland W-WH-1 is on the right side, the Great Swamp is located on the left.

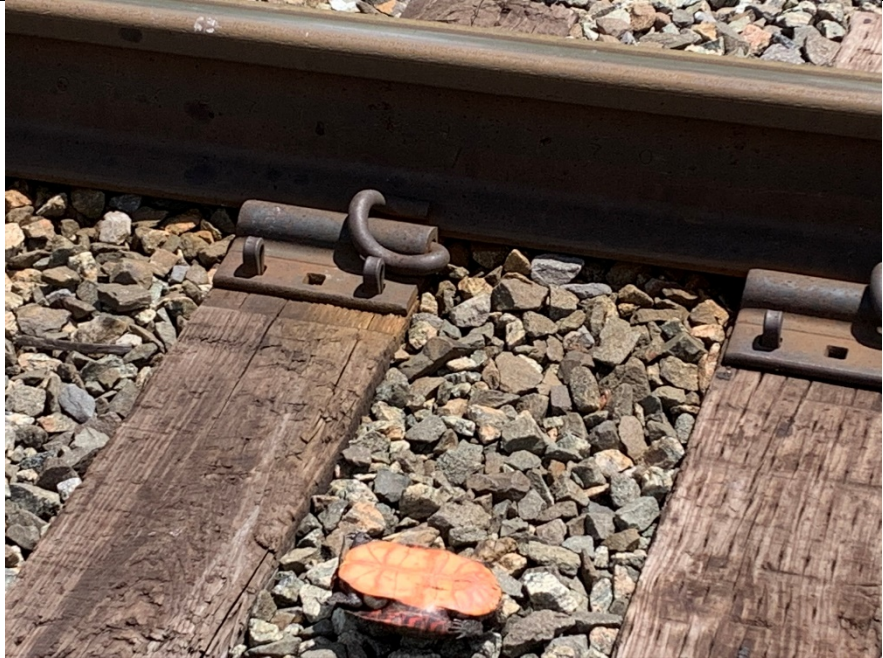
Cross-County Sanitary / Kessman Landfill	
<b>Photo: #7</b> <b>Date: 6/1/2020</b> <b>ID: W-WH-1</b> <b>Comments:</b> dead painted turtle trapped between railroad tracks on rail bed.
