REMEDIAL SYSTEM OPTIMIZATION REPORT

**CROSS-COUNTY SANITARY/KESSMAN LANDFILL
286 CORNWALL HILL ROAD
PATTERSON, NEW YORK 12563
NYSDEC Site No. 340011
Work Assignment No. D009812-07**

Prepared by:
TRC Engineers, Inc.

DECEMBER 2020

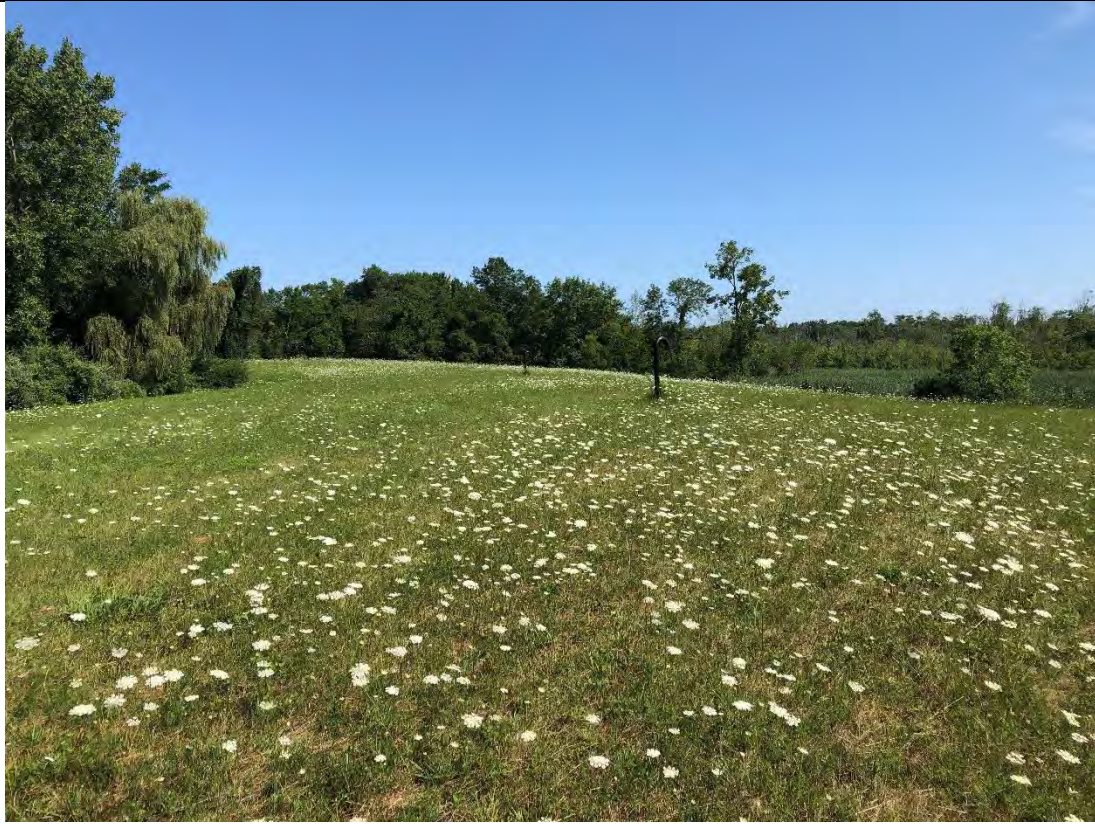
Client Name: NYSDEC		Site Location: Cross County Sanitary/Kessman Landfill, Town of Patterson, New York
Photo Number: 1	Date: 08/01/2019

Description: Upland area in center of landfill with visible stick-up aeration pipes. Photo facing northeast.		
Photo Number: 2	Date: 08/01/2019

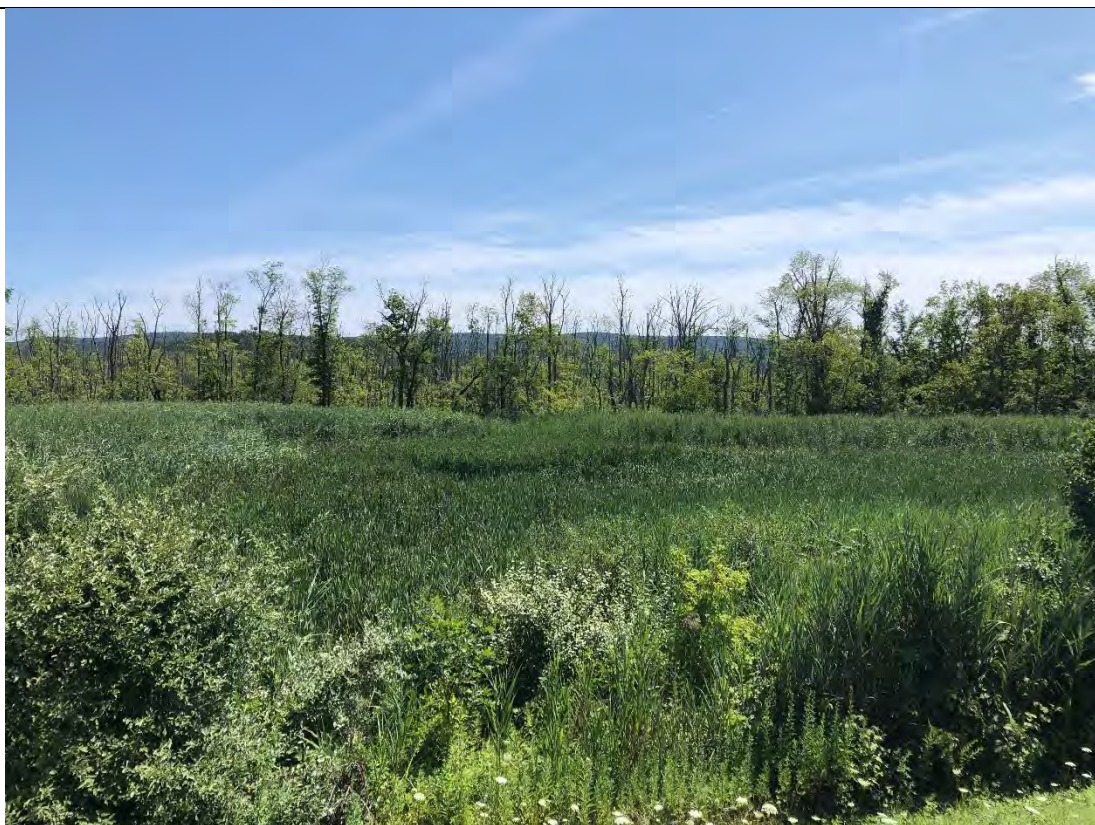
Description: Overview of wetland W-WH-1 from the eastern edge of the landfill. Photo facing east.

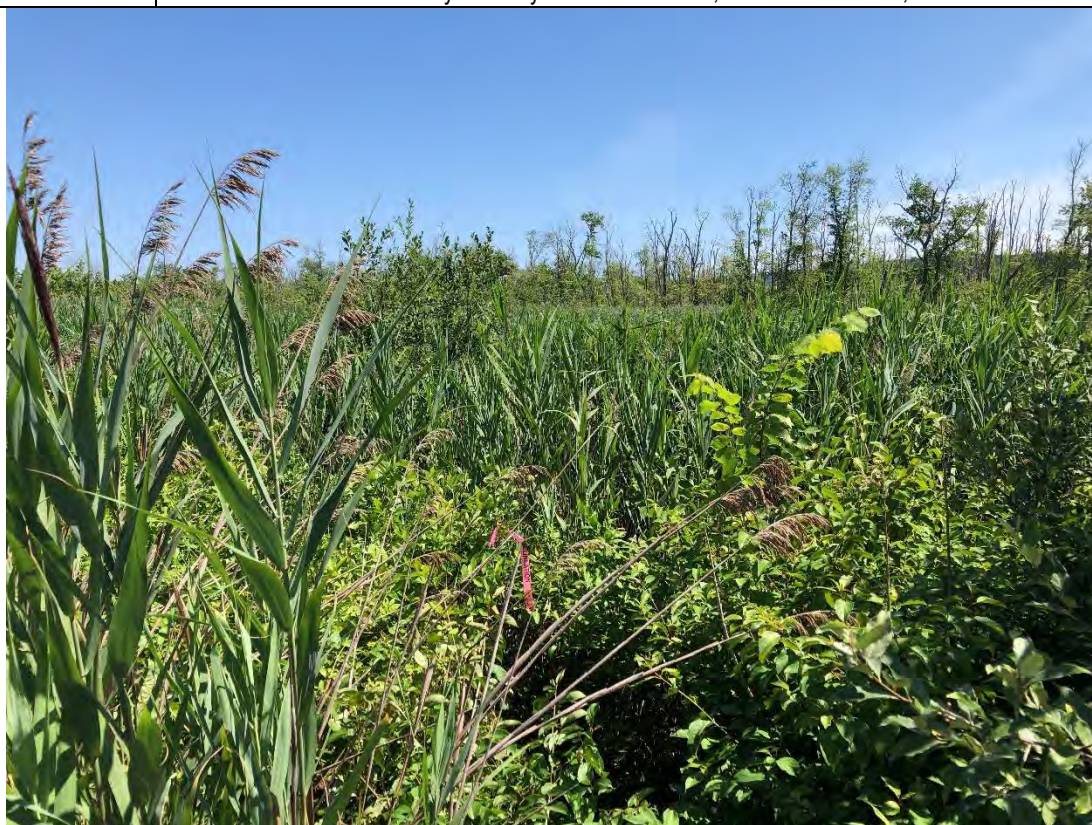
MW-20A along the W-WH-1 boundary.

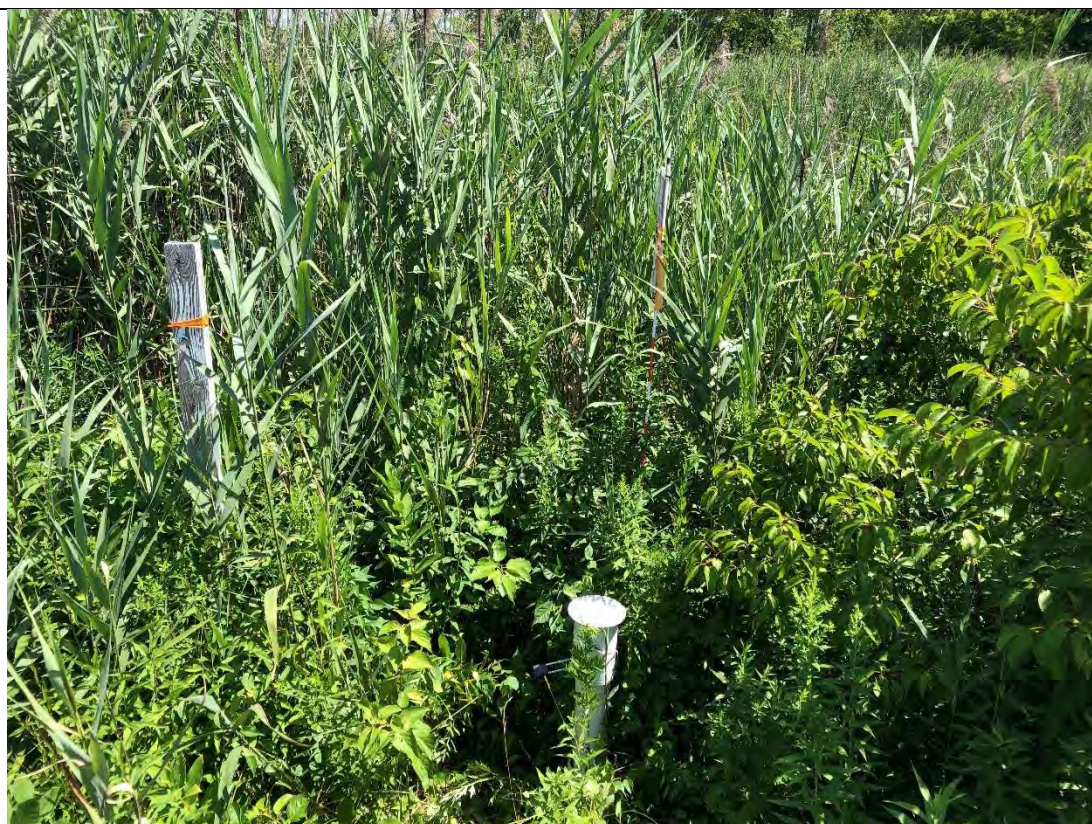
MW-20B along the W-WH-1 boundary.

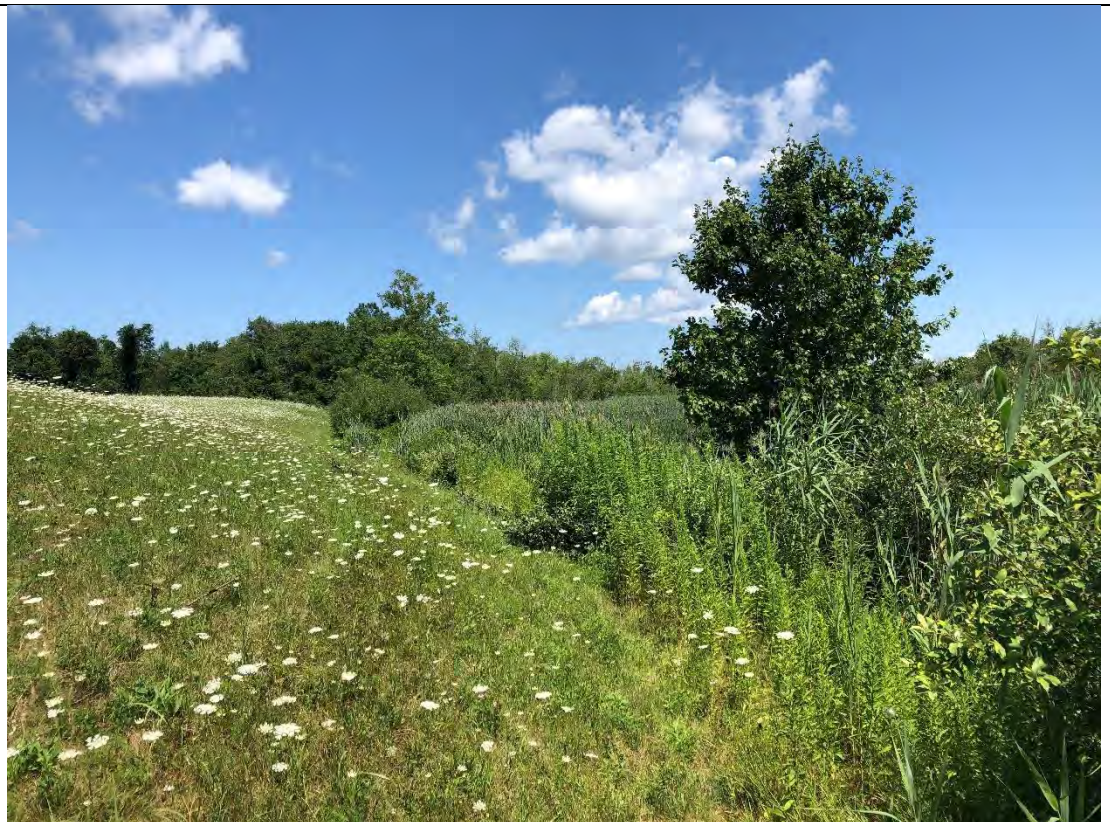
MHC-1 along the W-
WH-1 boundary.

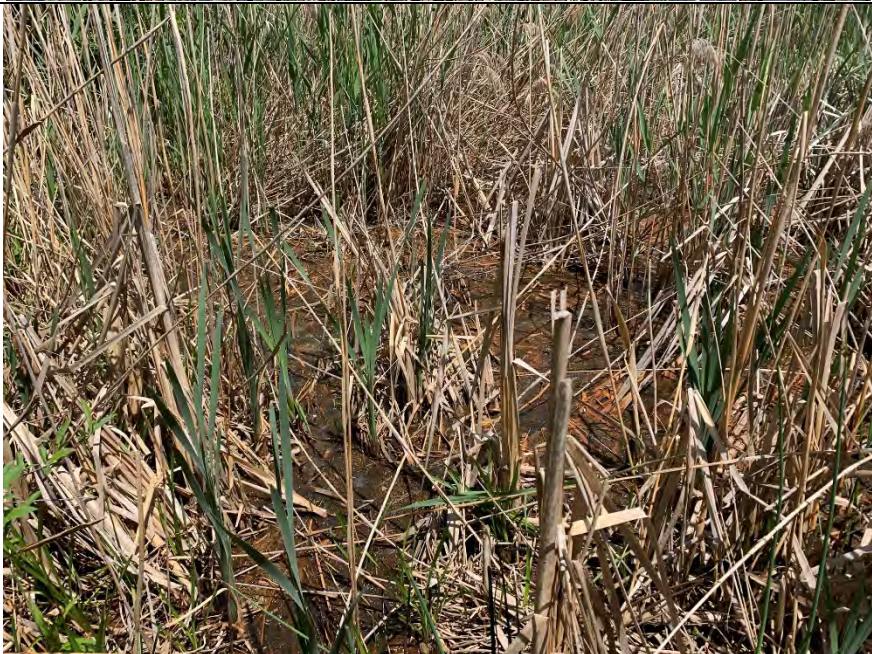
Photo: #4 Date: 6/1/2020 ID: W-WH-1 Comments: Mucky iron rich soils under the phragmites canopy.
