# Climate Change Vulnerability Assessment and Green Resiliency Corrective Action Report

## Cross-County Sanitary / Kessman Landfill

April 2022

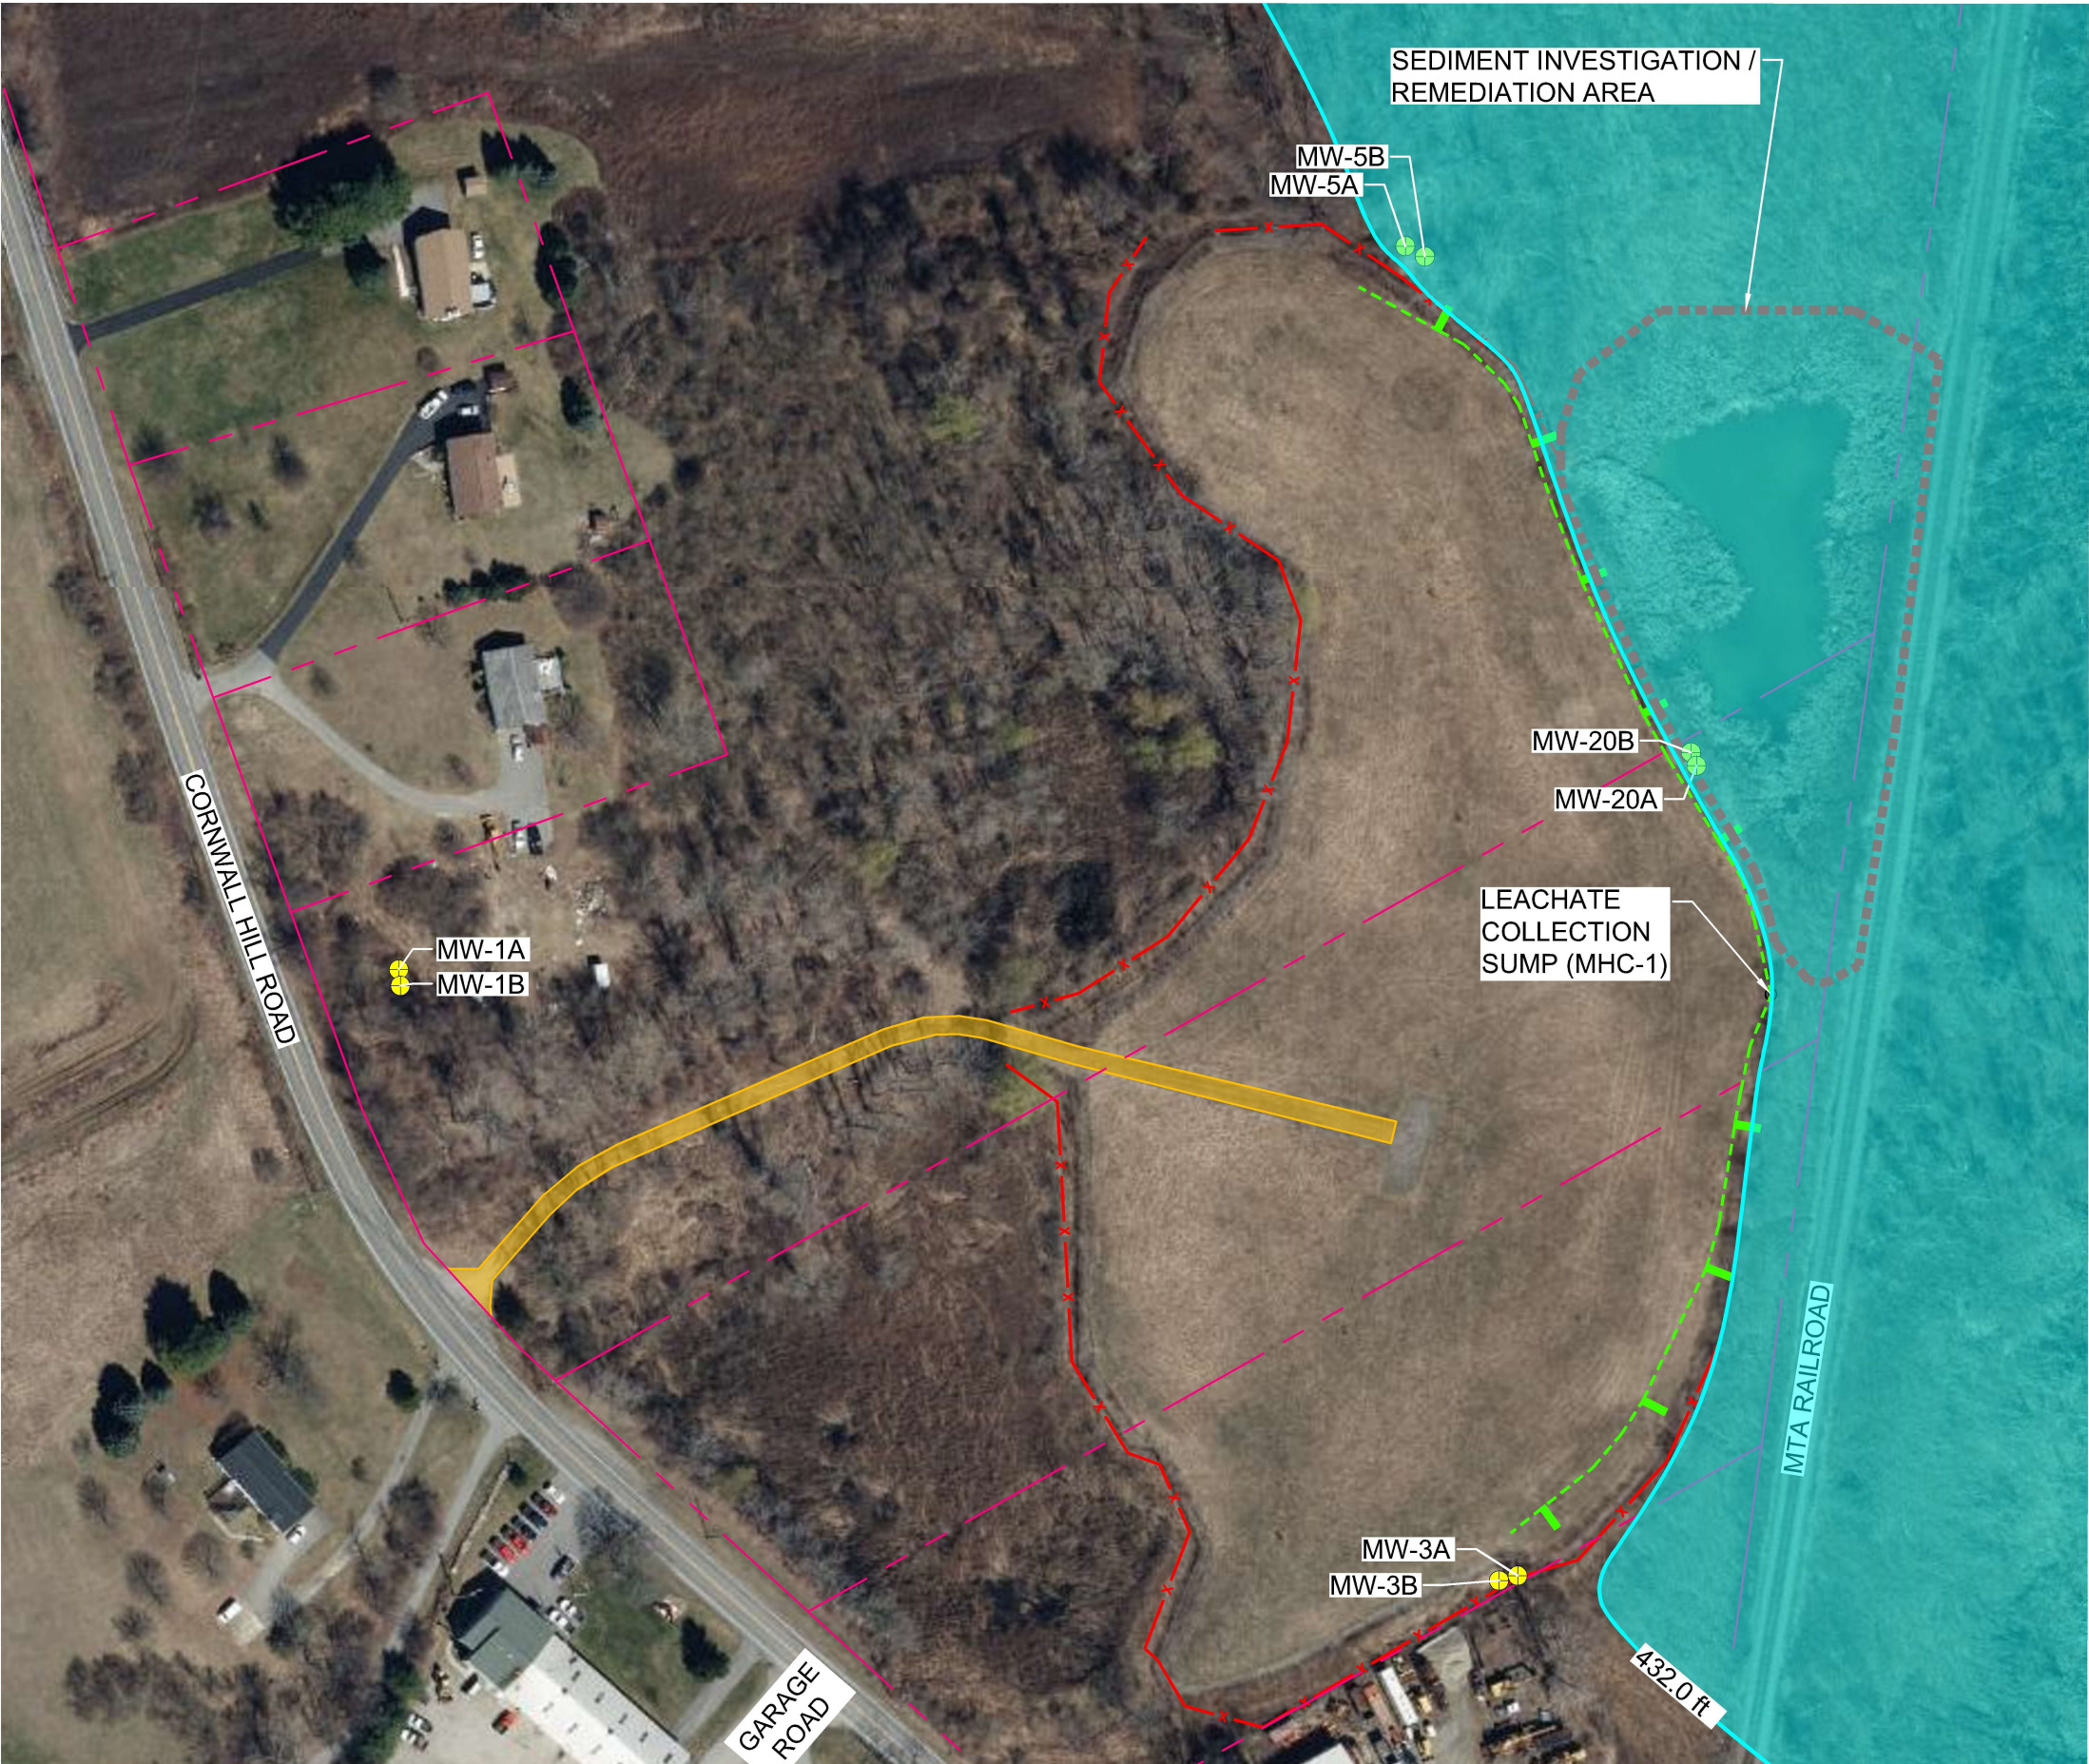
- ACCESS ROAD
- FENCE LINE
- PROPERTY BOUNDARY
- SEDIMENT INVESTIGATION / REMEDIATION AREA
- MONITORING WELL LOCATION AND IDENTIFICATION NUMBER
- LEACHATE MANHOLE LOCATION
- LEACHATE COLLECTION PIPE (WITH APPROXIMATE LOCATION OF OUTLETS SHOWN. NOT FIELD VERIFIED.)
- AT OR BELOW BASE FLOOD ELEVATION OF 432.0 FT ABOVE MEAN SEA LEVEL

FEMA flood maps are available for the Site. According to the FEMA Map #36079C0151E<sup>3</sup> the northeast edge of the landfill is contiguous with the Special Flood Hazard Area Zone AE (i.e. Great Swamp Park), which is defined as a special flood hazard area subject to inundation with 1% annual chance flood. This Special Flood Hazard Area has a base flood elevation of 432 feet and encroaches on the eastern portion of the Site (Figure A2). A topographic map of the Site, provided as Figure 3, shows the approximate location of the 432-foot elevation line along the eastern toe of the landfill slope. According to the FEMA flood maps the Site is bordered to the north and south by a Flood Hazard Area with a 2% annual chance flood, and these areas border monitoring wells 3A and 3B, 5A and 5B and 20A and 20B. The Site is also located approximately 700 feet northwest of a Regulatory Floodway (regulatory floodplain) associated with Muddy Brook.
