**2012 PERIODIC REVIEW REPORT  
BREWSTER VILLAGE WELL FIELD SITE**

**(Site No.: 3-40-012)  
Village of Brewster, Brewster, Putnam  
County, New York**

Prepared for:  
New York State Department of  
Environmental Conservation

September 2013

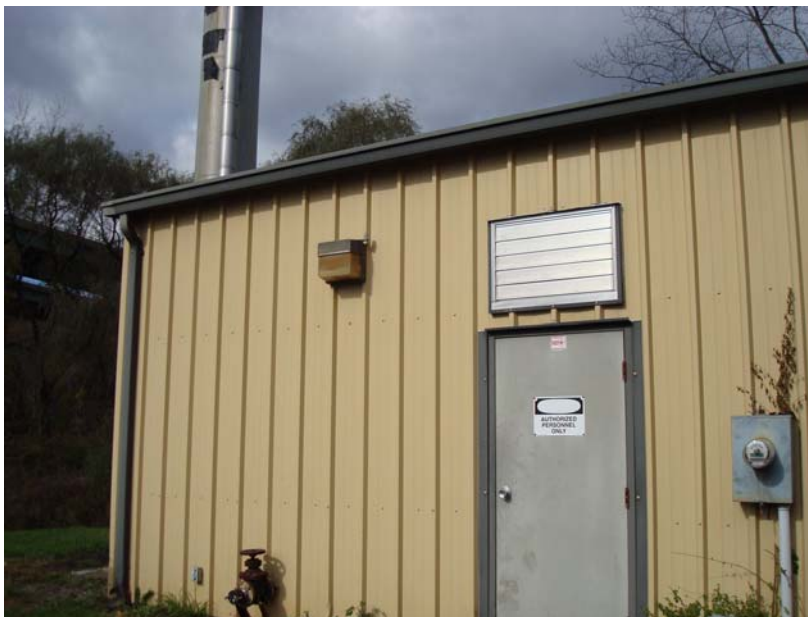
In 2012 the original remediation system was demolished and removed from the site by an EPA contractor. The associated extraction wells were abandoned, however the injection wells were not abandoned and remain on-site. At this time, EPA does not intend to abandon the injection wells.

Old groundwater treatment system, demolished in 2012.

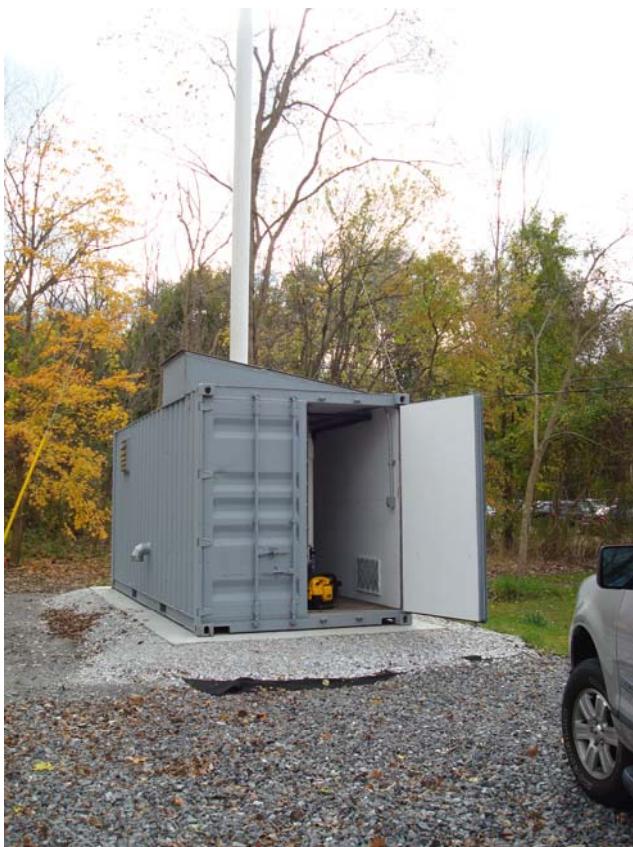
New groundwater treatment system installed in 2007.
