**2013 PERIODIC REVIEW REPORT
BREWSTER VILLAGE WELL FIELD SITE**

**(Site No.: 3-40-012)
Village of Brewster, Brewster, Putnam
County, New York**

Prepared by:
Camp Dresser McKee & Smith
11 British American Boulevard, Suite 200
Latham, New York

March 2014

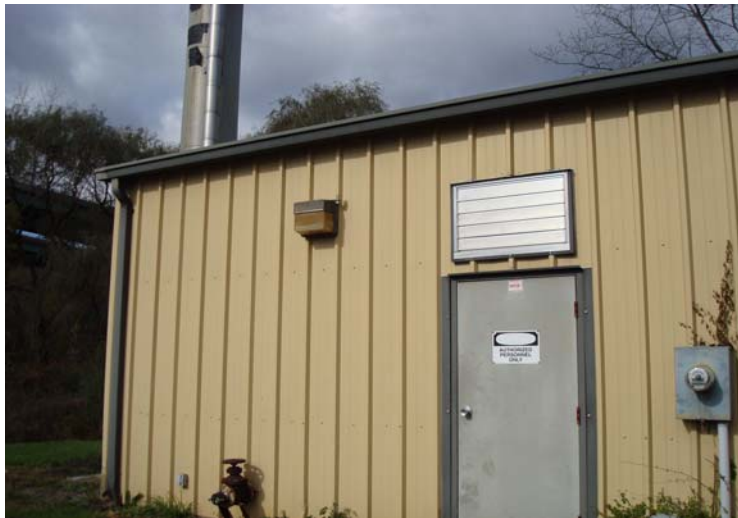
Old groundwater treatment system, demolished in 2012

In 2012, the original remediation system was demolished and removed from the site by an EPA contractor. The associated extraction wells were abandoned; however, the injection wells were not abandoned and remain on-site. At this time, EPA does not intend to abandon the injection wells.

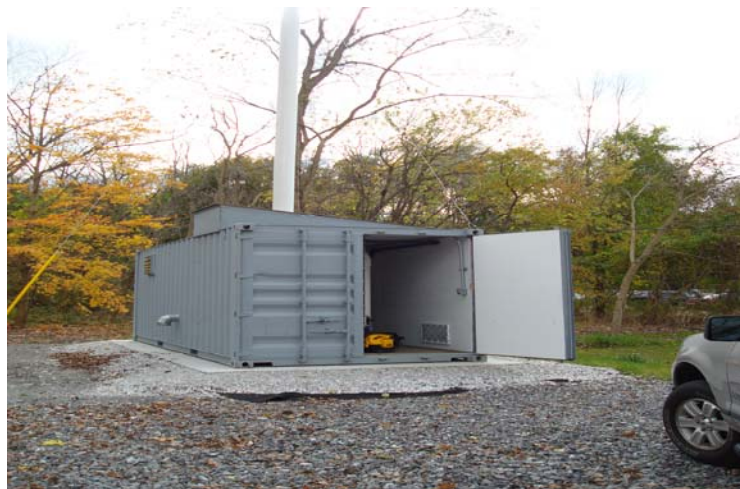
New groundwater treatment system installed in 2007
