COLD SPRING MGP

PERIODIC REVIEW REPORT

SITE NO. 340026
PUTNAM COUNTY, NY

PERIODIC REVIEW REPORT
COLD SPRING FORMER MANUFACTURED GAS PLANT
NYSDEC SITE NO. SITE 340026

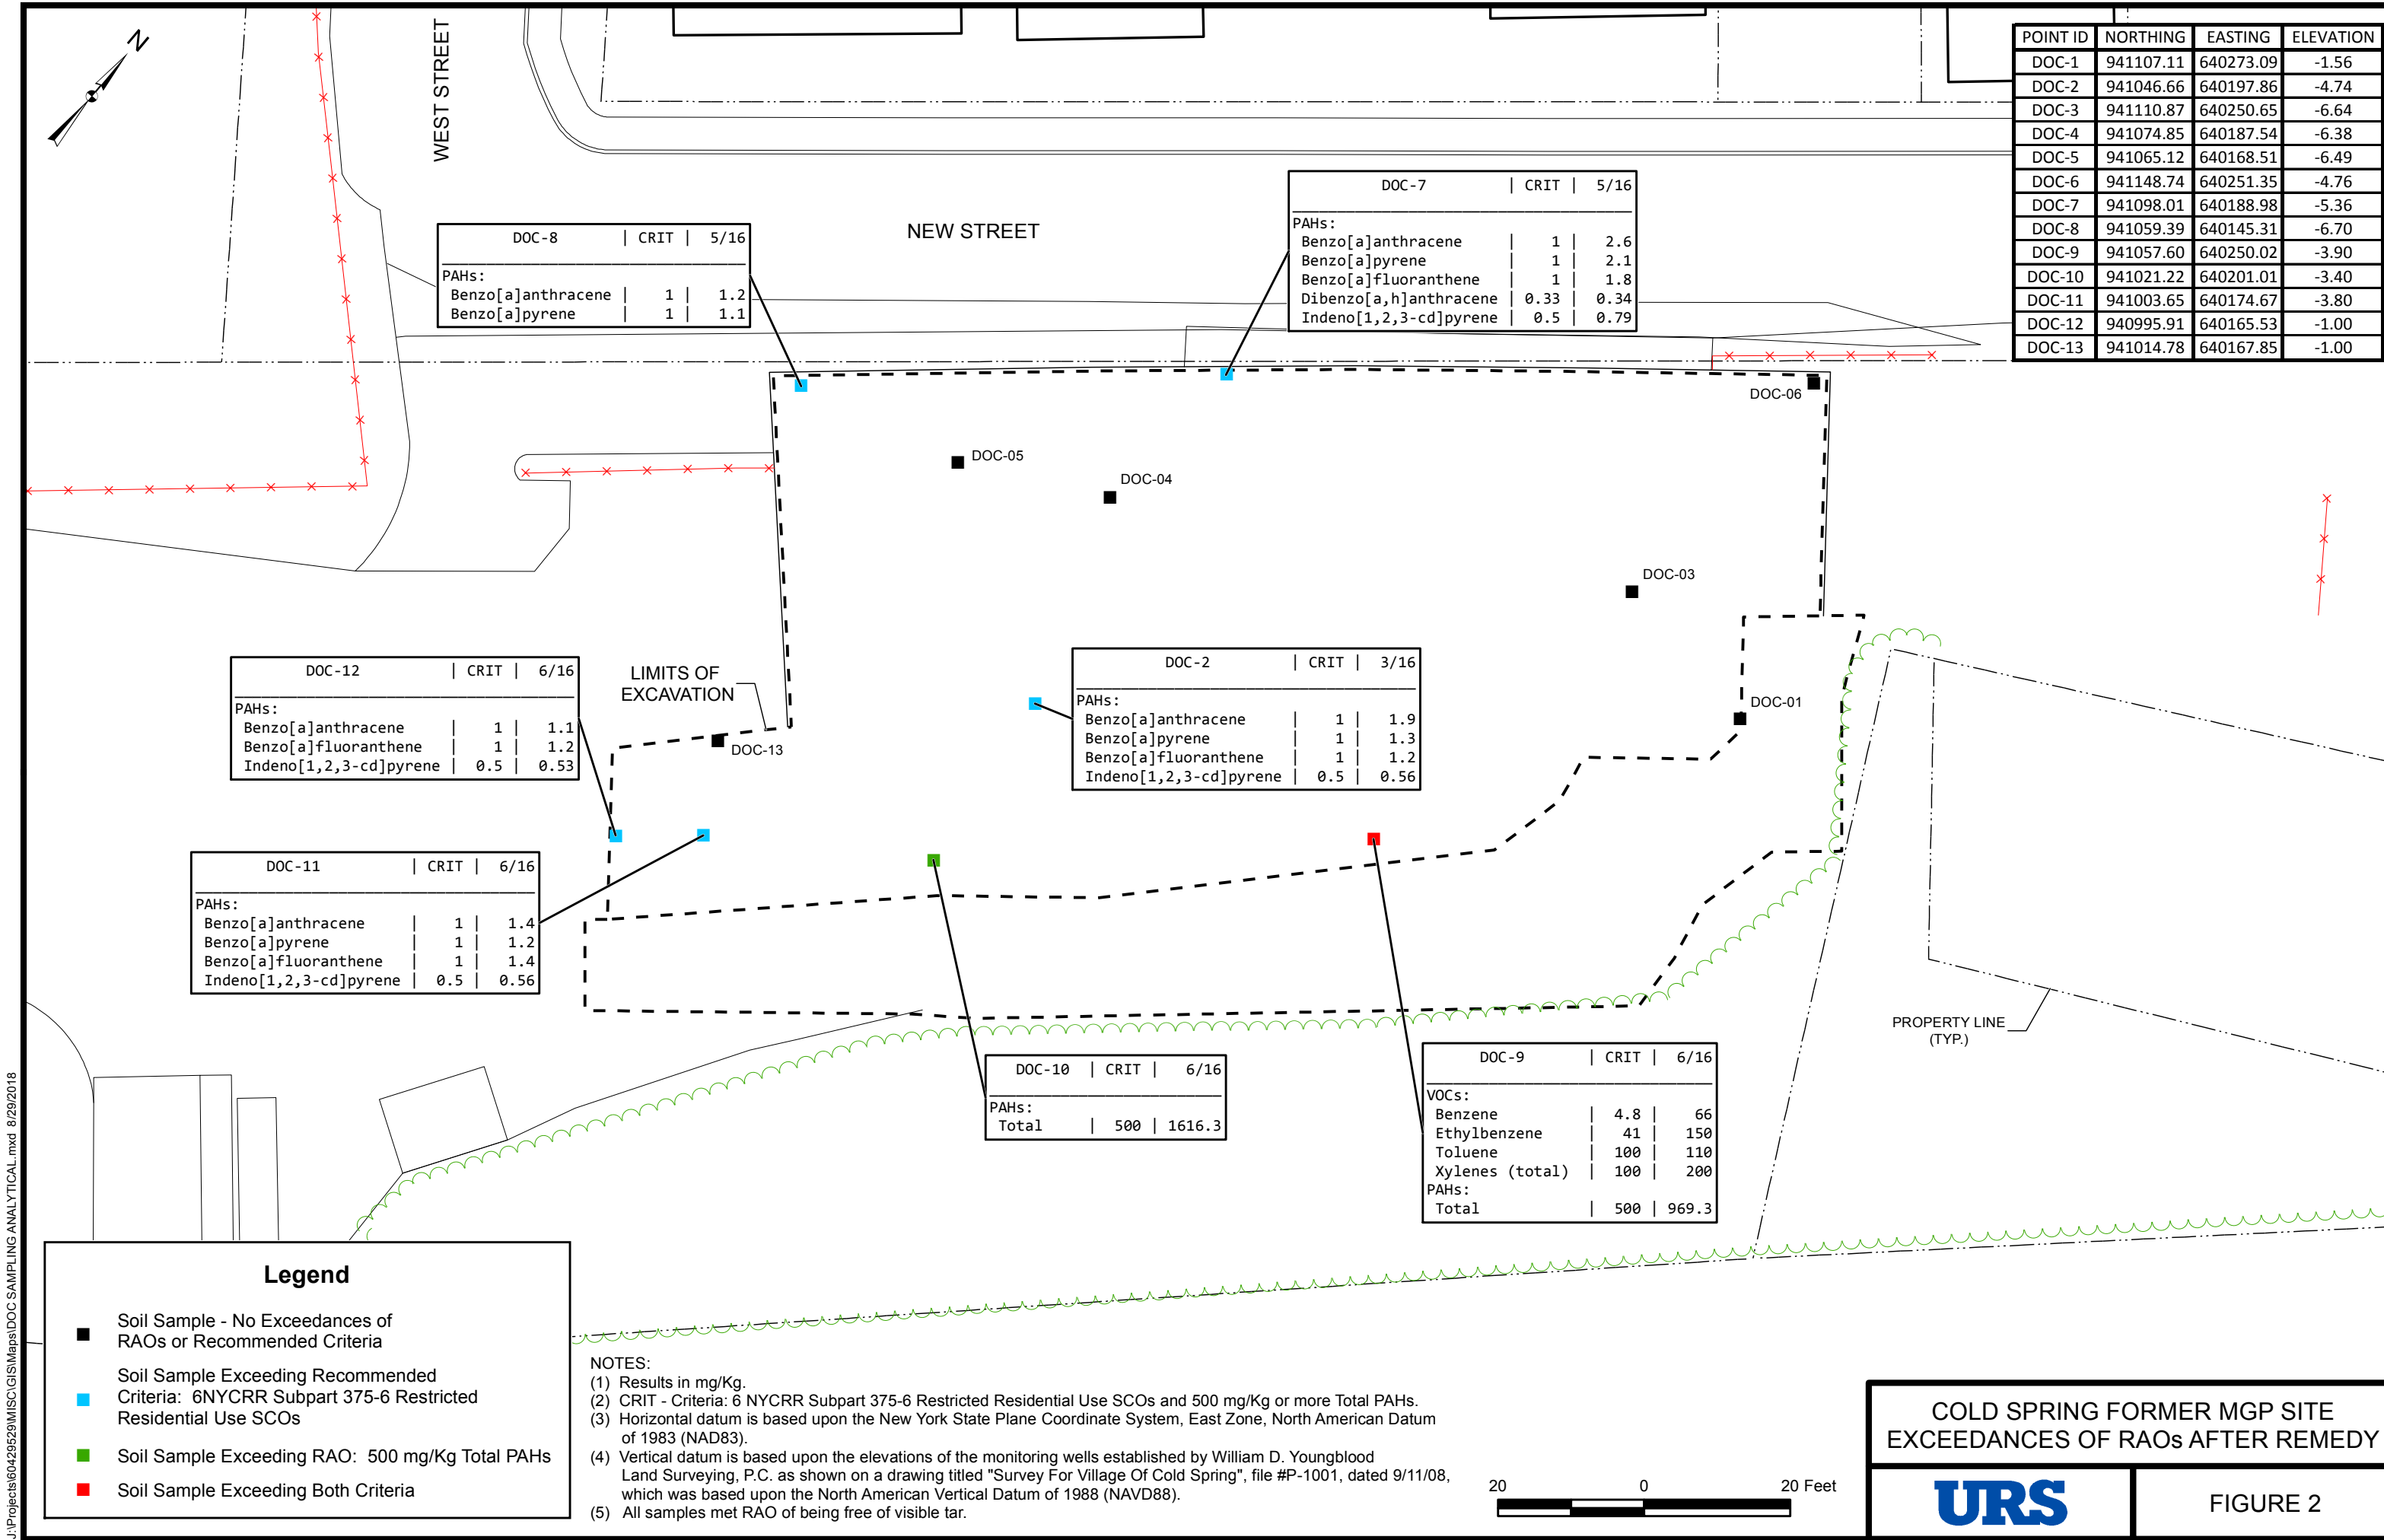
J:\Projects\60429529\MISC\GIS\Maps\DOC SAMPLING ANALYTICAL.mxd 8/29/2018

BTEX and PAHs were the major contaminants detected in site soil. Thirteen soil samples (DOC-1 through DOC-13) were collected during the remediation to document contaminant levels remaining on site. Samples DOC-1 through DOC-11 were collected from the bottom of the excavation and DOC-12 and DOC-13 were collected from the sidewalls of the excavation. The results showed that documentation samples DOC-2 and DOC-7 through DOC-12 contained contaminants at concentrations above the 6 NYCRR Subpart 375-6 Restricted Residential Use SCOs (see Figure 2 and Table 1).

In accordance with the draft SMP, groundwater samples were collected by GES from five monitoring wells in July 2018. The groundwater results were compared to NYSDEC's Class GA Ambient Water Quality Standards and Guidance Values and Groundwater Effluent Limitations (TOGS 1.1.1). Exceedances for benzene, toluene, and acenaphthene (a PAH) were observed in one downgradient monitoring well (GW-07) at the western excavation limit (see Figure 2 and Table 2). A groundwater elevation contour map is provided in Figure 3.
