Nimham Mountain Mines Site
Town of Kent, Putnam County

Nimham Arsenic Site #340033 Mt. Nimham Multiple Use Area Kent, Putnam County

Nimham Arsenic Mine Site, Nimham Mountain Multiple Use Area

Trail Capping Project Area

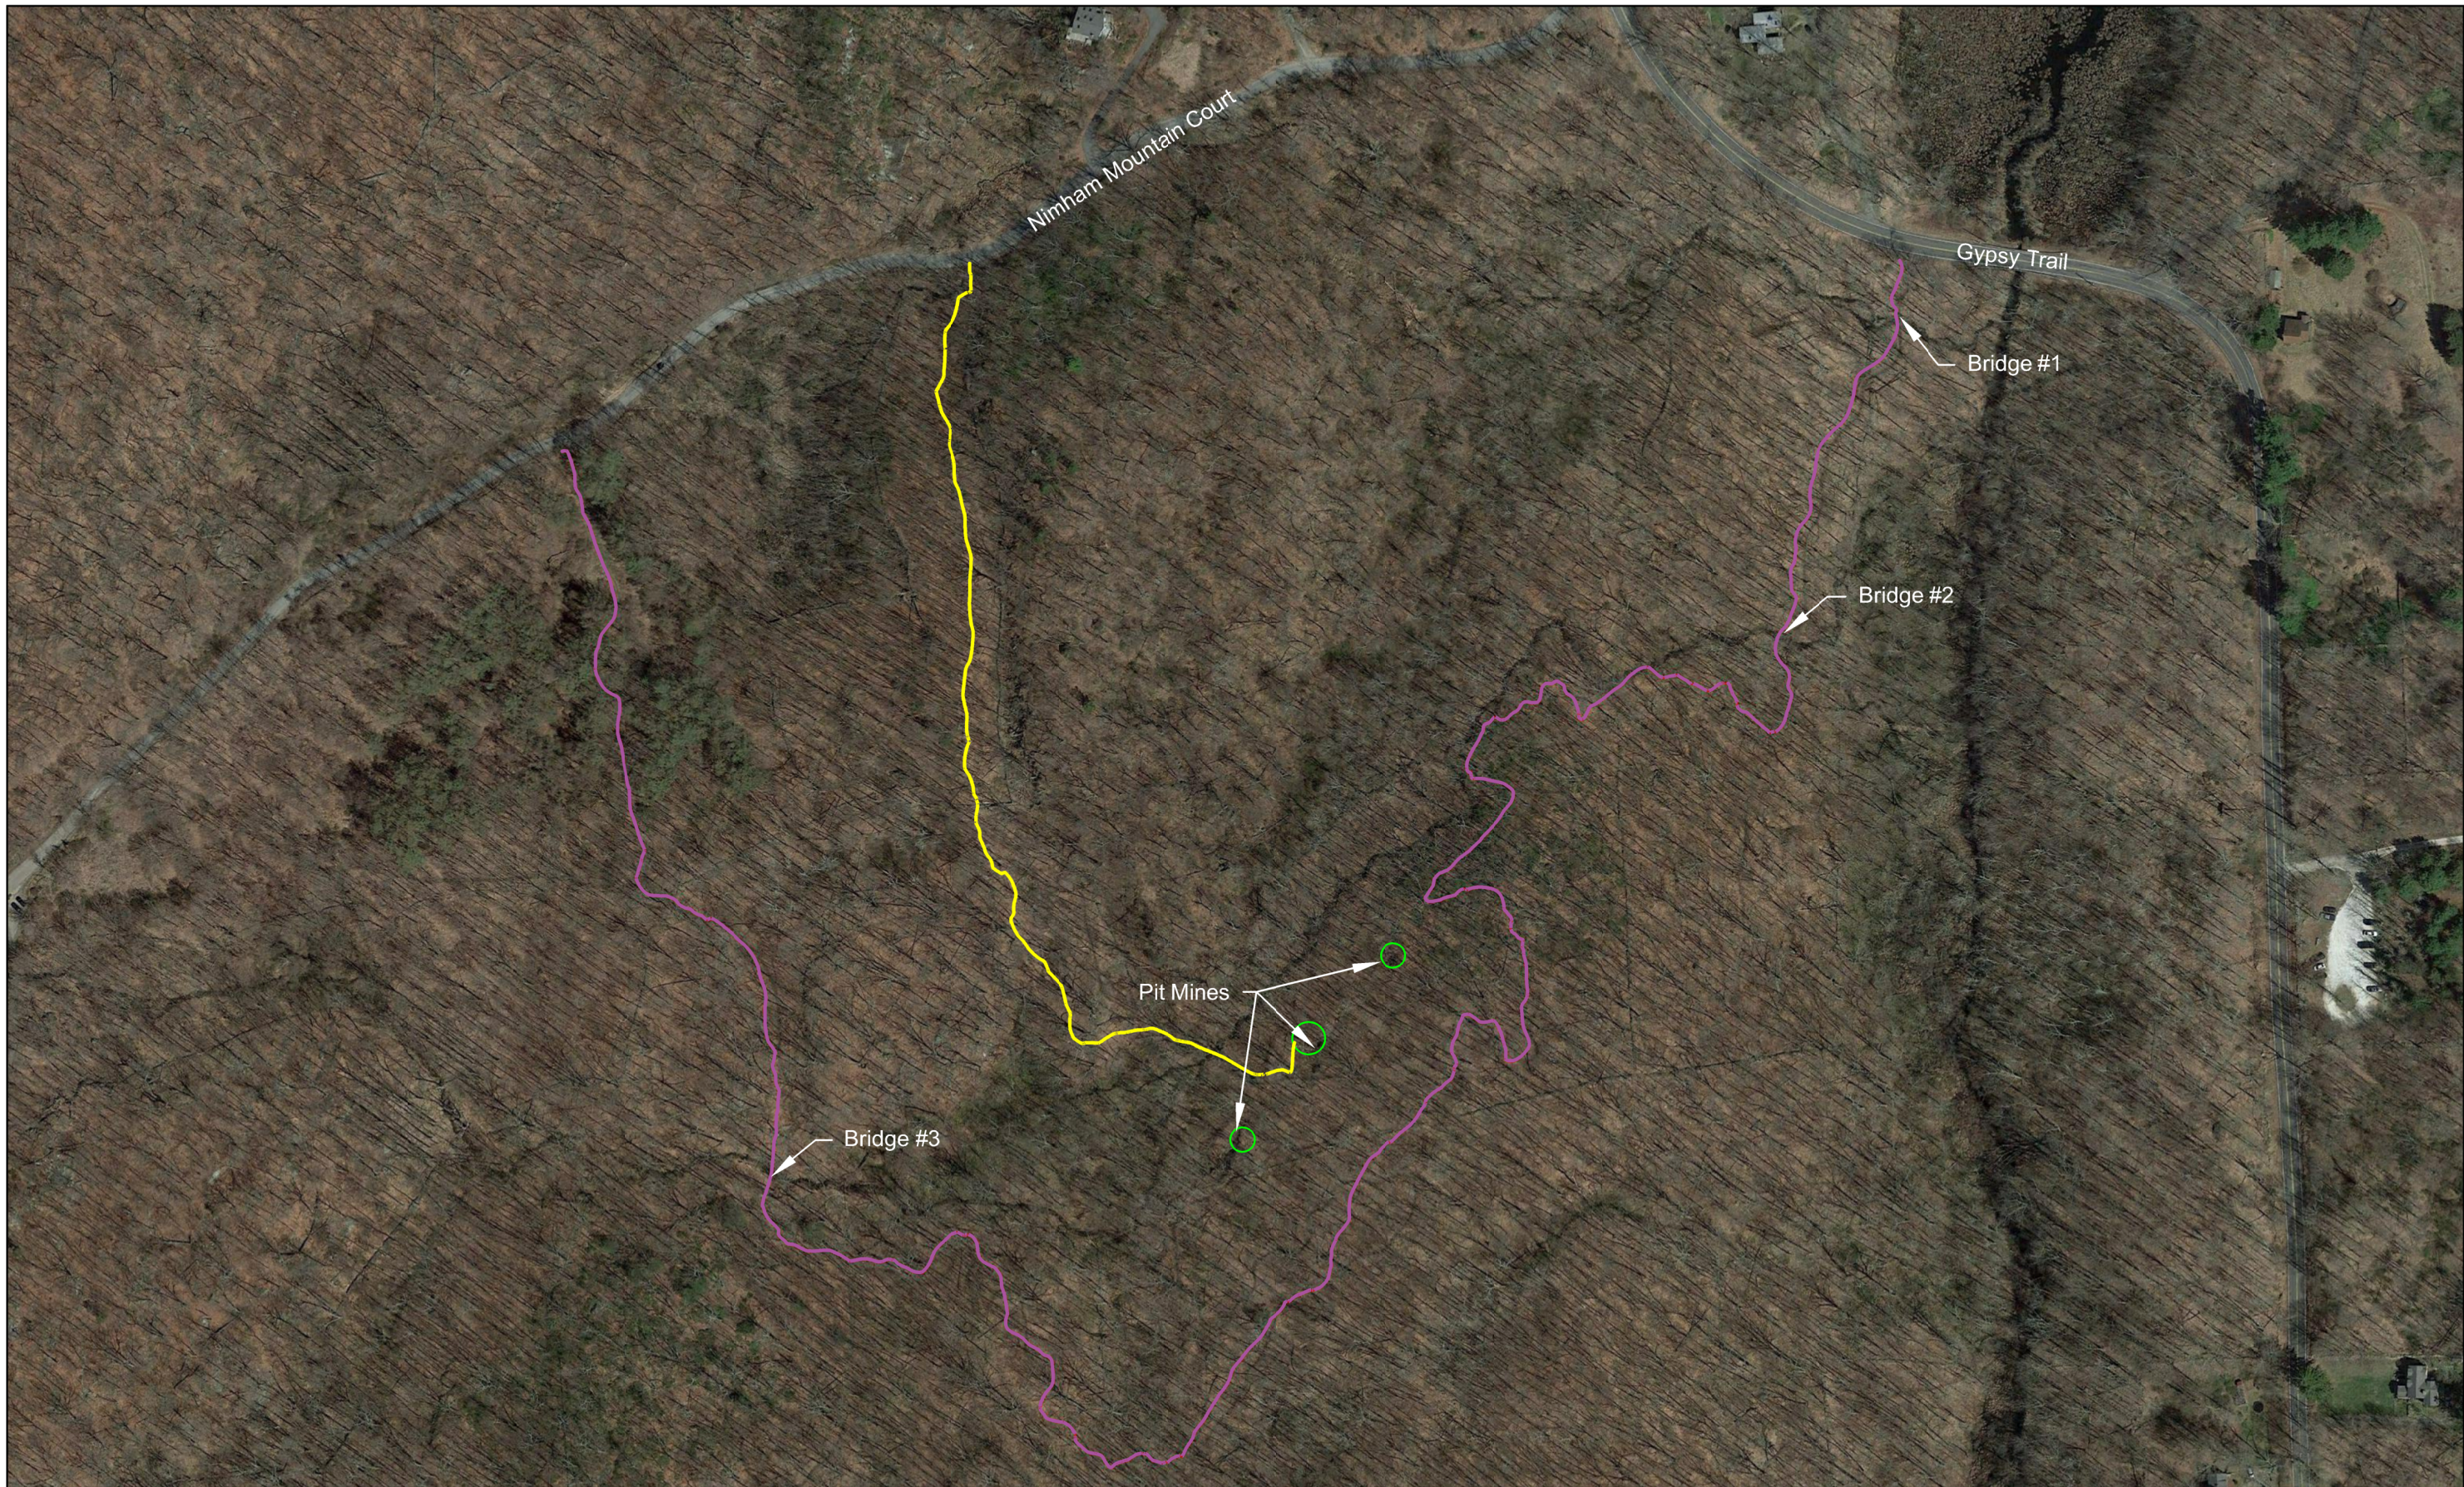
XRF Results Pits 2 & 3 Post Fill/Cover

Arsenic Concentrations in ppm

- Arsenic
- 0 - 16
 - 16 - 123
 - 124 - 500.000000
 - 501 - 1000
 - 1001 - 8000

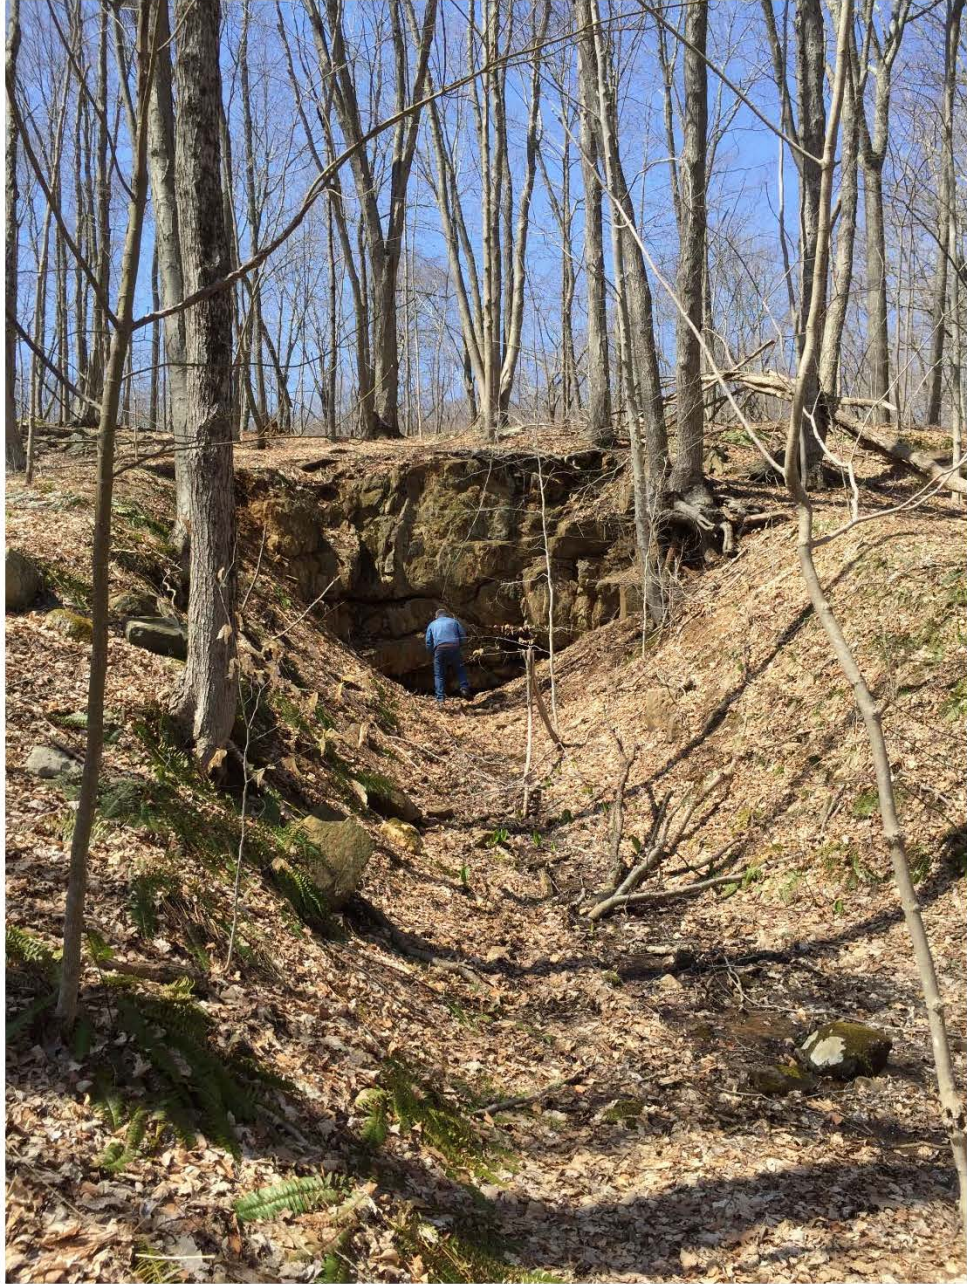
Photo 1: Mine 1 - Looking West

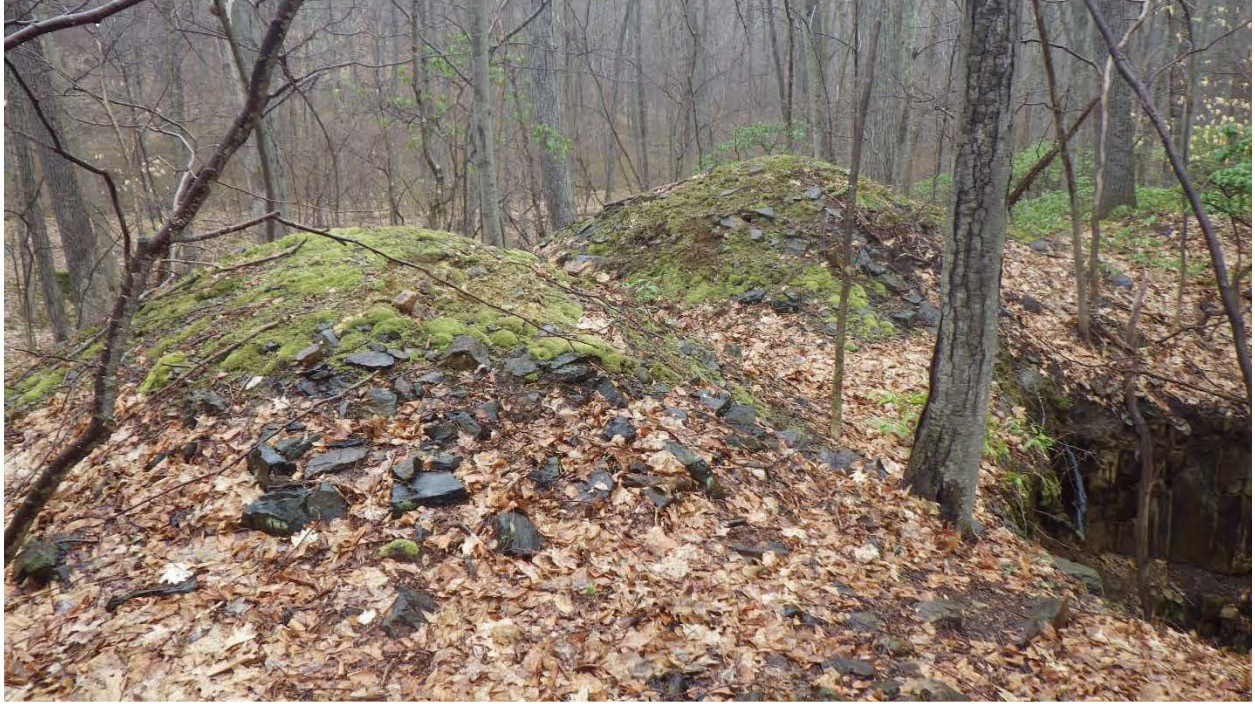
Photo 5: Pit 2 - Tailings Pile

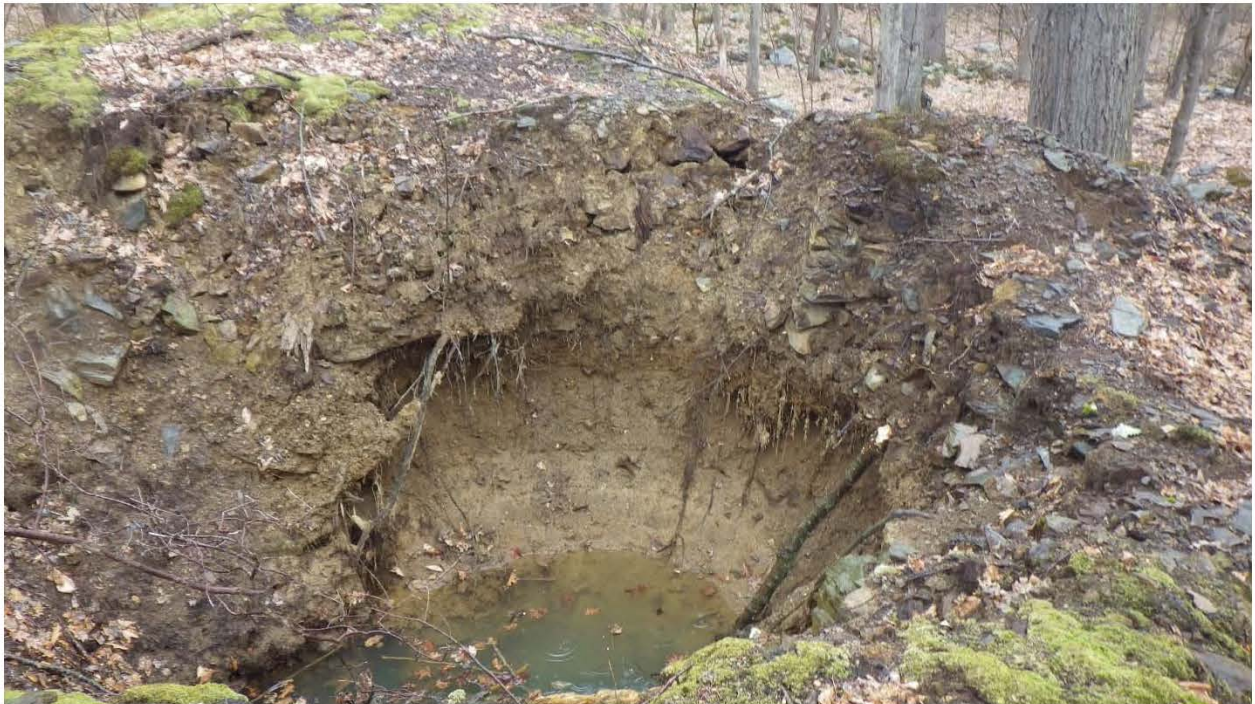
Photo 6: Pit 3

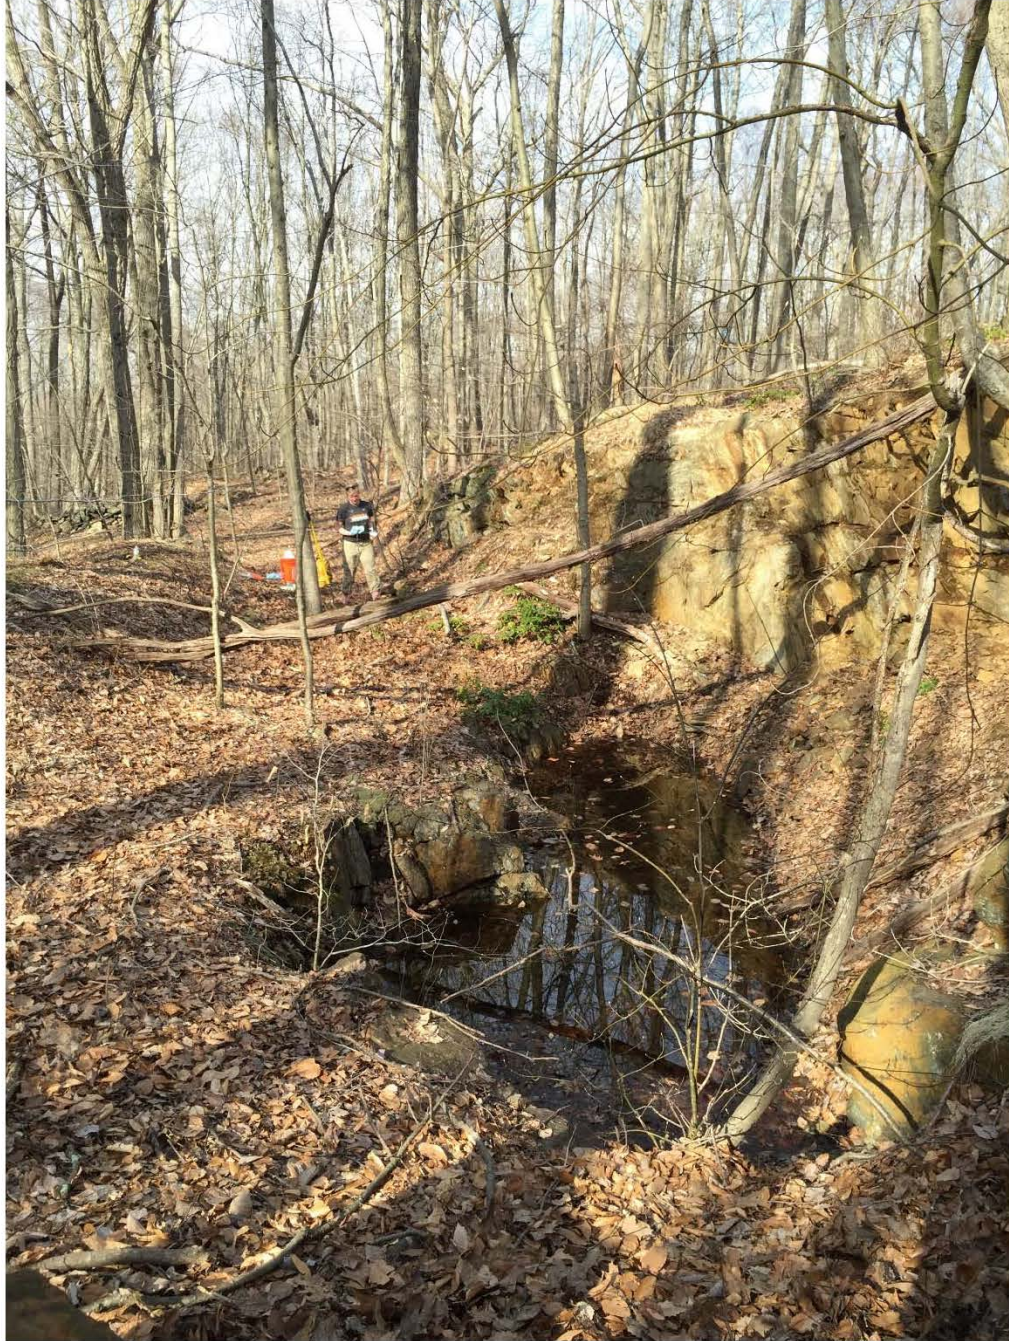
Photo 9: Pit 4 – Looking Northeast

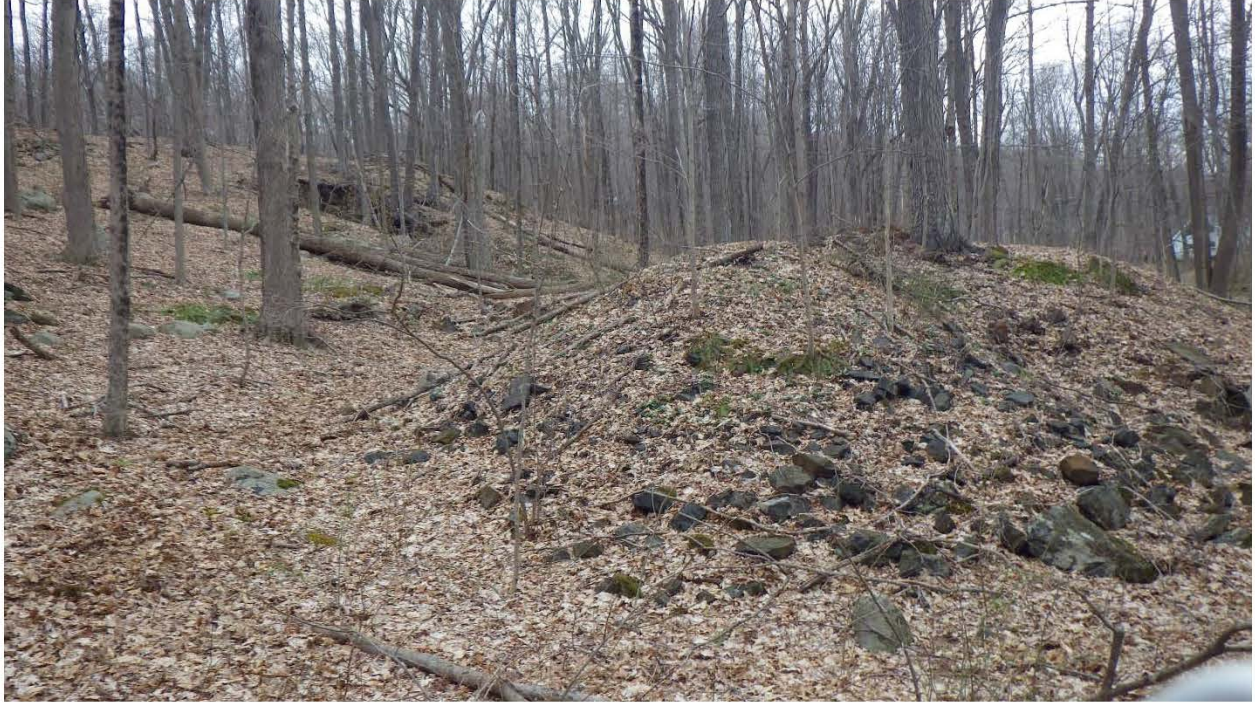
Photo 3: Mine 1 - Tailings Pile Looking Northeast

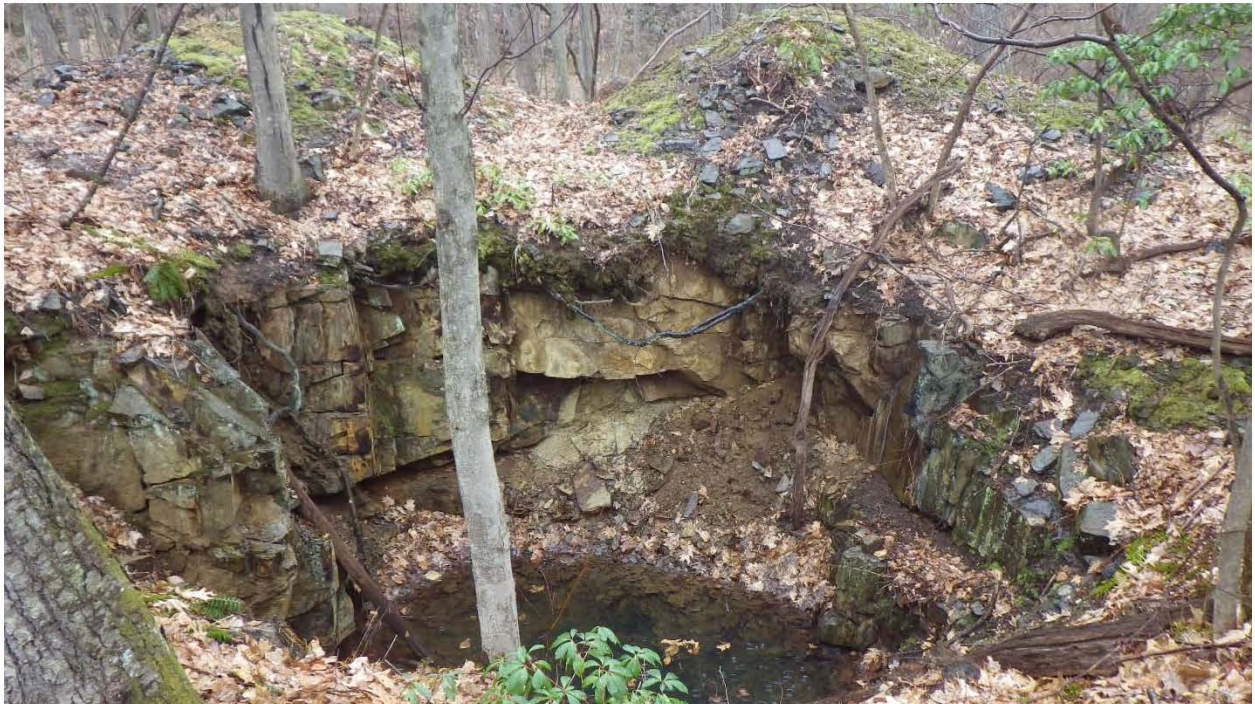
Photo 4: Pit 2

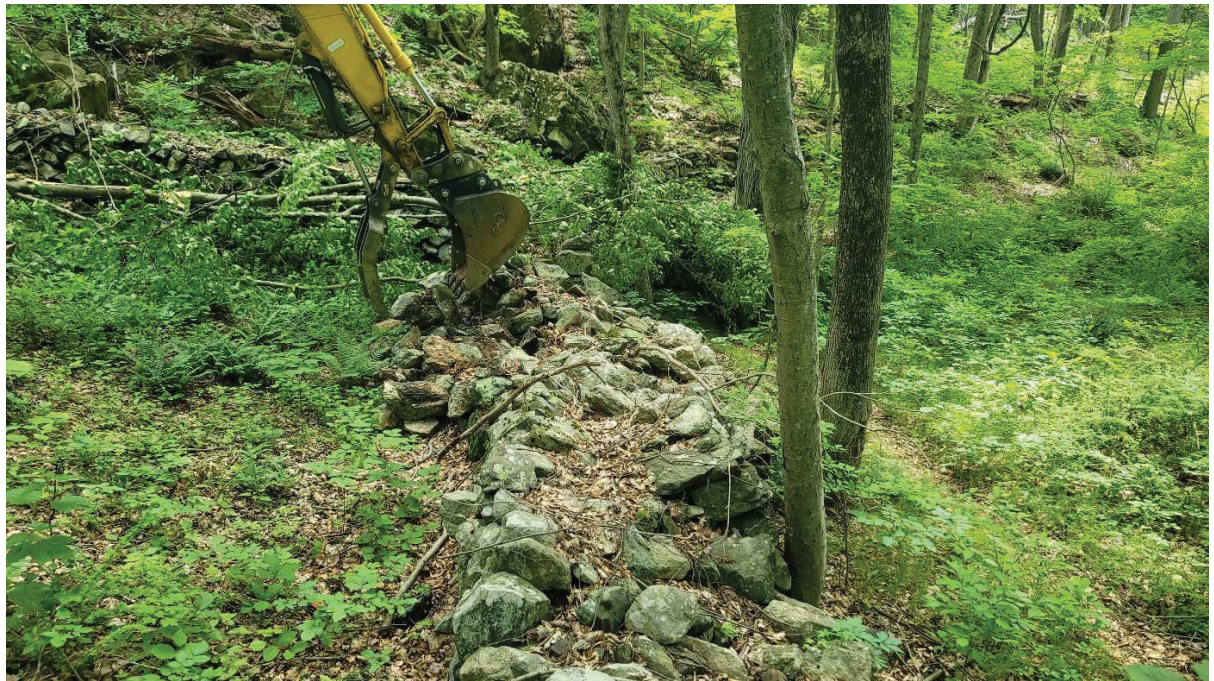
Creating a path
into the pit mines
and moving crane
mats to assist in
water crossing.

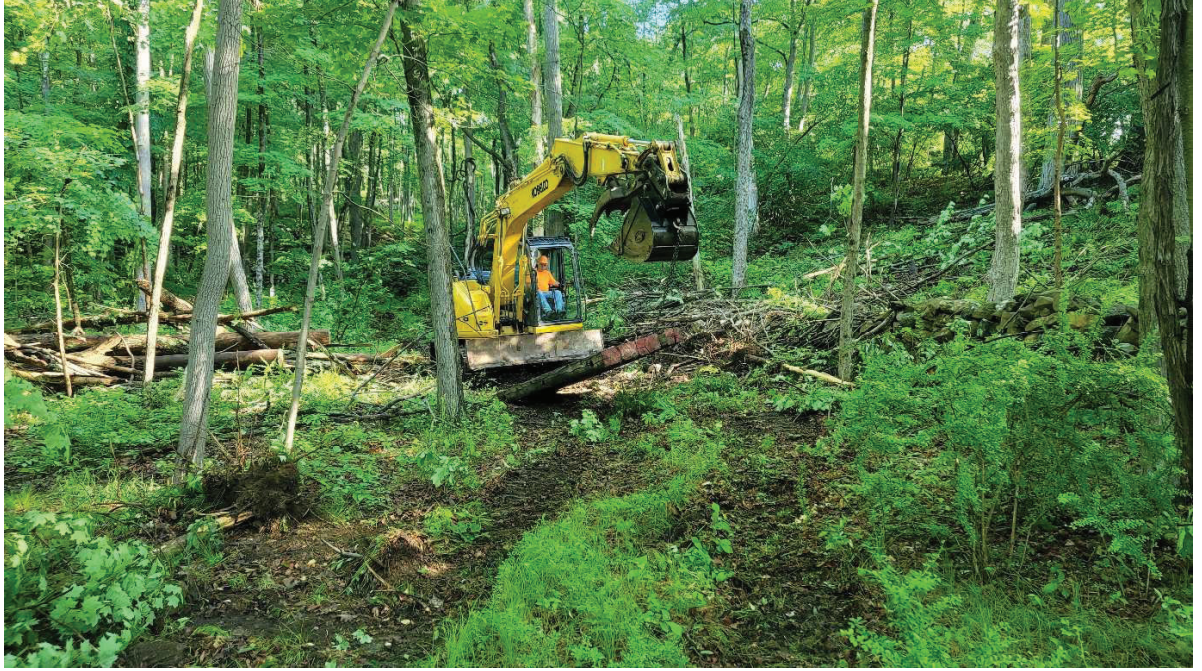
Clearing trees
around
Pit #3 and
beginning to
push in spoils
piles.

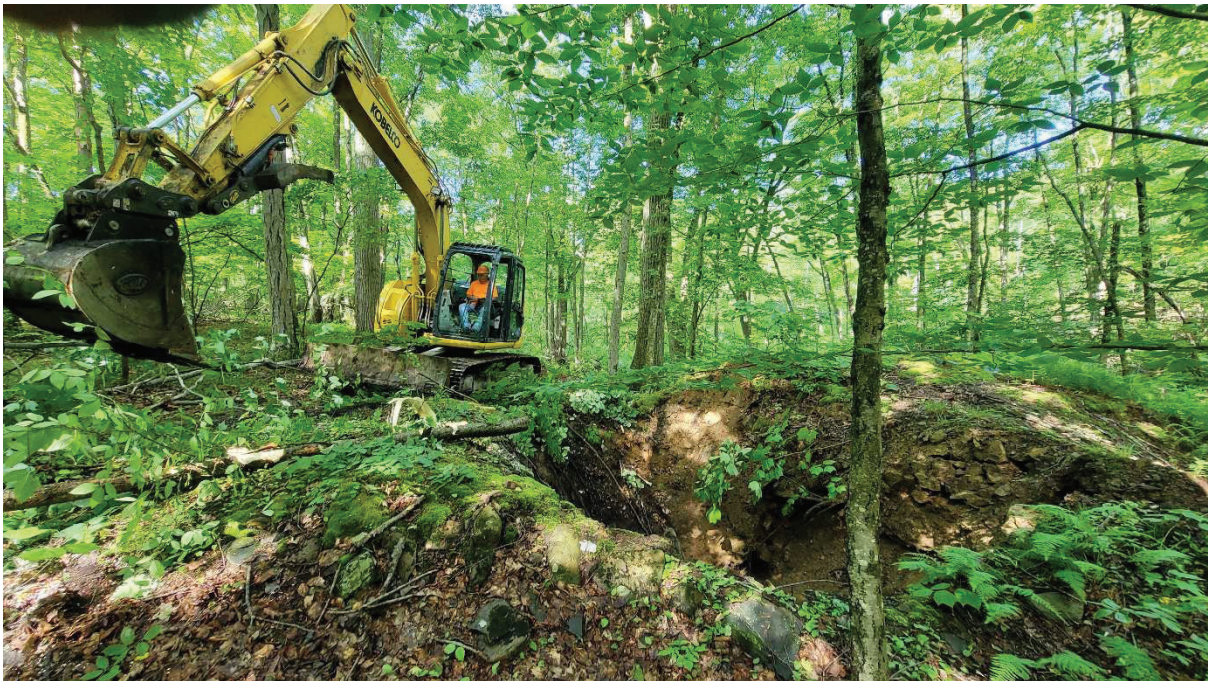
Subject:
Filling Pit #3 with
spoils and trees.

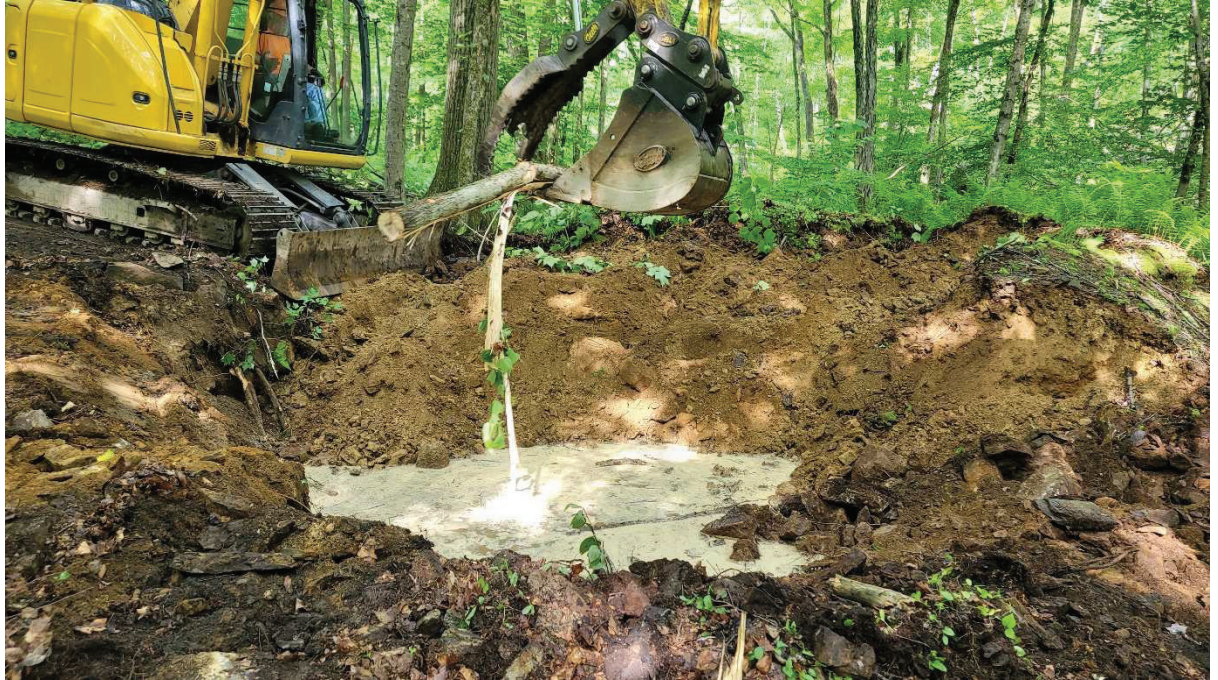
Subject:
Preparing to
remove trees and
fill Pit #2.

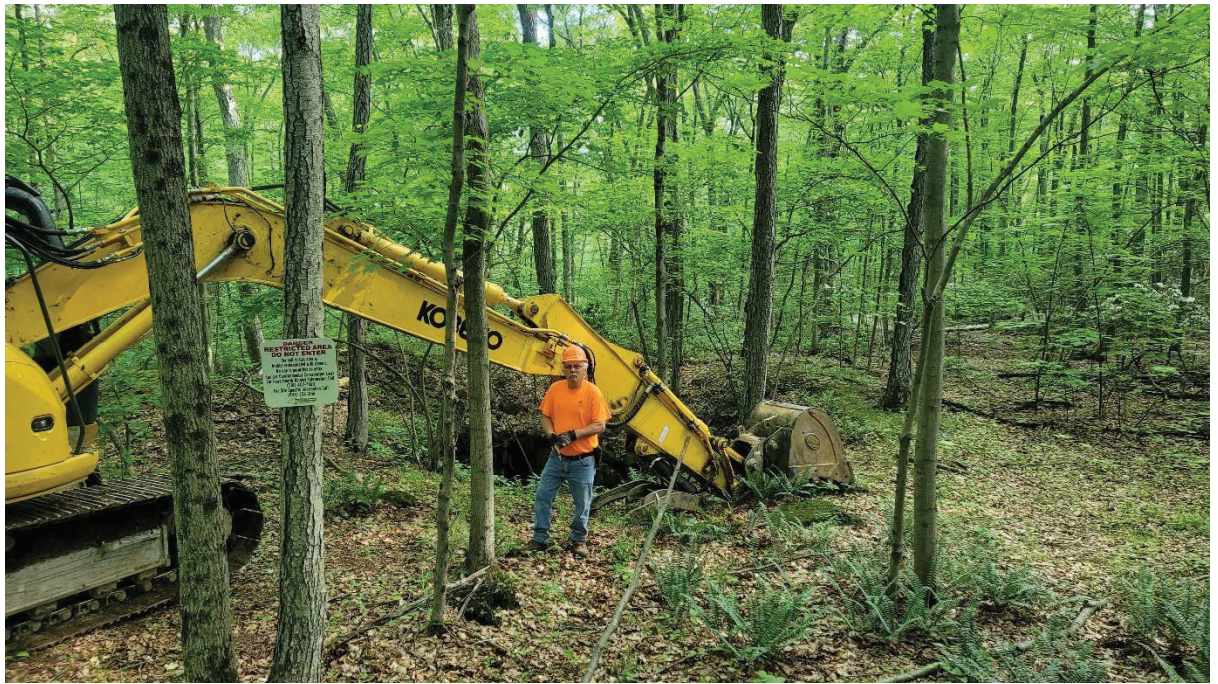
<p><u>Date:</u> June 10, 2021</p>	 
<p><u>Direction:</u> Northeast</p>	
<p><u>Subject:</u> Filling Pit #2 with spoils and trees.</p>

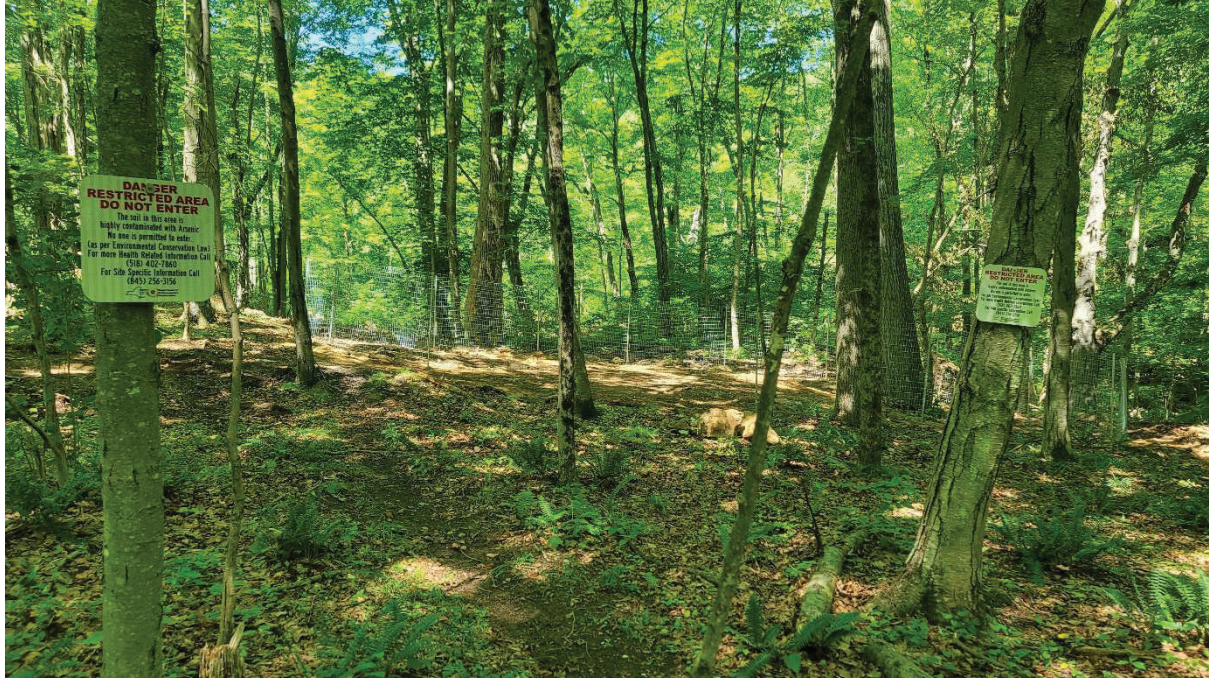
Subject:
View of Pit #2
with fence
installed.
